## BAT SURVEY AT

St Bees Methodist Chapel

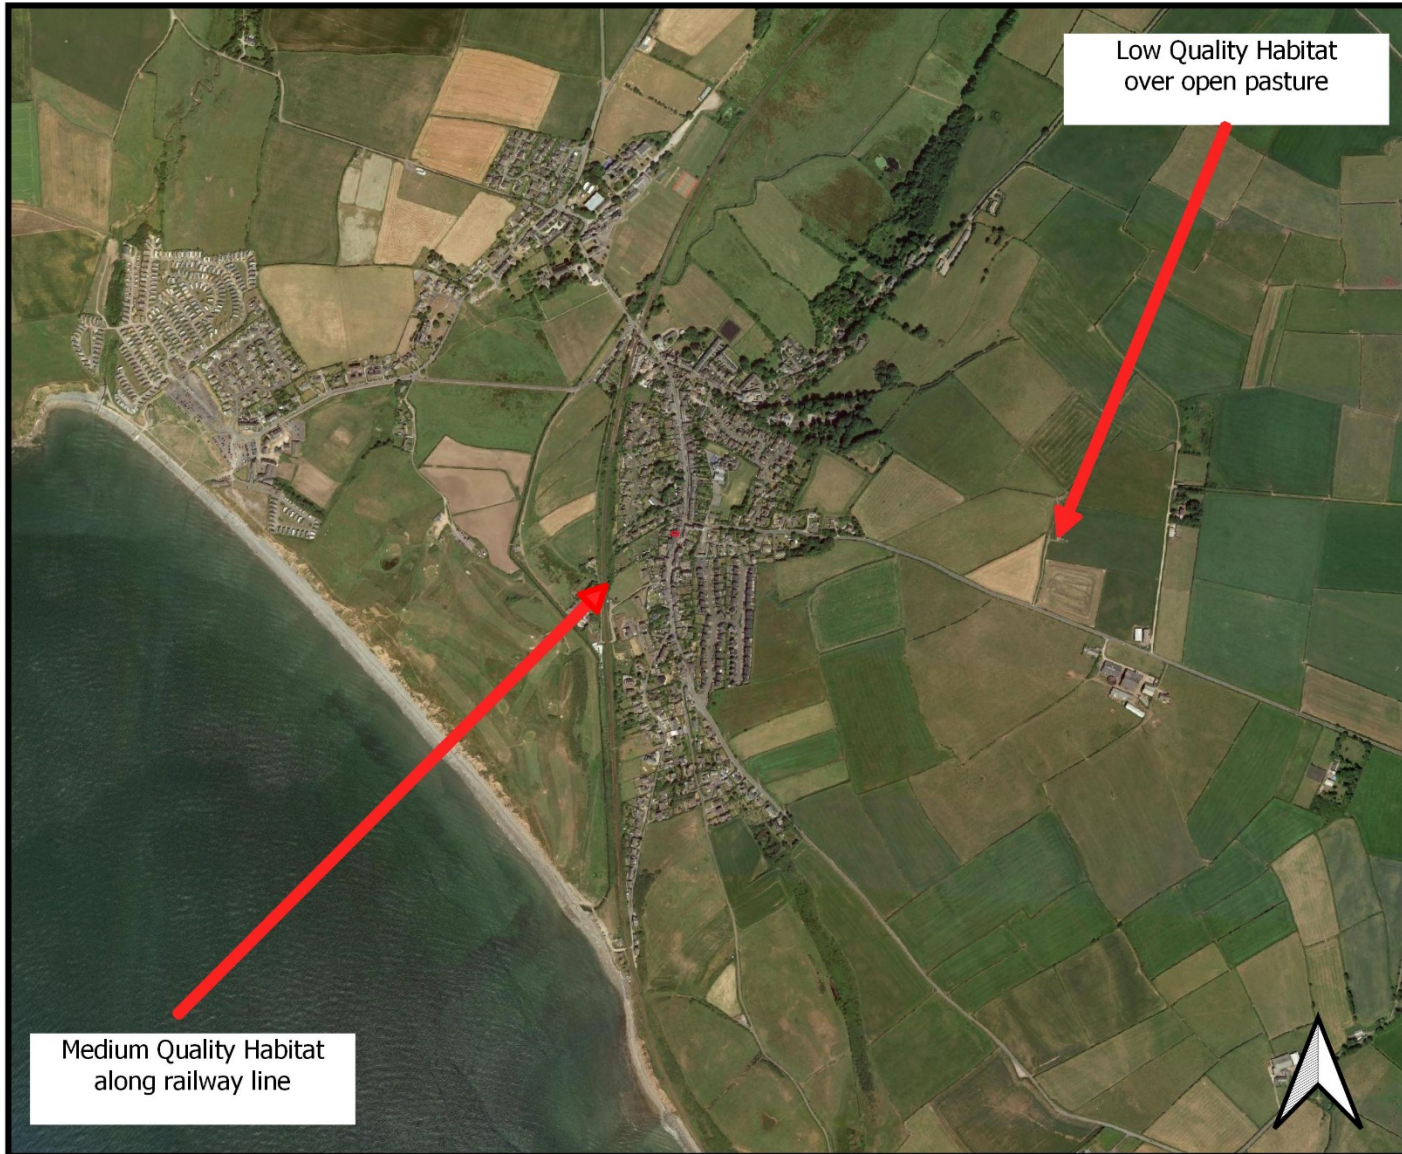
Figure 5

The habitat at and adjacent to the site was assessed from satellite imagery this was then ground truthed, Figure 5.

The habitat on and adjacent to the site identified from satellite images was ground truthed. Details of the habitats found on and adjacent to the site are detailed in Figure 5.

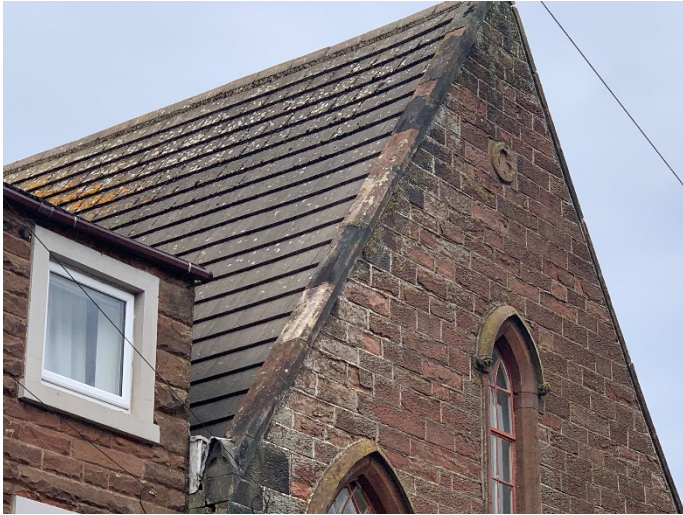
The roof of the building is made from tiles. The roof coverings appear tight fitting, the roof pitch is steep. The North elevation could not be fully seen from the ground as it is blocked by adjacent buildings. If it is in the same condition as the rest of the building, and there are no indications it is not, it will also be fully sealed.

The tile roof is fully sealed and very steep

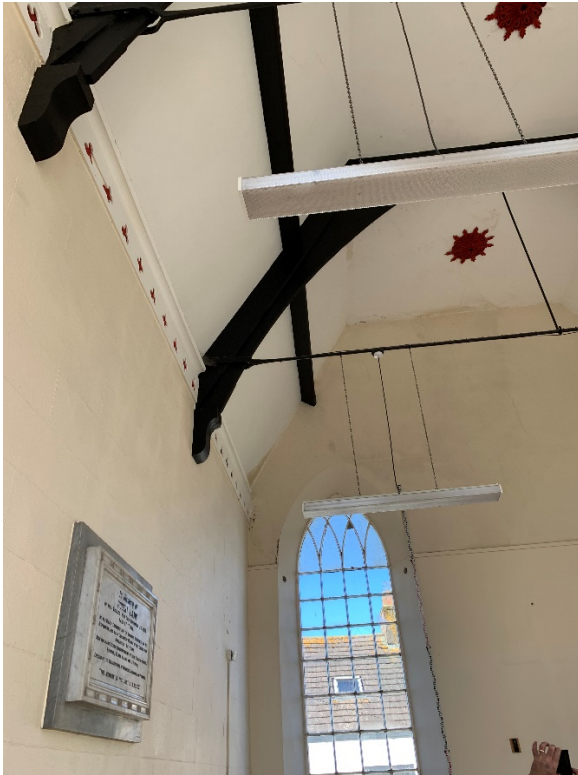
The internal rooms are vaulted
