Summary Information Report

To support the Demolition of Calder Control Rod Mechanism Workshop

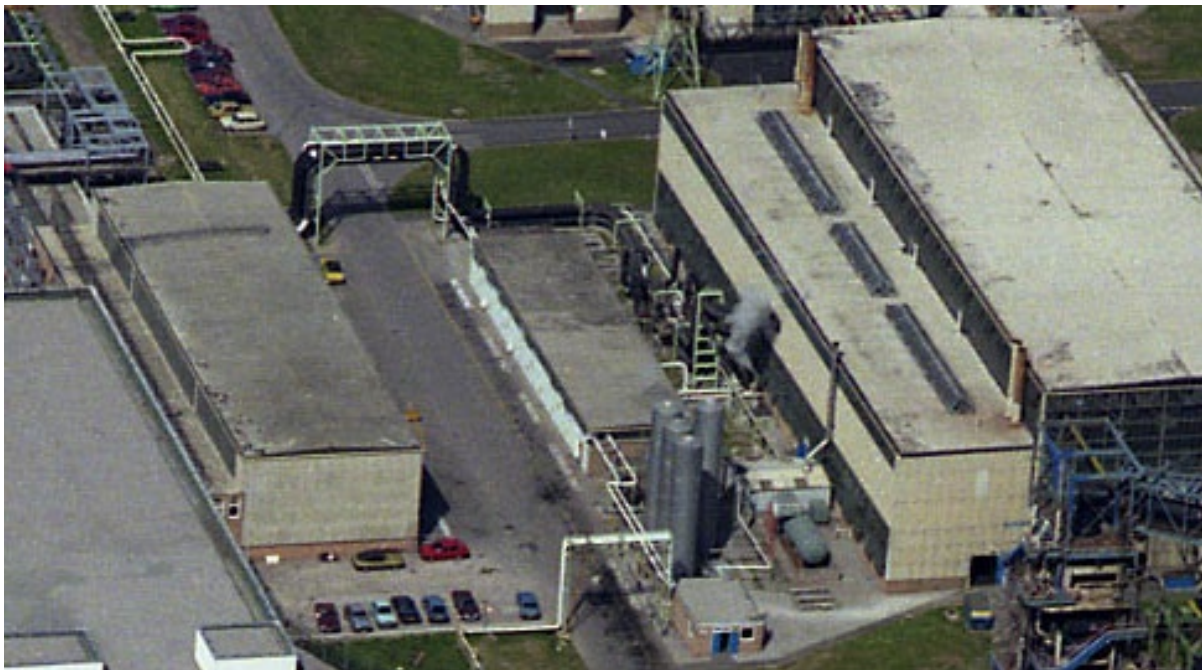
The CRMW building in 1984 with the original bulk CO₂ storage tanks at the south end. To the east is Turbine Hall A and to the west across the road is the Engineering Workshop.

The Control Rod Mechanism Workshop (CRMW) was built in 1956 and was originally intended to be used as a carbon dioxide store. This appeared to be the buildings' sole purpose until around 1991 when the original gas storage tanks were removed, and newer replacement bulk CO₂ storage tanks were located at the south end of the building. In addition to this, a small area at the northwest corner of the building was partitioned off for the construction of a control room for supplying gas to the turbine hall.

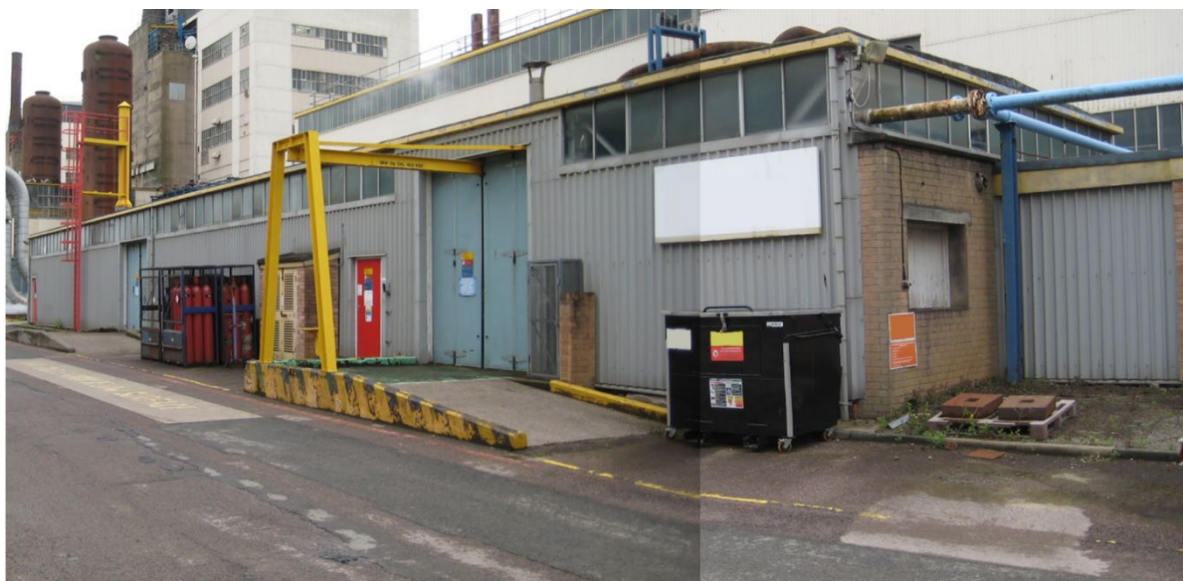
The CRMW in 2018 showing the west elevation and the lifting beam on that side.

The CRMW is located to the East of the Calder Engineering Workshop and to the West of Turbine Hall A. The building is approximately 38m long, 9m wide and 5m high, externally the building has metal cladding to the longitudinal elevations. The gable elevations are constructed from brickwork supported at the sides and to a central wind post. There are a number of lifting beams internally, these service the loading bay on West elevation (see photo above).
