Arboricultural Impact Assessment

**Millom School, Salthouse Road,
Millom, Cumbria, LA18 5AB**

**ARBORICULTURAL IMPACT ASSESSMENT
MILLOM SCHOOL, SALTHOUSE ROAD, MILLOM**

Project No.: BTC2691

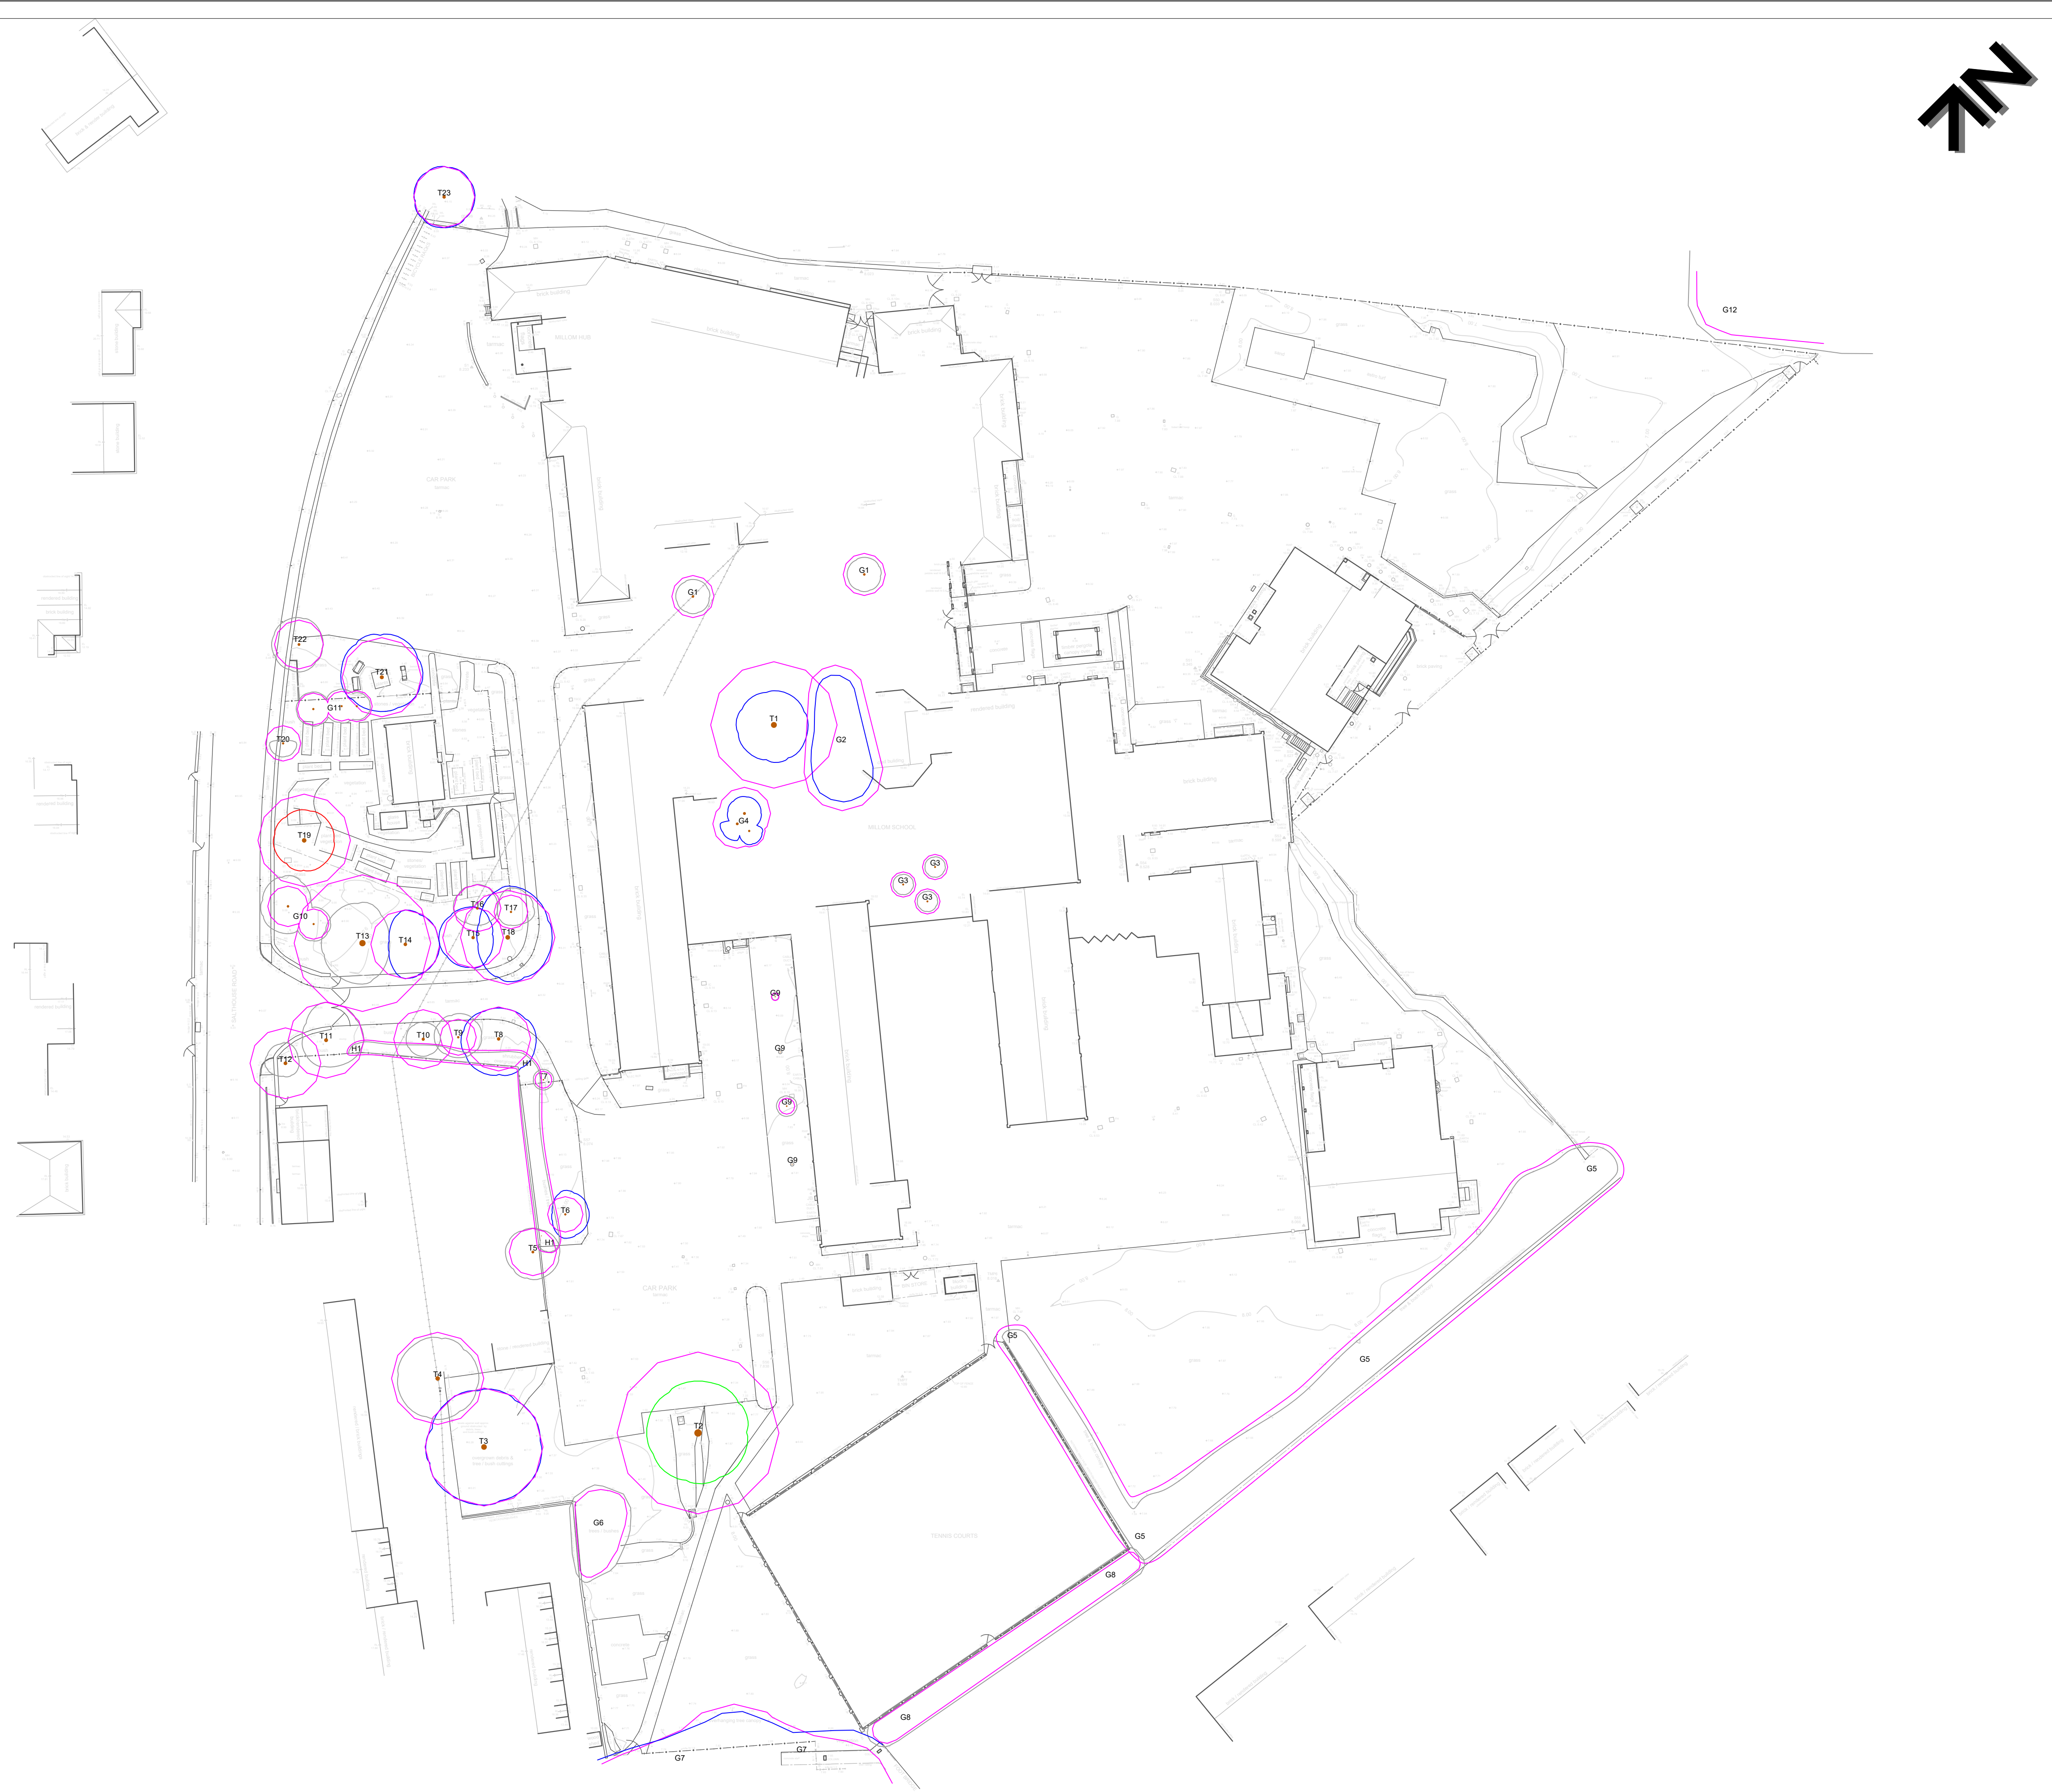
Title:
TREE CONSTRAINTS PLAN
in Relation to Various Development Proposals

Note: The locations of the trees T1, T8 and T12, and the groups of trees G1-G8 and G12 were not included on the topographical survey plan provided, and were subsequently plotted by the arboriculturist at the time of the survey using GPS and, where possible, measurement from existing site features or, where not possible, estimation. As such, the locations of these trees and the locations and extents of the groups cannot therefore be considered to be entirely accurate

RPAs
Area(s) of Ground Around Trees that Should be Protected Throughout Development Works with Protective Fencing to form a Construction Exclusion Zone - see Temporary Protective Fencing Specification

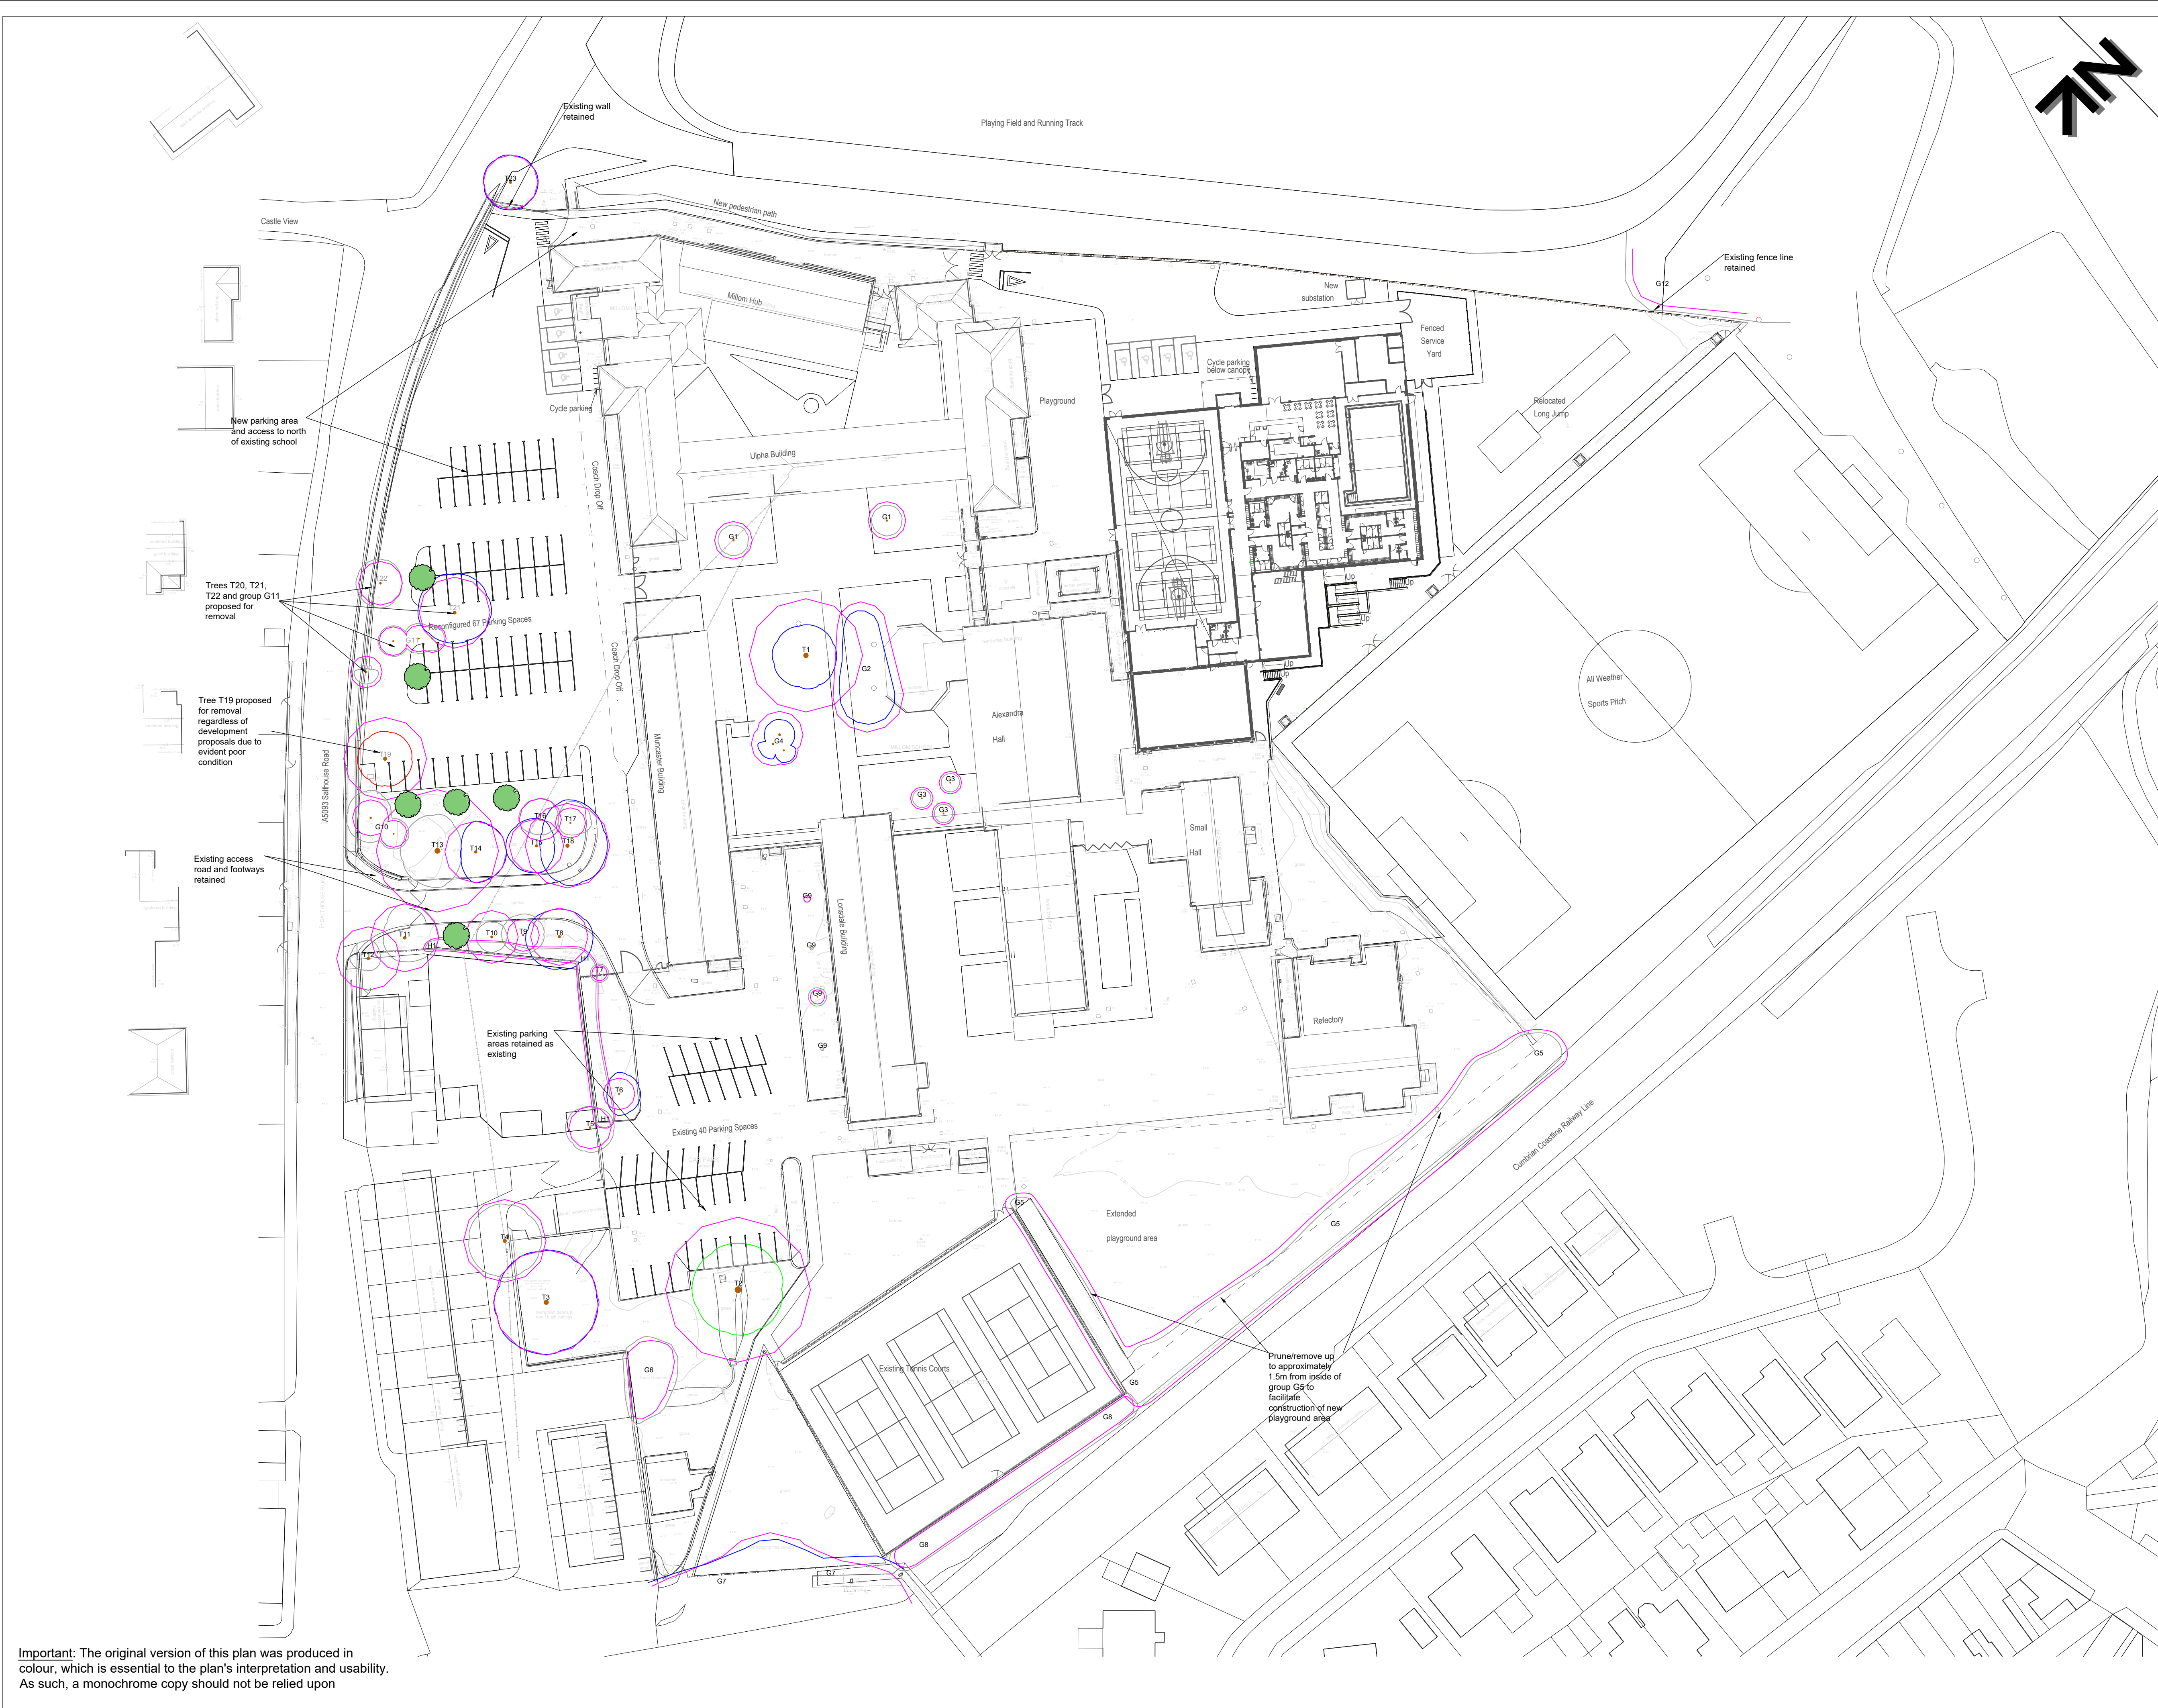
Title:
TREE IMPACT PLAN
in Relation to Various Development Proposals

Note: The locations of the trees T1, T8 and T12, and the groups of trees G1-G8 and G12 were not included on the topographical survey plan provided, and were subsequently plotted by the arboriculturist at the time of the survey using GPS and, where possible, measurement from existing site features or, where not possible, estimation. As such, the locations of these trees and the locations and extents of the groups cannot therefore be considered to be entirely accurate

RPAs
Area(s) of Ground Around Trees that Should be Protected Throughout Development Works with Protective Fencing to form a Construction Exclusion Zone - see Temporary Protective Fencing Specification

Suggested Approximate Indicative Locations for New Tree Planting, with Trees of Species of Suitable Species for Locations. NB: New Tree Planting to be Included in a Landscape Proposal Plan
