Client: Thomas Armstrong

Site: Land at Griffin Close
Frizington
Cumbria
CA26 3SH

Tree Survey and Impact Assessment

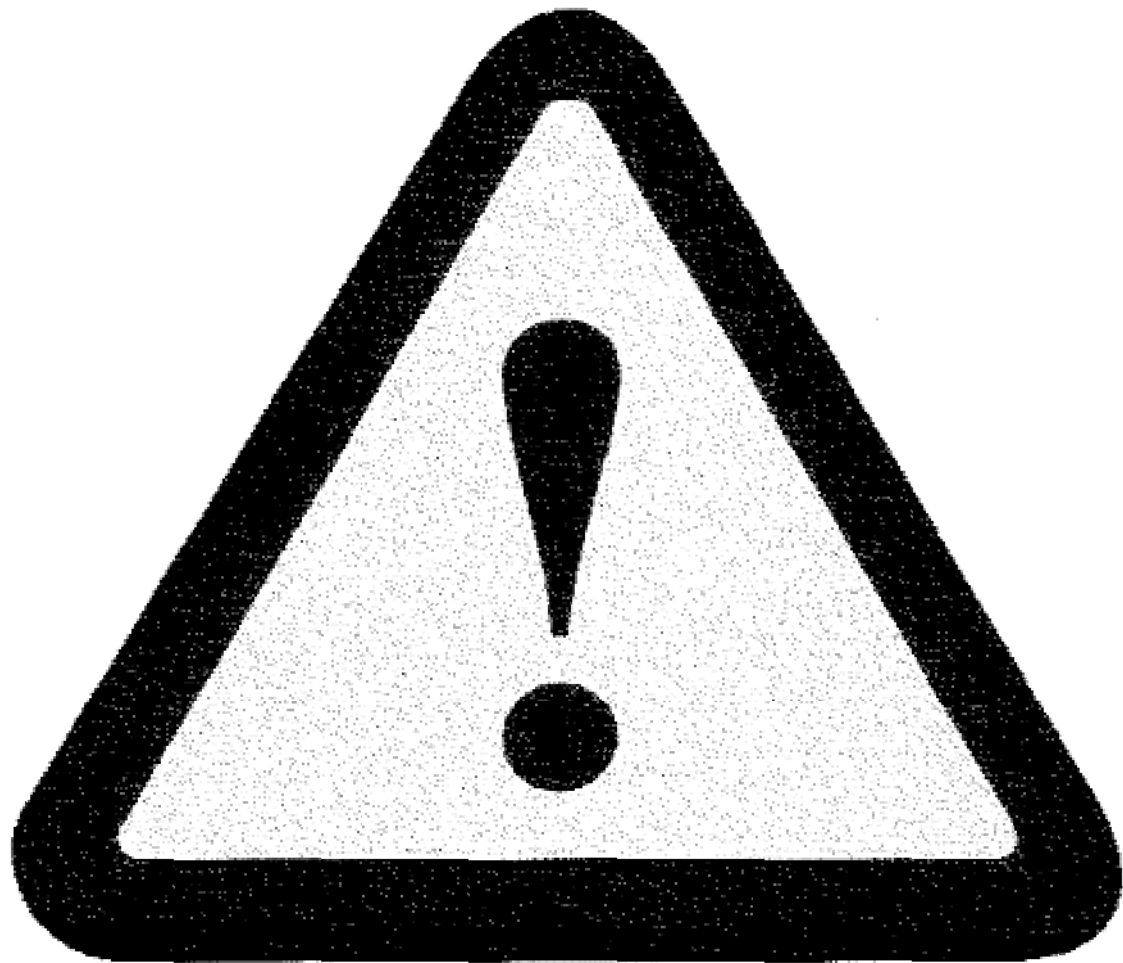
**TREE PROTECTION
AREA**

KEEP OUT!

**ANY INCURSION INTO THE PROTECTED AREA MUST BE WITH THE
AGREEMENT OF THE LOCAL AUTHORITY OR ARBORICULTURAL
CONSULTANT**
