# West Cumberland Hospital

## Ground Investigation Report

Curtins Ref: 073983-CUR-00-XX-RP-GE-002

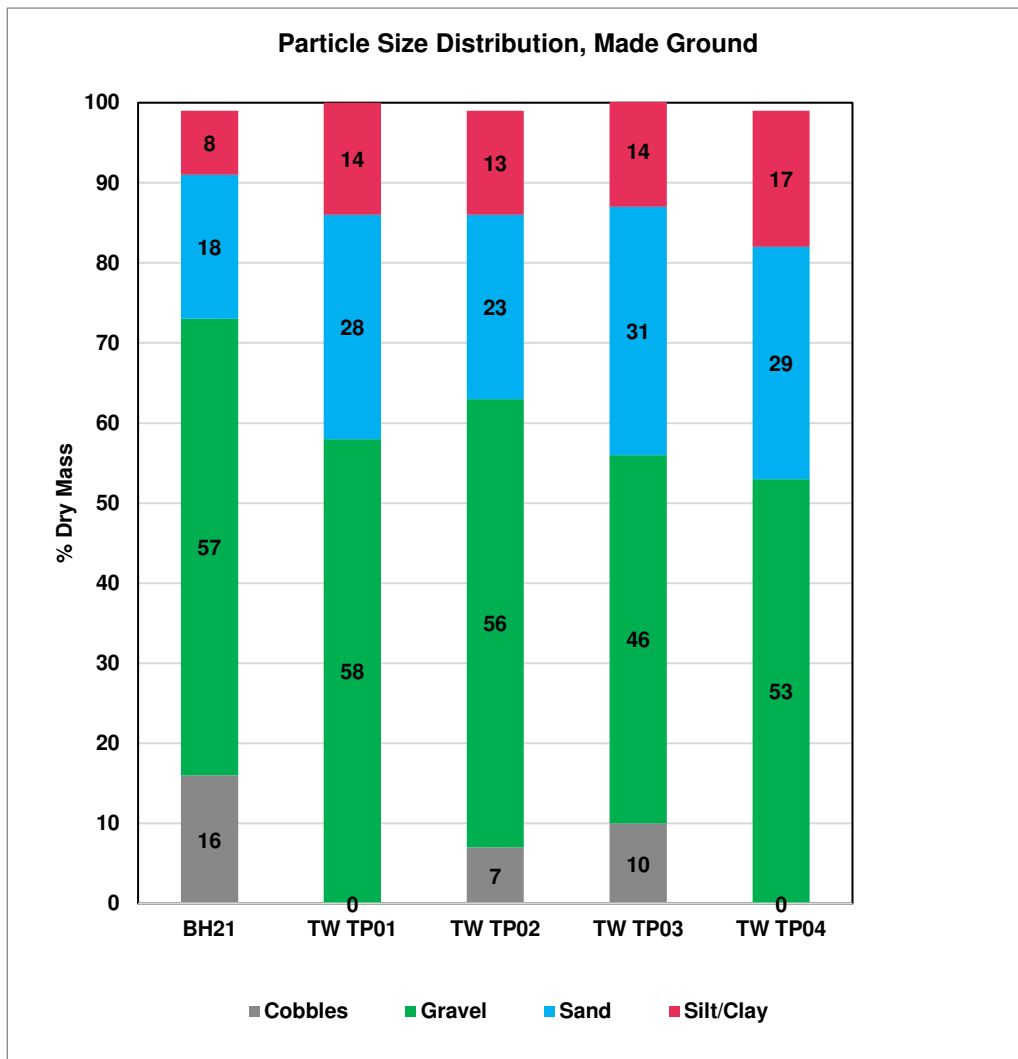
**Figure 5.3a** – Summary of PSD test results in Made Ground.

Uniformity coefficients generally have tested as being greater than 170.
