West Cumberland Hospital

Ground Investigation Report

Curtins Ref: 073983-CUR-00-XX-RP-GE-002

Revision: 03

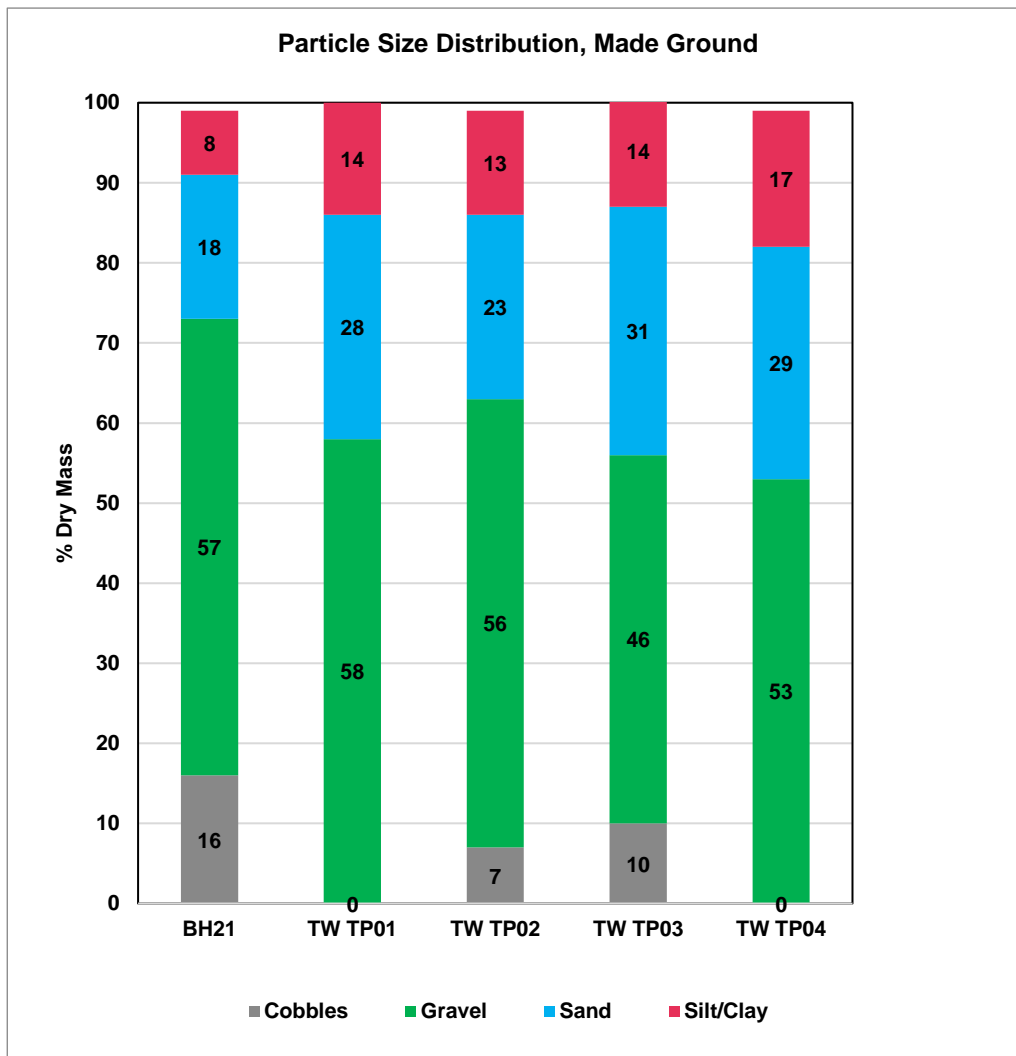
Figure 5.3a – Summary of PSD test results in Made Ground.

Uniformity coefficients generally have tested as being greater than 170.

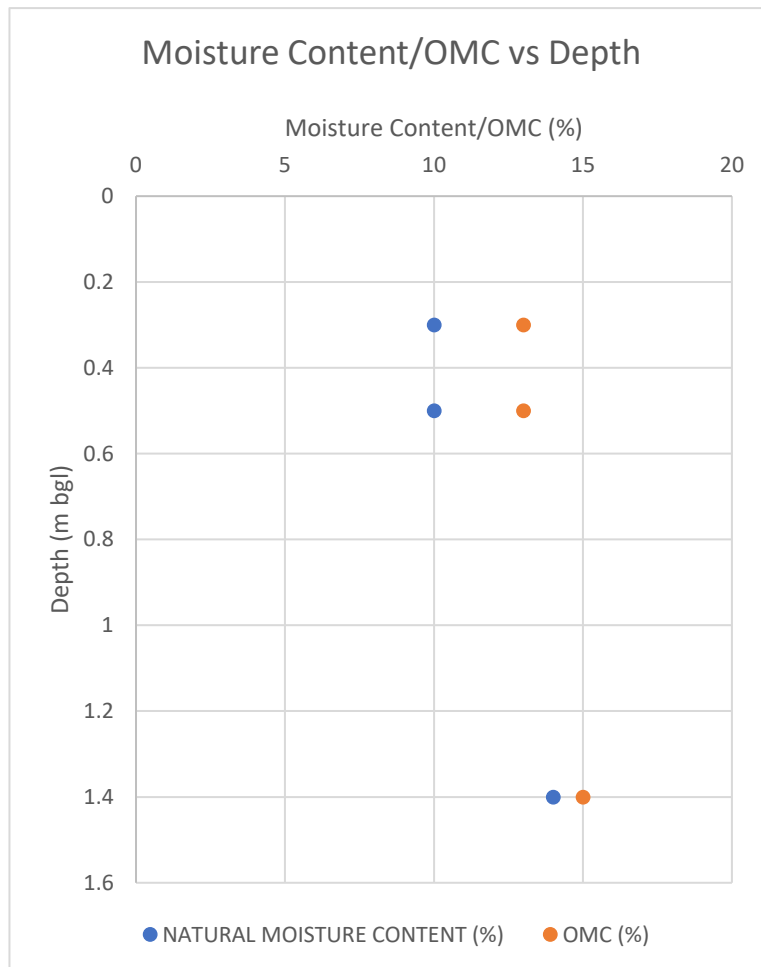
Figure 5.3b – Made Ground Moisture Content and OMC vs. Depth

Natural moisture content (MC) and Optimum Moisture Content (OMC) tests have been undertaken on made ground samples obtained on site with the results summarised in Table 5.3c and Figure 5.3b.

Exploratory Hole Location	Depth (m bgl)	Moisture Content %
TW TP01	0.5-0.6	10
TW TP02	0.3-0.4	10
TW TP04	1.40-1.50	14

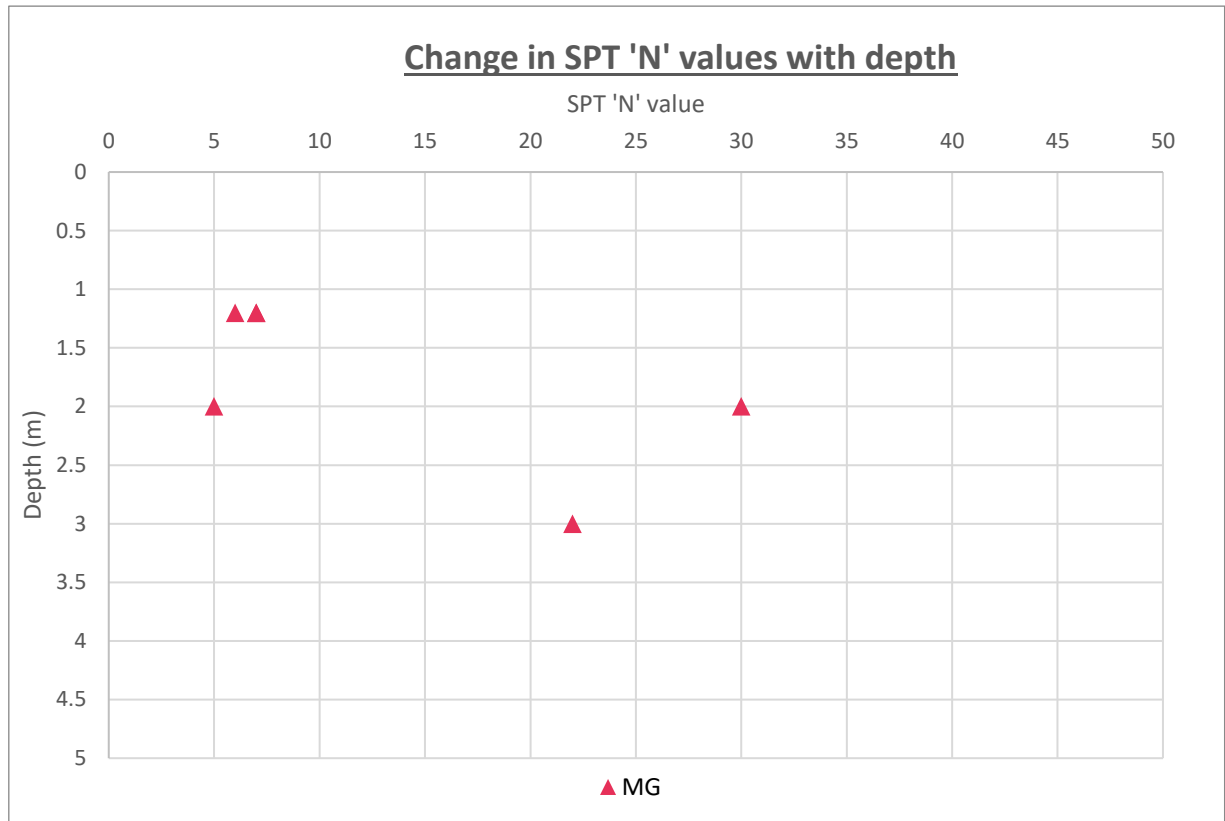
Figure 5.3c – Graph showing changes in SPT results with depth in Made Ground.

Due to the small cohort of results within both cohesive and granular Made Ground, the graph above shows highly variable strength within Made Ground material with depth but does generally increase with depth.

On-situ SPTs within the made ground indicate a highly variable stratum as shown in Figure 5.3c

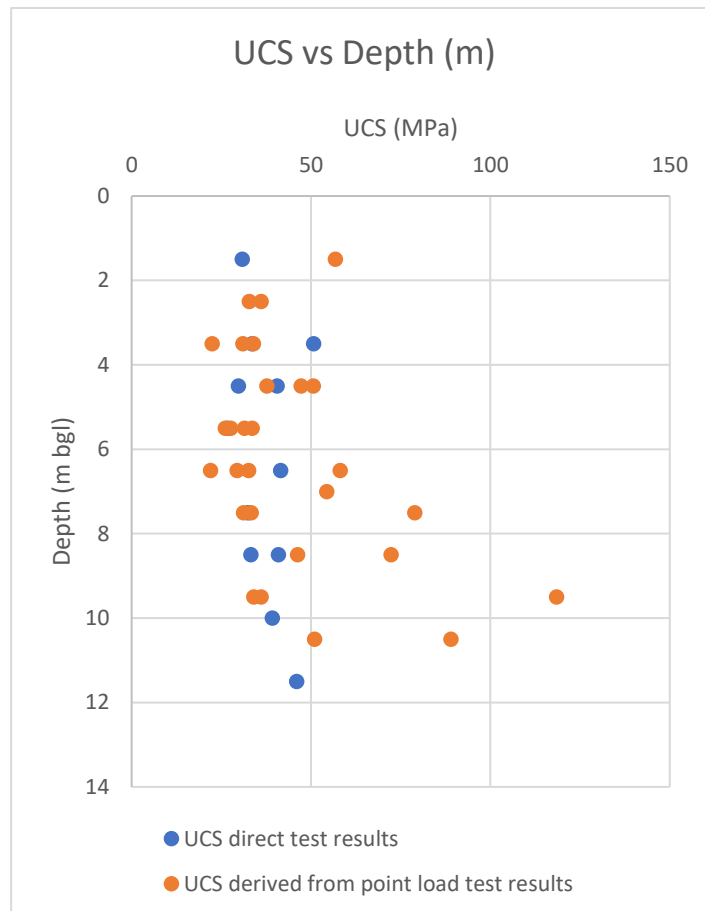
Figure 5.5 UCS vs. Depth

UCSs were determined from the Unconfined Compressive Strength (UCS) test results and Point Load test results. A factor of 20 has been used to correlate the I_{s50} determined from the Point Load tests to the UCS, Figure 5.5.

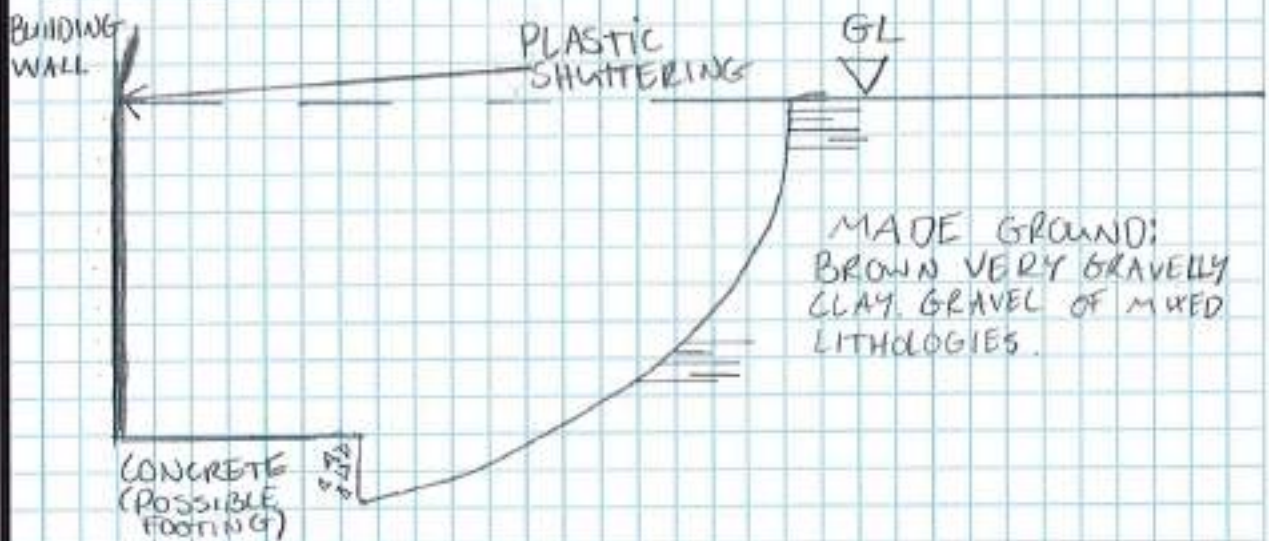
H005 SECTION

- NOT TO SCALE
- THICKNESS OF CONCRETE NOT PROVEN.
- FORMATION STRATA NOT PROVEN.

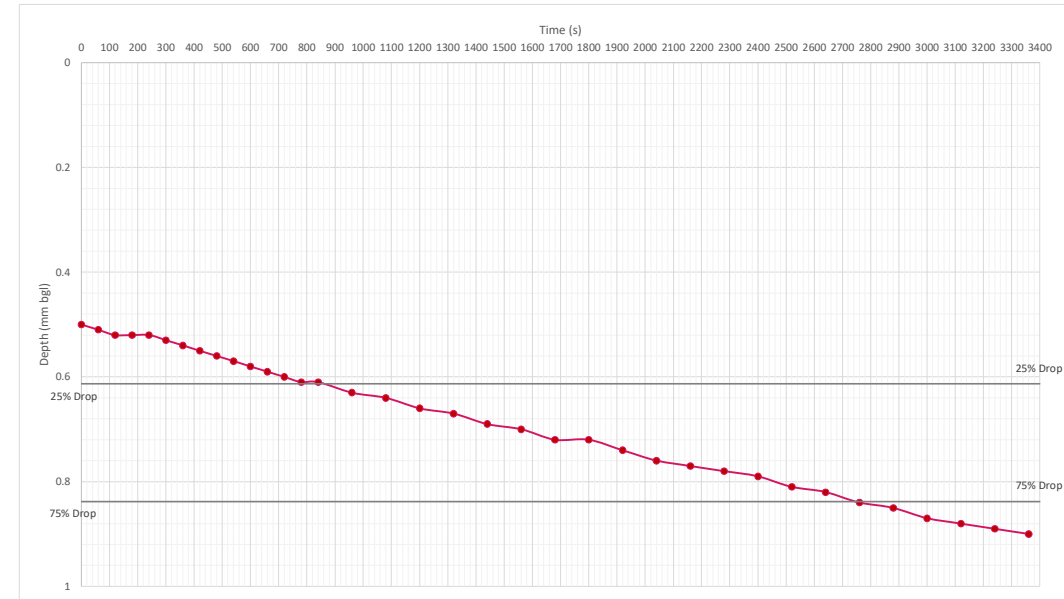
c	Time (min)	u _i	Time (s)	Depth (mm bgl)	Stratum
	0		0	0.5	Grey medium to coarse grain crystalline SANDSTONE
	1		60	0.51	
	2		120	0.52	
	3		180	0.52	
	4		240	0.52	
	5		300	0.53	
	6		360	0.54	
	7		420	0.55	
	8		480	0.56	
	9		540	0.57	
	10		600	0.58	
	11		660	0.59	
	12		720	0.6	
	13		780	0.61	
	14		840	0.61	
	16		960	0.63	
	18		1080	0.64	
	20		1200	0.66	
	22		1320	0.67	
	24		1440	0.69	
	26		1560	0.7	
	28		1680	0.72	
	30		1800	0.72	
	32		1920	0.74	
	34		2040	0.76	
	36		2160	0.77	
	38		2280	0.78	
	40		2400	0.79	
	42		2520	0.81	
	44		2640	0.82	
	46		2760	0.84	
	48		2880	0.85	
	50		3000	0.87	
	52		3120	0.88	
	54		3240	0.89	
	56		3360	0.9

Note 1: Pit backfilled with arisings.
