Persimmon Homes

REMEDIATION STRATEGY

Former Marchon Site, Whitehaven

REPORT No: 22PER008/RS

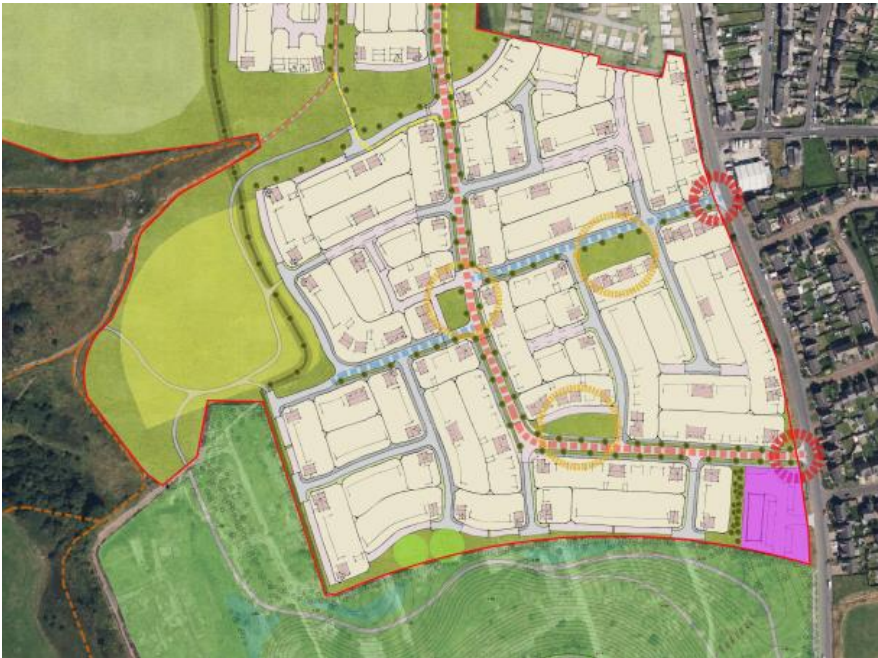
Betts Geo Environmental (Betts) has been commissioned by Persimmon Homes to prepare a Remediation Strategy for the remediation and preparatory works for the former Marchon site redevelopment in Whitehaven. The plan below shows the proposed site layout;

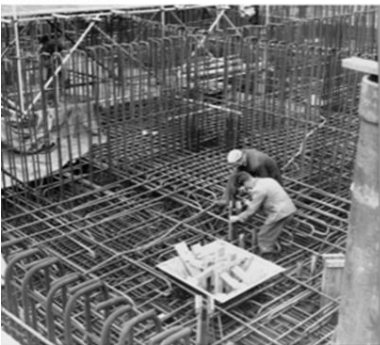
Date: 8 Oct 1953

Workmen constructing formwork for the machine base in the kiln building at the Solway Chemical Works in Whitehaven

Buried obstructions are anticipated given the historic site use and SI findings therefore an allowance for breaking out should be allowed for. Examples of archive photos showing typical foundations / structures are shown below:

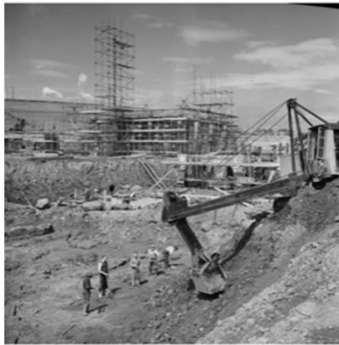
Date: 18 Jul 1953

Construction of the Solway Chemical Works in Whitehaven, showing excavation in progress for the kiln building with limestone being cleared and tested for faults

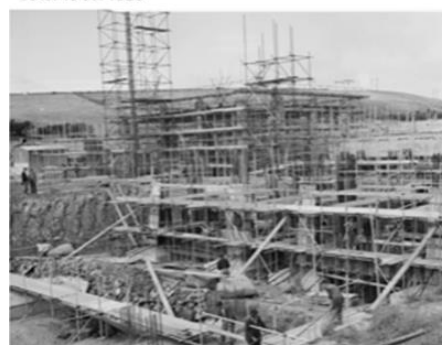
Date: 18 Jul 1953

A view of construction in progress at the Solway Chemical Works in Whitehaven
