FORESHORE AND CLIFF ACTION MANAGEMENT PLAN

COASTAL & CLIFF ACTION MANAGEMENT PLAN

Revision: A (04.10.11)

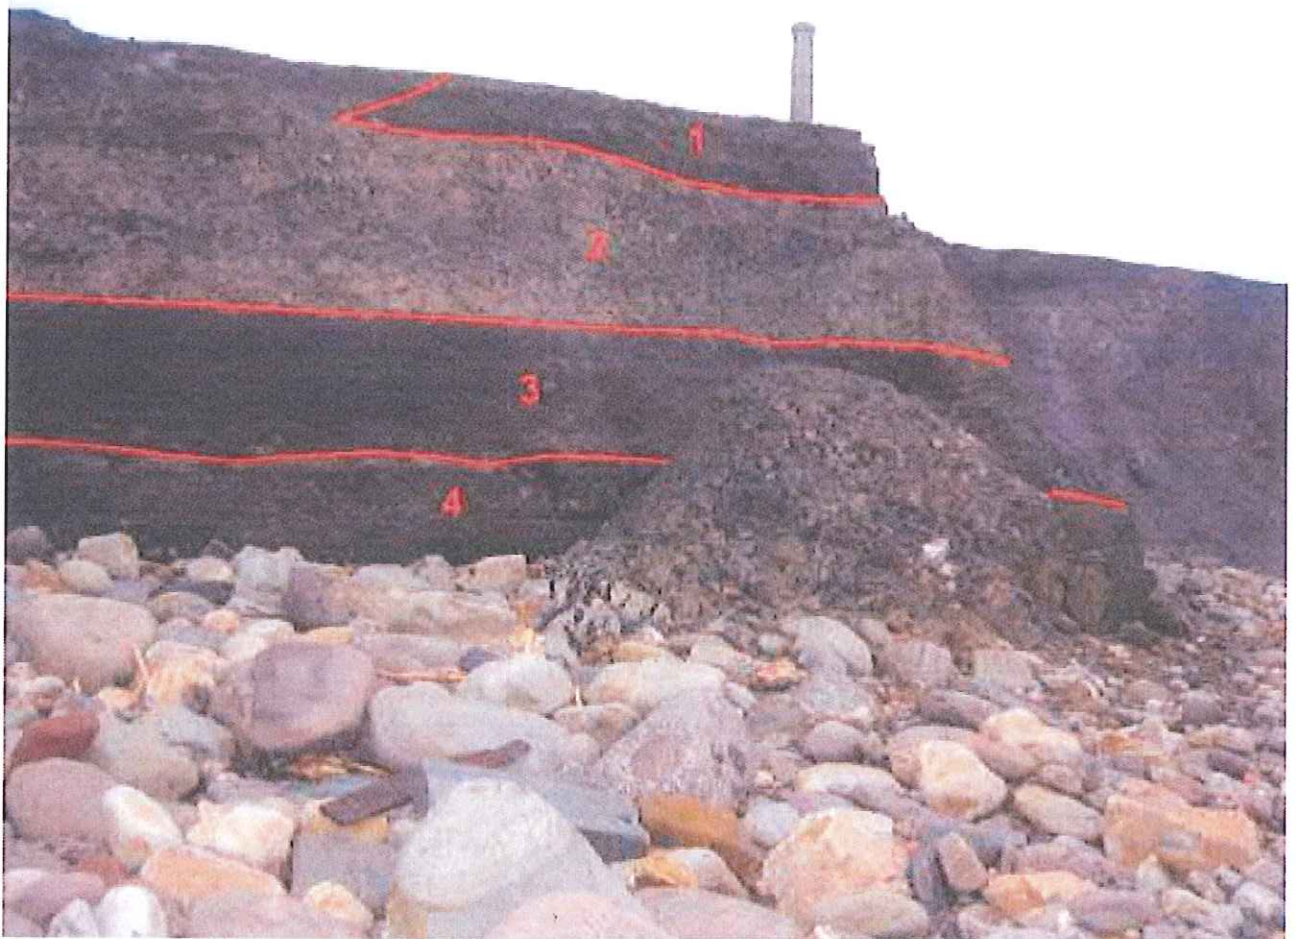
Following on from the survey, a number of observations were made of the geological succession near the site. The landslide occurred in colliery spoil material, which showed a distinct stratigraphy (layering), with four identifiable units. Brief descriptions of each unit, based upon inspection of material at the cliff face are given below

Due to the nature of the material and the mechanism of land sliding the landslide can be classified as a debris fall. Rainfall figures for November and December 2006 were 125 to 150% and 175 to 200% respectively above the 1961-1990 average (Met Office, 2006 & 2007). This high rainfall had saturated the colliery spoil material, increasing the pore water pressure and causing the material to become unstable. The grassed area above the cliff was observed to be flat and therefore deemed likely to provide poor drainage. This, coupled with prolonged heavy rainfall may have lead to the saturation of the spoil

material. In addition, high tides and rough seas have eroded the cliff, and created a slope beyond the angle at which the material is stable (angle of repose). It is likely that this removal of support by wave action, coupled with the saturated ground has caused the colliery spoil material to become unstable and fail.
