Cleator Moor Conservation Area Appraisal

2021

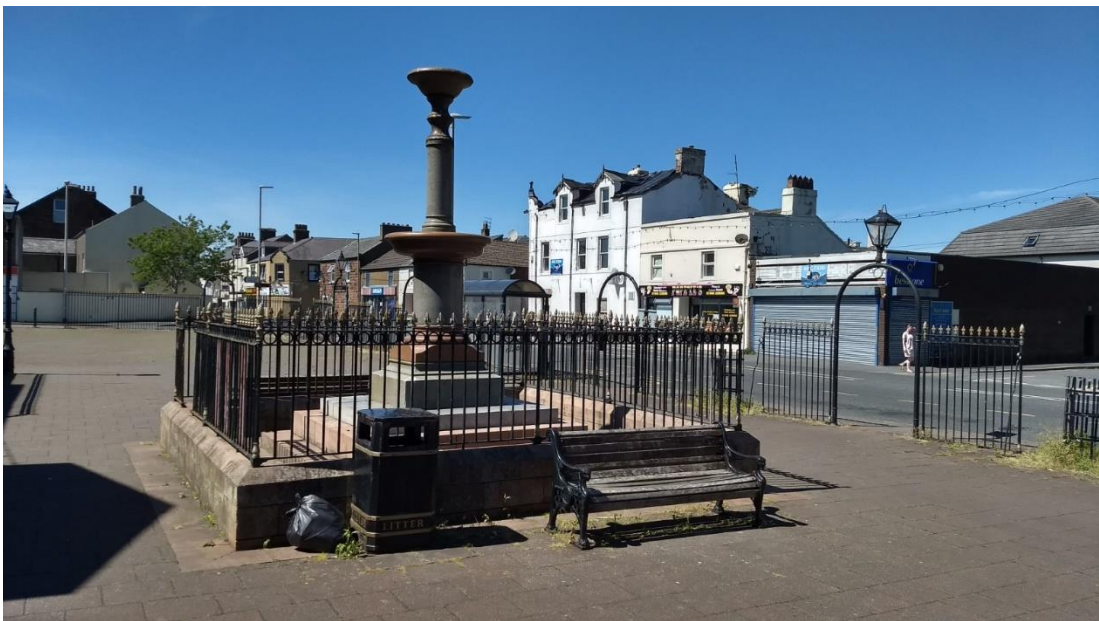
In Market Place, to the front of the Local Government Offices, stands the grade II listed memorial fountain. This is not a war memorial, but a dedication to the town’s benefactor John Stirling on the occasion of his golden wedding anniversary. It dates from 1903, and was originally topped with a finial in the shape of a heron or pelican, which had been lost by the time of listing in 1973. It is conceivable that this still exists somewhere in the locale, but no information about it is currently known.

Figure 10 The 1903 memorial fountain, listed grade II, which used to be topped by a finial shaped like a bird

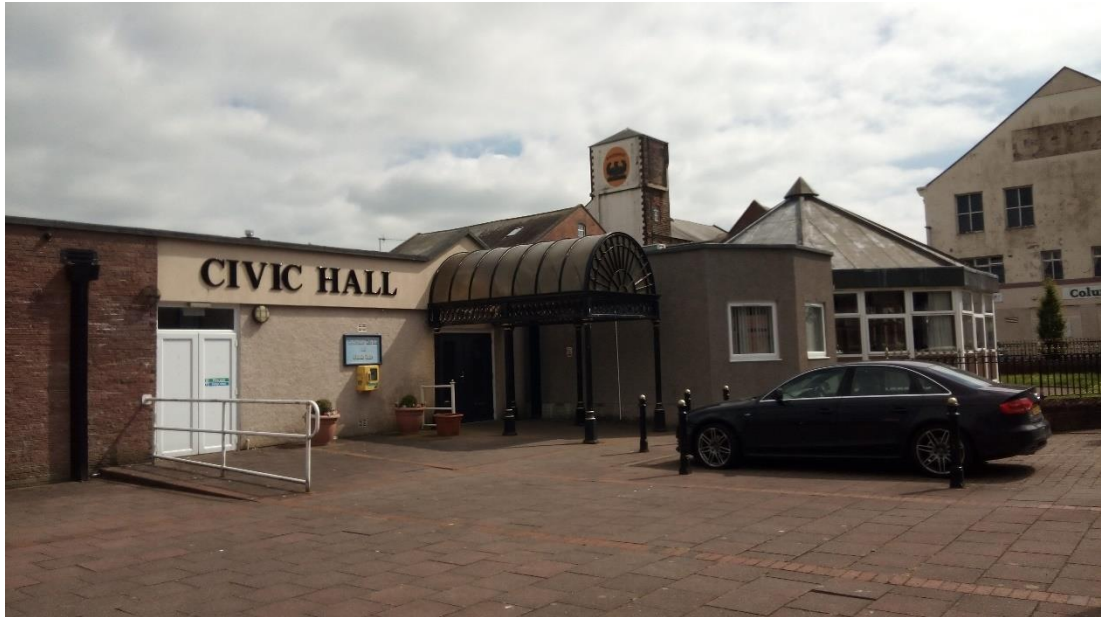
Figure 12 Civic Hall

The impression is further eroded by the Civic Hall, an unfortunate post-war building, the harm of which is fortunately limited by it being only a single storey. It replaced an earlier market hall that dated from the first phase of the Square in 1879 but burnt down in 1966 following its use to a plastics factory.

The current hall does feature an octagonal annexe, which is a slightly interesting addition, although it is not externally detailed to a high standard. Alteration involving higher quality fenestration, coupled with a more attractive solution for the rest of the building, could do much to improve and add definition to the whole rear half of the square, bounded by Jacktrees Road, Cragg Road and Market Street. Most recently, this site has been added to with a meeting room, granted consent in 2007. Interestingly, this building closely resembles a Victorian goods shed. It is in red-orange brick, with coped and kneelered gables, slate roof and semicircular-headed windows. It is of quite minimalist design and sits unobtrusively within its surroundings despite being something of an anachronism, this site never having been used for rail freight.

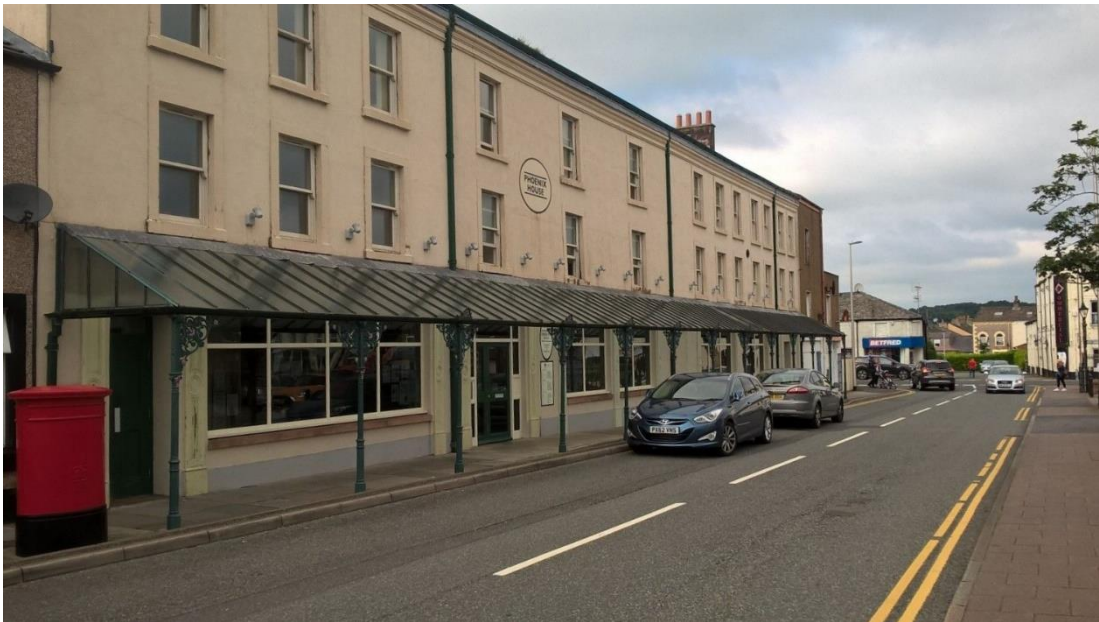
Figure 14 5 Jacktrees Road and its veranda, listed Grade II

The building's current colour scheme, like that of most of the buildings surrounding the square, is very muted, with an essentially white-on-white theme that, while it does accentuate the dark green of the ironwork, fails to add much vivacity to the townscape.

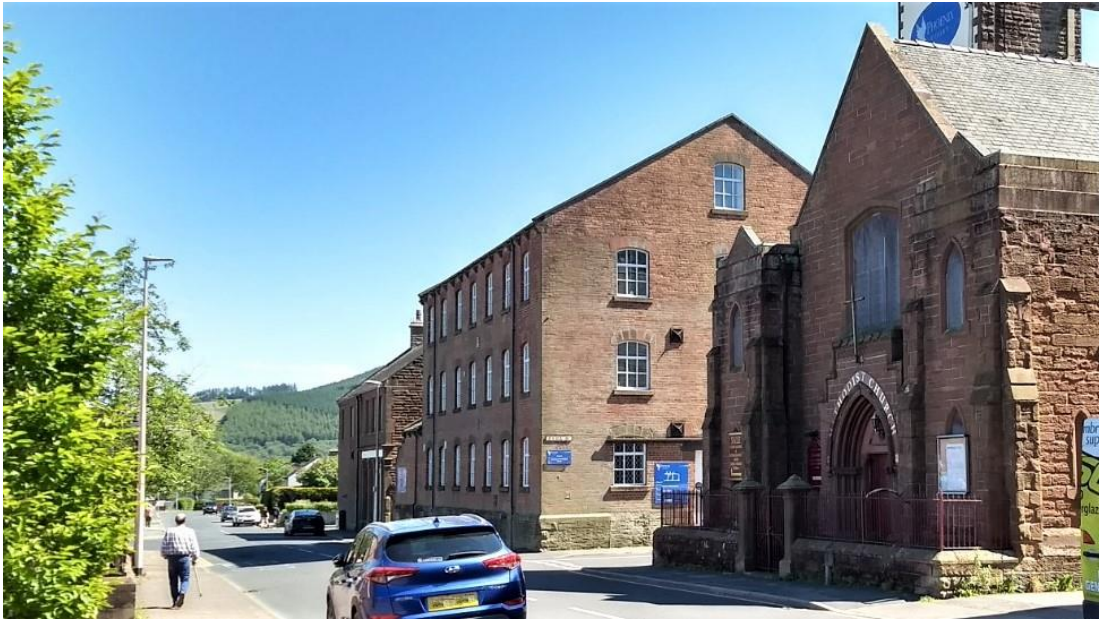
Figure 17 Methodist church and Phoenix Court

The Methodist church is gothically styled in red sandstone. Adjoining it to the rear is a Sunday school in the international style. This is an unusual but not unwelcome addition to the conservation area and presents a handsome façade to Earl Street composed of a mixture of pink, brown and umber bricks. This building dates to during or shortly after World War Two, although the pink brick sections of the façade appear later and are poor. Its two main doorways are beautifully executed in bricks of various sizes and colours with butterscotch coloured pointing, but both have been disfigured by the inept insertion of steel joists, presumably to support the lintels.

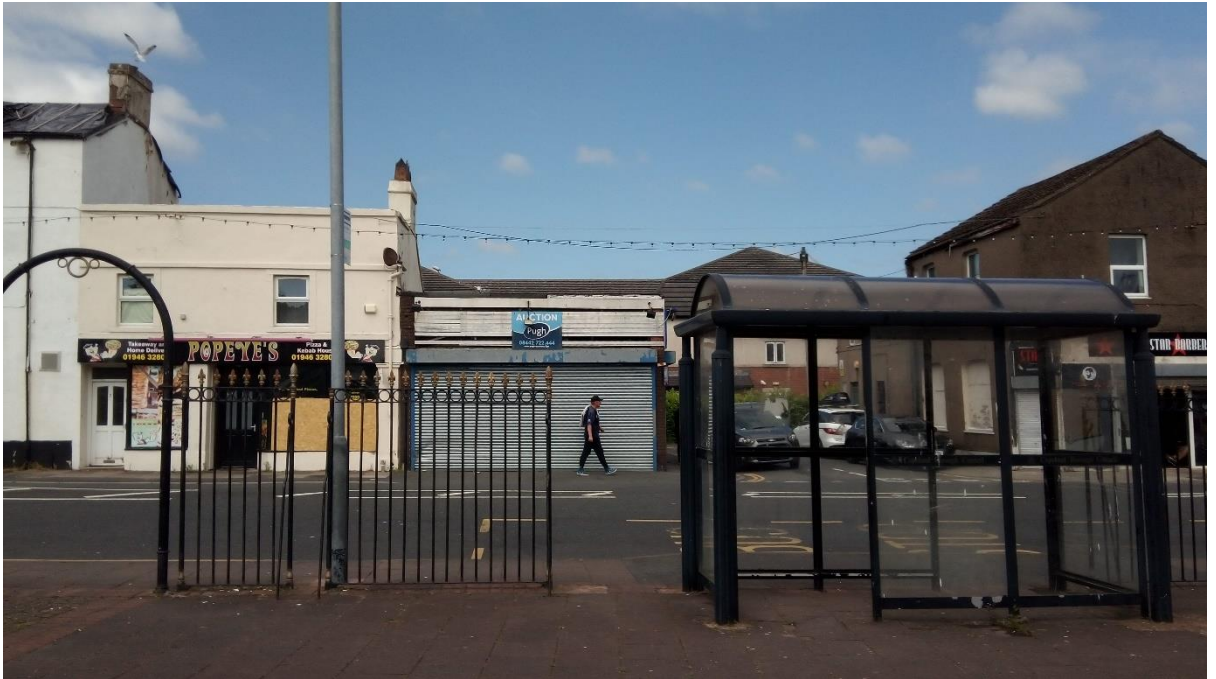
of its least successful. The buildings to either side of the junction are low and irregular and suffer from poor quality detailing and alteration. 9 High Street, on the west side of the junction, makes a particularly negative impression. It is a single storey unit in brown brick which is to the detriment of this conspicuous part of the conservation area. It appears to originally have been a continuation of the adjoining number 8, which extended to the corner.

Figure 27 Entrance to Aldby Street from High Street, showing the building housing Numbers 7 and 8 High Street (the two storey building), which formerly extended to the corner now occupied by the single storey number 9

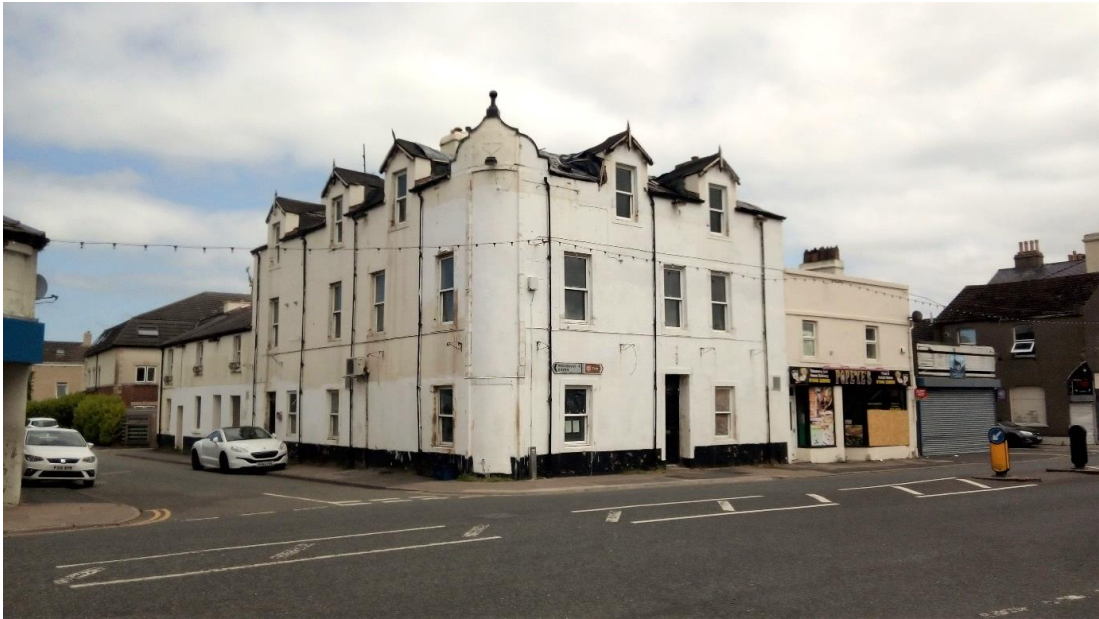
Figure 28 The Commercial public house on the corner of High Street and North Street

On the corner of High Street and North Street is the Commercial, a public house of three stories with a distinctive curved Dutch gable on its corner. It also features five dormer windows flush with the facades, two on High Street and three on North Street. It has the potential to be an attractive part of the local area, although this potential is not currently capitalised upon. This building, and the junction of Jacktrees Road and High Street, serve as a gateway into and out of the square for traffic taking the road to Hensingham and Whitehaven.

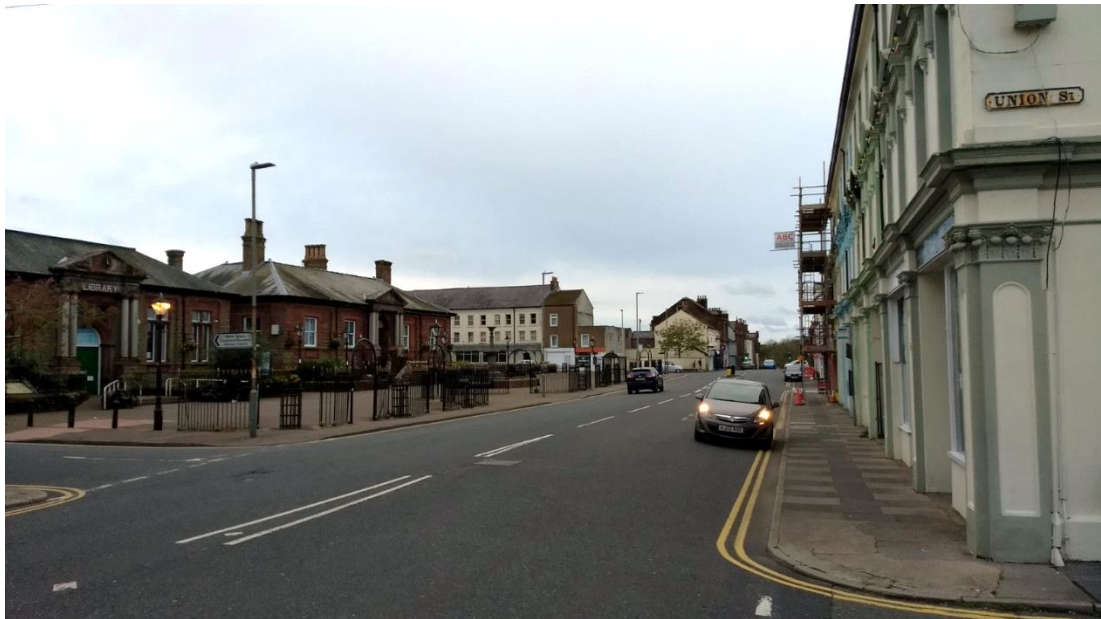
Figure 35 Vista from High Street, looking west past Market Place and 13-20 Jacktrees Road. At the centre of this vista is a gap site, where the building on the corner of Jacktrees Road and High Street has been demolished.

The removal of the corner building on Jacktrees Road and High Street has had a negative effect on the vista shown in Figure 35, which would be a far stronger embodiment of the conservation area were it resolved fully. Also apparent here is the potential for the Market Place public realm to be improved, bringing a more useable public area and less partitioning between the street, the buildings and the interstitial space.

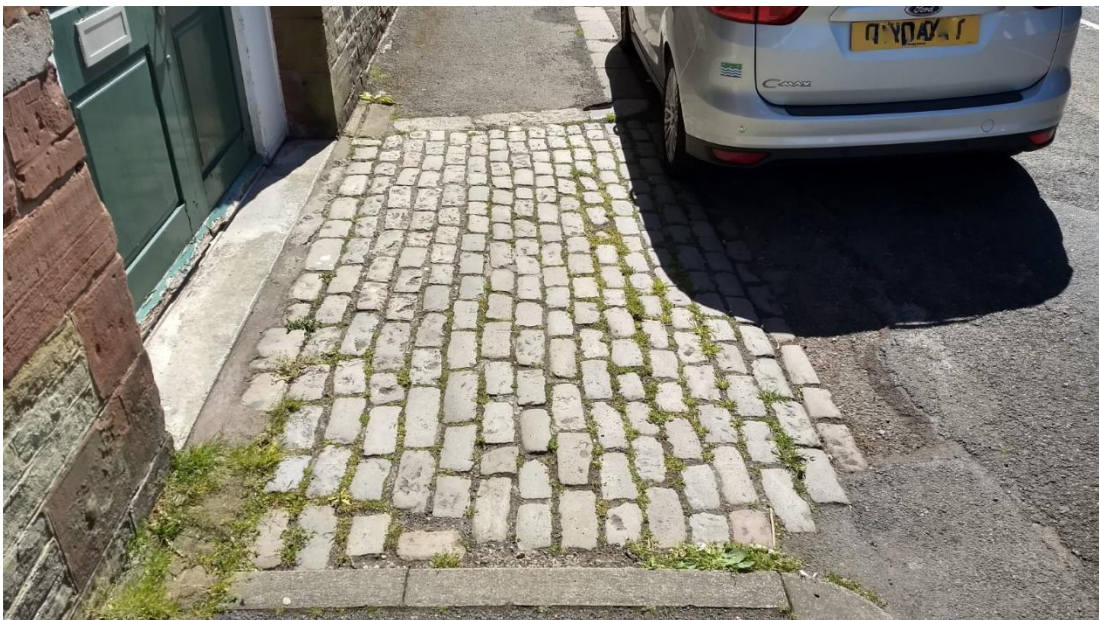
The surfacing of pavements and the road itself is otherwise tarmac in poor condition, with some pavements on High Street being a slightly more attractive grey cement paving slab.

Figure 38 An area of original stone setts outside a door at Phoenix Mill on Ehen Road. This is one of very few original areas of surfacing left

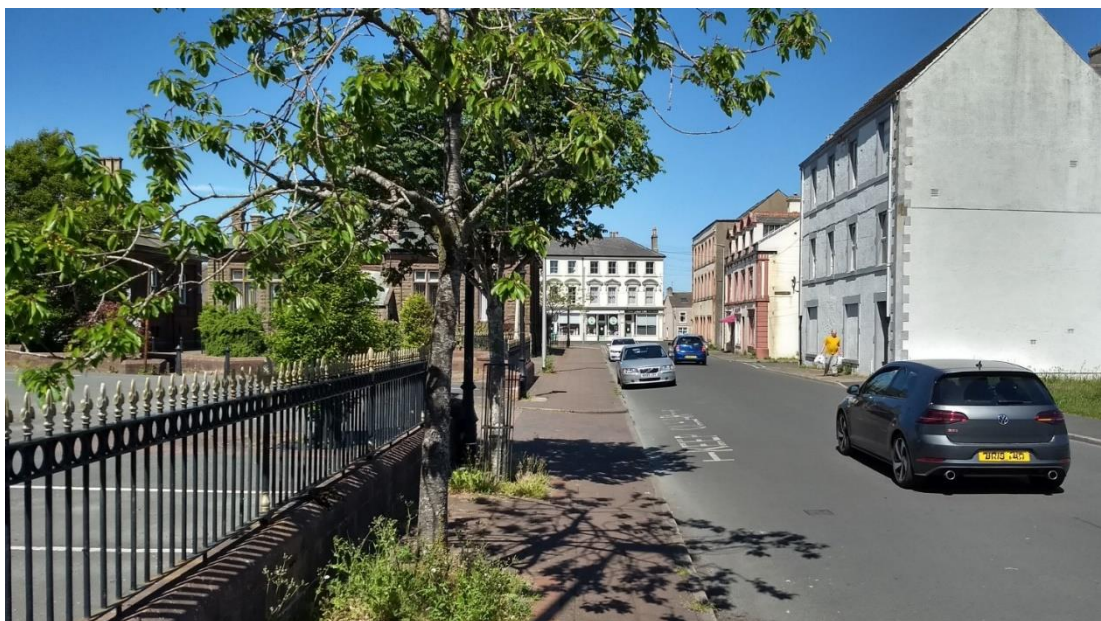
Trees are not numerous, being limited to a number of examples that date from the early 1990s public realm works. These are located in tree pits, mostly with metal protectors around them at regular intervals around the perimeter of the Square. Some of them have died, and none is a particularly fine example. They do not frame or highlight any particular qualities of the area, and instead clutter and obscure views across it, but do at least provide softening and greenery to break up the mass of hard surfaces.

Figure 40 Trees in pits dating from the 1993 public realm works
