DESIGN / HERITAGE IMPACT
ASSESSMENT

HENNERY / PIGGERY AT
BARWICKSTEAD, BECKERMET – 22
March 2022

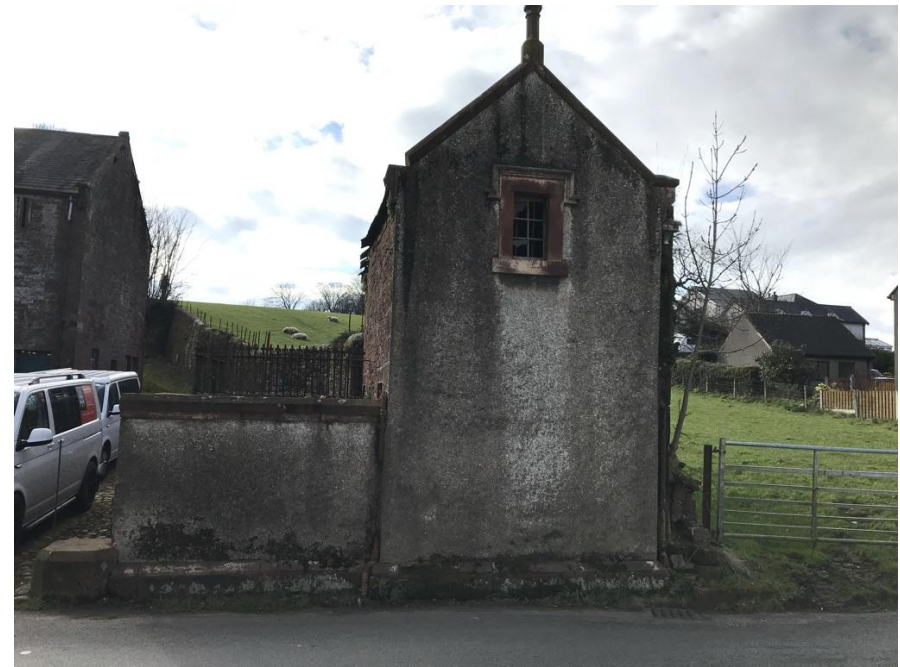
Front elevation with spar dash to roadside and hooded mouldings to gable window

1. External walls - retained and repaired where required to include re-bedding loose stonework, mouldings etc and bedding with lime mortar. Removal of all vegetation growth from the jointing of the stonework. Elevations to be cleaned off with power washing with option for light sandblast cleaning in areas of lime wash / render. Loose mortar joints to be raked out and re-pointed in lime mortar.
2. Internal walls - these are to be cleaned down and re-pointed with all vegetation growth removed.
