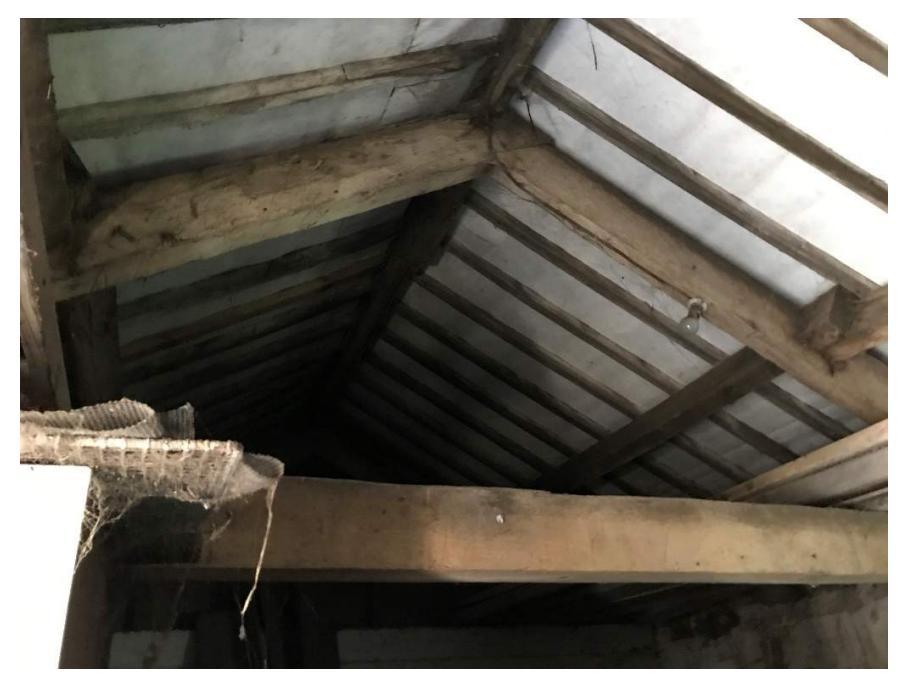
Figure 3.31 – Internal roof structure

Barn Four consists of several ground floor stalls adjacent to the farm house. It was difficult to survey the internal walls due to the building being used for storage. The barn appeared to have been recently reroofed, with cement tiles similar to Barn Two. The roof was supported by timber trusses and purlins, with some sagging noted in the purlins. This was also noted externally and a dip in the ridge adjacent to the cottage. The external stonework appeared sound, with full mortar joints. One horizontal crack was noted through a door framing stone adjacent to the farm house. The area adjacent to the cottage could not be surveyed at the time of our visit as the farm dog was being held in this area.

The majority of the internal structures consisted of timber, and therefore, we would recommend that all timber is assessed by a specialist and any remedial treatment or repairs carried out as required.

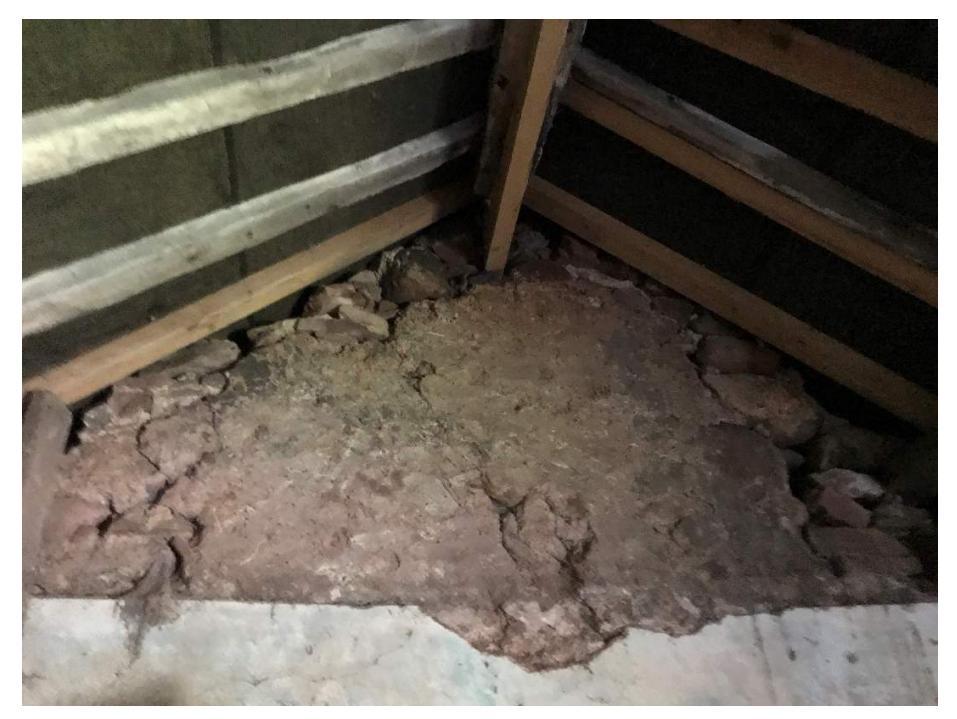
Figure 3.40 – Gable wall adjacent to Barn Four

A twist in the truss rafter was observed at the bearings when viewed from directly underneath the apex. There was also a drop in the purlins, particularly over the stair partition. Loose stonework was observed at eaves level and the stonework pier supporting the ridge was noted to be leaning to the rear (although there was little, if any cracking so it could have been constructed this way). We were unable to inspect the chimney breast and gable wall on the first floor due to the unstable nature of the floor.
