former Whittles furniture store,
Duke Street, Whitehaven,
CA28 7ER

Visual building feature and fabric assessment

AS21.35 Rev 01
July 2021

Applicant: BEC

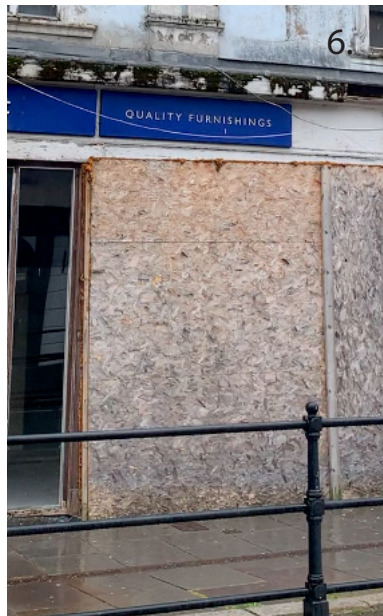
2. Elevation adsorbed into retail unit as retail use extended and adapted over time to create retail open plan floor space. Simple form and elevation palette when compared to the original buildings feature corner. Evidence of shop awning support zone mid level.

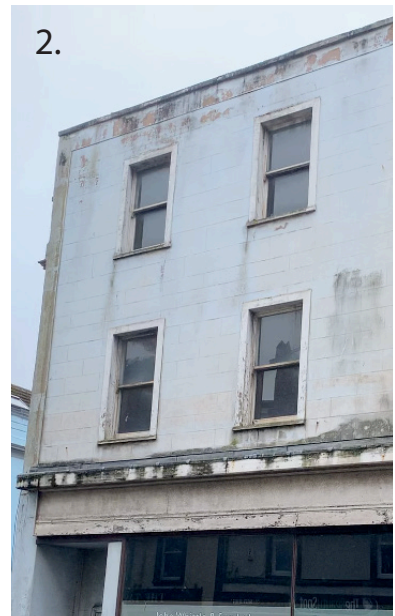
3. Building dressed in retained feature stucco columns, window dressing and plaques.

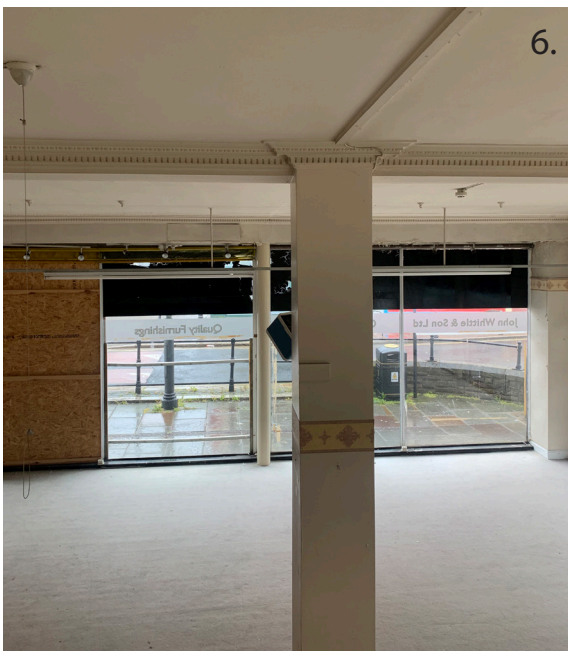
1. Building has been adapted over time to create retail open plan floor space. Photo shows typical arrangement with downstand beams cutting across floor plate, with evidence of damp and plaster failure.
2. As above, but in certain bays cornice feature in play, dressed around downstand beams. Evidence of solar overheating with blanking film being introduced at high level on retail frontage.
3. Existing back of house partitions, full height.
4. Existing goods lift with cage gate way. Existing balustrade feature, that appears also to be picked up in shopfront glazing framing.
5. Evidence of water penetration at window heads. Potentially showing water egress either running through render facade, head of windows or cills above.

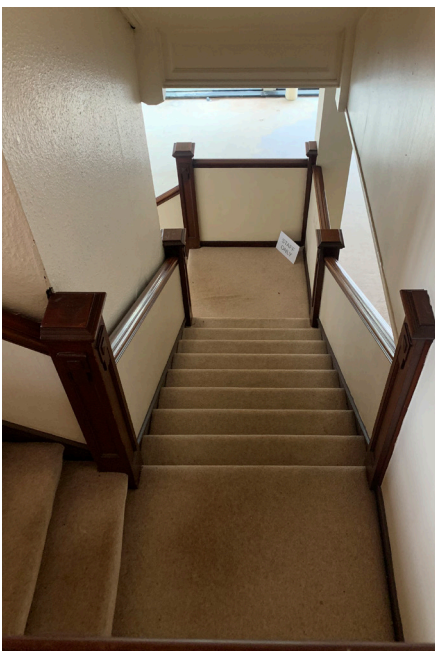
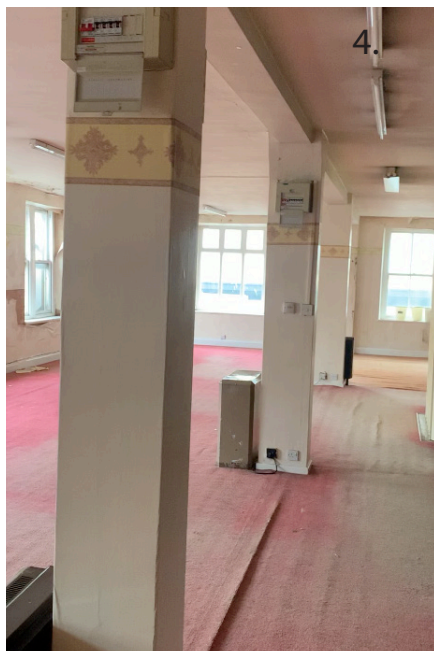
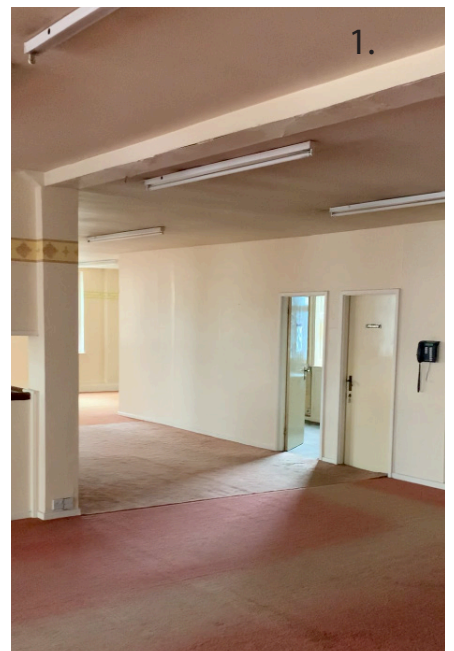
1. Existing back of house partitions, full height.
2. Existing external wall and ceilings failing and in poor state of repair, showing water egress either running through render facade.
3. Evidence of water penetration at window heads. Potentially showing water egress either running through render facade, head of windows or cills above.
4. Building has been adapted over time to create retail open plan floor space. Photo shows typical arrangement with downstand beams cutting across floor plate.

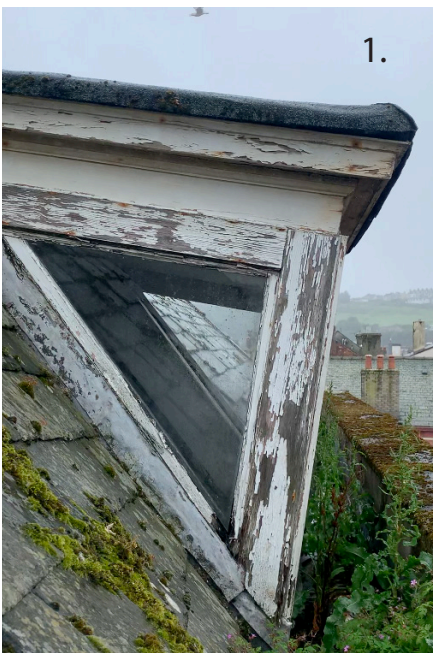
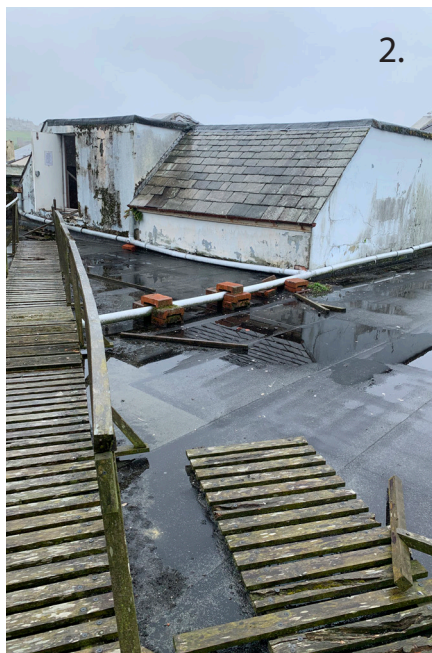
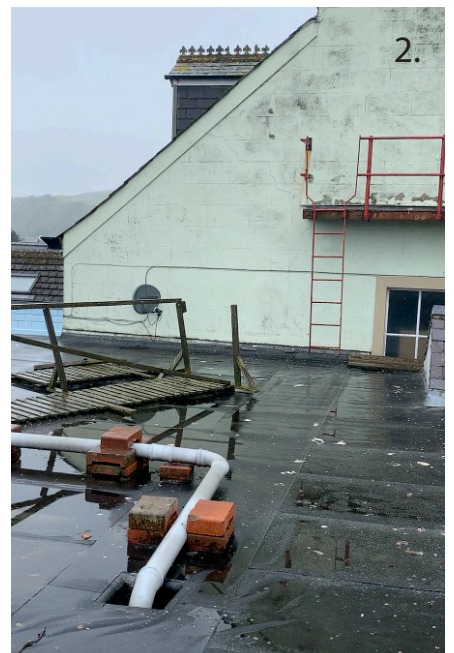
- 1. Dormer window failure. Main cause of below floor water damage.
- 2. Inadequate positive surface water connection to drainage system.
- 3. Existing external wall and ceilings failing and in poor state of repair, showing water egress either running through render facade, head of windows or cills above.
- 4. Existing external wall failing and in poor state of repair.

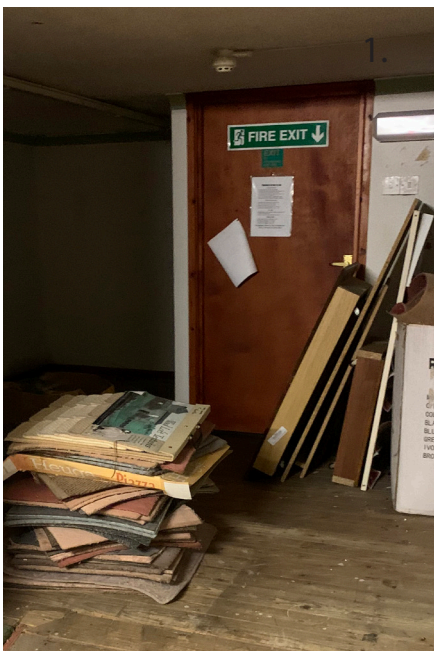
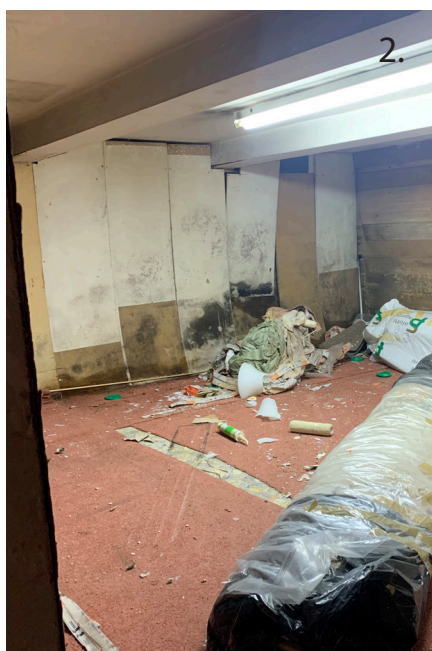
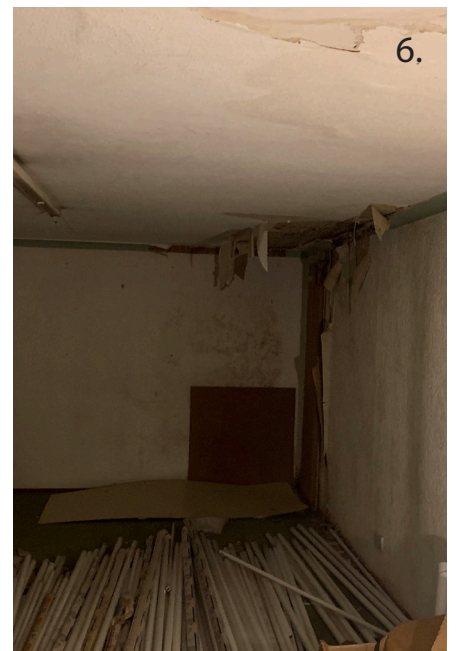
1. Existing fire escape route to ground floor.
2. Low ceiling height storage room. Wall panels potentially blocking void space under retail unit containing drainage termination points.
3. Loading hatch positioned off main stair.
4. Existing lift car to basement.
5. Location of incoming main services cup'd.
6. Evidence of ceiling zone failing, showing water egress from floor above. Tanked basement walls look in good repair.
