Refurbishment Survey (with MA + PA)

10-11 South Parade
Seascale
CA20 1PZ

**West Coast Surveys
Unit 2
Derwent Building
40 Lakes Road
Derwent Howe
Workington
Cumbria CA14 3YP**

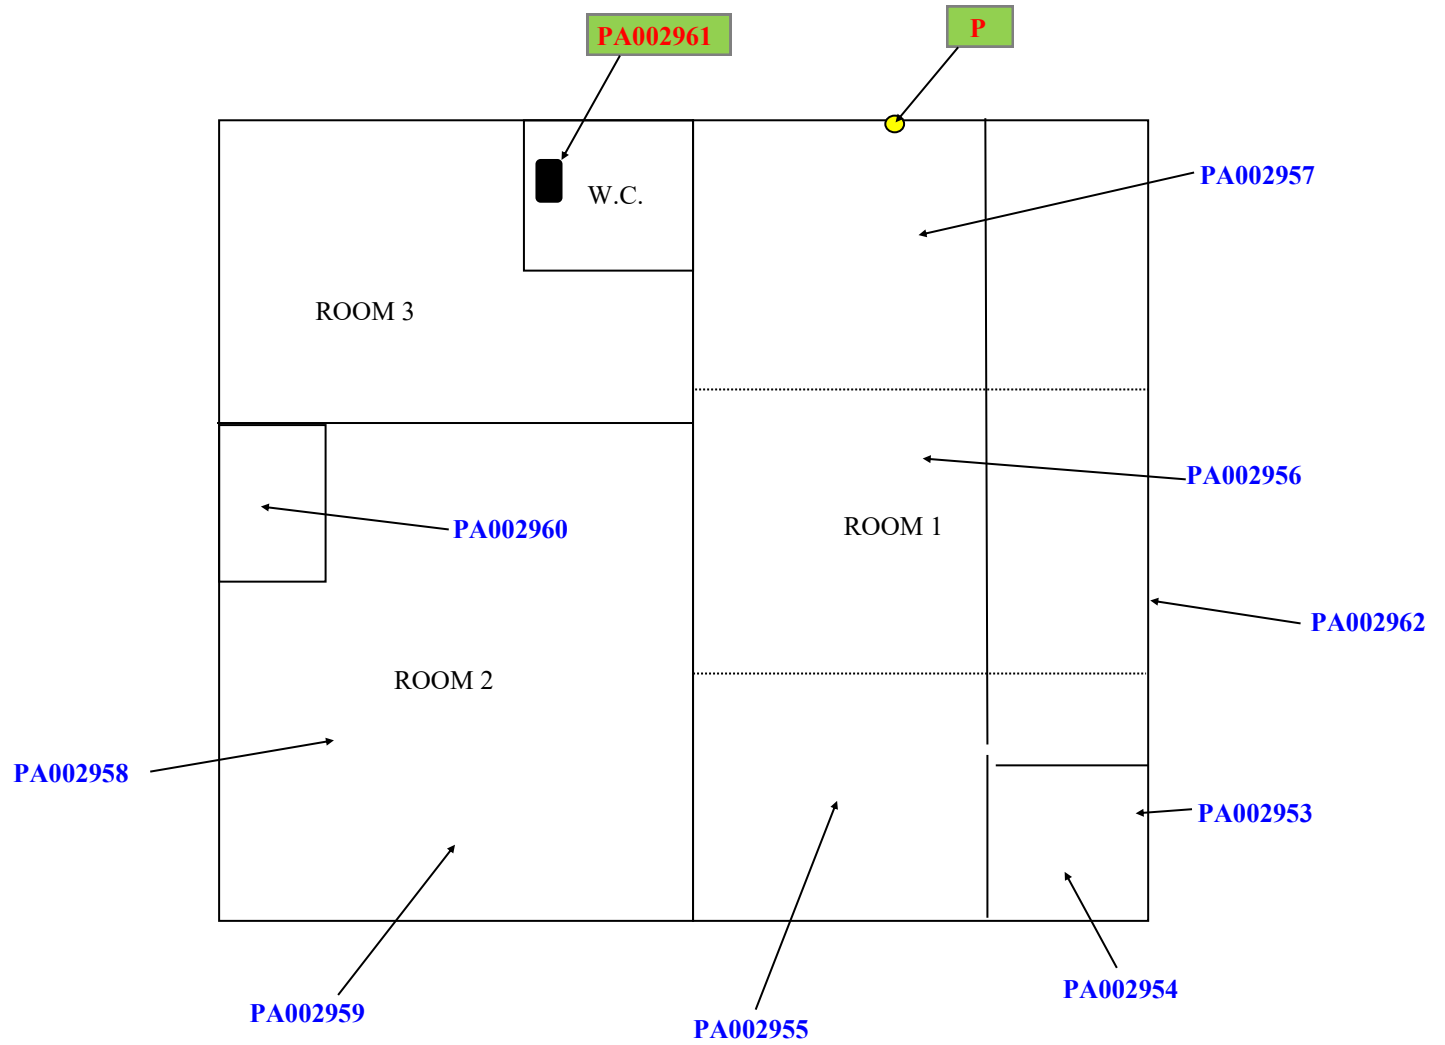
GROUND FLOOR

Building	Floor	Room	Item	Material	Risk assessment Score	Recommendations
Commercial property	Ground Floor	Room 1 G01	Flash pad material, No access for sampling due to possible live feed	Asbestos Textiles/Paper	LOW (10)	E - Inspect Prior to Disturbance
Commercial property	Ground Floor	Room 3 G05	Cistern material	Reinforced Composite	LOW (10)	D - No Attention Required, Label
