CCTV Inspection Report

JEFFERSON PARK ADDITIONAL SURVEYS LOW ROAD WHITEHAVEN

22/11/2021
Approved By: S. OAKES
Job Number: SK-S 256/2021

SK Drainage Solutions

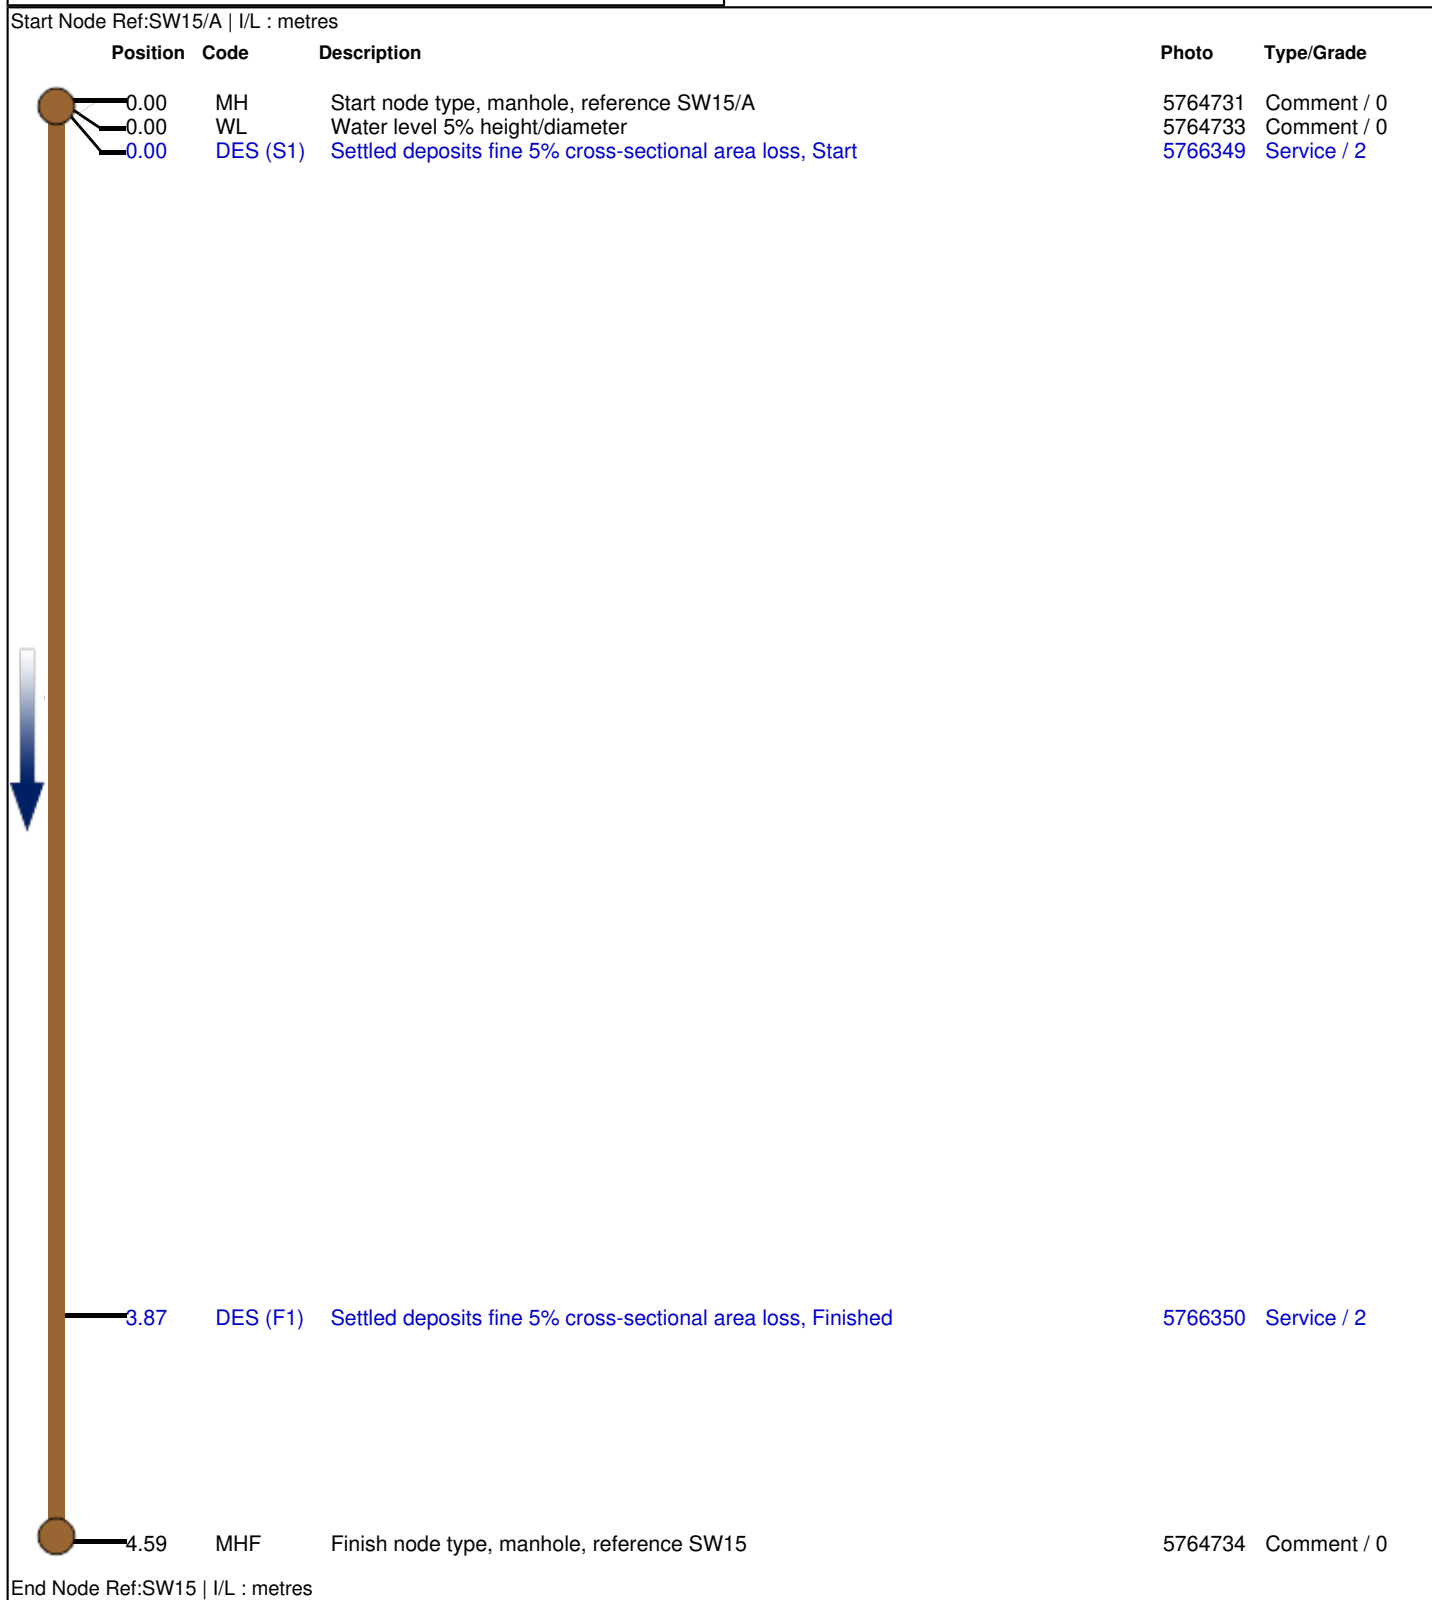
Manholes: **SW15/A to SW15**
 Pipe Length: **4.59 metres**
 Structural Grade: **0**
 Service Grade: **2**
 Material:
 Pipe Size: **525mm**
 Use: **Surface water**

SMALL AMOUNT OF DEBRIS THROUGHOUT.
