CCTV Inspection Report

**HARRAS DYKE FARM / WHITEHAVEN GOLF COURSE**

**16/10/2023**

**Approved By: S. OAKES**  
**Job Number: SK-S 161-2023**

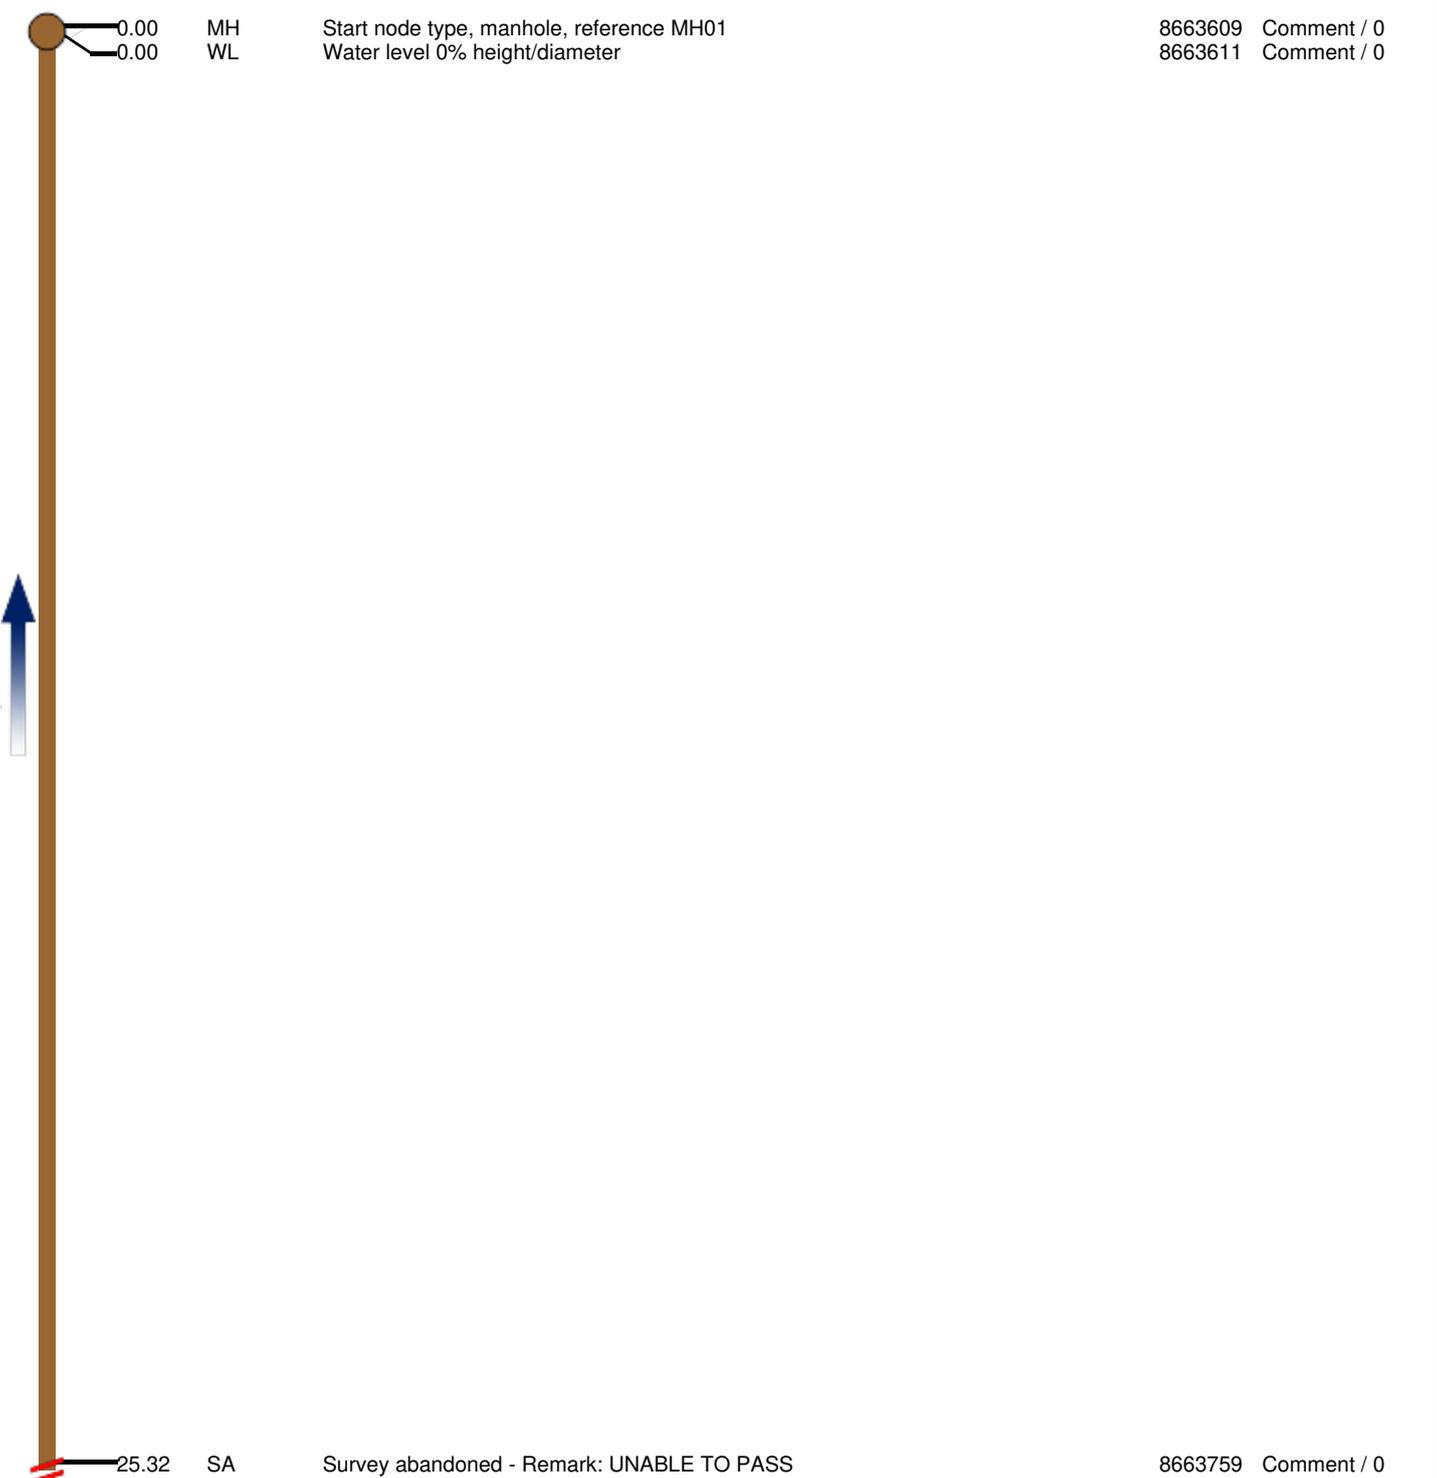
Start Node Ref:MH01 | I/L : metres

Position	Code	Description	Photo	Type/Grade
0.00	MH	Start node type, manhole, reference MH01	8663609	Comment / 0
0.00	WL	Water level 0% height/diameter	8663611	Comment / 0

25.32	SA	Survey abandoned - Remark: UNABLE TO PASS	8663759	Comment / 0

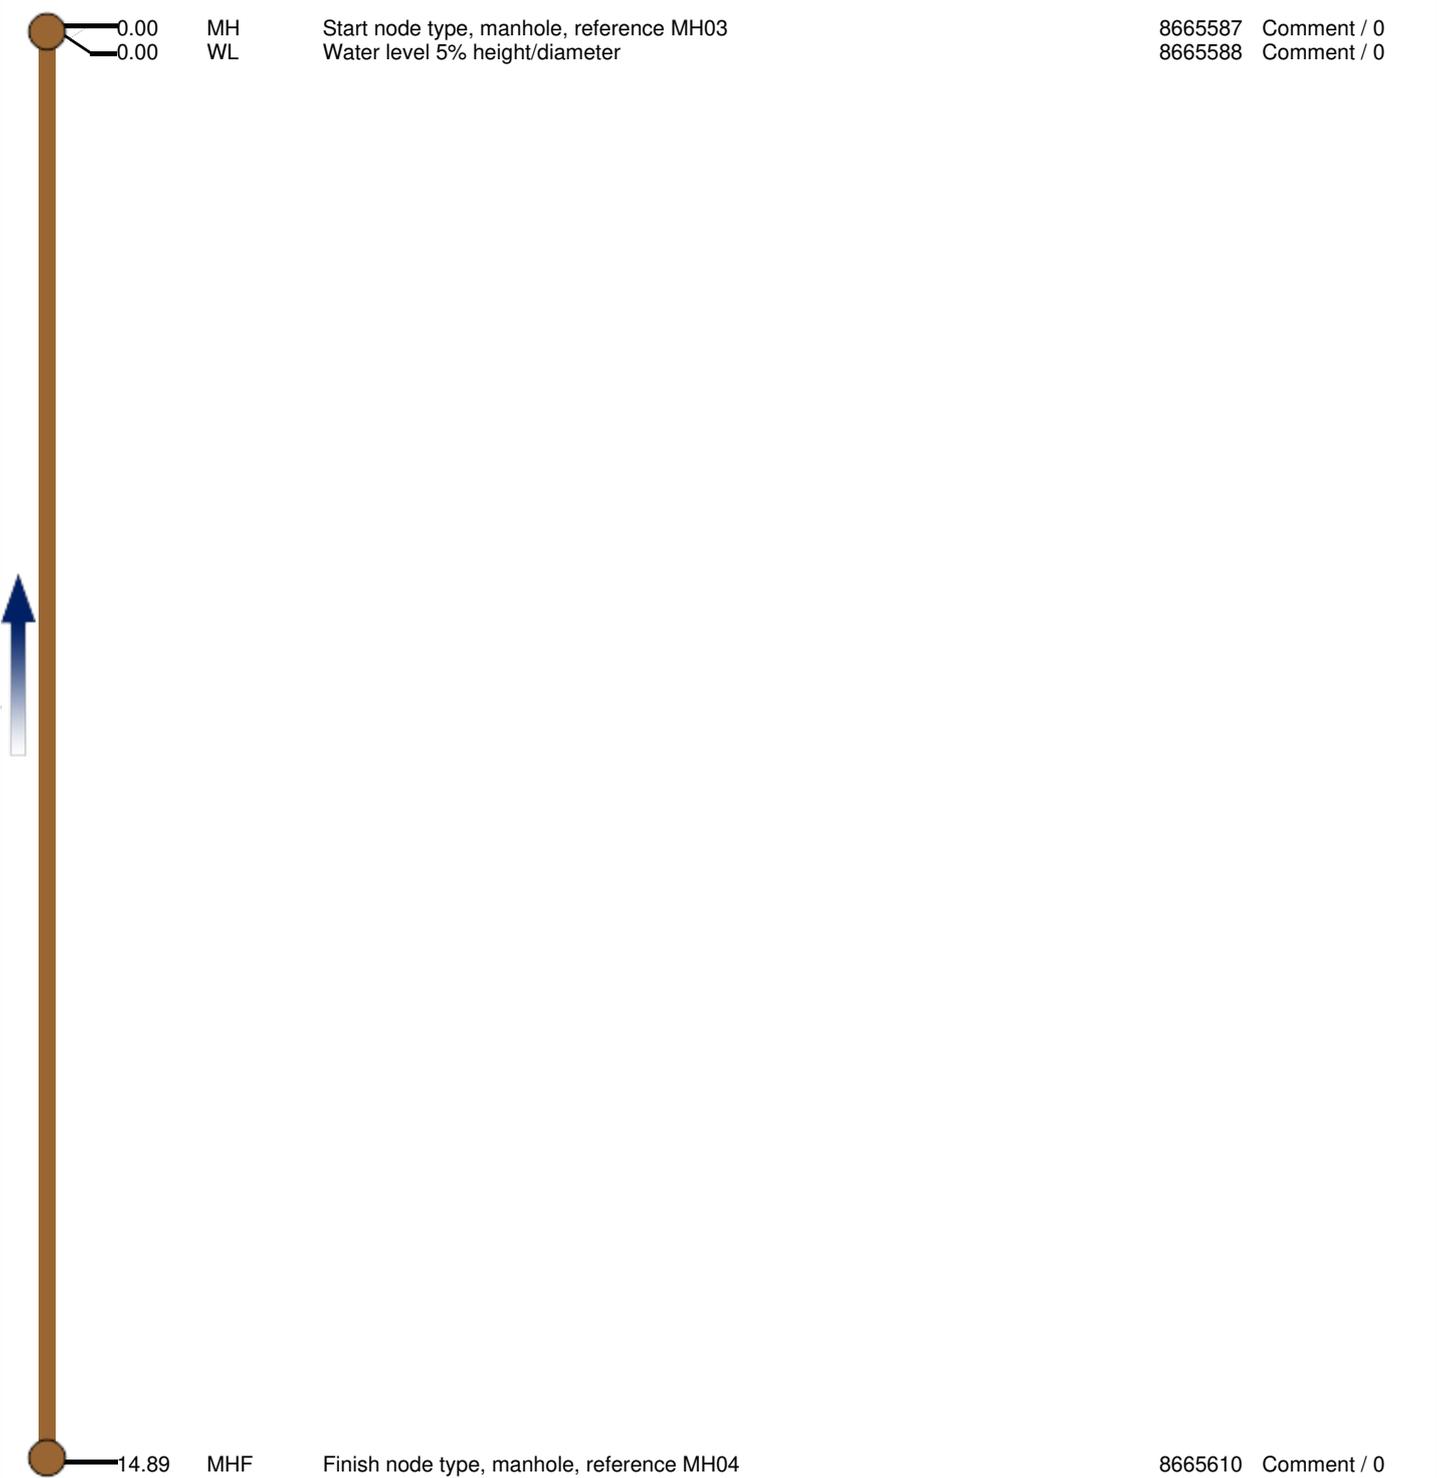
Start Node Ref:MH03 | I/L : metres

Position	Code	Description	Photo	Type/Grade
0.00	MH	Start node type, manhole, reference MH03	8665587	Comment / 0
0.00	WL	Water level 5% height/diameter	8665588	Comment / 0

14.89	MHF	Finish node type, manhole, reference MH04	8665610	Comment / 0

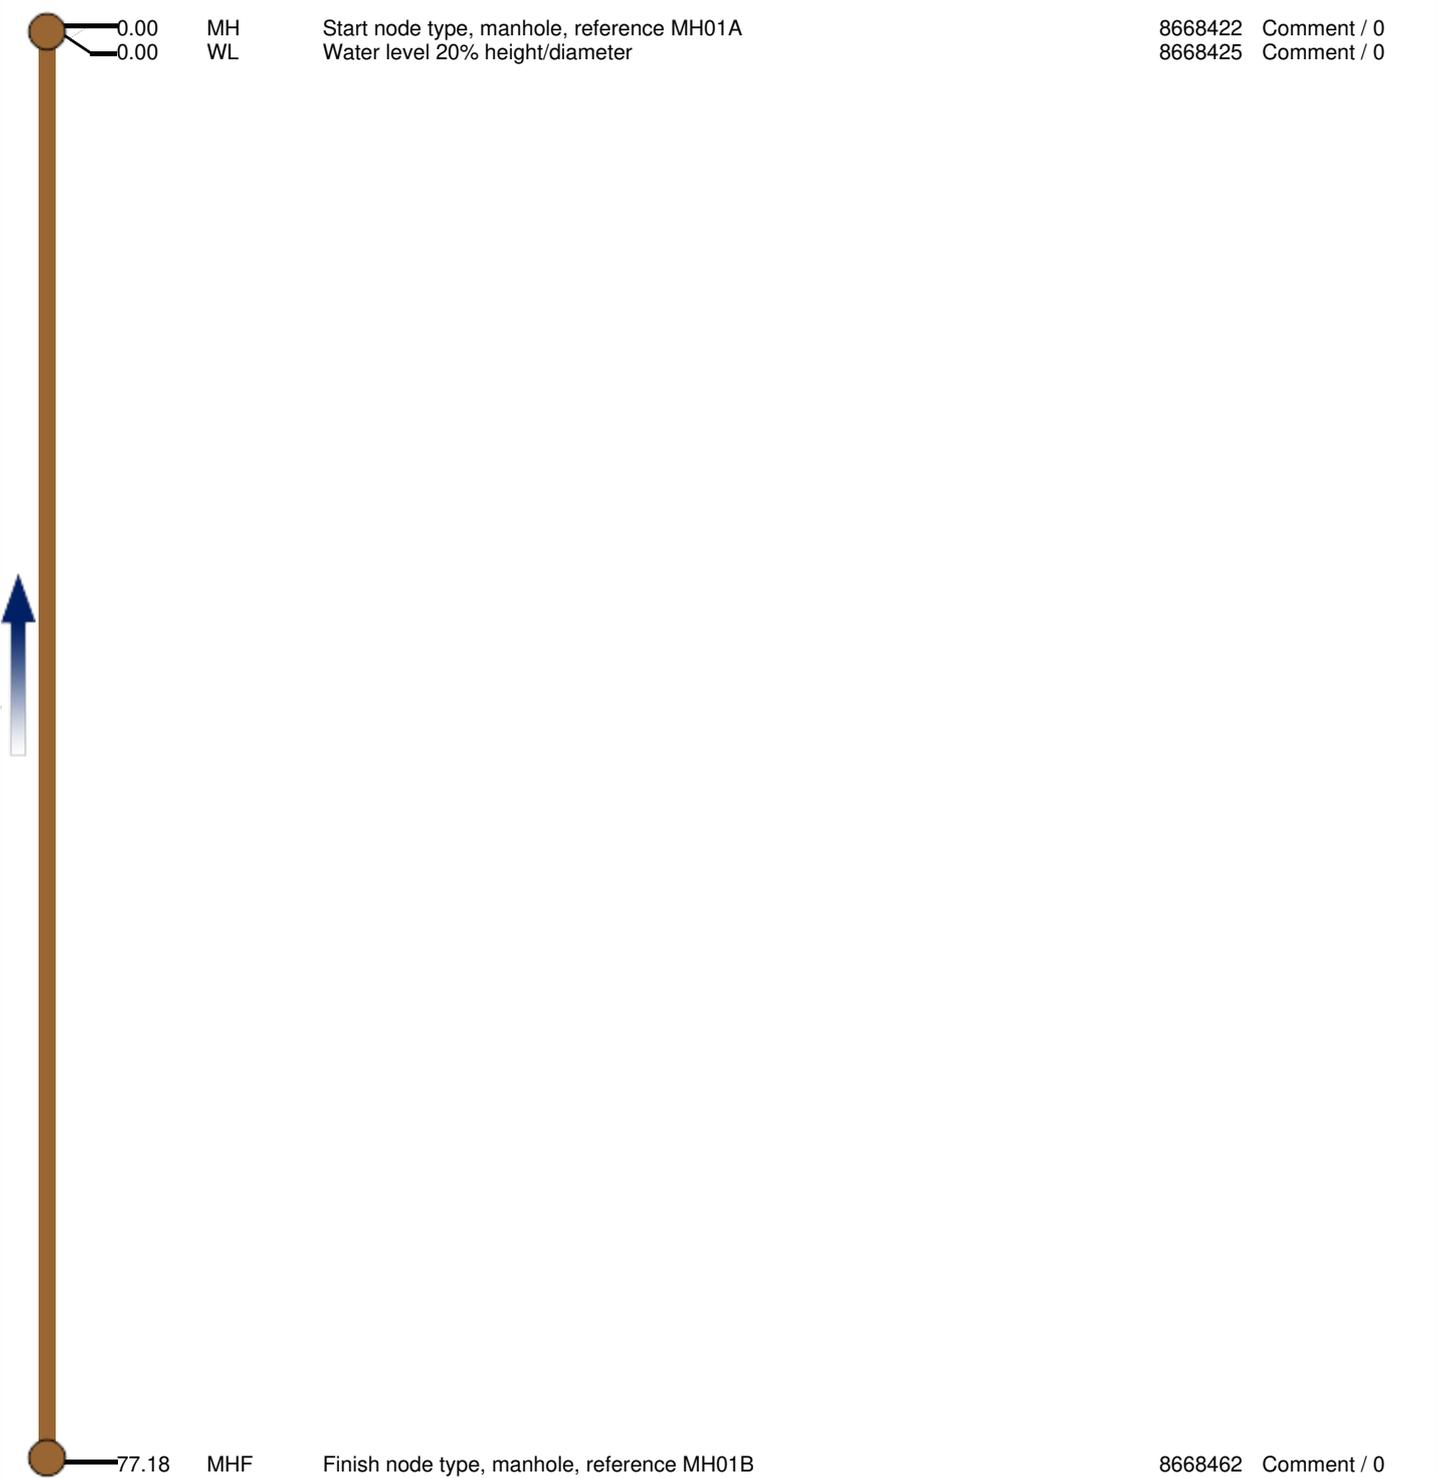
Start Node Ref:MH01A | I/L : metres

Position	Code	Description	Photo	Type/Grade
0.00	MH	Start node type, manhole, reference MH01A	8668422	Comment / 0
0.00	WL	Water level 20% height/diameter	8668425	Comment / 0

77.18	MHF	Finish node type, manhole, reference MH01B	8668462	Comment / 0
