Design & Heritage Statement
9 Oakbank, Whitehaven
June 2020

Grade II Listed Building. Listing ref. 1336011. NGR NX 97959 18930

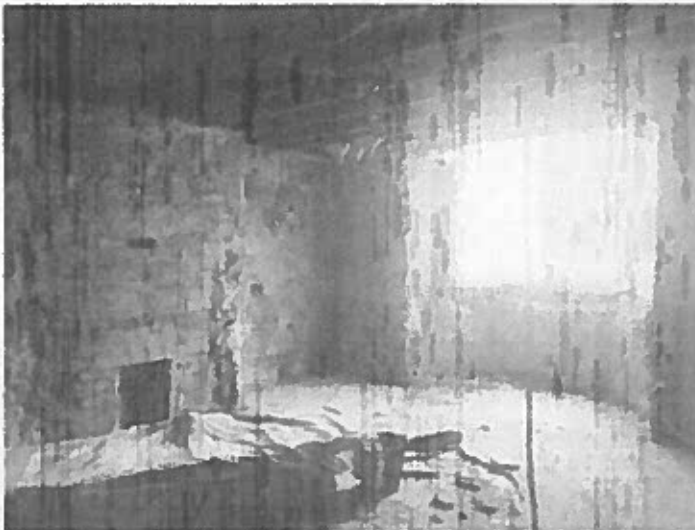
- a. Photograph of the basement at the front of the property. Marked as Bedroom in appendix 2.

In the basement the kitchen, radiators, flooring, gas fire and surround, door frames and skirting boards have all been removed. The walls have been stripped back to bare brick and stone. The ceiling was removed so that the joists could be exposed and examined.

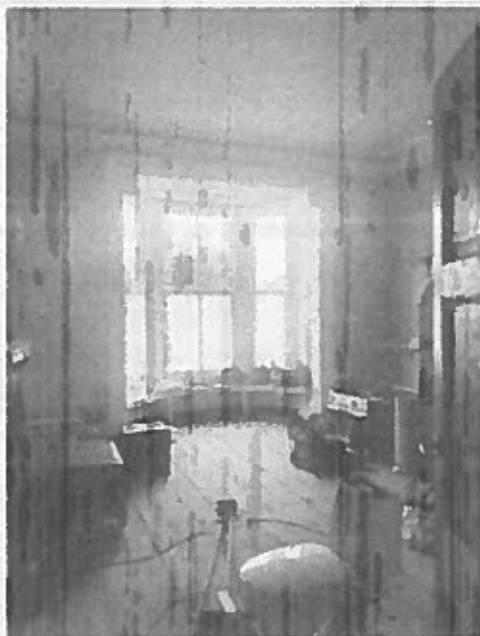
- c. Photograph of the ground floor at the front of the property, Marked as sitting room in appendix 2.

On the ground floor the bathroom and airing cupboard and the stud wall between them have been removed and the walls stripped back to bare brick and stone. The flooring in the bathroom and the vestibule area next to the exterior door has been removed. The bathroom and vestibule ceilings have been removed to expose the joists so they could be examined. The electric

fire in the former sitting room and its surround have been removed. The boiler has been replaced as the existing one was no longer working.

The former sitting room will be converted into a bedroom. This will include a freestanding bath. The structural engineer will provide a specification for strengthening the floor once we have chosen a bath. The fireplace and surround will be replaced with a decorative fireplace and/or surround but there will not be a working fire in the room.
