HERITAGE STATEMENT

FULL RENOVATION OF EXISTING No 11 TERRACE HOUSES

St Bees, 1-11 Lonsdale Terrace, Parish Council, Cumbria

M.A.C Architects, Project Number: 2019:303

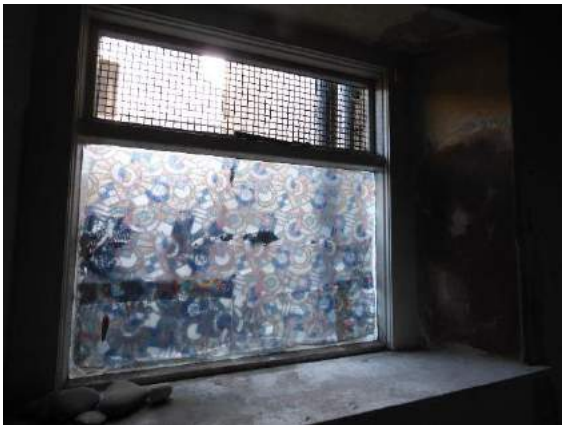
Left: The ground floor window to the rear is not original and requires replacement. The proposed replacement will reinstate the original Georgian style traditional door as whilst the dwelling was built in the mid-19th Century, which would be some years after the end of the Georgian period, even if counting the Regency but reflect the style none the less.

All existing features are to be retained.

Existing external cills to be repaired and decorated.

Existing Velux windows to be replaced with Velux conservation rooflights (or rooflight company, heritage rooflights) (size to match existing), and new flashings to suit.

Localised lead repair work may be required to chimneys, to prevent leaking.

Roof to be repaired where necessary with slates to match existing to make the roof completely watertight.

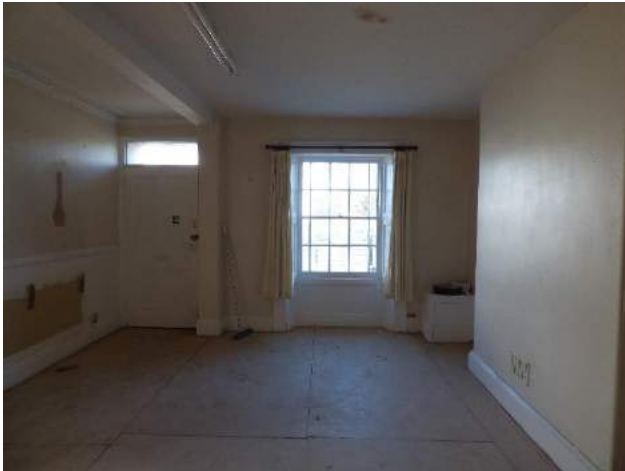
Much of the original historic internal fabric has been removed, although there are elements that have been saved and it is intended to reinstate elements of the building that have been removed, such as the cornices and skirtings.

The existing door and fanlight are to be refurbished and decorated.

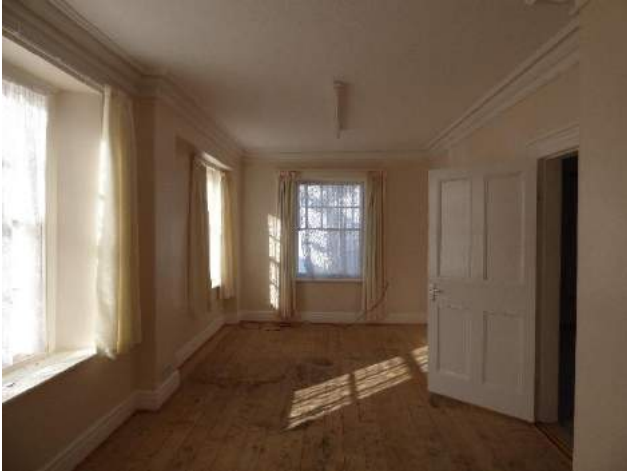
Both existing windows have the original shutters to the inside of the windows which are in excellent condition. It is proposed for these to be retained and carefully restored and decorated.

New doors at ground floor to be provided as heritage style four panel painted timber fire doors to enhance the heritage asset.

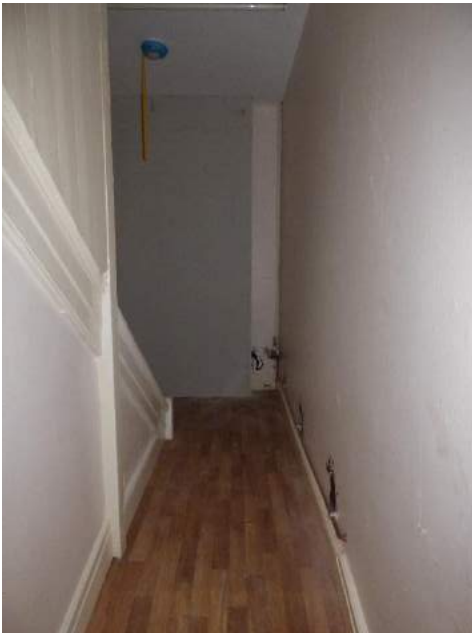
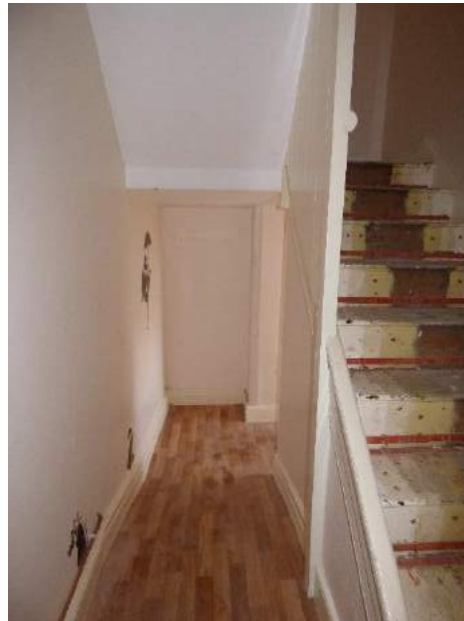
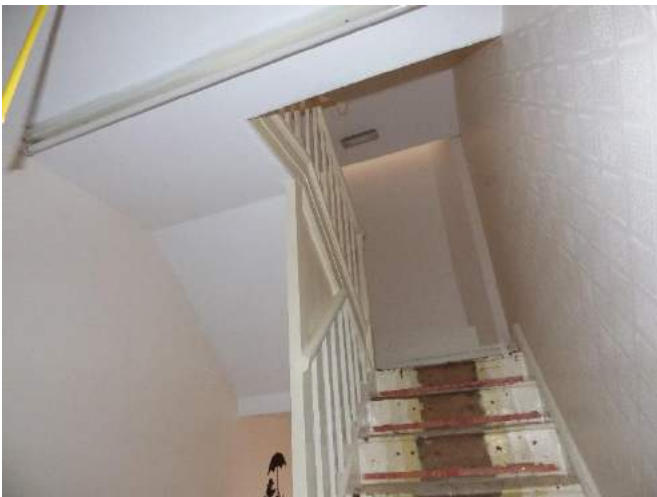
The existing staircase at ground floor has been modified as part of later alterations to the building. It is proposed to reinstate balusters and rails to match the existing to the lower part of the staircase, where they have been removed.

The existing staircase is to be retained as existing throughout the rest of the building.

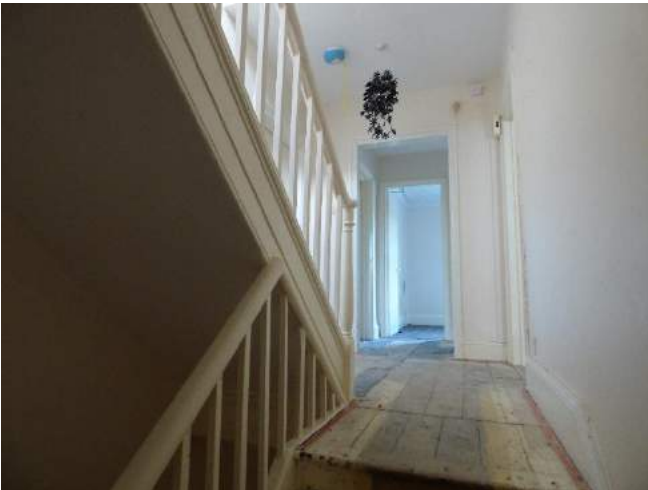
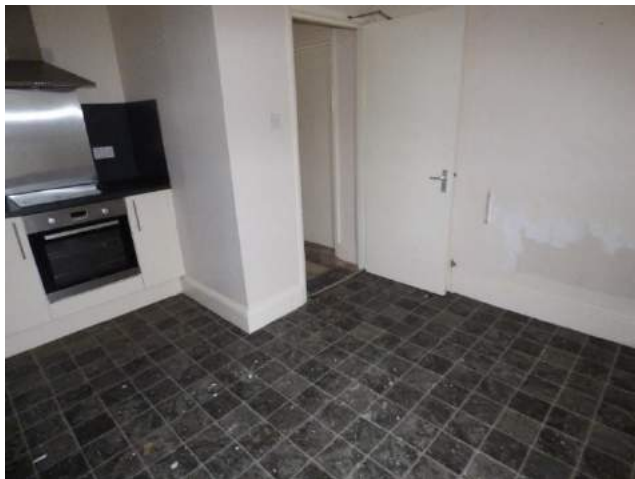
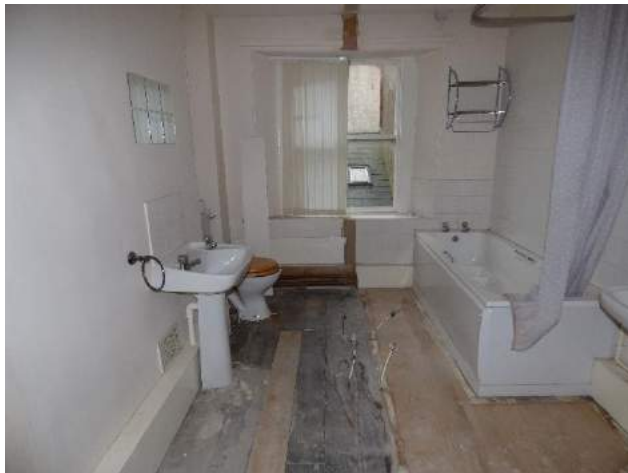
Existing kitchen, bathroom and living area at the front of the first floor, has lost most of the original heritage features.

It is proposed to remain as existing subject to minor decorative repairs. Flush panel doors to be replaced with heritage style 4 panel painted timber fire doors to enhance the heritage asset.

Where skirtings are missing it is proposed to replace with new skirtings in the same style as the original.

The proposal is to create an open plan living / dining kitchen.

The existing wall that separates the existing kitchen and living area has already an opening walled up, however it is proposed to fully open up the space to fulfil the requirements of modern day living.

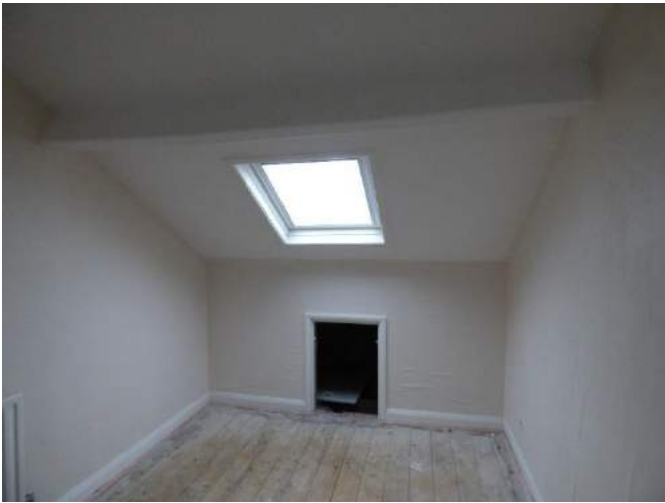
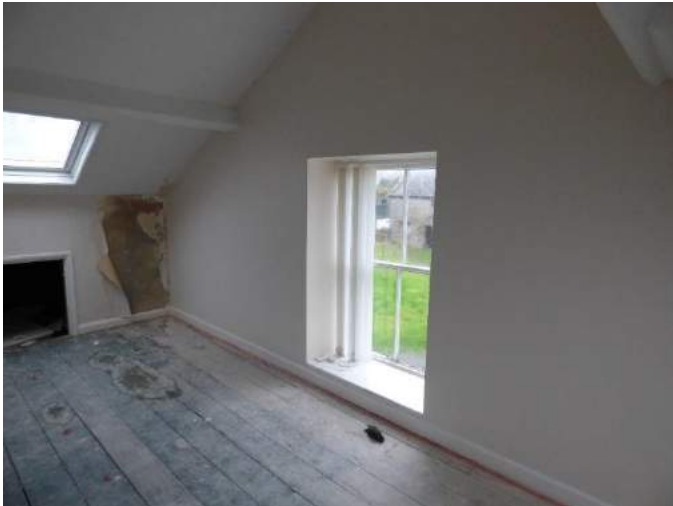
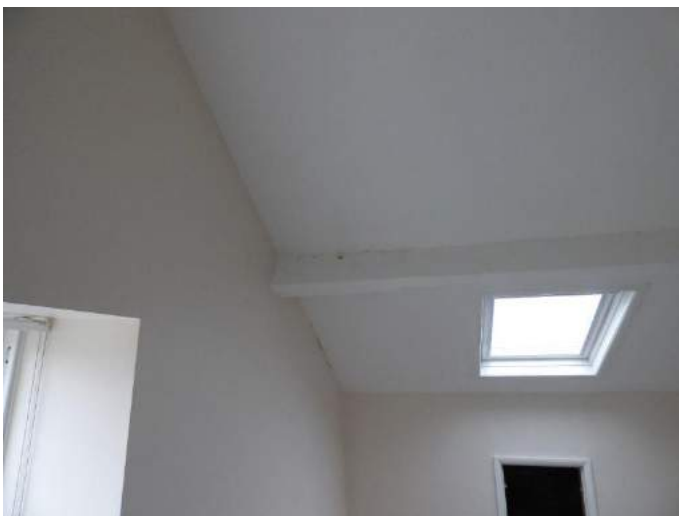
Attic Bedroom (gable end)

Floorboards are in good condition (but may require minor repairs.

Remove all damp and damaged / blown plasterwork and repair with lime plaster. (Solo lime plaster from Lime Centre).

Apply an insulated plasterboard 62mm thick to underside of ceiling. The Laminated plasterboard and PIR has a vapour barrier incorporated so interstitial moisture would be prevented. New rooflights to be installed with flashing kit that mounts unit flush with the roof surface.

Existing flush panel doors are to be removed and replaced with new heritage style four panel fire rated doors.

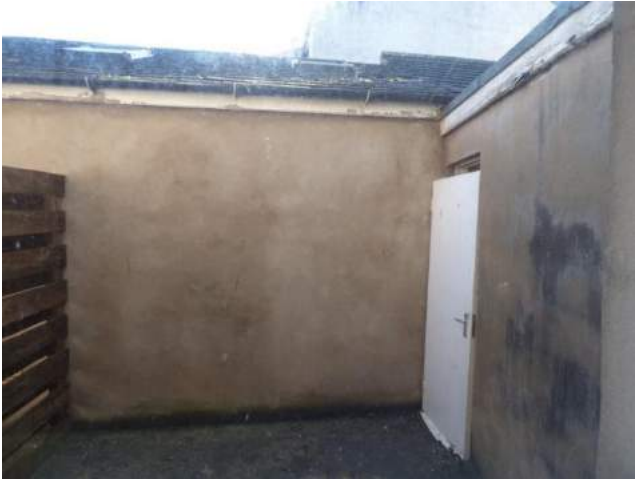
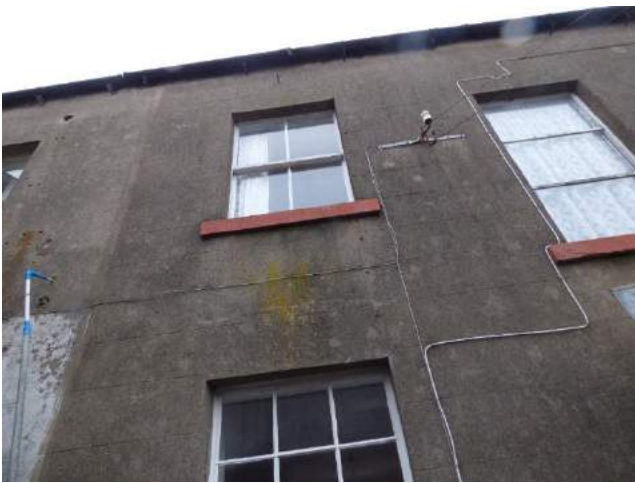
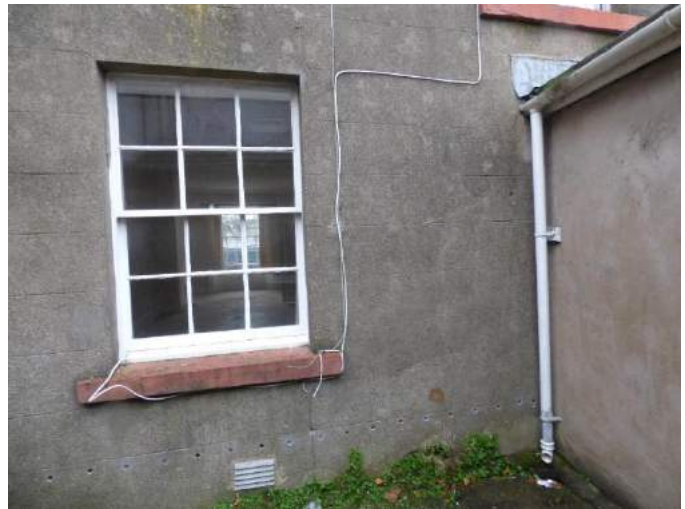
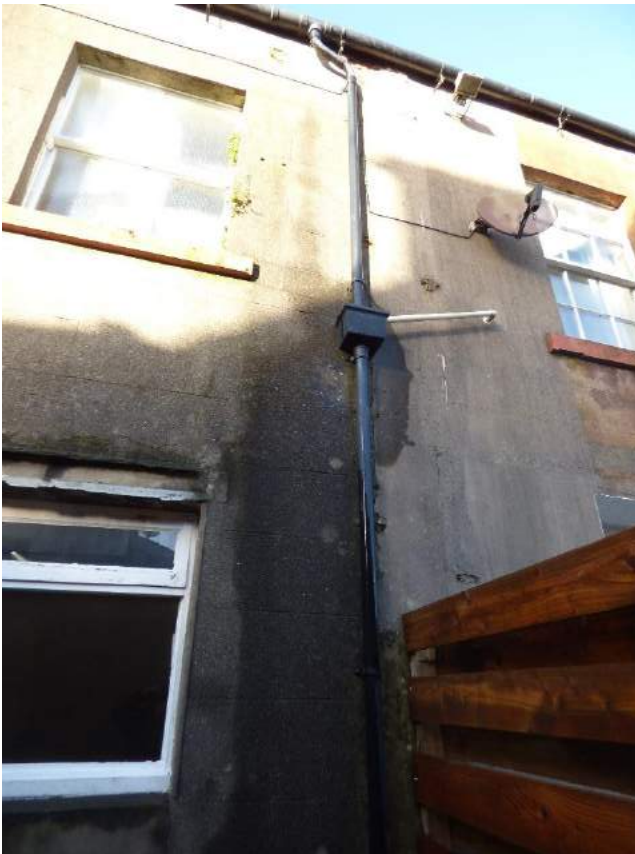
The rear courtyard is divided by a single storey 'link' building to an outbuilding at the rear. It is proposed to demolish both these structures. The link building is in extremely poor condition, and also to demolish the existing rear building, as they were a later mid-century addition to the property and the intention is to restore the rear garden to its original state to provide additional amenity space for the property and allow more light into the existing dwelling.

All existing single glazed windows to be replaced with new white painted slim profile double glazed. 'Heritage' windows to match the existing style by specialist supplier such as Batty Joinery Ltd.

Existing cills to be repaired and decorated.

Existing roof windows to be replaced with Velux conservation rooflights (or rooflight company, heritage rooflights)

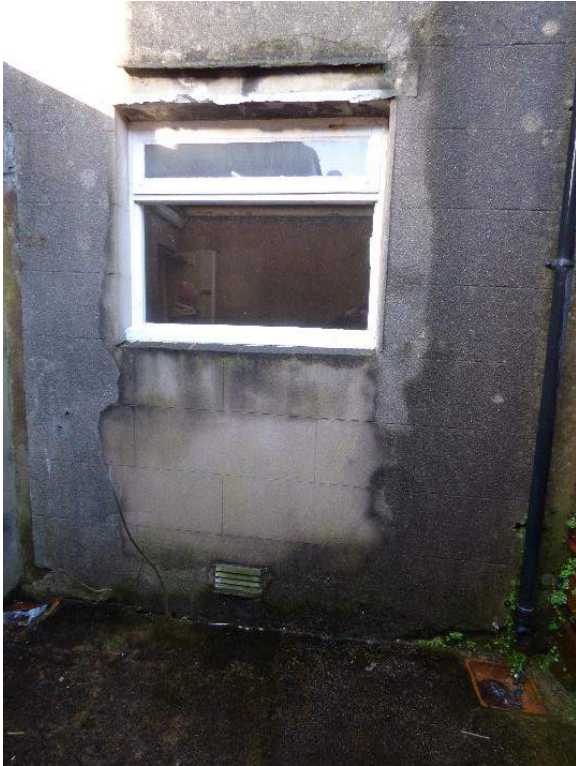
Left: The ground floor window to the kitchen is not original and requires replacement. The proposed replacement will reinstate the original Georgian style of window, in the original opening (which has been walled up), with a double-glazed slimline heritage painted timber window that would have been originally installed.

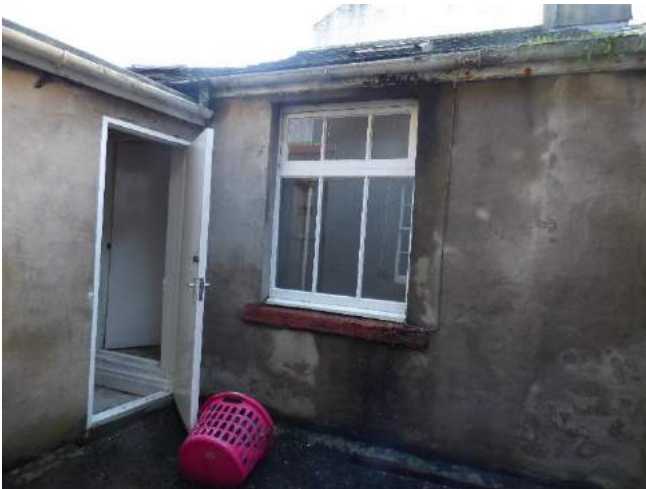
Poorly constructed 'link' building and out building to be removed to return the original building back to its former configuration.

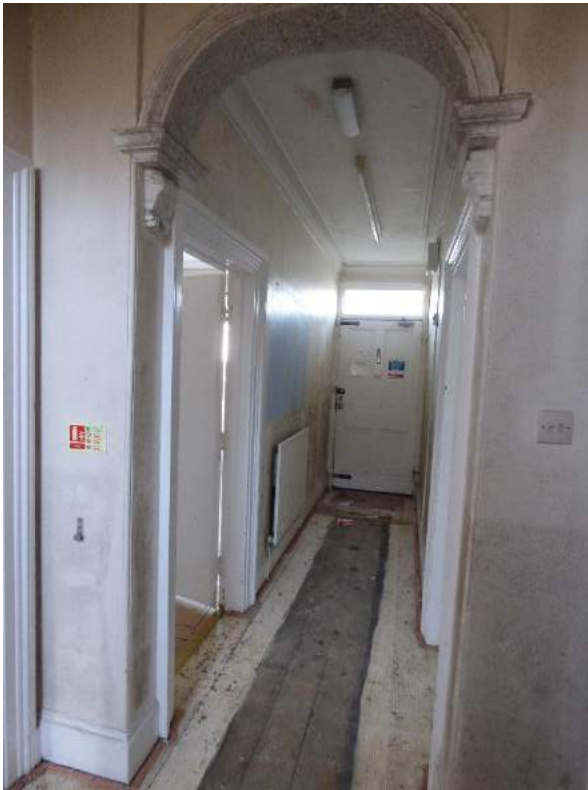
Left: The existing walls and floor are generally in good condition.

Redundant M&E to be removed and wall / ceiling finishes made good, and primed, prepared, and fully decorated.

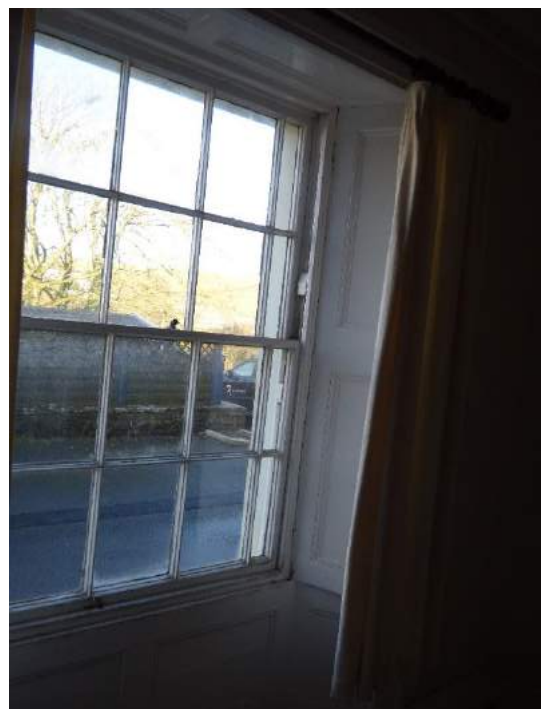
Above: In the existing lounge at the front of the property and

Left and below: the existing dining area to the rear of the property, the period features below and to the sides of the existing window are in good condition, it is proposed to carefully refurbish the existing timber shutters.

Below: Existing cornice to be made good in locations and where hairline cracks have appeared.

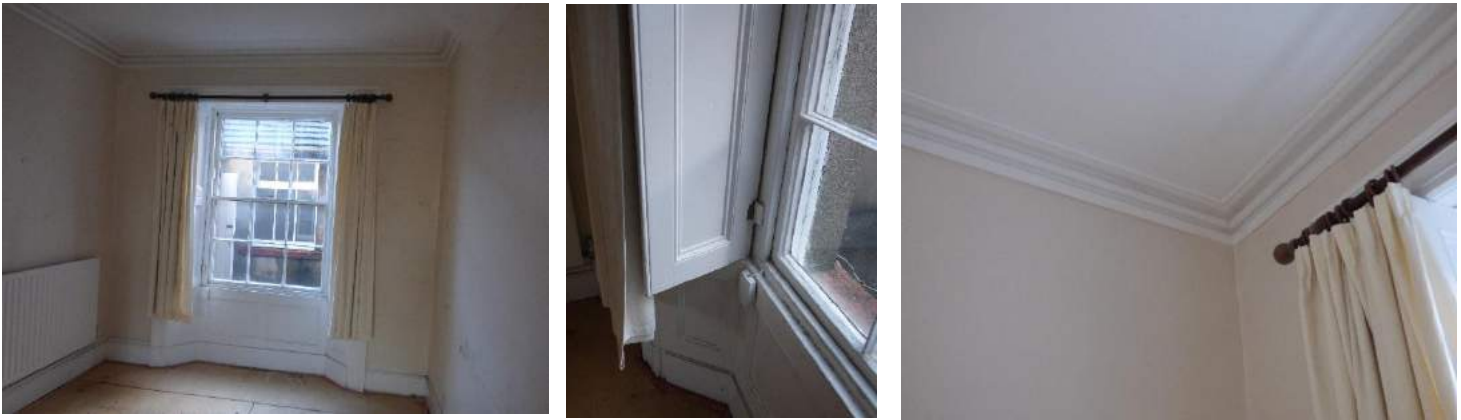
Above: Existing architraves, and skirtings to be retained and made good

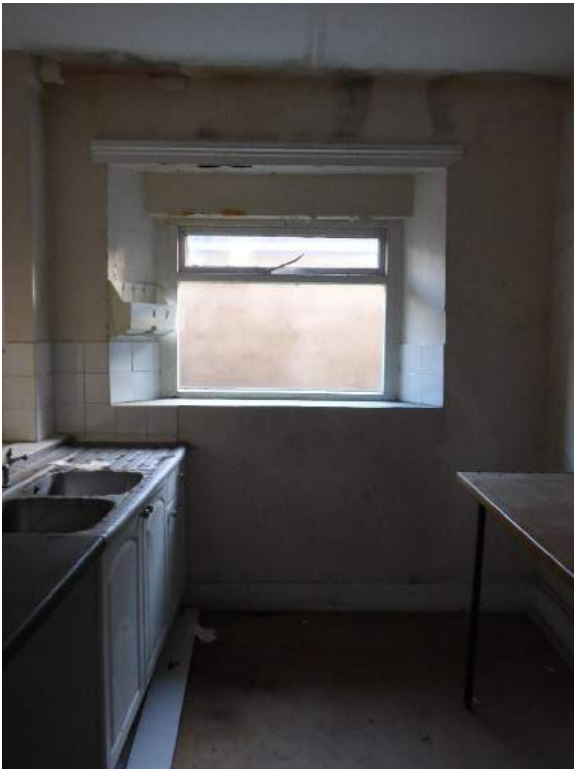
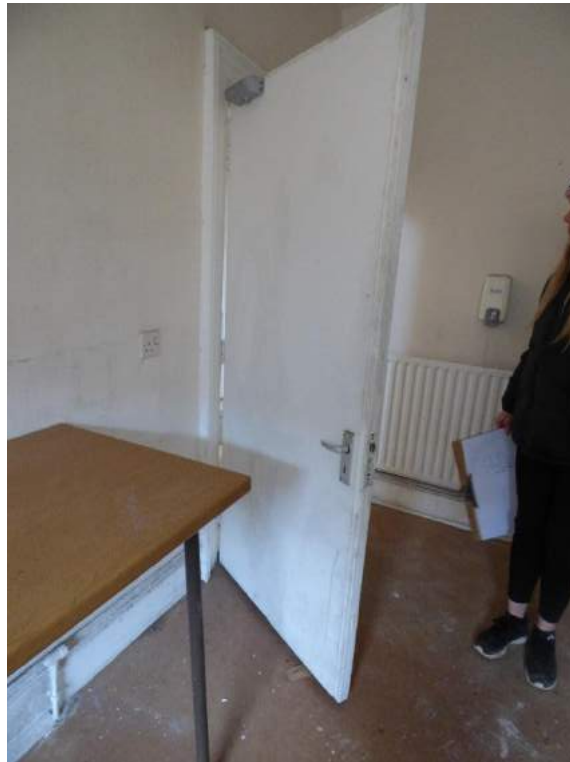
Existing modern single glazed window to be replaced by new double glazed heritage sash hardwood painted timber window, that would have been installed originally. The existing opening is to be adjusted to return the window opening to its original size.

Flush panel doors to be replaced with heritage style four panel painted timber fire doors to enhance the heritage asset.

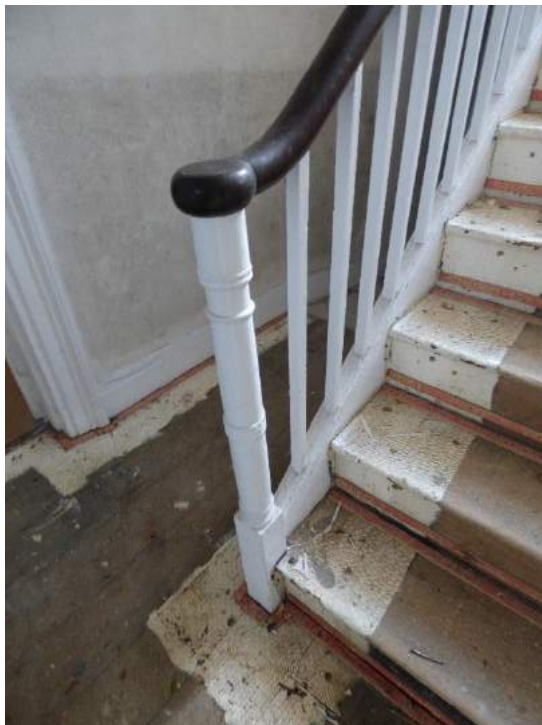
Left: Retain original staircase, which is in good condition. One missing baluster between first and second floor staircase to be provided with new baluster to match existing.

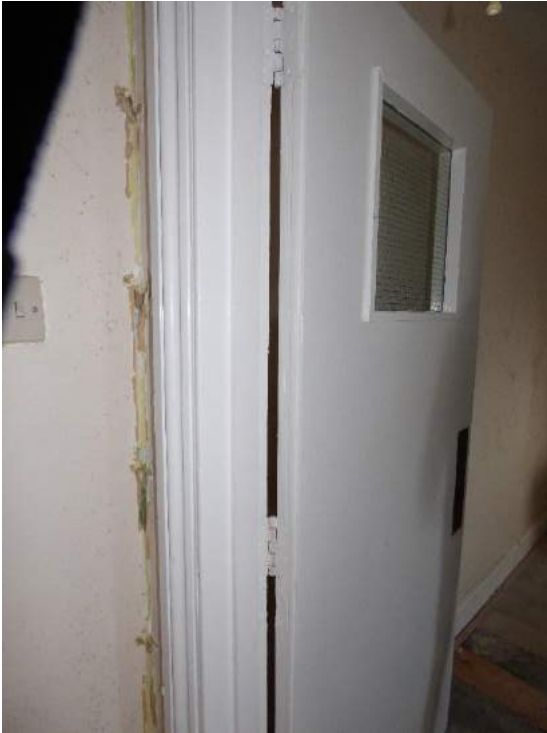
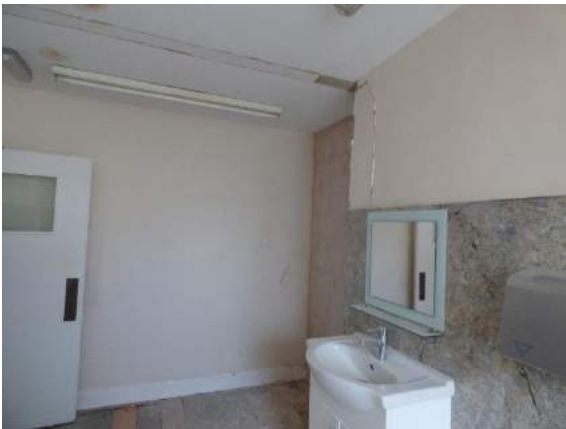
Left and Below: Existing bathroom, all to be completely renovated. All existing FF&E and M&E to be removed and all surface finishes to be completely removed and walls made good.

New Georgian heritage style 4 panel door to be provided and installed by specialist joinery company such as Batty Joinery Ltd. All fabric damage to be carefully repaired. New four panelled heritage door to be provided and installed.

Bathroom to be reduced in size to accommodate new en-suite to master bedroom.

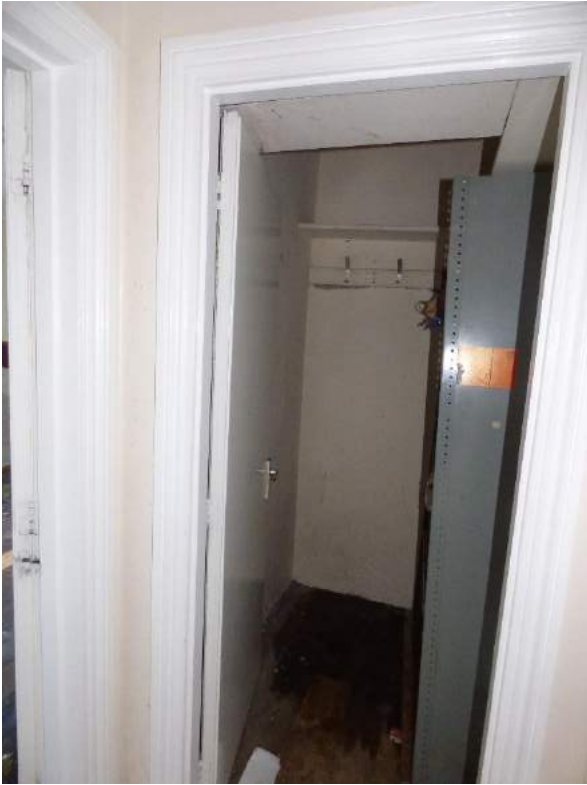
All architraves, to be retained. New Georgian four panel doors to be provided in lieu of flush panel doors.

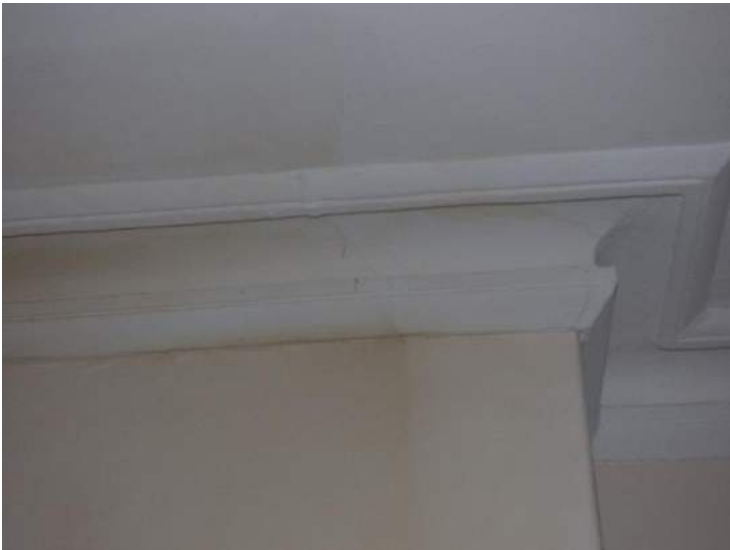
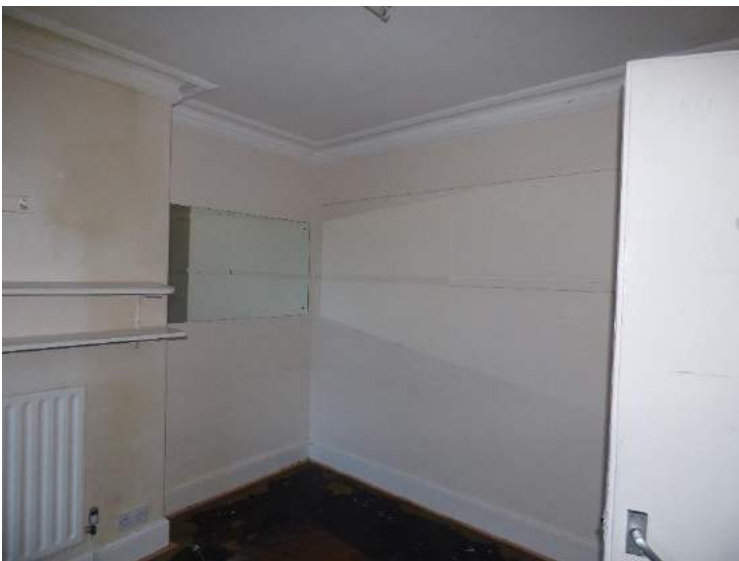
Front bedroom (First floor RHS), cornice, skirtings, and architraves to be retained. Existing flush panelled door to be replaced with new Georgian heritage style 4 panel fire door to be provided and installed by specialist joinery company such as Batty Joinery Ltd.

Existing floorboards in good condition.

It is proposed to form new doorway with architraves to match existing, and new four panelled door, into a new en-suite to be formed from part of the existing over large bathroom to make efficient use of the space and reflect the requirements of modern-day living.

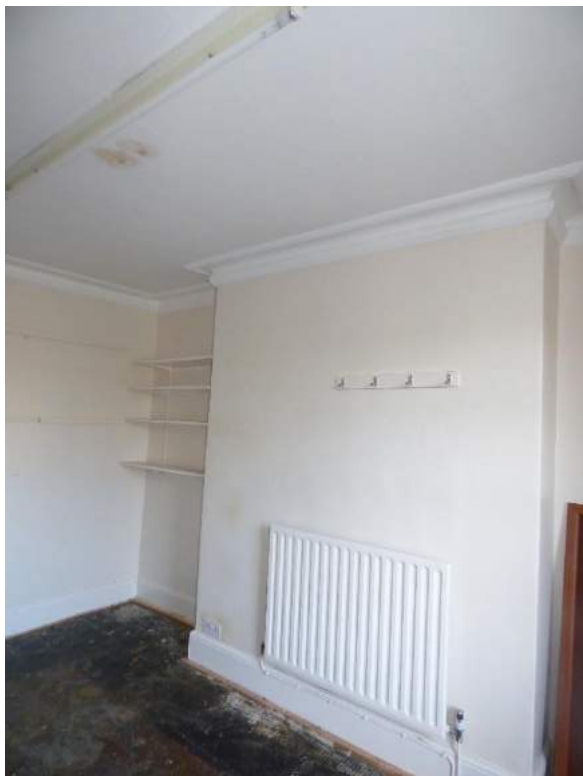
Rear bedroom existing skirtings and architraves to be retained. Existing modern flush panelled door to be replaced with new Georgian heritage style 4 panel door fire door to be provided and installed by specialist joinery company such as Batty Joinery Ltd.

Damp ingress has affected plasterwork by window. It is proposed to rake back existing blown plaster and repair with new lime plaster. The installation of the new window should resolve the damp ingress.

Existing floorboards in good condition. Minor repairs may be necessary.

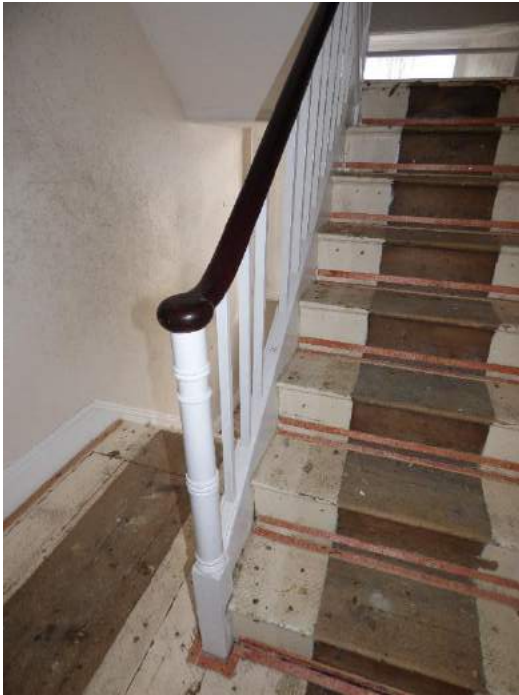
Handrail, balusters, and rails are original and are to be retained. Missing baluster to be replaced with matching baluster and decorated to match existing.

Apply an insulated plasterboard 62mm thick to underside of ceiling. The Laminated plasterboard and PIR has a vapour barrier incorporated so interstitial moisture would be prevented. Tape and skim and undertake full decorations.

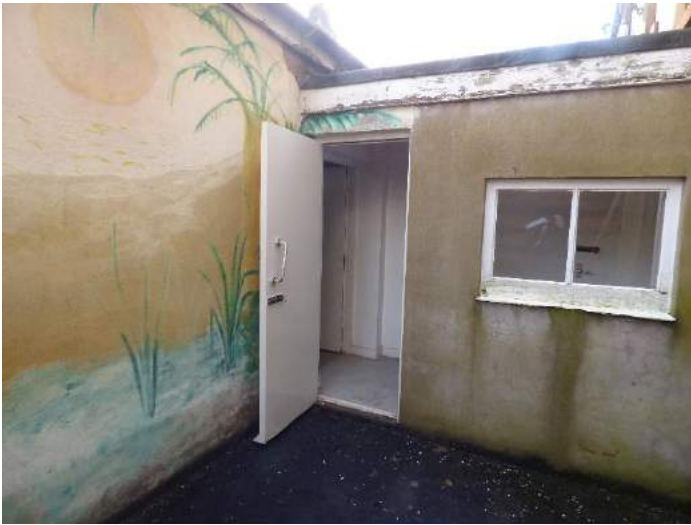
It is proposed to demolish the existing link and rear building, as they were a later mid-century addition to the property and are not good quality construction, so it is the intention is to restore the rear garden to its original state to allow for additional recreation space for the property.

Existing link building to be completely removed and the existing house to be made good. New door to rear to be Georgian style as front door as although the estimate for the date of the buildings is mid-19th Century, which would be some years after the end of the Georgian period, even if the counting the Regency, but reflect the style none the less.

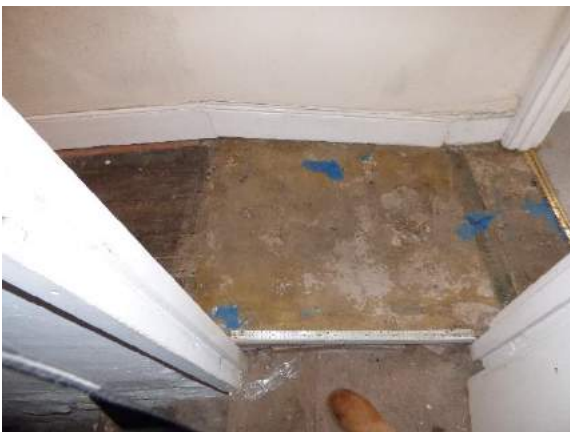
Left: The existing walls and floors are generally in good condition.

Redundant M&E to be removed and wall / ceiling finishes made good, and primed, prepared, and fully decorated.

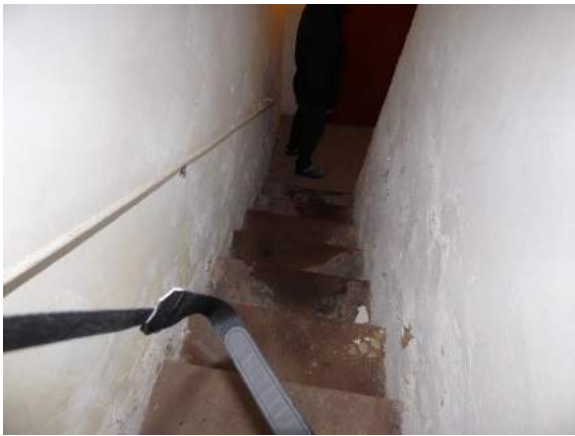
Left: The basement

The existing walls and floor are generally in sound condition so would be suitable for the application of damp proof slurry system. All existing paint and surface finishes must be removed and made good including all snots removed, and damage to existing surfaces, prior to the installation of a Koster Polysil NB1. This migratory crystalline tanking slurry is used to seal below ground structures against water ingress.

Koster NB1 works by both providing a physical barrier against water ingress as well as providing a migratory crystal sealant that penetrates deep into the structure to seal micropores and cracks against water ingress.

Once applied then the walls can be prepared and primed for decorating and for the floor finish to be installed. Complete new boiler and heating system is required, new distribution boards etc.

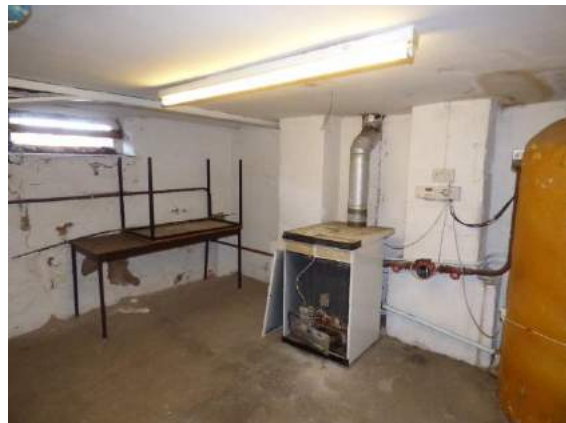
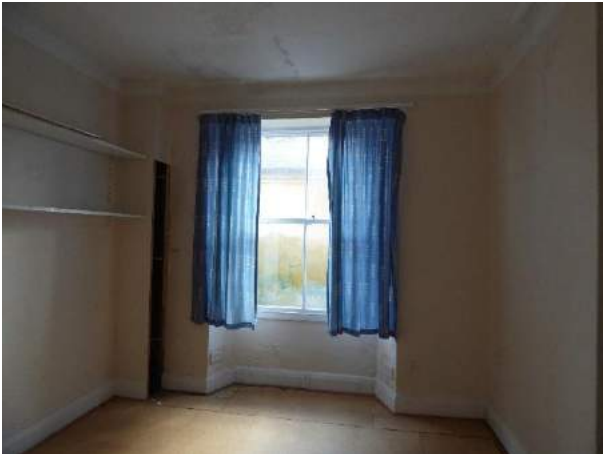
In the existing study, the period features below and to the sides of the existing window are in good condition, it is proposed to carefully refurbish the existing timber shutters.

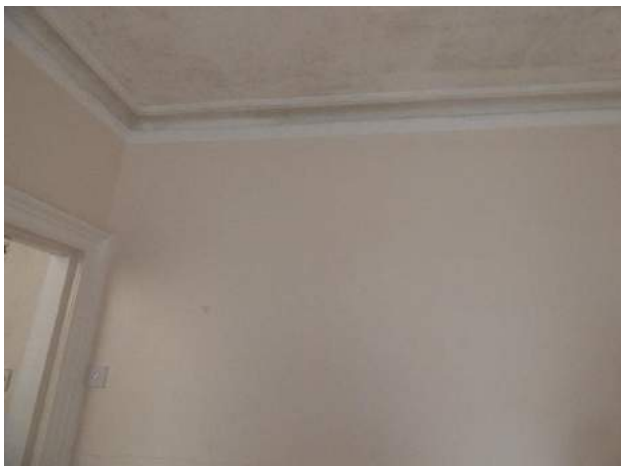
Left and below: the existing dining area to the rear of the property, the period features below and to the sides of the existing window are in good condition, it is proposed to carefully refurbish the existing timber shutters.

Below: Existing cornice to be made good in locations and where hairline cracks have appeared.

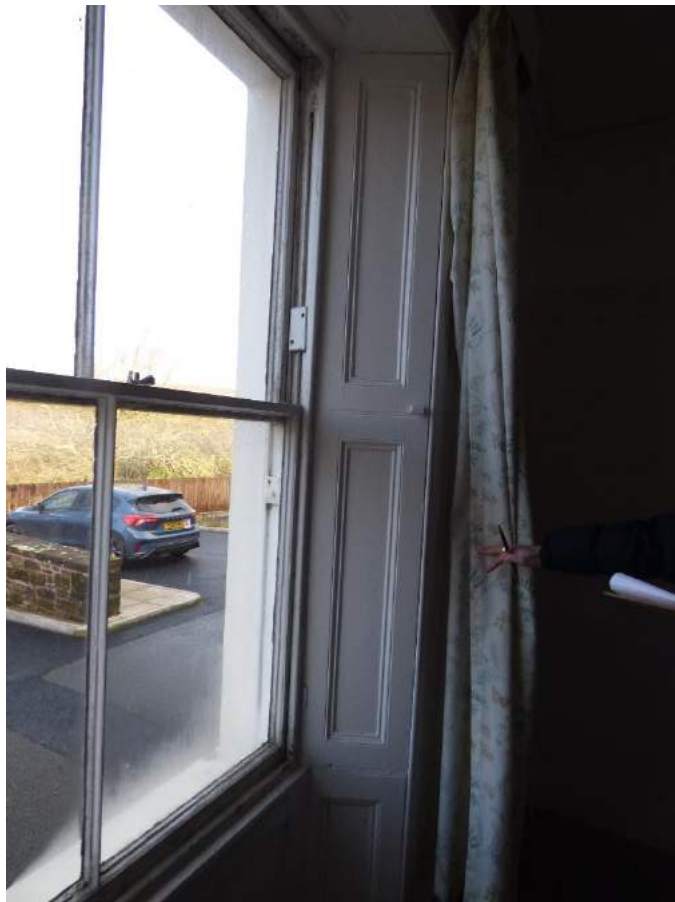
Above: In the existing lounge at the front of the property and

Existing architraves, and skirtings to be retained and made good.

Flush panel fire door to be replaced with heritage style four panelled fire doors to enhance the heritage asset.

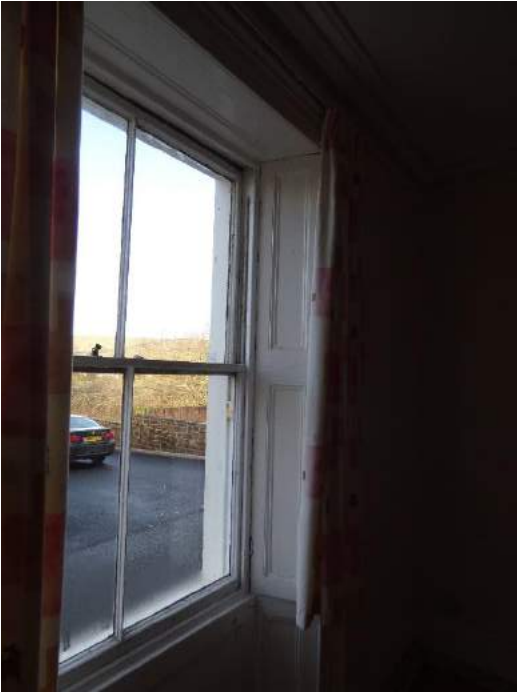
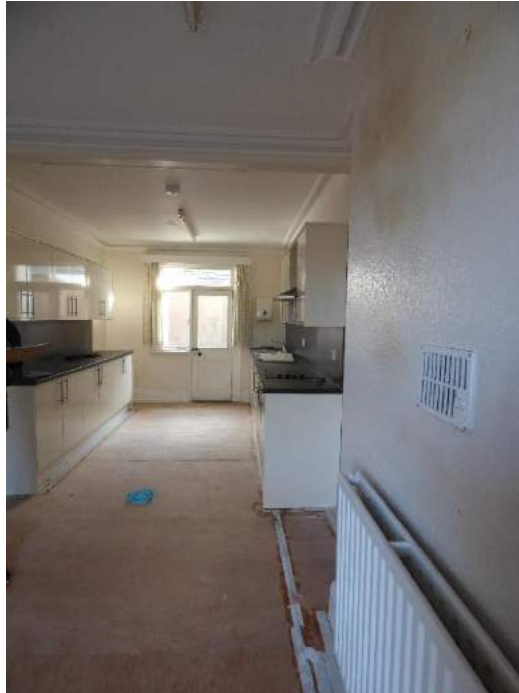
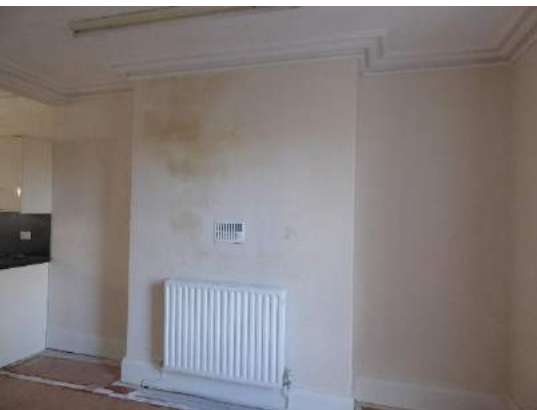
Above, Right, and below: In the existing lounge, the period features below and to the sides of the existing windows both front and back are in good condition, it is proposed to carefully refurbish the existing timber shutters.

Existing cornice to be made good in locations where redundant services are to be removed and where hairline cracks have appeared.

Existing architraves, and skirtings to be retained and made good.

Flush panel doors to be replaced with heritage style four panel painted timber fire doors to enhance the heritage asset.

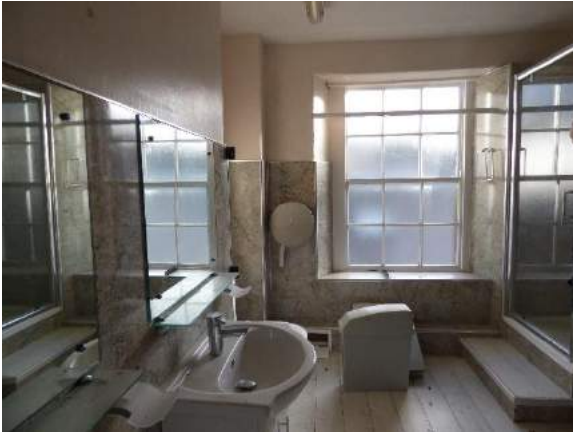
Left: Existing bathroom to be reduced in size to allow for new en-suite to master which backs on to the bathroom. This allows for a decent sized family bathroom and a new en-suite providing accommodation suitable for modern day living.

Existing ceiling to be made good and provide and install new extract fan linked back to light switch.

Glazing to new heritage style Georgian double glazed sash window to be obscure.

New bathroom door to be new four panelled heritage style door - bathroom door does not need to be a fire rated door.

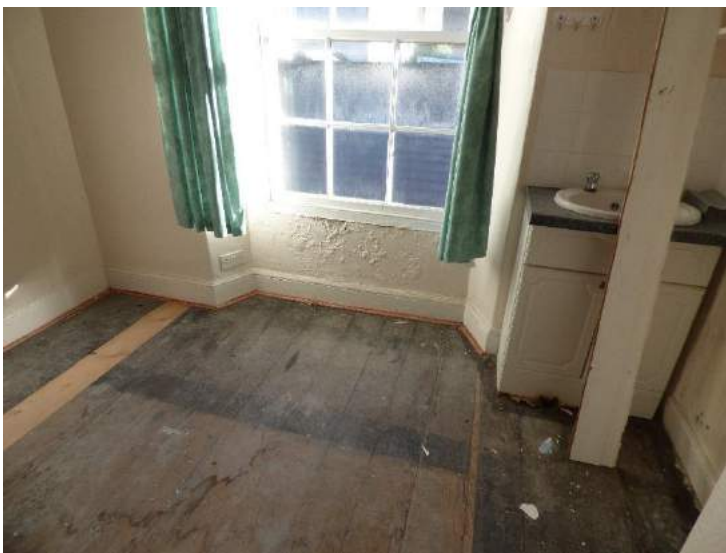
Existing floorboards generally in good condition.

Damp and associated blown plaster below window and to window reveals to be repaired with lime plaster. New heritage style double glazed window will be fitted to ensure no water ingress.

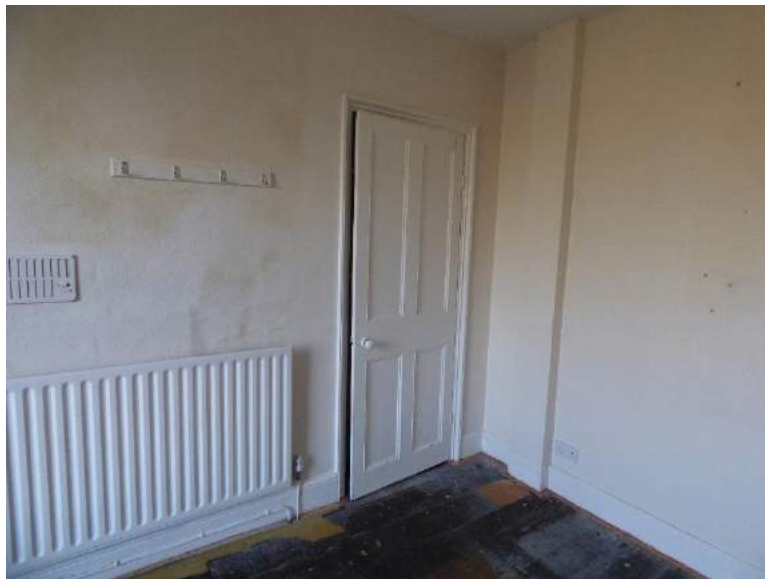
Front bedroom (First floor RHS), skirtings and architraves to be retained. Existing flush panelled door to be replaced with new Georgian heritage style 4 panel door to be provided and installed by specialist joinery company such as Batty Joinery Ltd.

Existing floorboards in good condition.

It is proposed to form new doorway with architraves to match existing, and new four panelled door, into a new en-suite to be formed from part of the existing over large bathroom to make efficient use of the space and reflect the requirements of modern-day living.

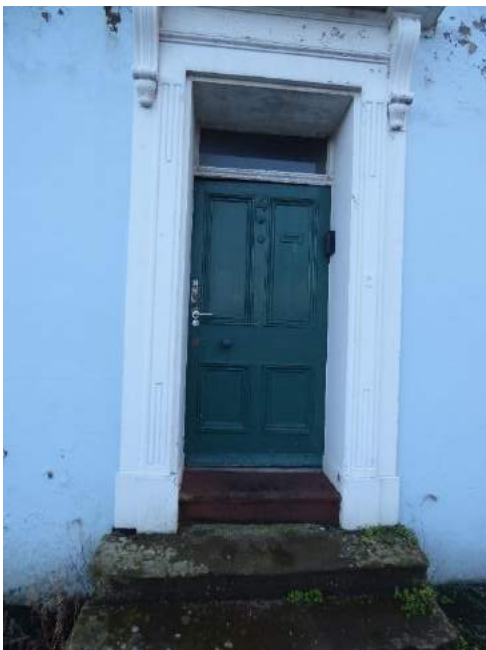
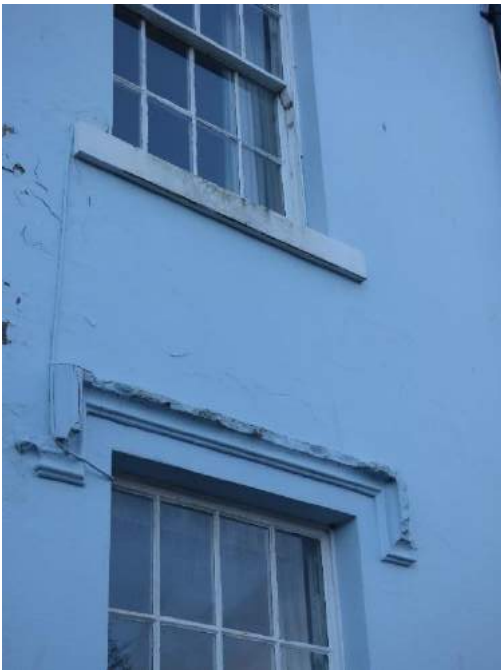
All existing single glazed windows to replace with new white painted slim profile double glazed.

'heritage' windows to match the existing style by specialist supplier such as Batty Joinery, specialists in historic and listed building joinery works.

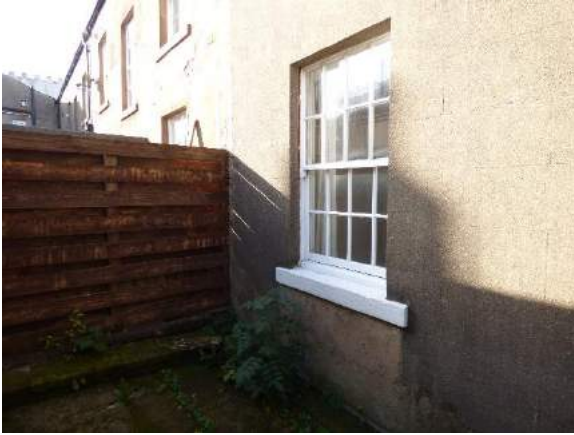
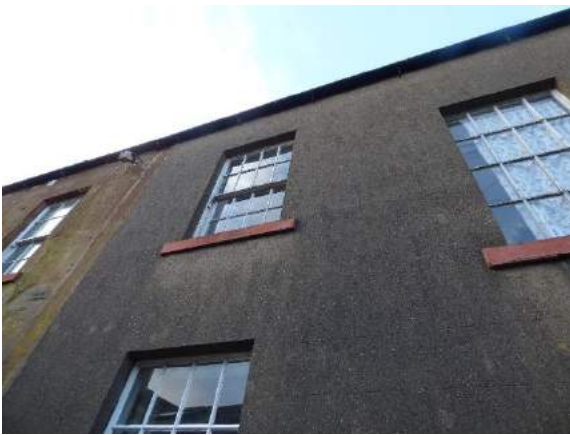
The rear courtyard is divided by a single storey 'link' building to an outbuilding at the rear. It is proposed to demolish this link structure as it is in extremely poor condition, and also to demolish the existing rear building, which was a mid-20th Century addition to the property to facilitate washroom accommodation for the boarding house, to provide additional amenity space for the property and allow more light into the existing dwelling.

Windows to be replaced with new painted timber double glazed heritage style sash windows by specialist joinery company such as Batty joinery ltd.

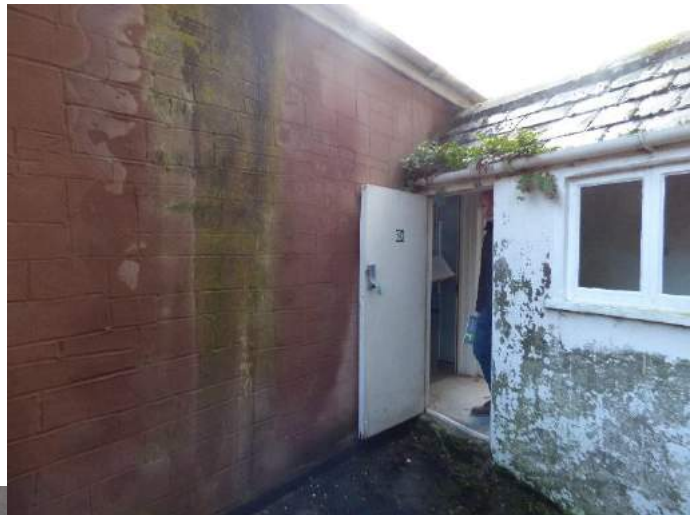
Rear of property – render to be repaired by specialist and decorated with off white render.

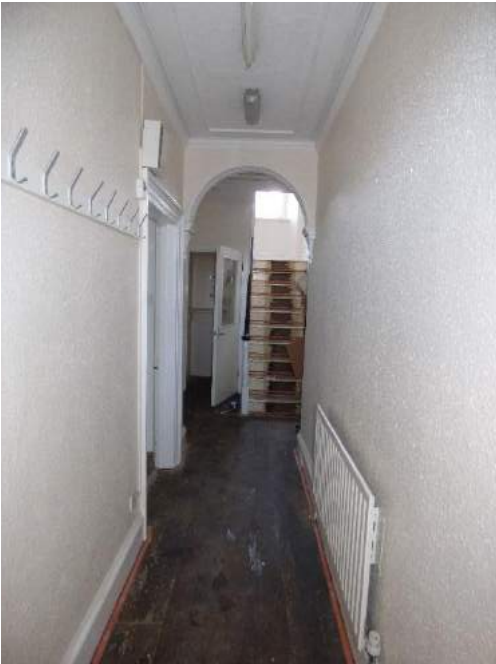
Left: The existing walls and floor are generally in good condition.

Redundant M&E to be removed and wall / ceiling finishes made good, and primed, prepared, and fully decorated.

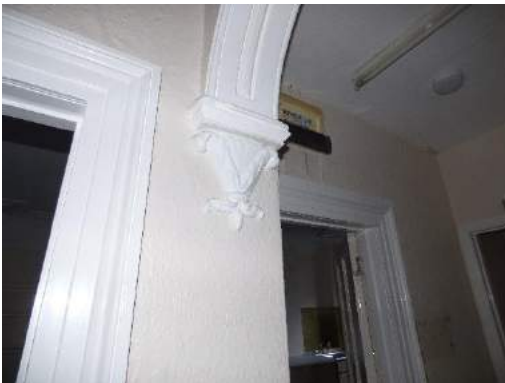
Left: period features to be retained, including archway and architraves. (Modern lighting to all be stripped out and make good surfaces). All architraves and plaster features to be retained.

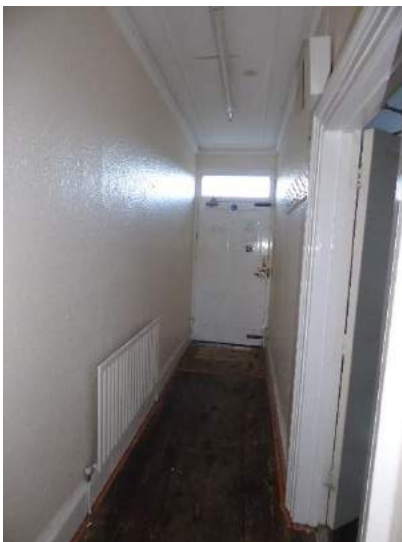
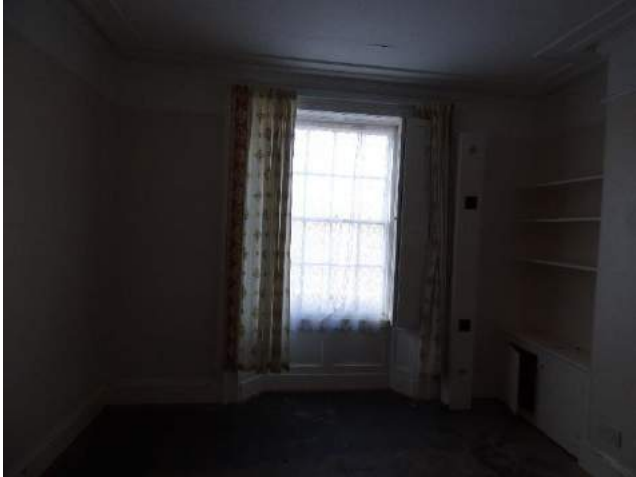
Left: In the existing study, the period features below and to the sides of the existing window are in good condition, it is proposed to carefully refurbish the existing timber shutters.

Left: Existing cornice to be made good in locations where redundant services are to be removed and where hairline cracks have appeared.

Existing architraves, and skirtings to be retained and made good.

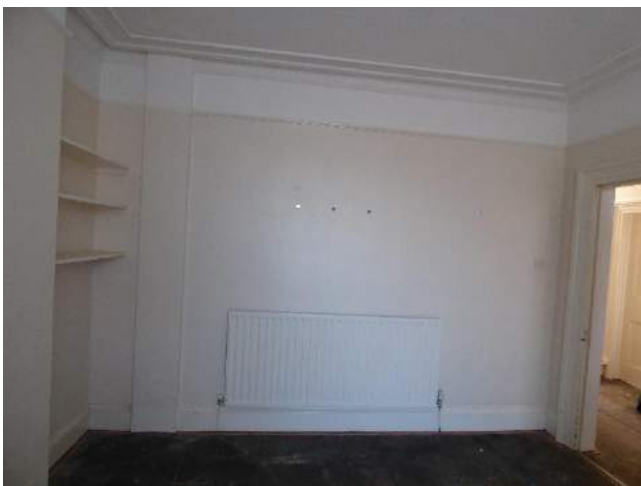
Flush panel doors to be replaced with heritage style 4 panel painted timber fire doors to enhance the heritage asset.
