HERITAGE STATEMENT

FULL RENOVATION OF EXISTING No 11 TERRACE HOUSES

St Bees, 1-11 Lonsdale Terrace, Parish Council, Cumbria

M.A.C Architects, Project Number: 2019:303

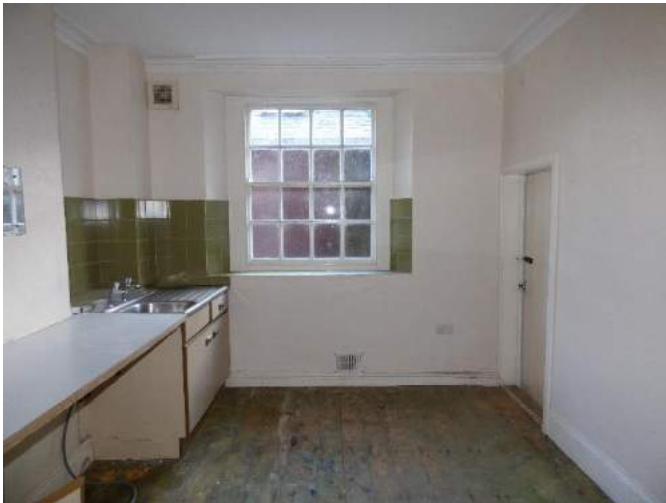
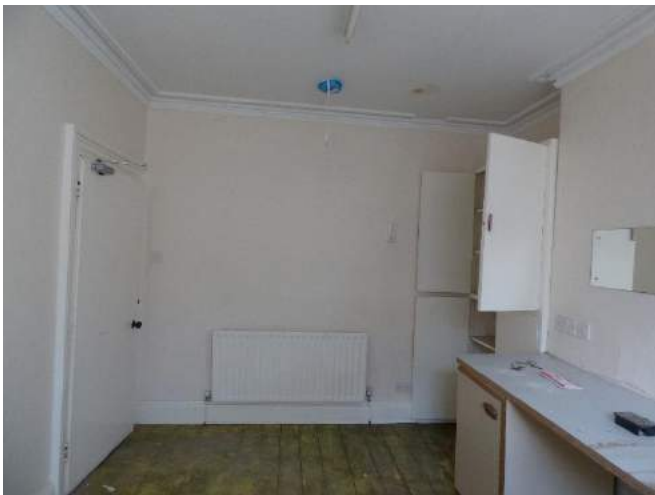
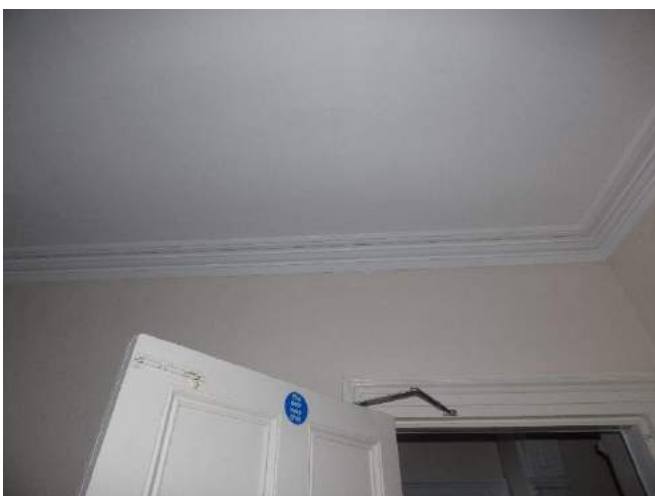
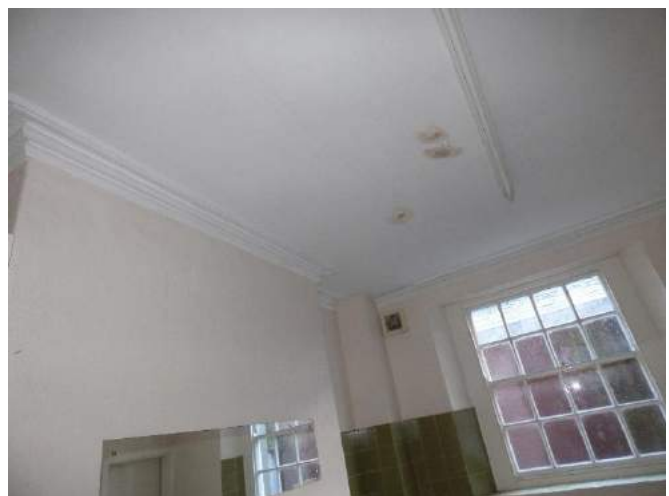
Left and below: the existing kitchen area to the rear of the property, the period features below and to the sides of the existing window are in good condition.

Below: Existing cornice to be made good in locations and where hairline cracks have appeared.

Existing architraves, and skirtings to be retained and made good.

Flush panel doors to be replaced with heritage style 4 panel painted timber fire doors to enhance the heritage asset.

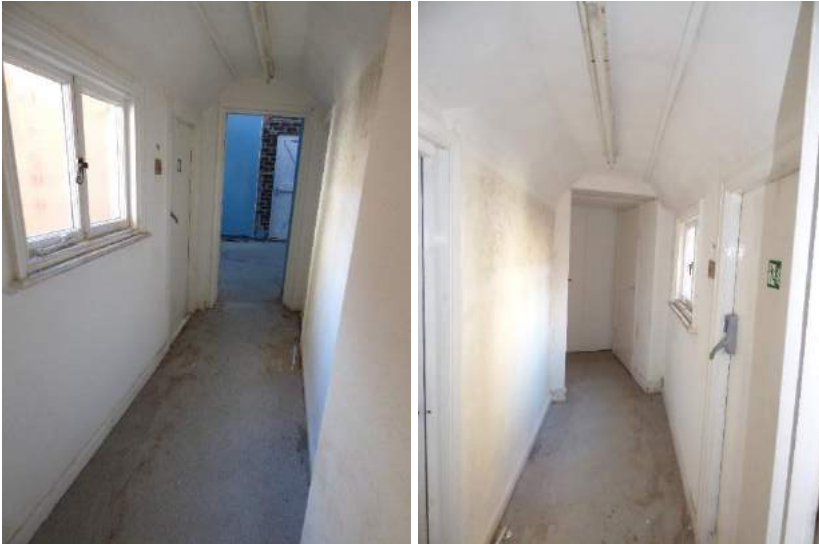
Left: Existing single skin link building extension to be removed.

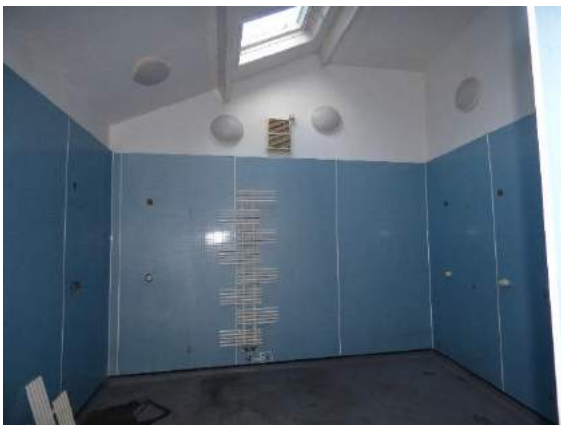
Left: Shower block to be removed to provide additional amenity space to the property. Not original building. Constructed mid-20th Century to provide washroom facilities for the boarding house.

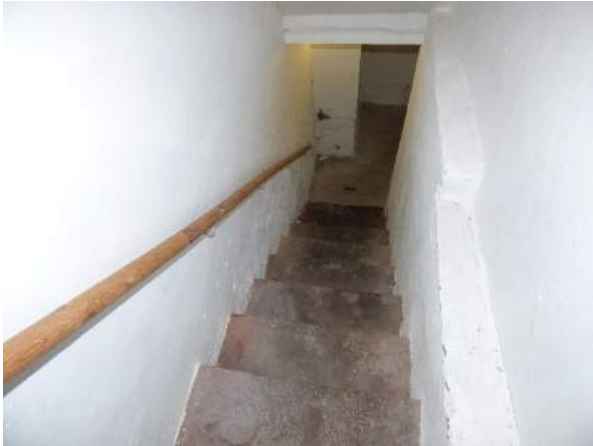
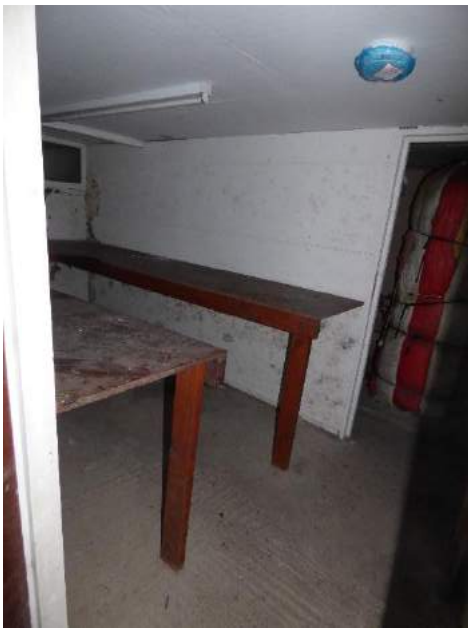
The existing walls and floor to the basement are generally in sound condition so would be suitable for the application of damp proof slurry system. All existing paint and surface finishes must be removed and made good including all snots removed, and damage to existing surfaces, prior to the installation of a Koster Polysil NB1. This migratory crystalline tanking slurry is used to seal below ground structures against water ingress.

Koster NB1 is considered to be a Type A waterproofing system as defined by BS8102:2009 and is generally used to seal the inside face of basement structures, slabs and retaining walls.

Koster NB1 works by both providing a physical barrier against water ingress as well as providing a migratory crystal sealant that penetrates deep into the structure to seal micropores and cracks against water ingress.

Once applied then the walls can be prepared and primed for decorating and for the floor finish to be installed. Complete new boiler and heating system is required, new distribution boards etc.

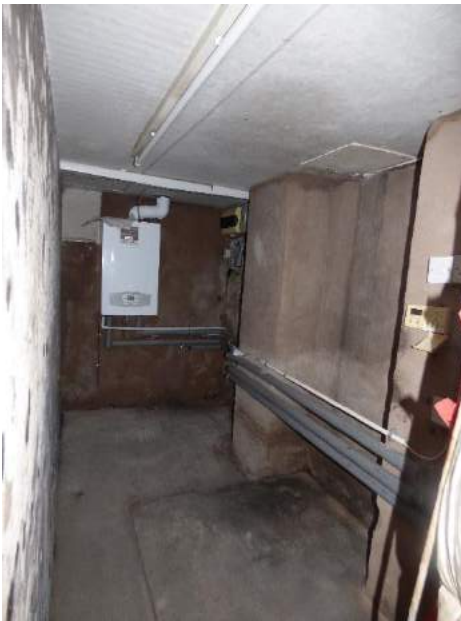
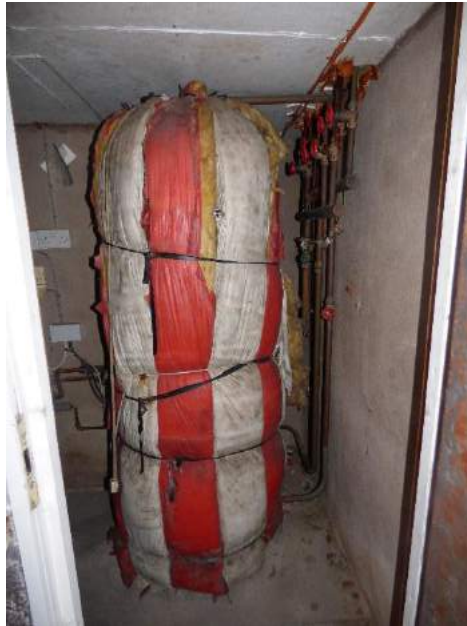
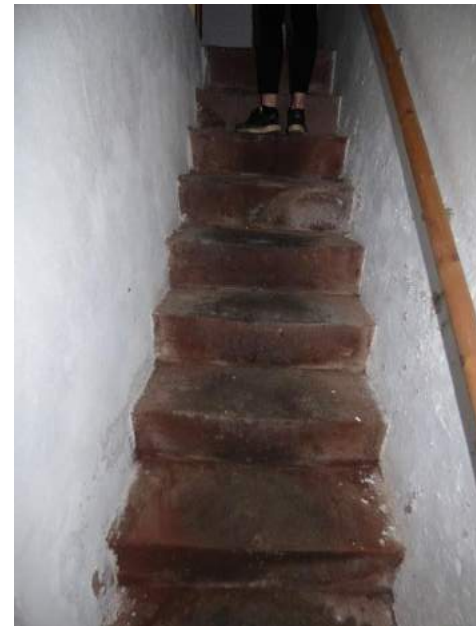
The walls down to the basement also require the full treatment.

Existing window to basement has been walled up. This is to be removed and reveals made good. Allow for the installation of a new double glazed heritage style window. We propose side hinged casements for the basement windows.

In the basement all existing services are to be carefully stripped out and replaced with new compliant infrastructure.

All existing services to be carefully removed and new gas and electric services installed.

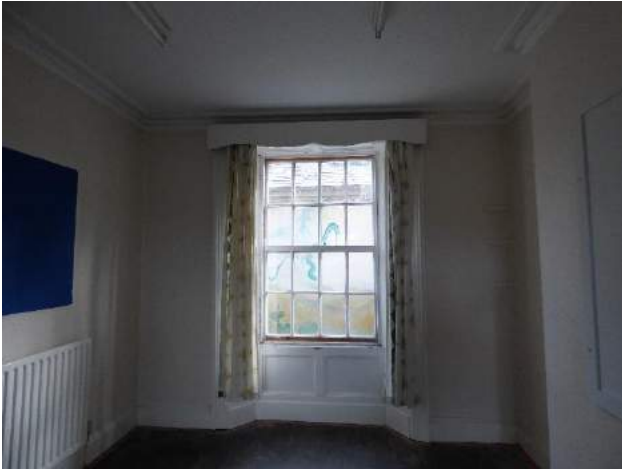
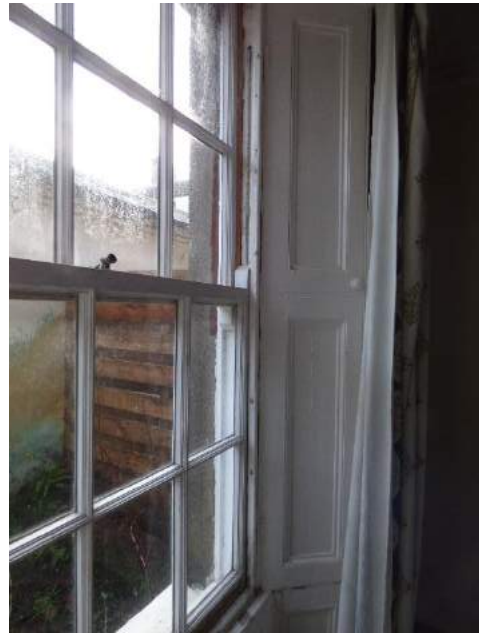
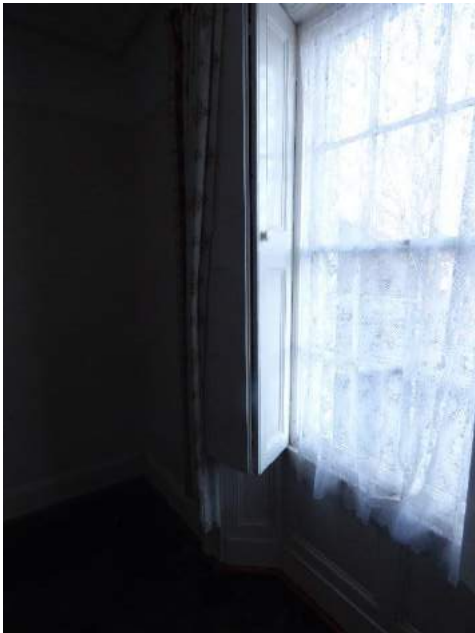
Above and Left: In the existing study, the period features below and to the sides of the existing windows both front and back are in good condition, it is proposed to carefully refurbish the existing timber shutters.

Existing cornice to be made good in locations where redundant services are to be removed and where hairline cracks have appeared.

Existing architraves, and skirtings to be retained and made good.

Flush panel doors to be replaced with heritage style 4 panel painted timber fire doors to enhance the heritage asset.

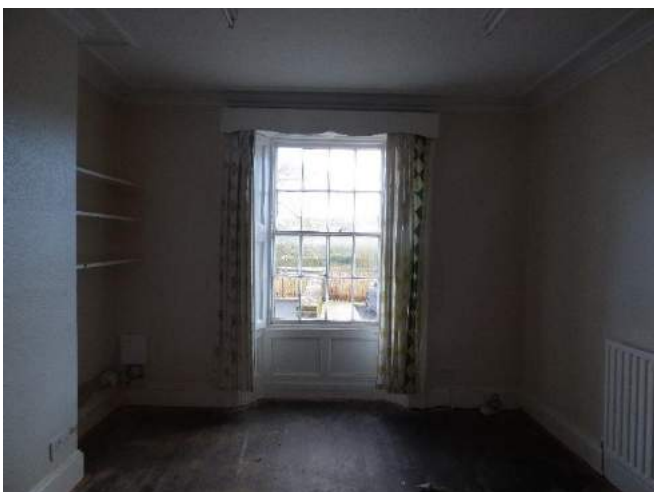
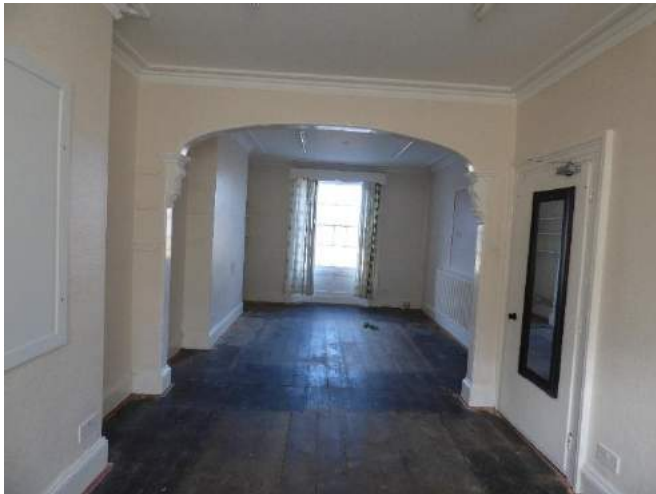
Left: period features to be retained, including archway and architraves. (Modern lighting to all be stripped out and make good surfaces). All architraves and plaster features to be retained.

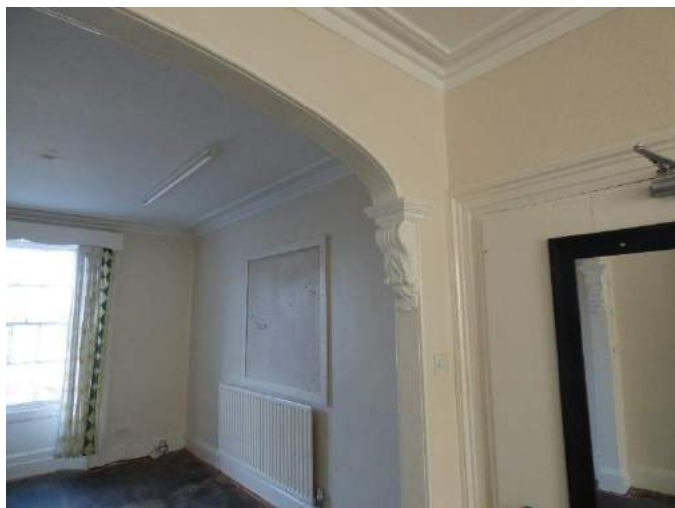
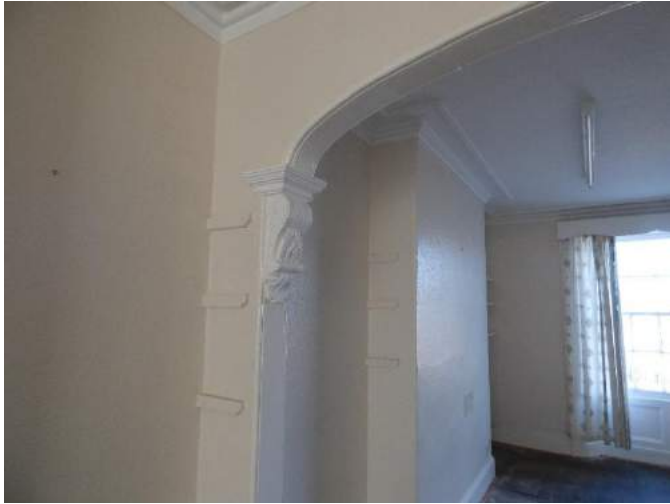
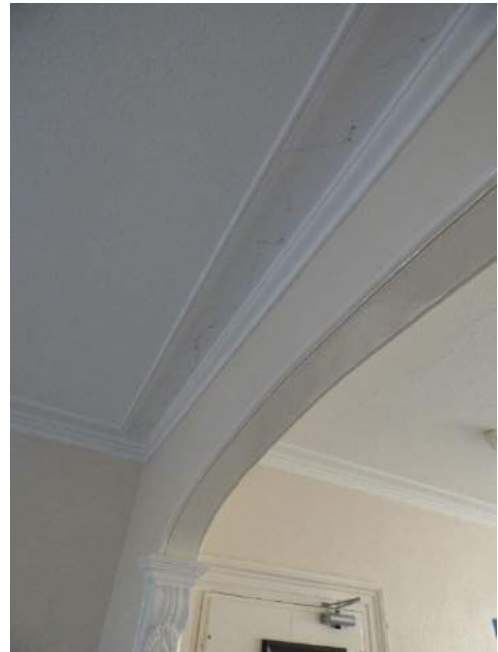
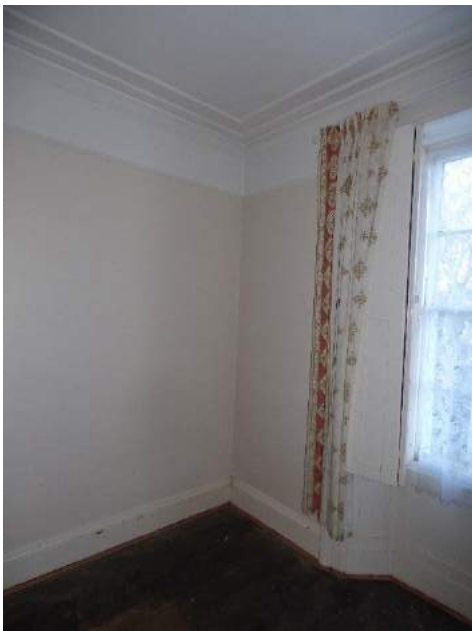
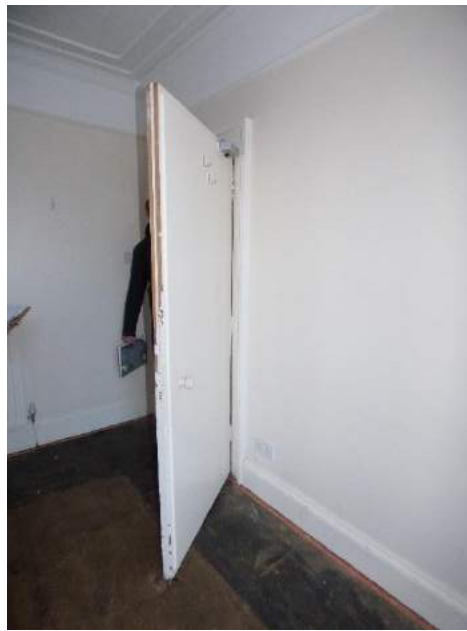
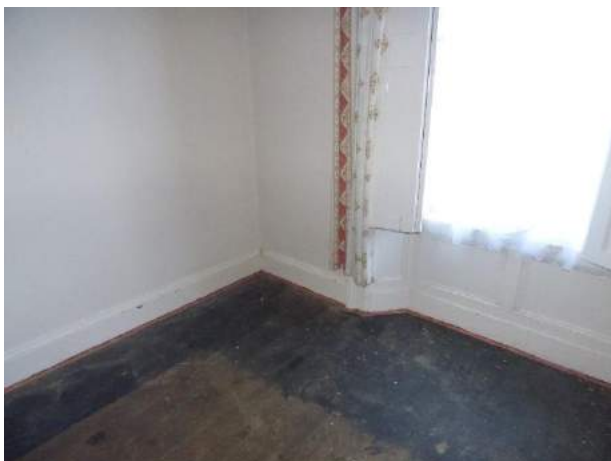
Above and Left: In the existing lounge, the period features below and to the sides of the existing windows both front and back are in good condition, it is proposed to carefully refurbish the existing timber shutters.

Existing cornice to be made good in locations where redundant services are to be removed and where hairline cracks have appeared.

Existing architraves, and skirtings to be retained and made good.

Flush panel doors to be replaced with heritage style four panel painted timber fire doors to enhance the heritage asset.

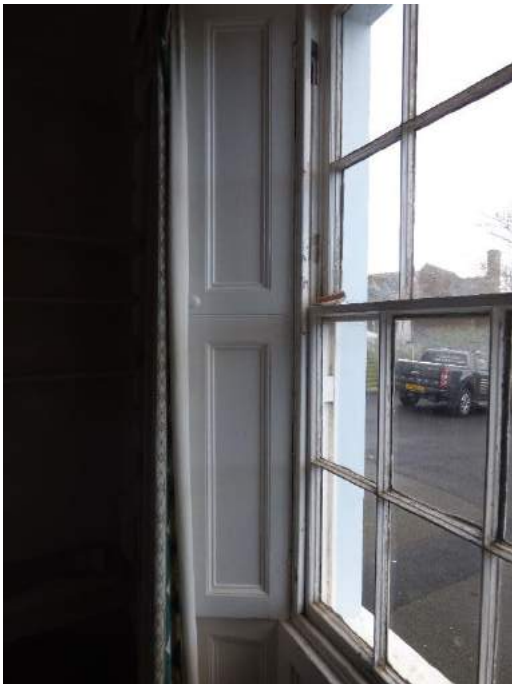
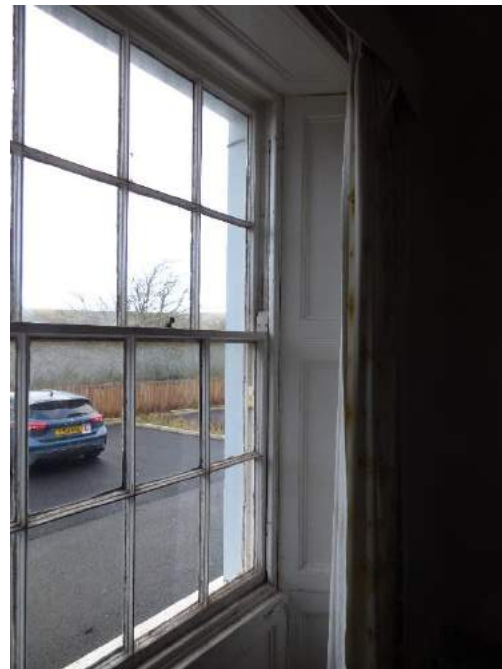
Above: In the existing lounge, the period features below and to the sides of the existing windows both front and back are in good condition, it is proposed to carefully refurbish the existing timber shutters.

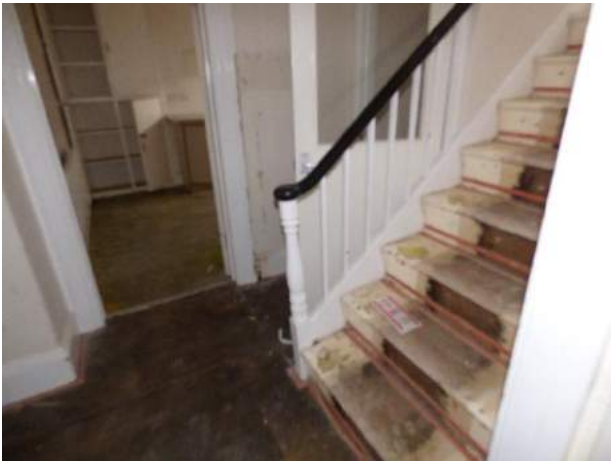
Retain original staircase, which is in good condition.

The requirement for the steel post at the top of the staircase

To be confirmed by structural engineer, if possible, the intention is to remove and strengthen the balusters if required to revert to the original staircase detail.

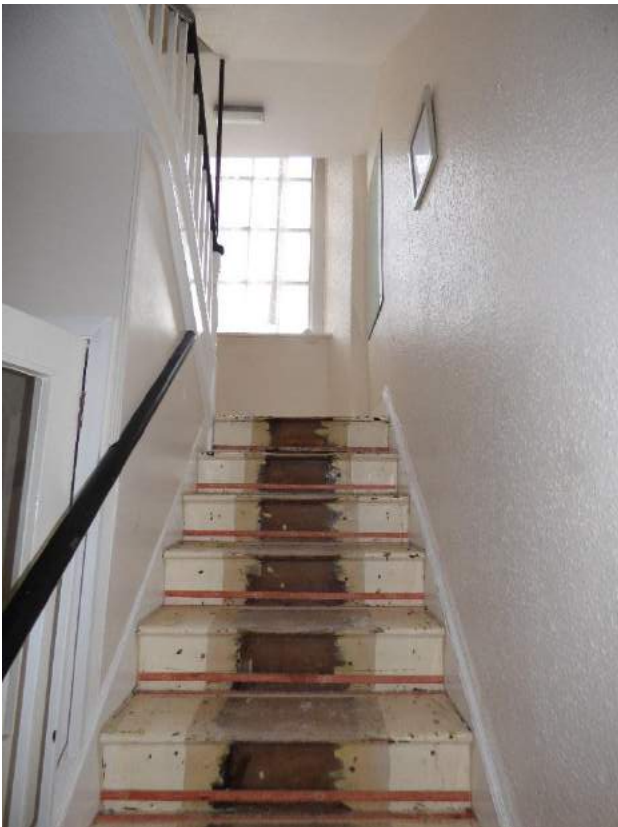
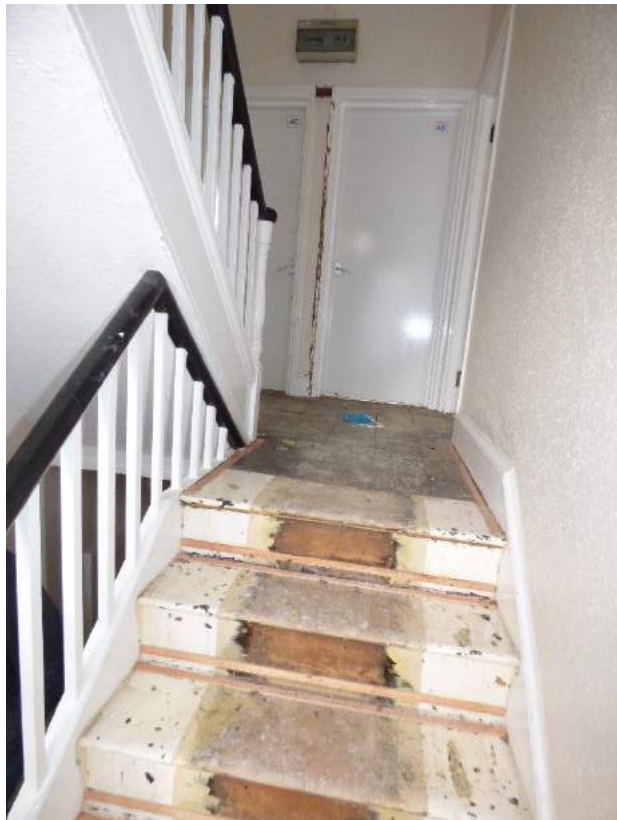
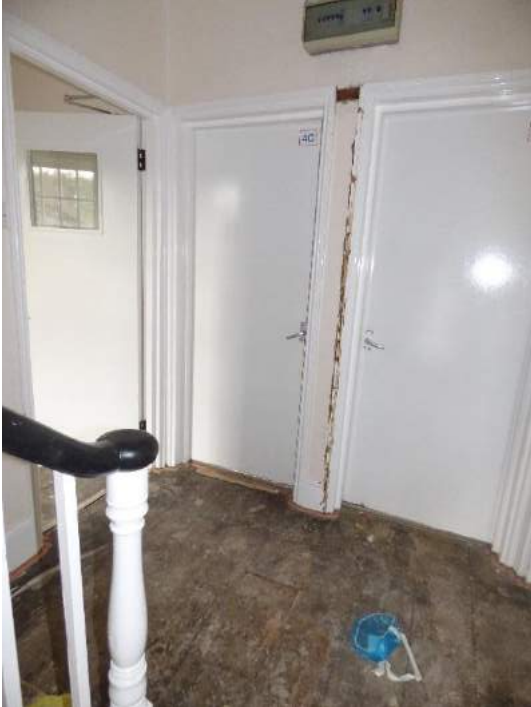
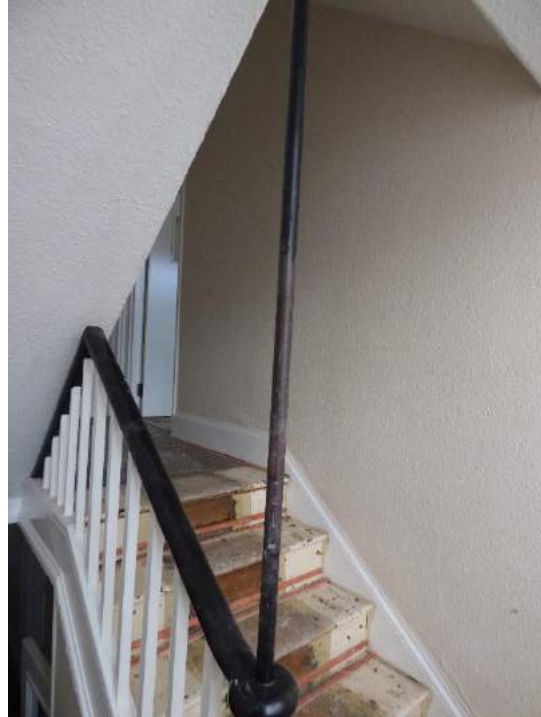
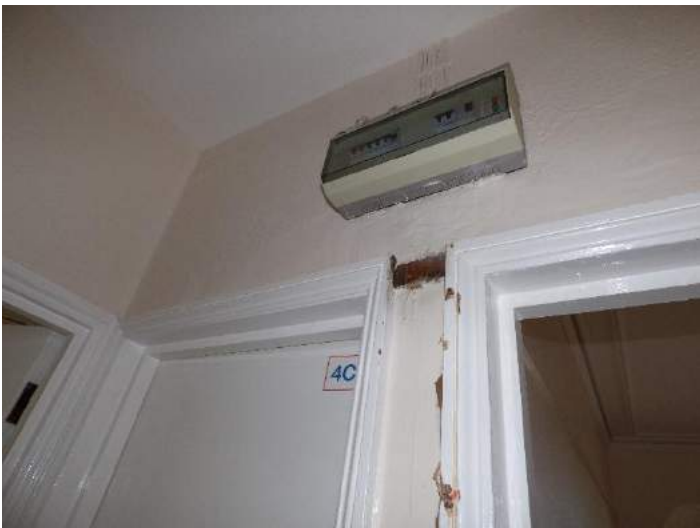
Original architraves to be retained.

Redundant M&E fixtures and fittings to be removed and surfaces made good.

Flush panel doors to be replaced with heritage style Georgian 4 panel fire doors.

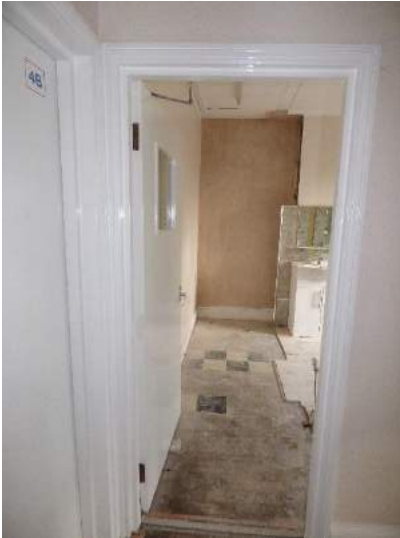
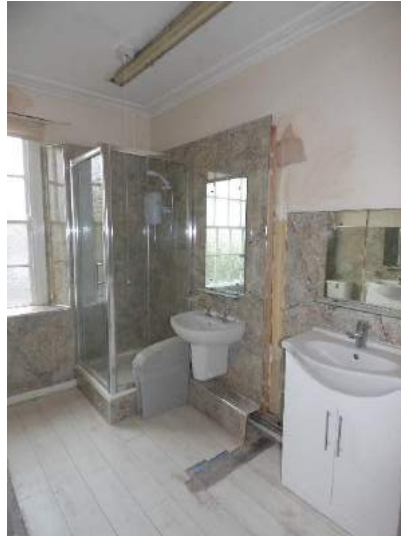
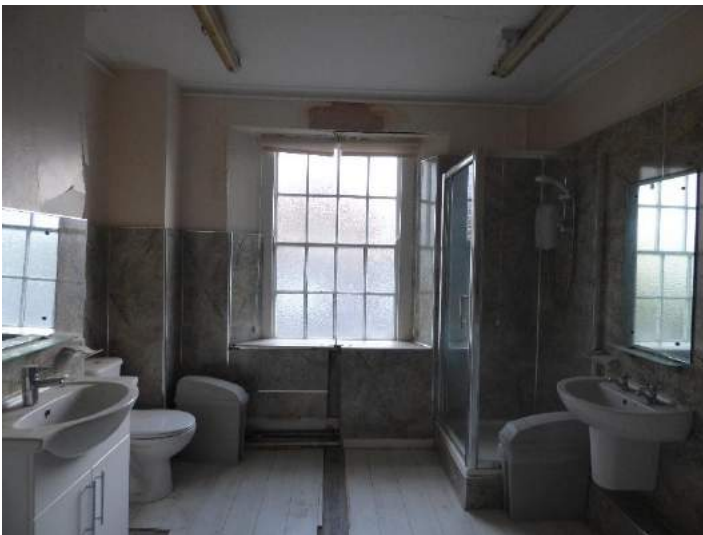
Left and above: Existing bathroom, to be completely renovated. All existing FF&E and M&E to be removed and all surface finishes to be completely removed and walls made good.

New Georgian heritage style four panel door to be provided and installed by specialist joinery company such as Batt Joinery Ltd. All fabric damage to be carefully repaired.

Bathroom to be reduced in size to allow for the installation of a new en-suite to the master bedroom.

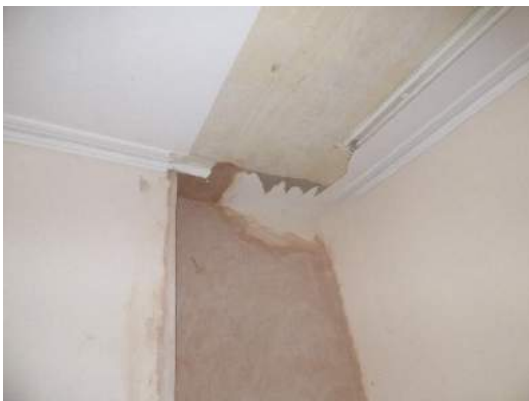
Front bedroom (First floor LHS), cornice, skirtings, and architraves to be retained. Existing flush panelled door to be replaced with new Georgian heritage style four panel door to be provided and installed by specialist joinery company such as Batty Joinery Ltd.

Existing floorboards in good condition.

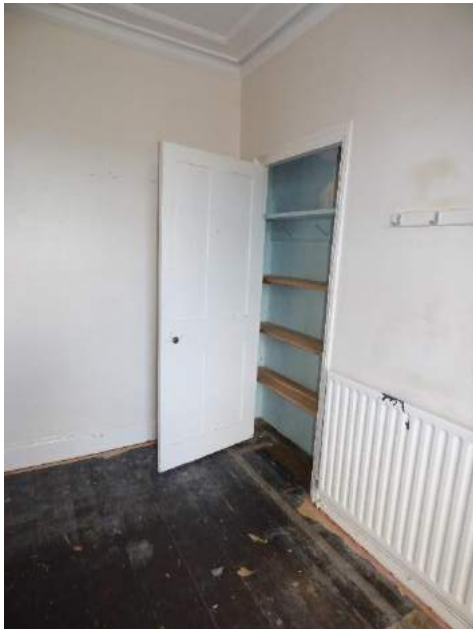
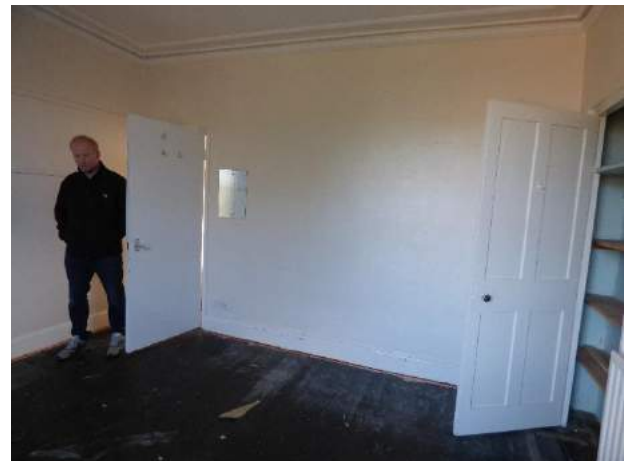
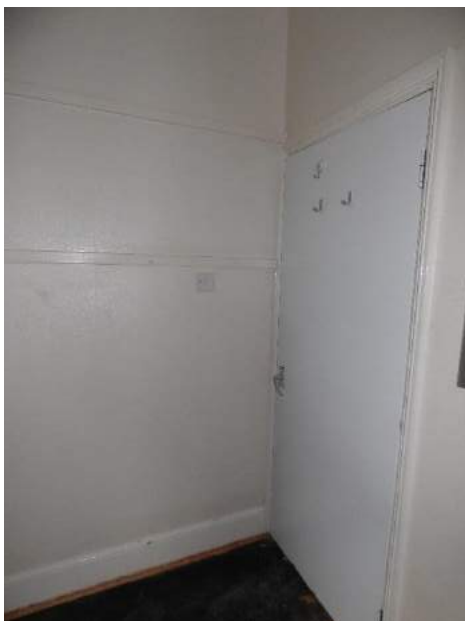
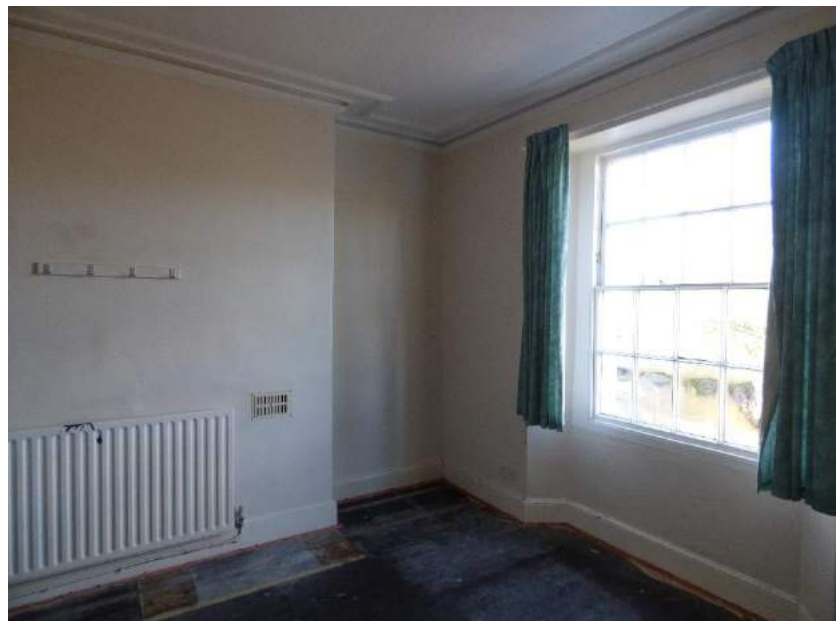
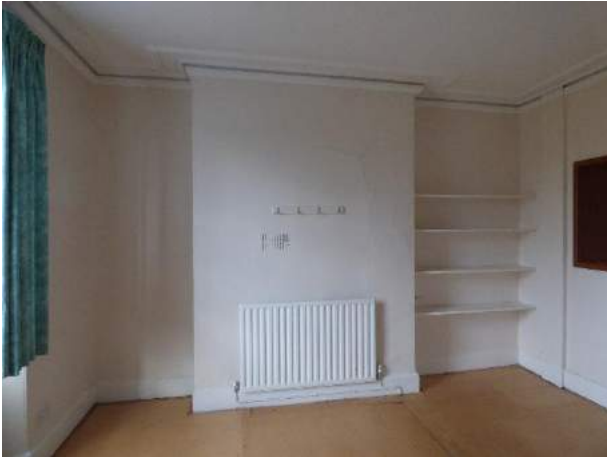
Front bedroom (First floor RHS), cornice, skirtings and architraves to be retained. Existing flush panelled door to be replaced with new Georgian heritage style 4 panel door to be provided and installed by specialist joinery company such as Batty Joinery Ltd.

Existing floorboards generally in good condition.

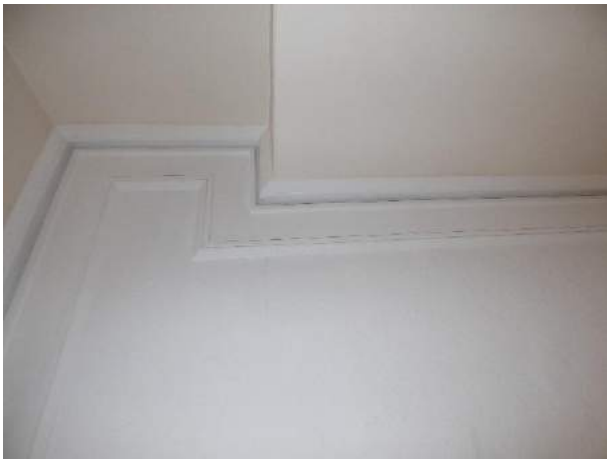
It is proposed to form new doorway with architraves to match existing, and new four panelled door, into a new en-suite to be formed from part of the existing over large bathroom to make efficient use of the space and reflect the requirements of modern-day living.

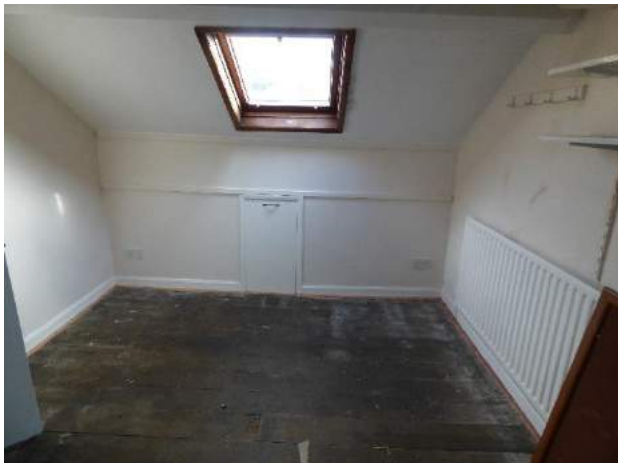
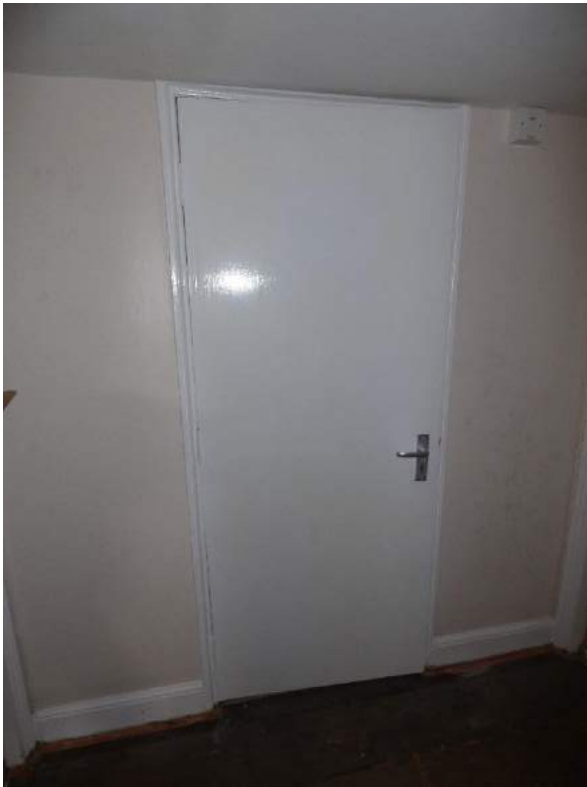
Left: Attic Store is proposed to be converted into a bathroom to be shared by the attic bedrooms by increasing the size of the room to each side to allow for the new bathroom.

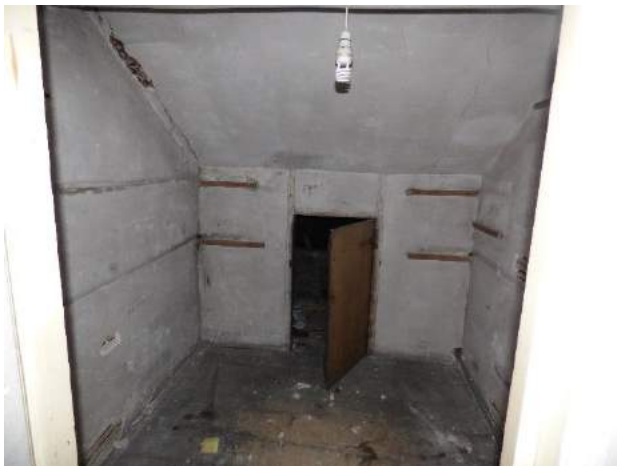
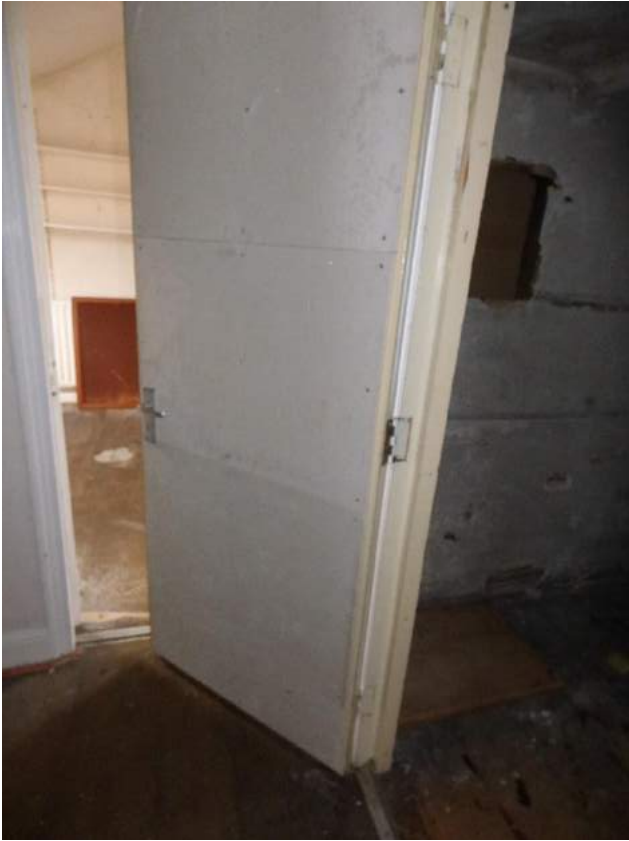
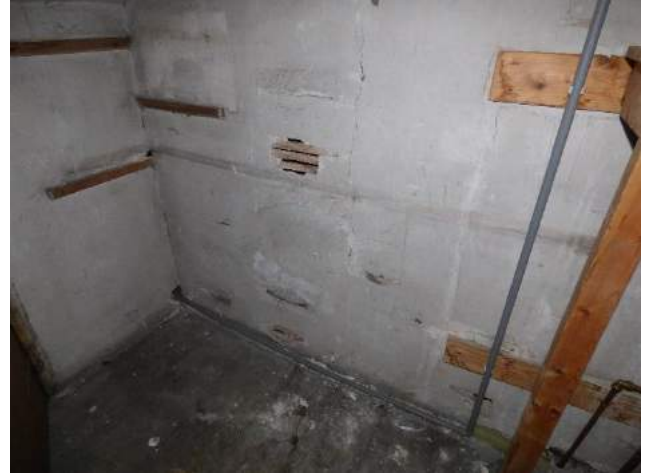
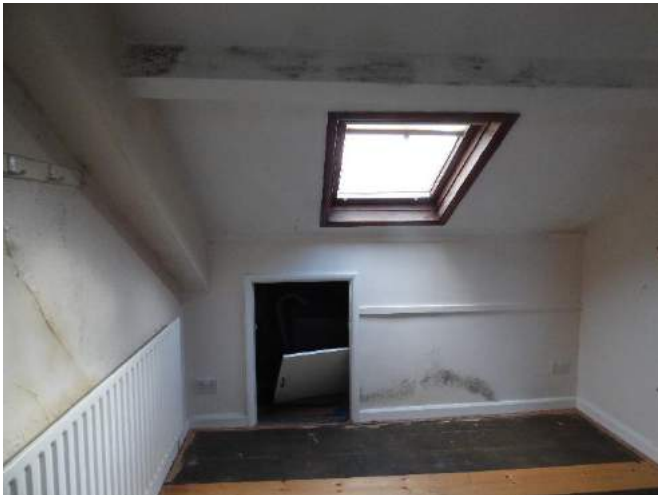
Left: Attic Bedroom

New plasterboard stud partition to be installed in lieu of removal of part of existing store / bedroom partition to allow for bathroom to be useable size.

In the bedroom remove all damp and damaged / blown plasterwork and repair with lime plaster (Solo lime plaster from Lime Centre) and skim and decorate throughout.

Floorboards are in good condition (but may require minor repairs).

Apply an insulated plasterboard 62mm thick to underside of ceiling. The Laminated plasterboard and PIR has a vapour

barrier incorporated so interstitial moisture would be prevented.

Replace modern Velux windows with heritage rooflight windows (Velux or similar with flashing kit that mounts unit flush with the roof surface).

Existing flush panel doors are to be removed and replaced with new heritage style four panel fire doors.

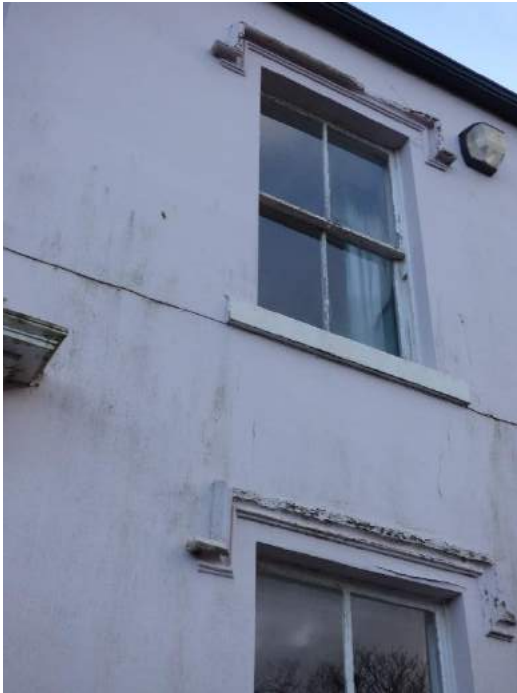
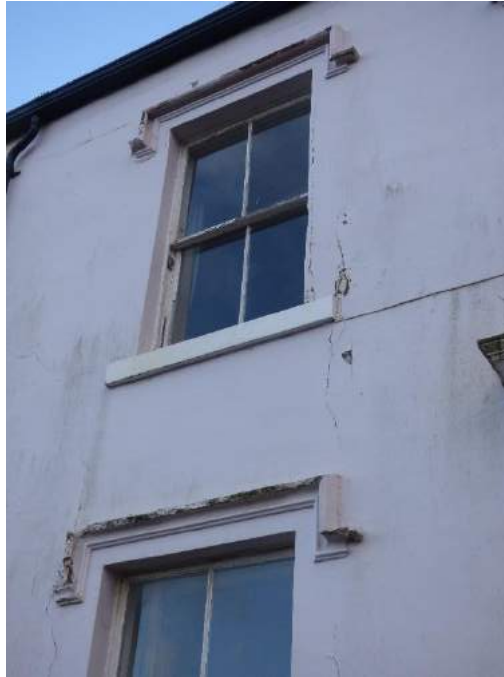
Localised lead repair work repair required to chimneys, to prevent leaking.

Existing cills to be repaired and decorated.

Existing Velux windows to be replaced with Velux conservation rooflights (or Rooflight company, heritage rooflights) (size to match existing) and new flashings to suit.

Rear of property – render to be repaired by specialist and decorated with off white render.

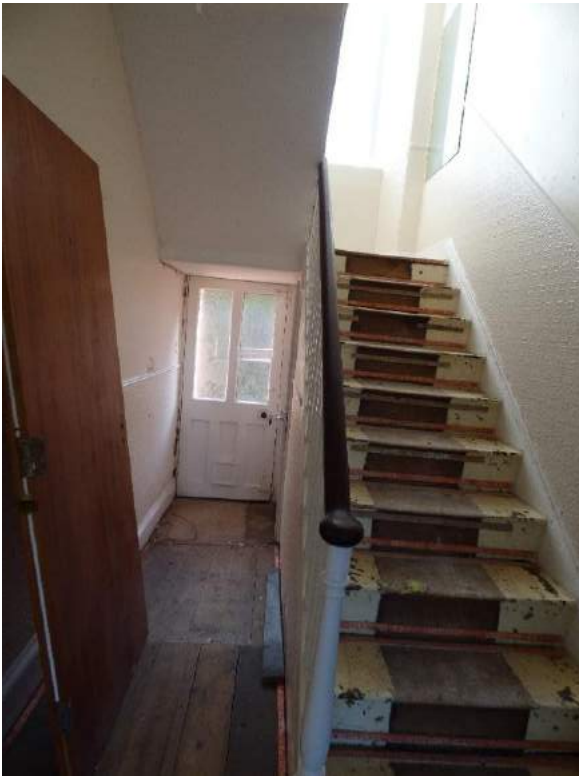
Retain original staircase, which is in good condition.

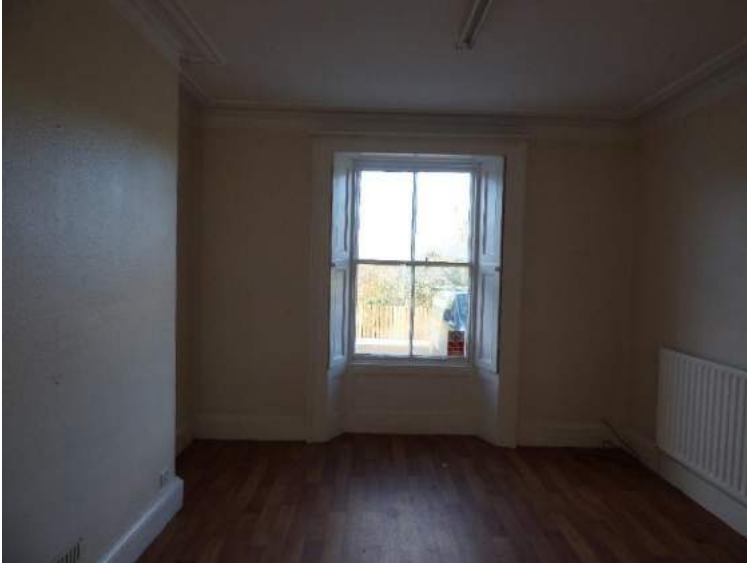
Above, right, and below: In the existing lounge at the front of the property and the existing dining area to the rear of the property, the period features below and to the sides of the existing window are in good condition, it is proposed to carefully refurbish the existing timber shutters.

Below: Existing cornice to be made good in locations and where hairline cracks have appeared.

Existing architraves and skirtings to be retained and made good.

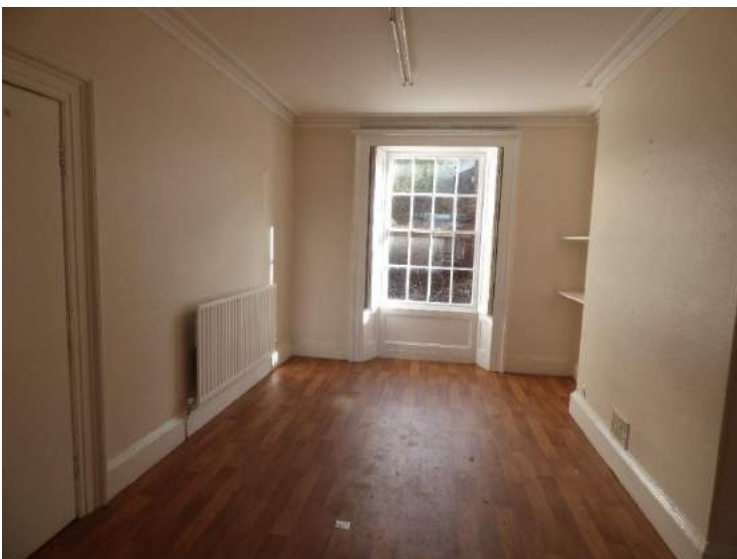
Below: In the existing lounge, the period features below and to the sides of the existing windows both front and back are in good condition, it is proposed to carefully refurbish the existing timber shutters

Existing cornice to be made good in locations where redundant services are to be removed and where hairline cracks have appeared.

Existing architraves and skirtings to be retained and repaired where necessary.

Flush panel doors to be replaced with heritage style for panel painted timber fire doors to enhance the heritage asset.

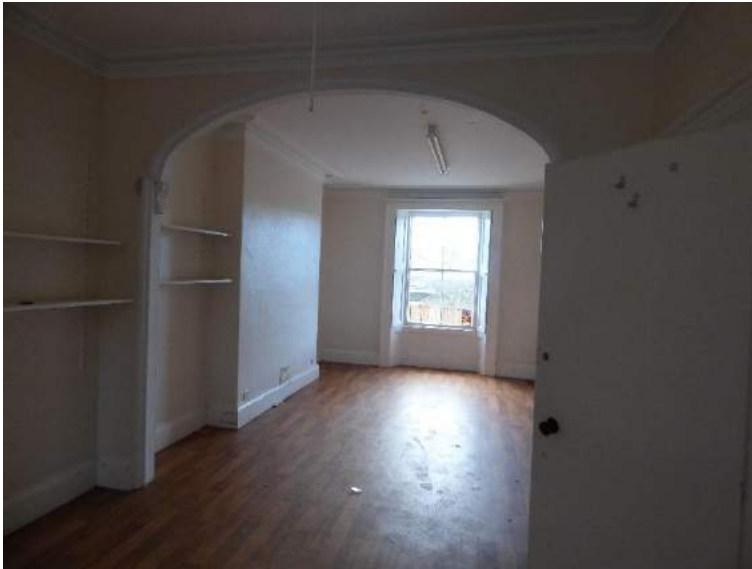
Left and below: In the existing lounge, the period features below and to the sides of the existing windows both front and back are in good condition, it is proposed to carefully refurbish the existing timber shutters.

Existing cornice to be made good in locations where redundant services are to be removed and where hairline cracks have appeared.

Existing architraves and skirtings to be retained and made good.

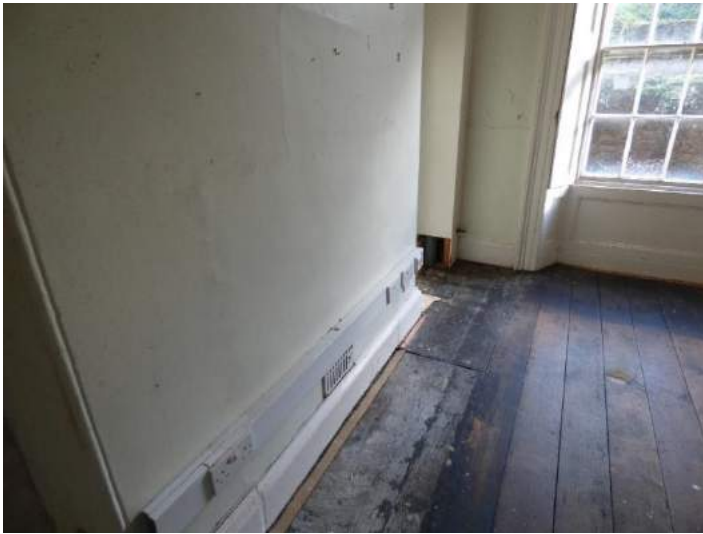
Left and below: The period features below and to the sides of the existing window are in good conditions, it is proposed to carefully refurbish the existing timber shutters.

Existing cornice to be made good in locations where redundant services are to be removed and where hairline cracks have appeared.

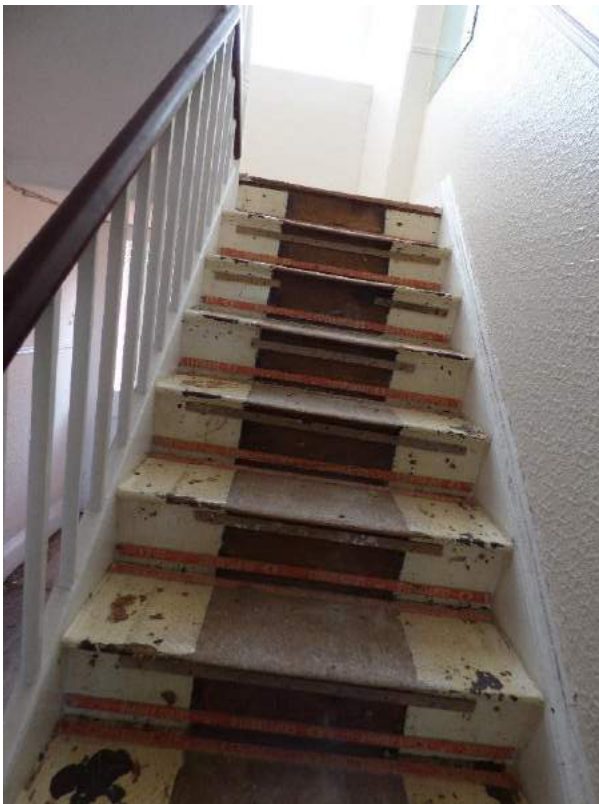
Retain original staircase, which is in good condition.

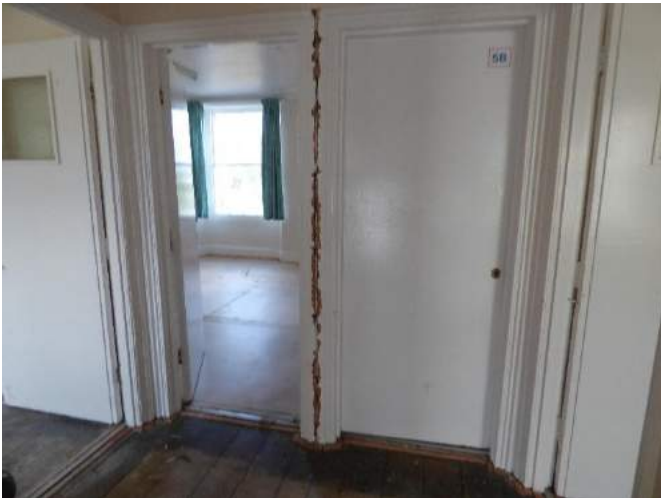
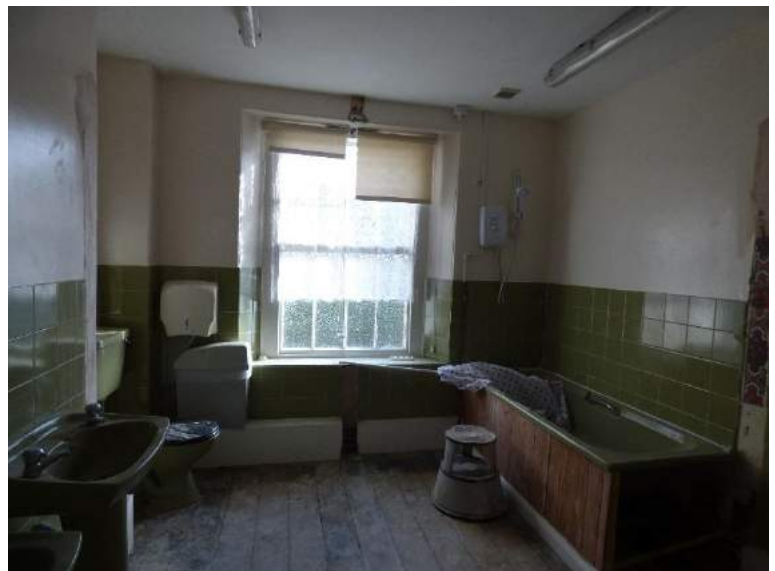
Existing floorboards are generally in good

condition.

Rear bedroom skirtings and architraves to be retained. Existing flush panelled door to be replaced with new Georgian heritage style four panel fire door to be provided by specialist joinery company such as Batty Joinery Ltd.
