HERITAGE STATEMENT

FULL RENOVATION OF EXISTING No 11 TERRACE HOUSES

St Bees, 1-11 Lonsdale Terrace, Parish Council, Cumbria

M.A.C Architects, Project Number: 2019:303

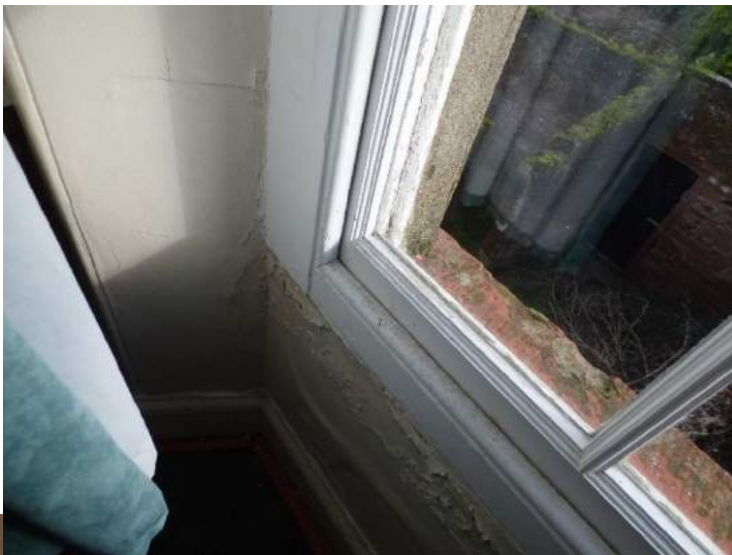
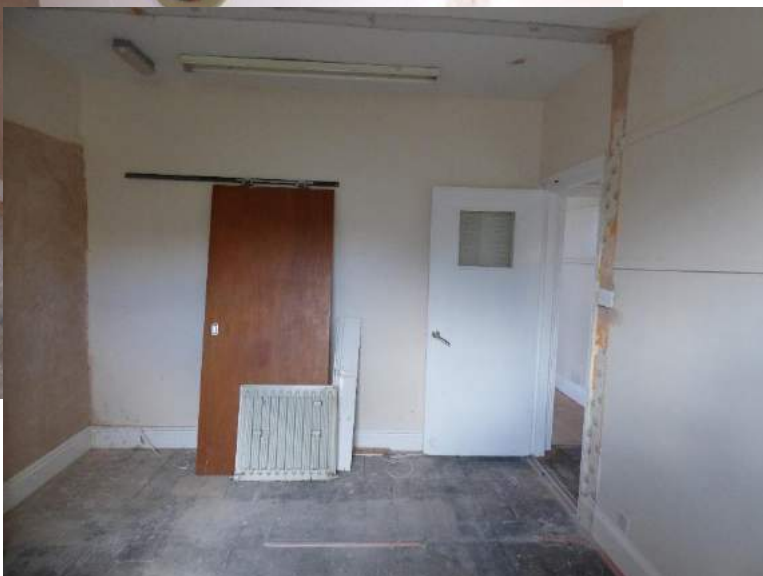
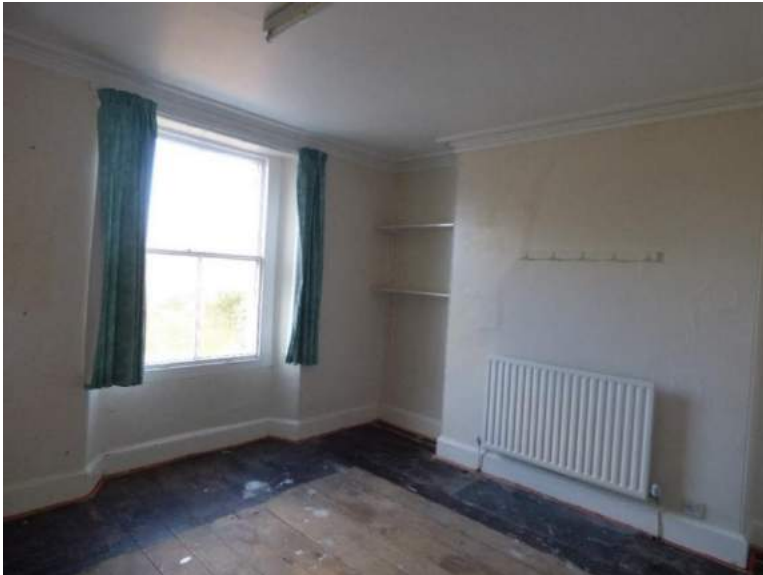
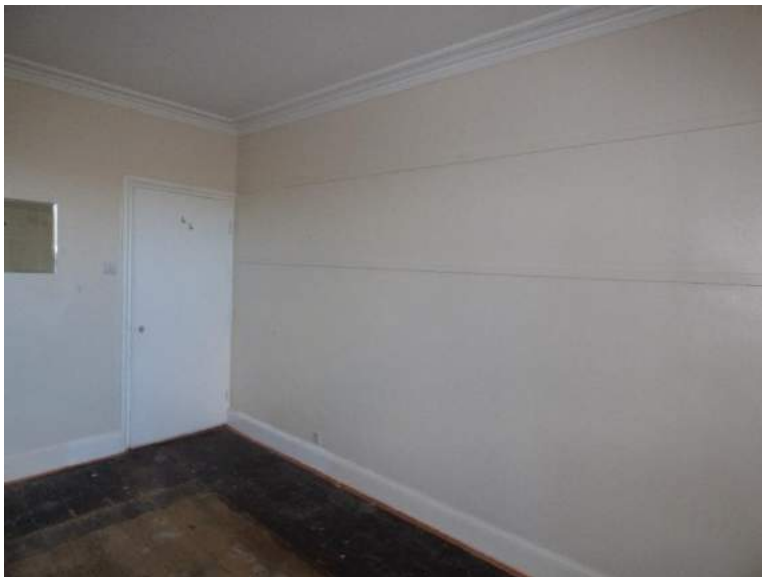
Existing floorboards in generally good condition.

Front bedroom (master) skirtings and architraves to be retained. Existing flush panelled door to be replaced with new Georgian heritage style 4 panel door to be provided and installed by specialist joinery company such as Batty Joinery Ltd.

Form new opening into new en-suite with new architraves and door to match the rest of the property.

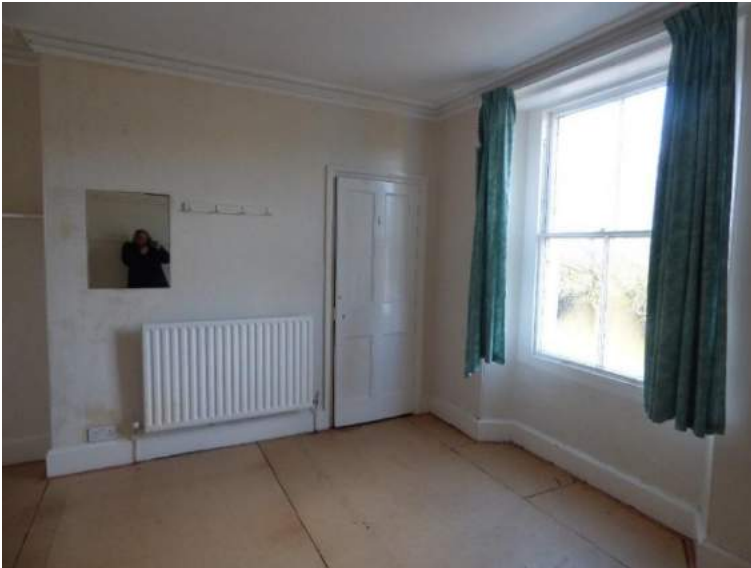
Existing floorboards have been concealed and over-boarded using large chipboard planks. It is proposed to lift the chipboard and evaluate the condition of the existing flooring underneath.

Front bedroom skirtings and architraves to be retained. Existing flush panelled door to be replaced with new Georgian heritage style 4 panel door to be provided and installed by specialist joinery company such as Batty Joinery Ltd.

It is likely that the existing timber floorboards may require significant replacement, if this is the case, the floorboards will be replaced as required on a like for like basis.

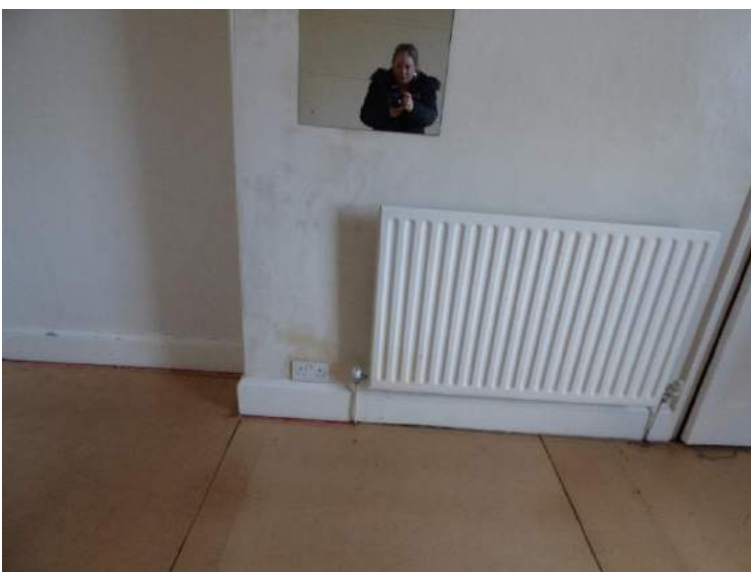
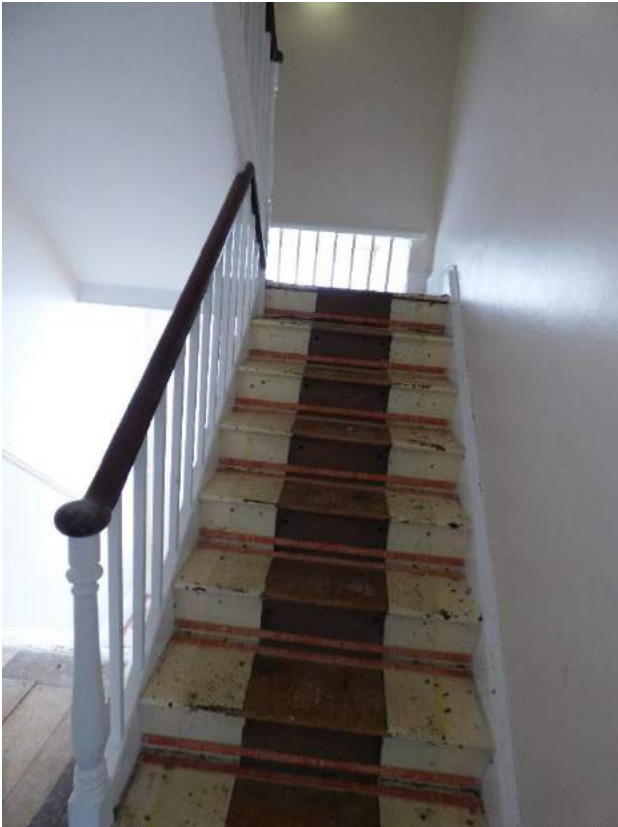
Left and below: Handrail, balusters and rails are original and are to be retained. Missing baluster to be replaced with matching baluster and decorated to match existing.

Apply an insulated plasterboard 62mm thick to underside of ceiling. The Laminated plasterboard and PIR has a vapour barrier incorporated so interstitial moisture would be prevented.

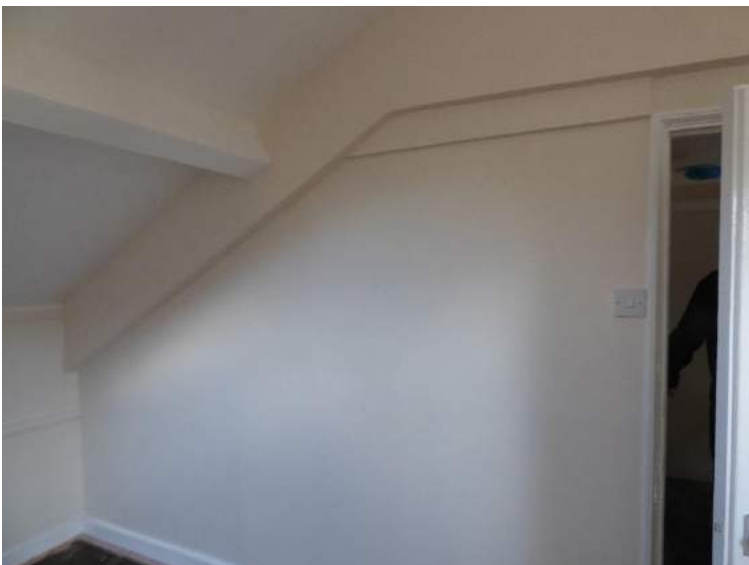
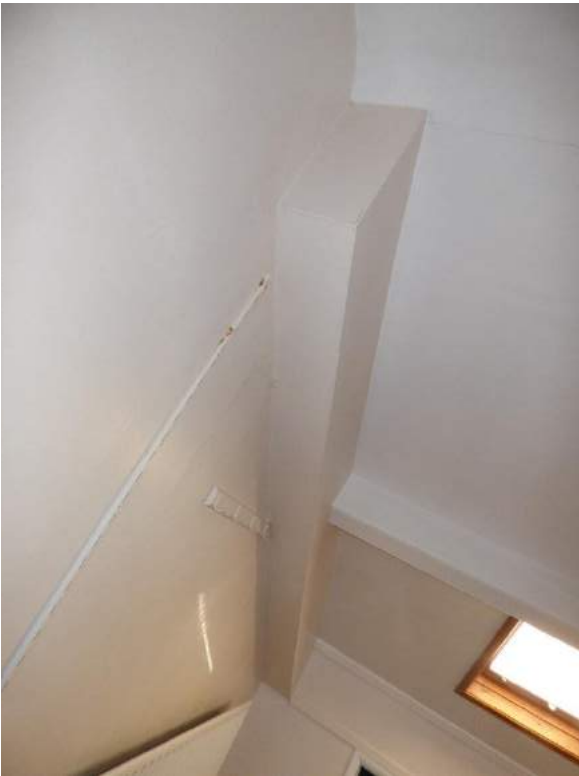
Left and below: Attic bedroom.

Floorboards are in good condition (but may require minor repairs)

In the bedroom, remove all damp and damaged/blown plasterwork and repair with lime plaster and skim and decorate throughout.

Provide and install new heritage rooflight window to replace the existing rooflights.

Existing flush panel doors are to be removed and replaced with new heritage style 4 panel doors.

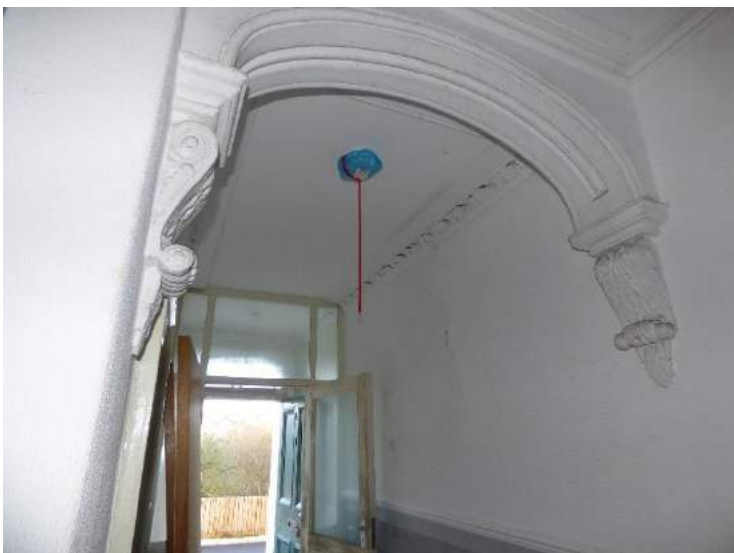
Left: Period features to be retained, including archway and architraves. (Modern lighting to all be stripped out and make good surfaces). All architraves and plaster features to be retained.

Flush panel doors to be replaced with heritage style four panel painted timber fire doors by Batty joinery Ltd or similar to enhance the heritage asset.

The handrails, balusters, and rails are not original; however it is proposed to be retain them, and decorate so they are more in keeping with the historic context of the property.

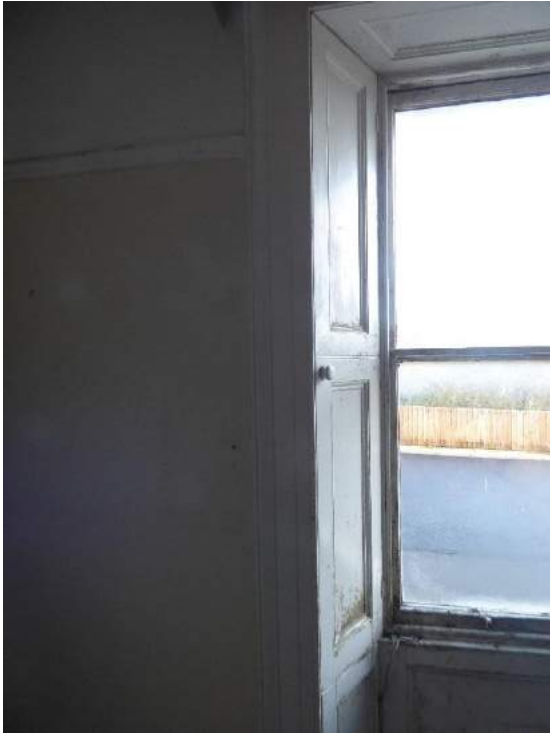
In the existing lounge, the period features below and to the sides of the existing windows both front and back are in good condition, it is proposed to carefully refurbish the existing timber shutters.

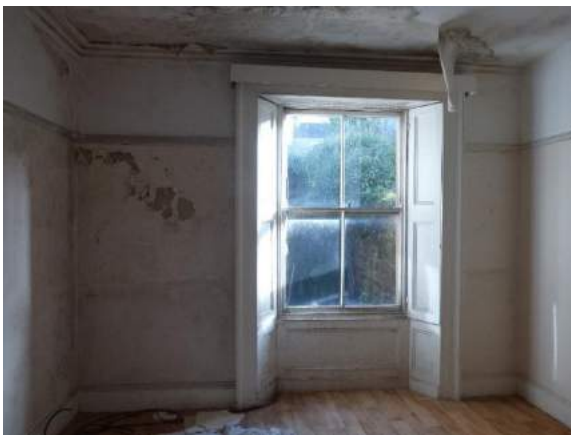
The existing shutters are generally in good condition but require minor restoration works to restore them.

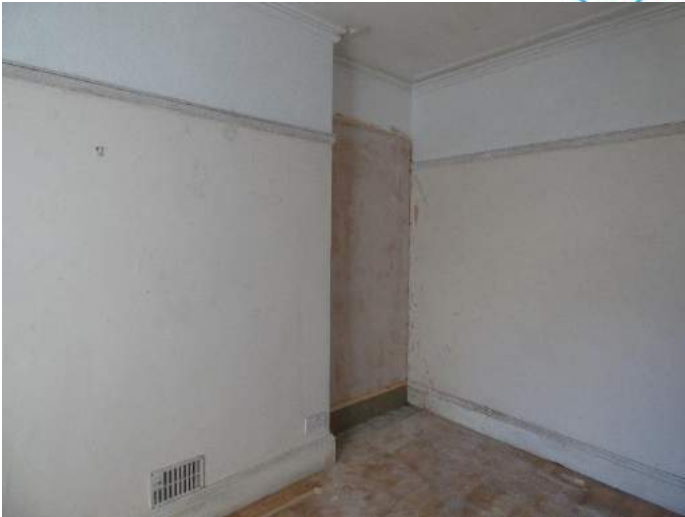
Not all the skirting is consistent. It is proposed to remove the recently installed skirting (where a doorway was walled up from the properties previous use as a school building) and replace with skirting to match the existing. It is proposed to reinstate the picture rail to match existing. It is proposed to form a new opening between dining and living as undertaken historically in houses 1-5, to make more suitable living accommodation for the present day.

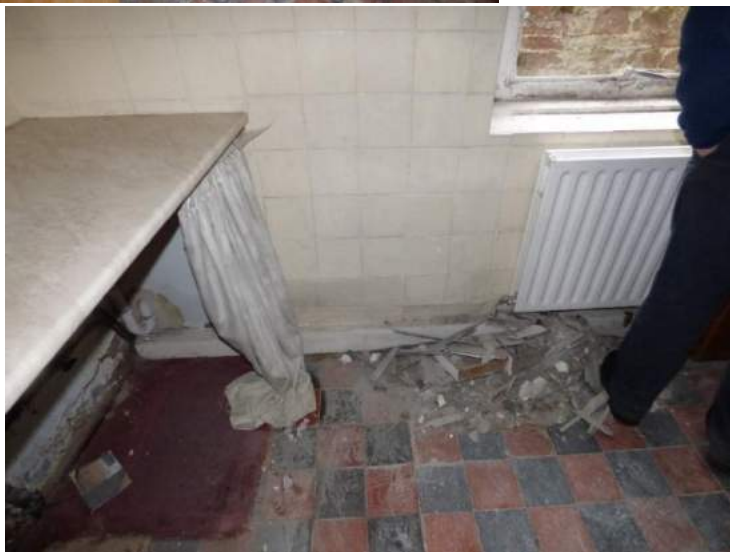
Left: Existing utility spaces to be fully renovated.

All damp and damaged/blown plasterwork and repair with lime plaster (Solo lime plaster from Lime Centre).and skim and decorate throughout.

Apply an insulated plasterboard 62mm thick to underside of ceiling. The Laminated plasterboard and PIR has a vapour barrier incorporated so interstitial moisture would be prevented. New heritage style rooflights to replace existing modern style rooflights and to be installed with flashing kit that mounts unit flush with the roof surface.

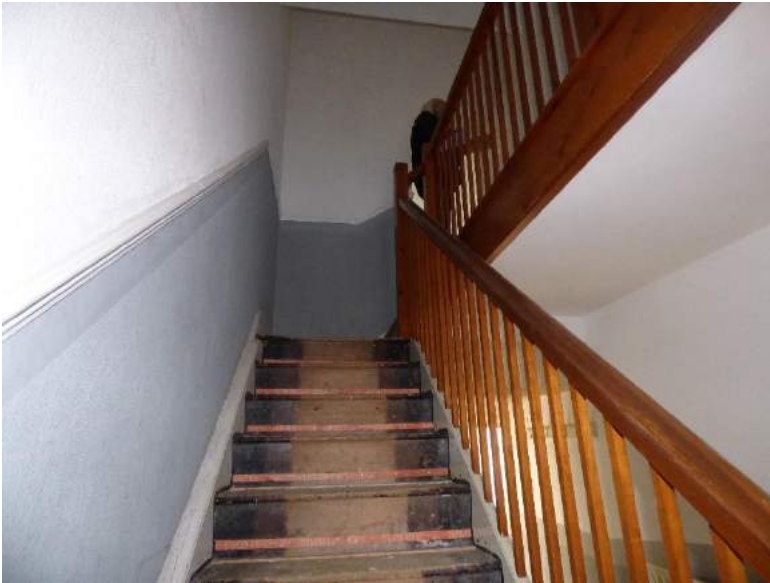
Left Retain staircase, which although not original is in good condition. Its is proposed to redecorate.

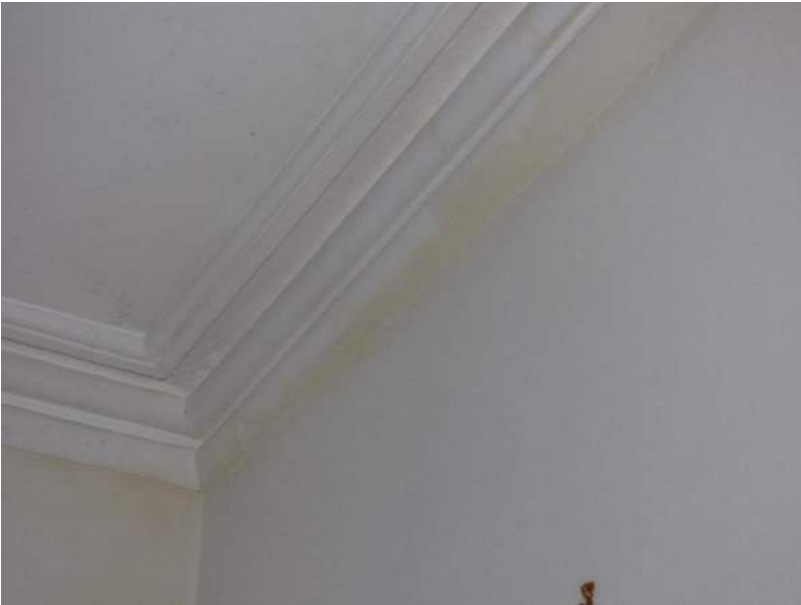
Front bedroom (First floor LHS) cornice, skirtings, and architraves to retained. Existing flush panelled door to be replaced with new Georgian heritage style 4 panelled door to be provided and installed by specialist joinery company such as Batty Joinery Ltd.

Existing floorboards in good condition.

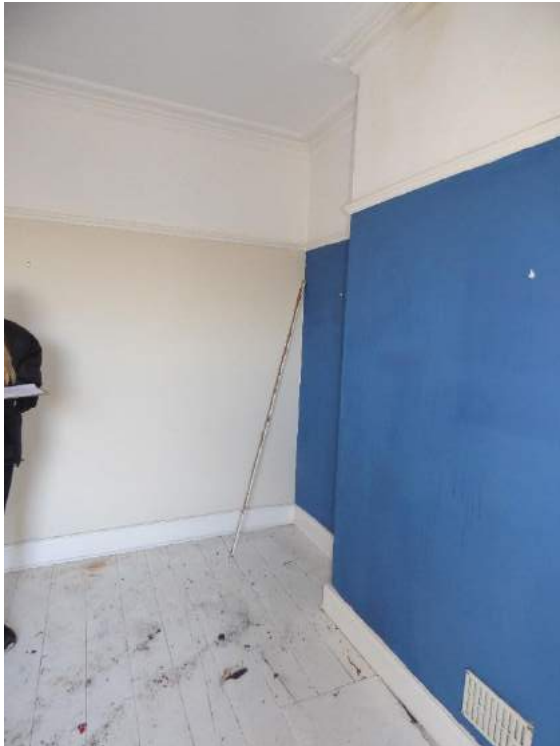
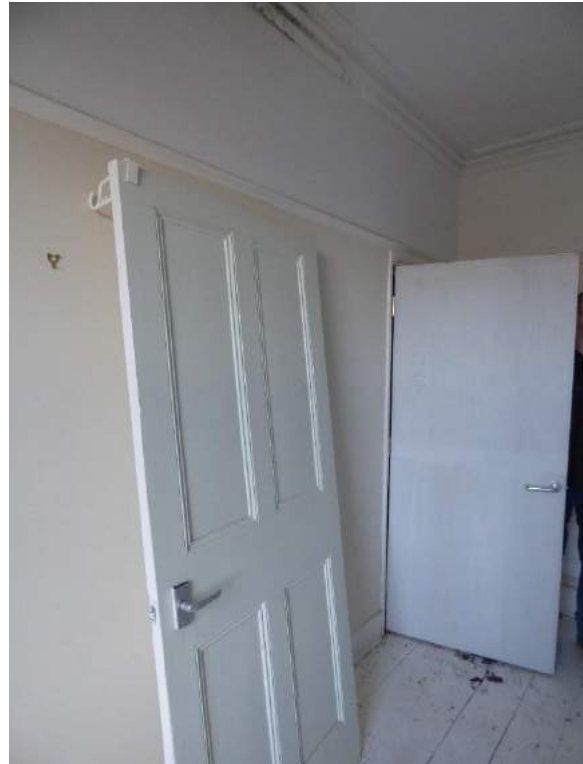
Front bedroom (First floor LHS) cornice, skirtings, and architraves to be retained. Existing flush panelled door to be replaced with new Georgian heritage style 4 panelled door to be provided and installed by specialist joinery company such as Batty Joinery Ltd.

Existing floorboards in good condition.

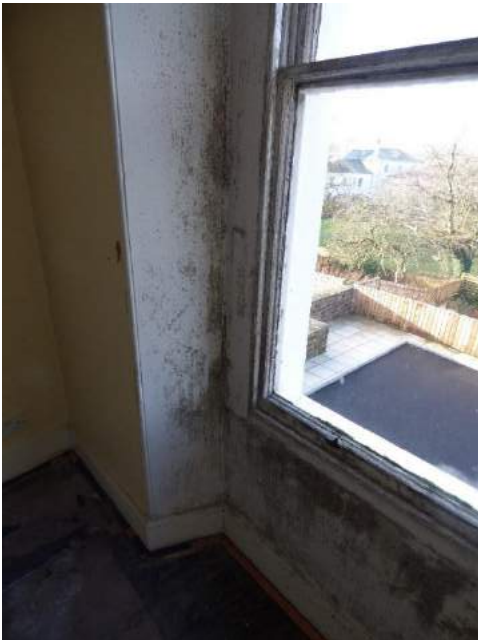
Left: Damp ingress around windows has blown the existing plaster. It is proposed to replace damaged plaster with lime plaster. New heritage style windows being installed will resolve the damp ingress.

Damp damage to plaster ceiling to be removed and reinstated. Any damage to lath and plaster to be repaired by specialist.

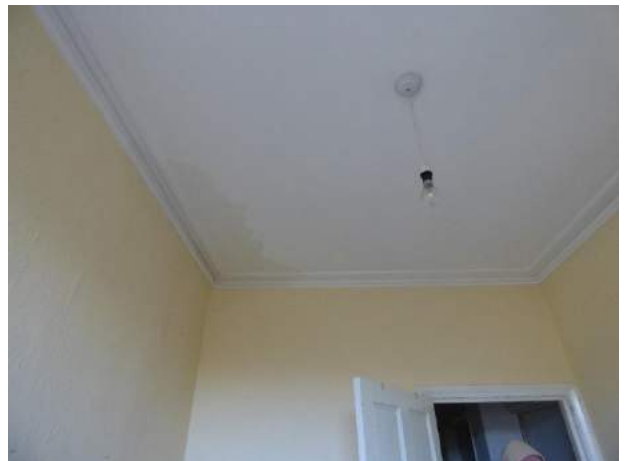
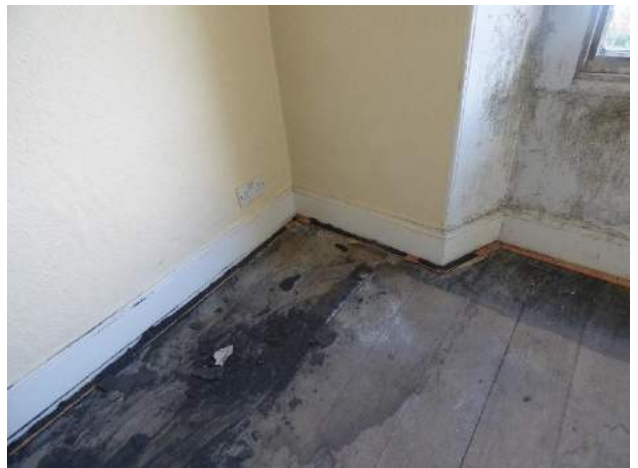
Existing w.c. to be removed and landing area to be reconfigured.

Partitions are not original.

Floors to be made good using timber floorboards to match existing.

All finishes to be made good, and skirtings to match the original to be installed.

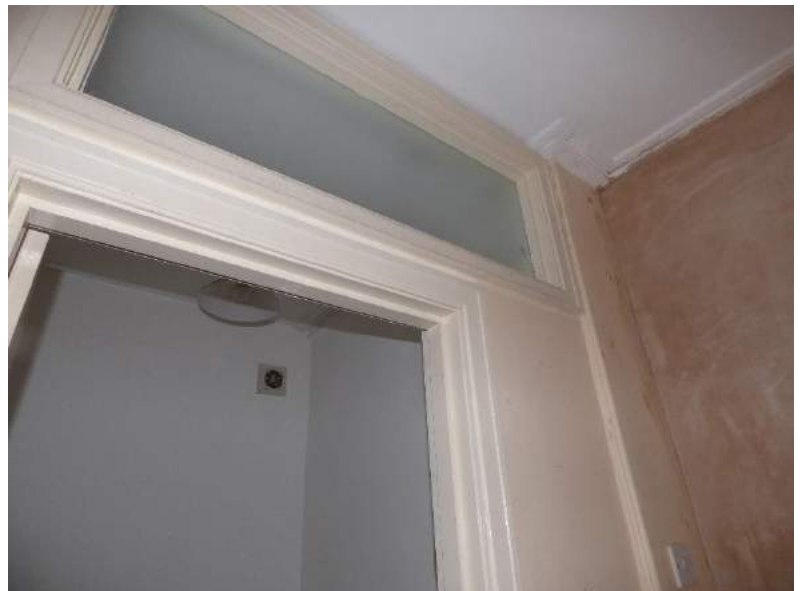
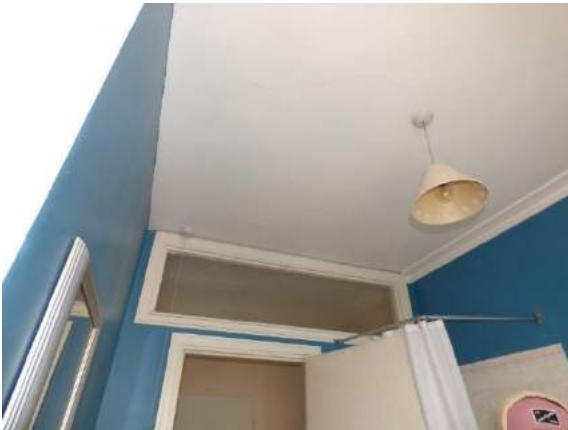
Left and below: Existing ceiling to be made good and provide and install new extract fan linked back to light switch.

Glazing to new heritage style Georgian double glazed sash window to be obscure.

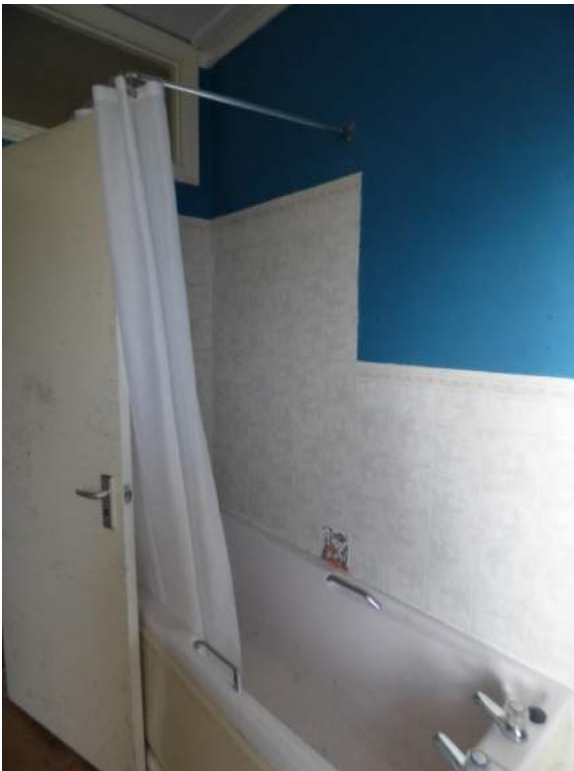
Blown plaster to be removed and new lime plaster repairs to be undertaken. Floor to be made good with floorboards to match the existing.

New bathroom door to be 4 panelled heritage style door – bathroom door does not need to be a fire rated door.

All finished to be made good and skirtings to match the original to be installed.

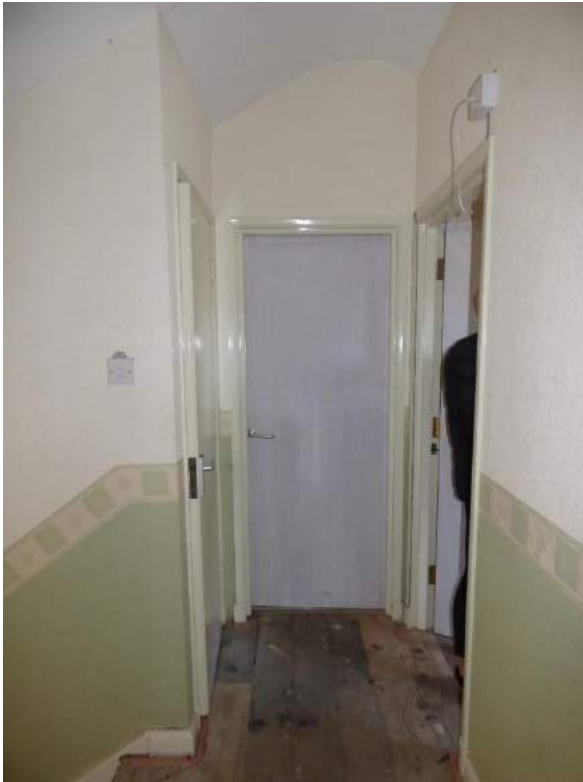
Second Floor Landing area to be reconfigured along with the layout of the second floor.

Existing rooflights to be replaced with new heritage style rooflights.

Apply an insulated plasterboard 62mm thick to underside of ceiling. The Laminated plasterboard and PIR has a vapour barrier incorporated so interstitial moisture would be prevented. New heritage style rooflights to be installed to replace existing modern style Velux rooflights with flashing kit that mounts unit flush with the roof surface.

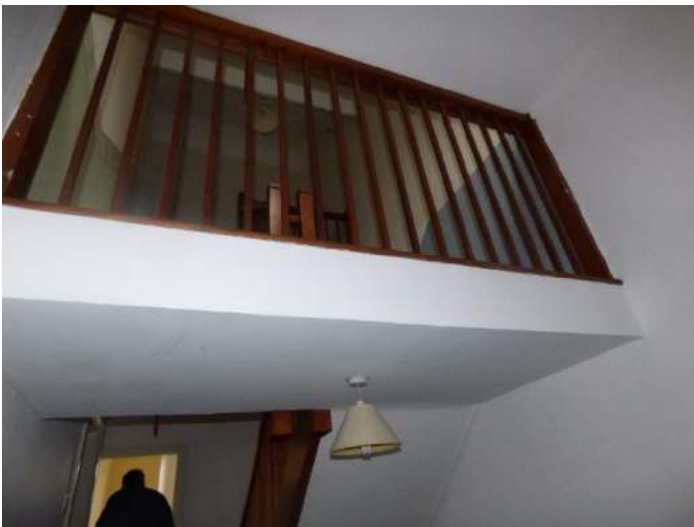
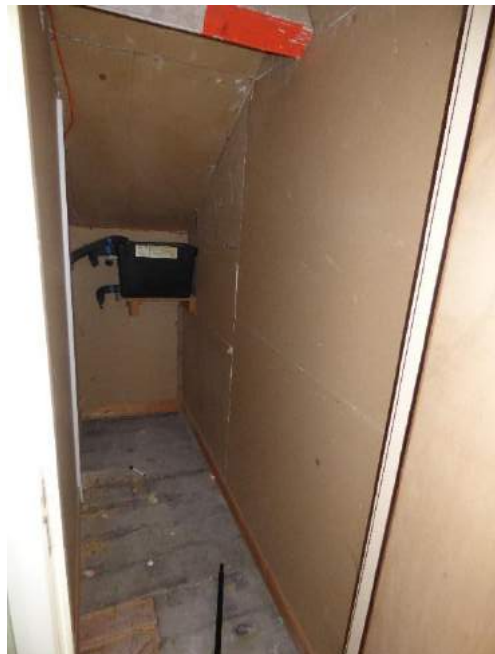
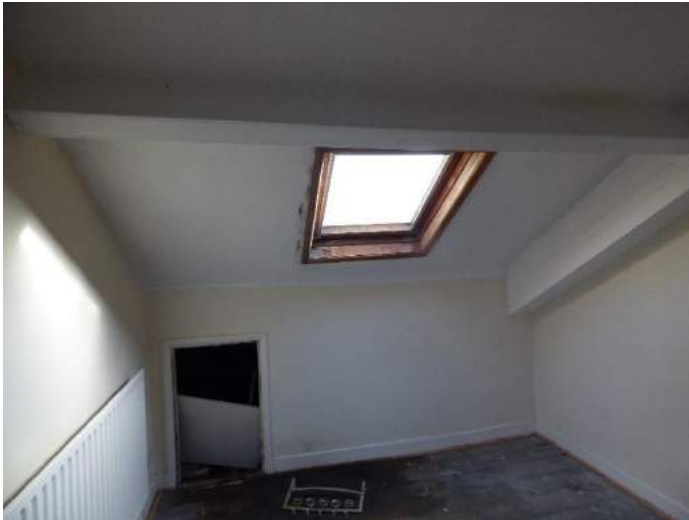
Left and below: Attic bedroom.

In the bedroom all damp and damaged/blown plasterwork will be repaired with lime plaster (Solo lime plaster from Lime Centre). and skim and decorate throughout.

Areas of water ingress to be investigated and roof repairs undertaken a necessary.

Floorboards are in good condition (but may require minor repairs, due to damp ingress).

Apply an insulated plasterboard 62mm thick to underside of ceiling. The Laminated plasterboard and PIR has a vapour barrier incorporated so interstitial moisture would be prevented tape and skim and undertake full decorations. New heritage style rooflights to be installed in lieu of the modern style Velux windows. New heritage rooflight windows (Velux or similar with flashing kit that mounts unit flush with the roof surface).

Existing flush panel doors are to be removed and replaced with new heritage style 4 panel fire doors.

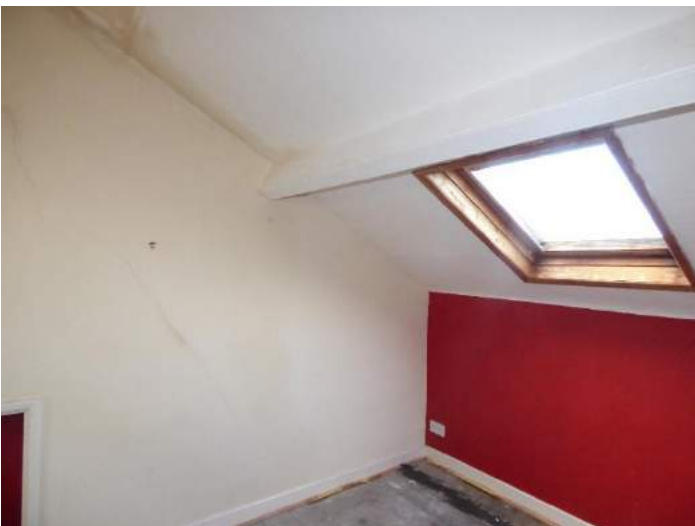
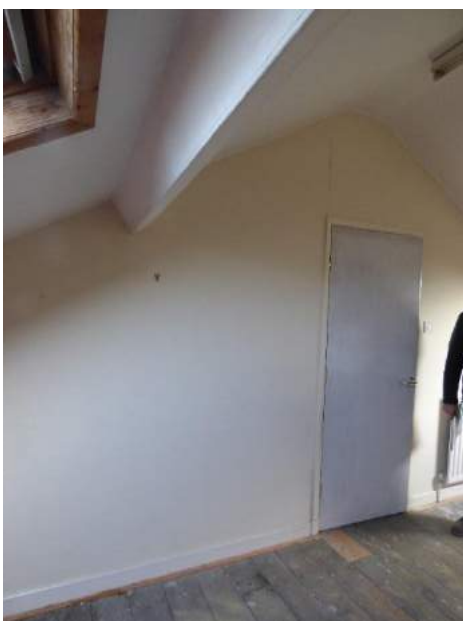
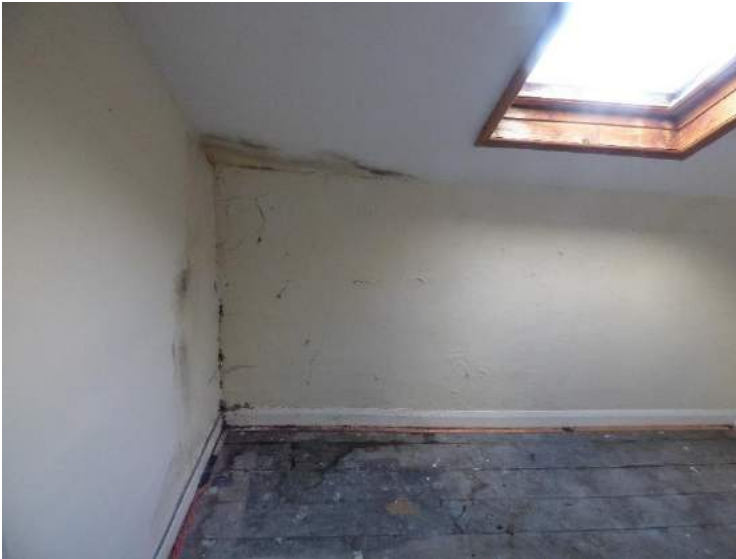
Left and below: Small attic bedroom.

In the bedroom all damp and damaged/blown plasterwork will be repaired with lime plaster (Solo lime plaster from Lime Centre) and skim and decorate throughout.

Areas of water ingress to be investigated and roof repairs undertaken a necessary.

Floorboards are in good condition (but may require minor repairs, due to damp ingress).

Apply an insulated plasterboard 62mm thick to underside of ceiling. The Laminated plasterboard and PIR has a vapour barrier incorporated so interstitial moisture would be prevented.

Existing flush panel doors are to be removed and replaced with new heritage style 4 panel fire doors.

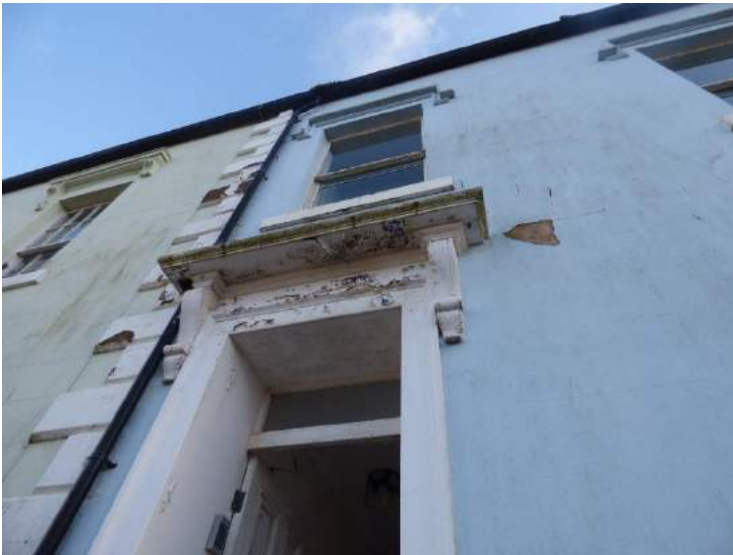
All single glazed windows to be replaced with new white painted slim profile double glazed 'heritage' windows to match the existing style by specialist supplier such as Batty Joinery.

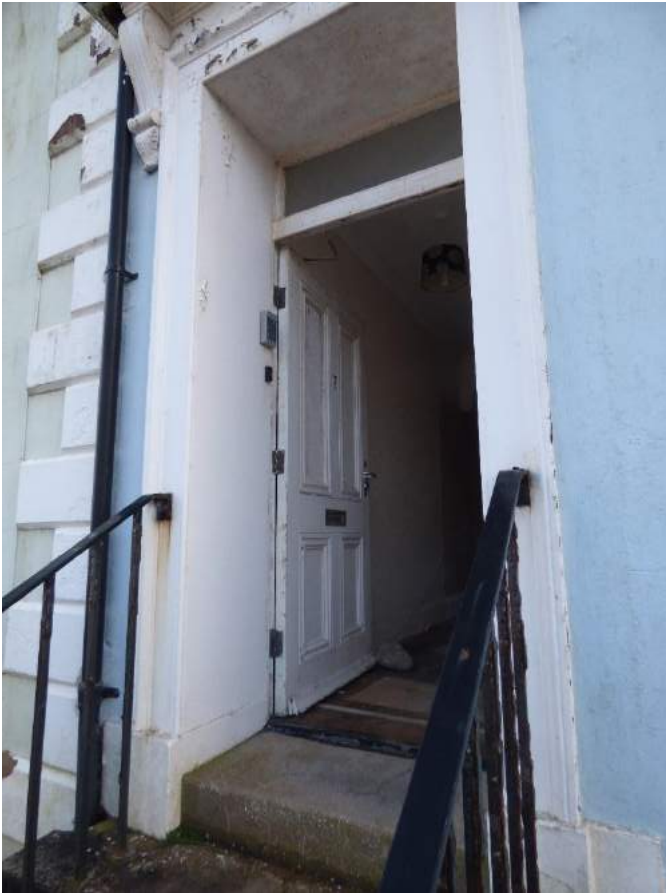
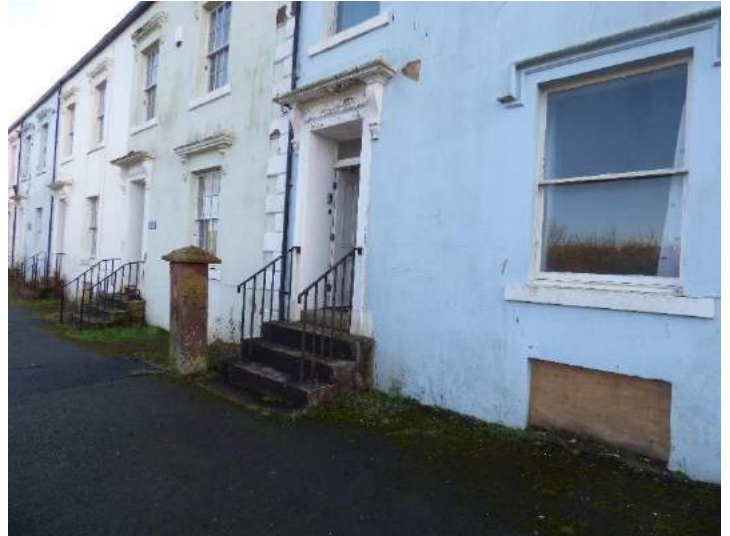
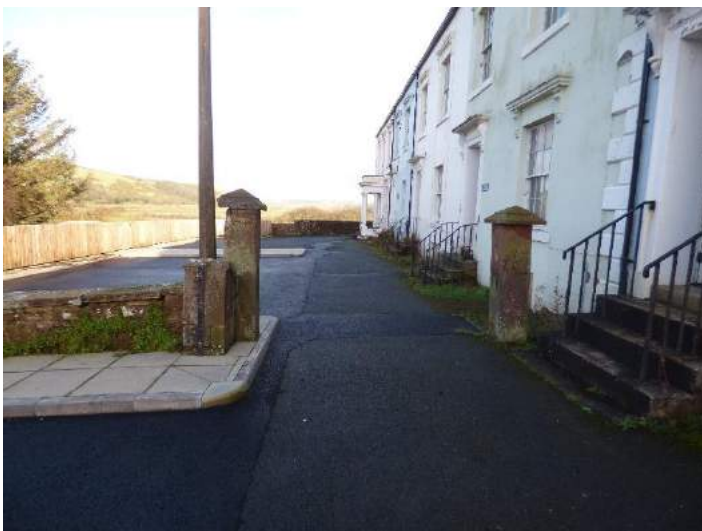
Existing cills to be repaired and decorated.

Existing Velux rooflight windows to be replaced with Velux conservation rooflights (or Rooflight Company, heritage rooflights) (sizes to match existing) and new flashings to suit).

Localised lead repair work required to chimneys, to prevent leaking.

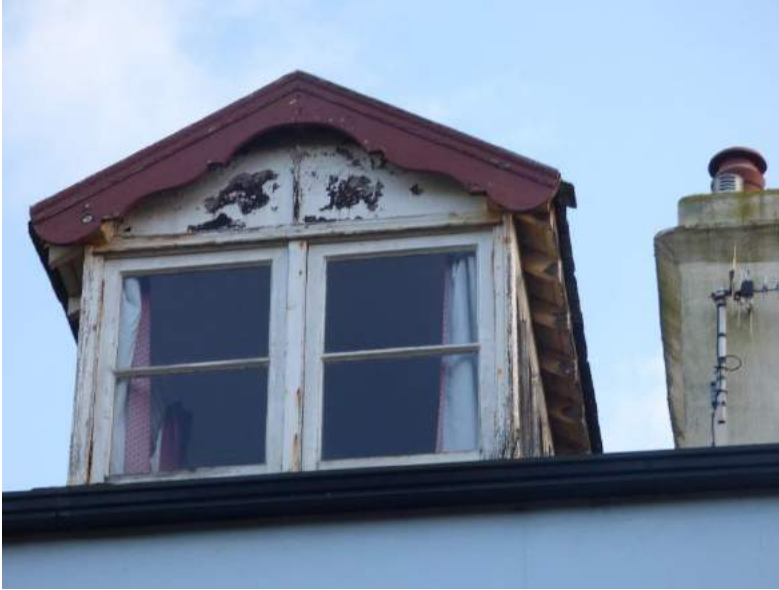
Existing dormer windows are in extremely poor condition. Considerable fabric damage internally has been the result of the extent of damage to these dormers. It is proposed to completely rebuild these in the same style as indicated on the proposed elevations with double glazed heritage style windows.

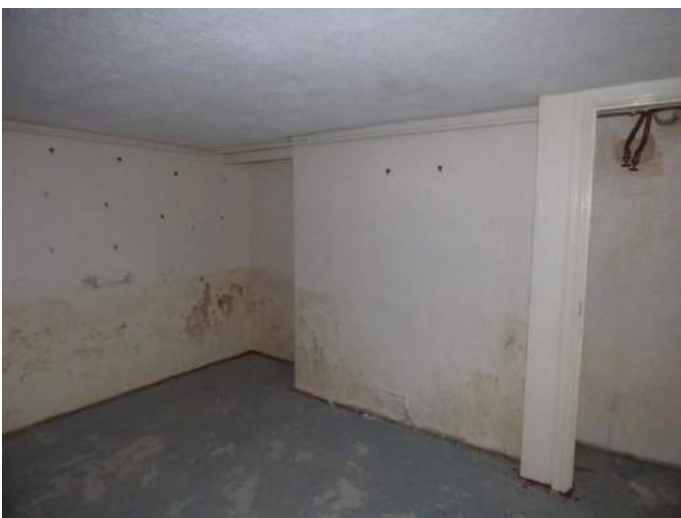
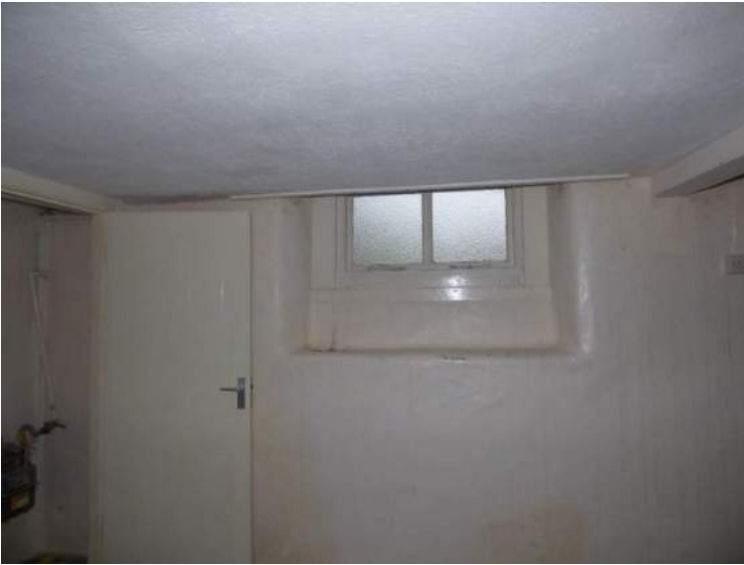
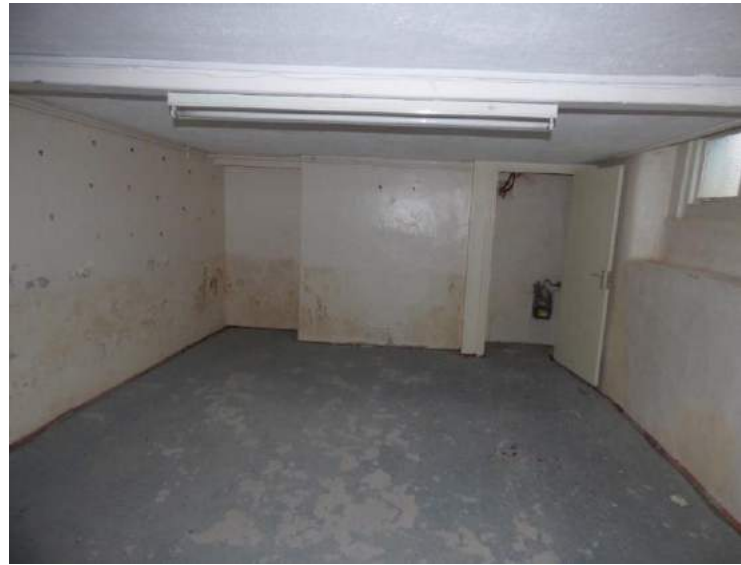
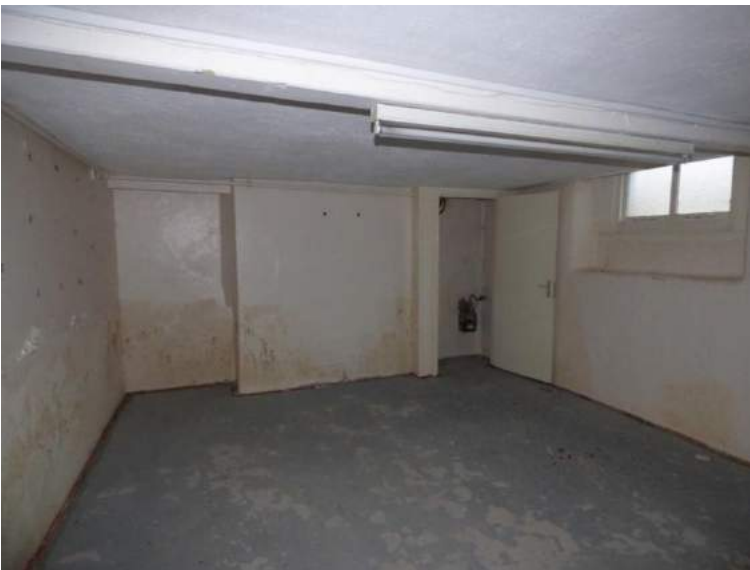
Views of basement to be renovated.

It is clear to identify where damp is penetrating the structure.

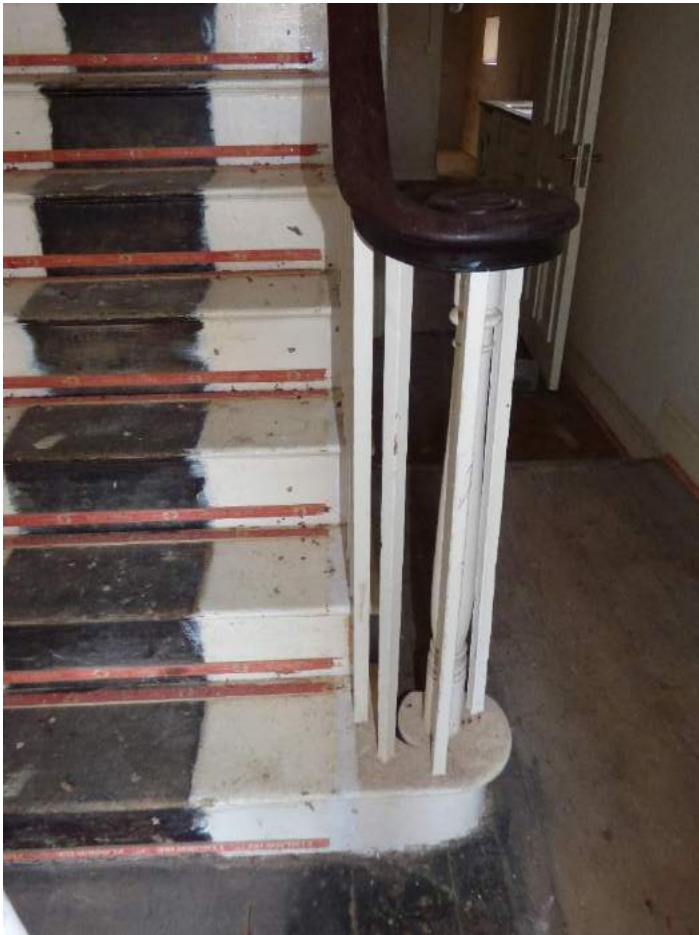
Original staircase to be retained.

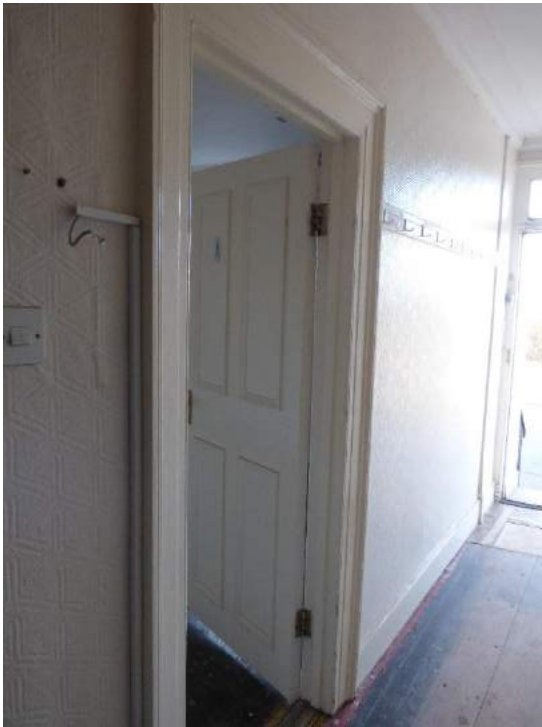
Existing doors potentially could be refurbished with intumescent paint to create fire doors alternatively they may need to be replaced with new 4 panelled Fire doors in the same style. Fire protection will be required by building control.

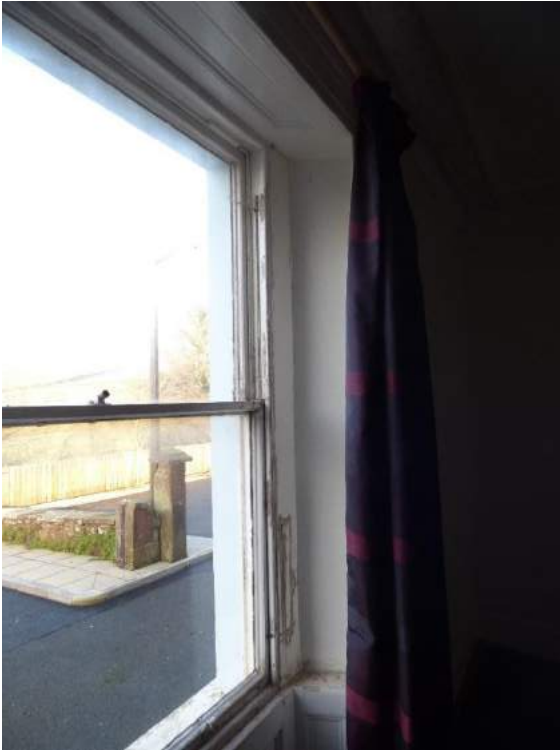
Left: In the existing lounge, the period features below and to the sides of the existing window are generally in good condition, it is proposed to carefully refurbish the existing timber shutters, which require careful minor repairs by a specialist.

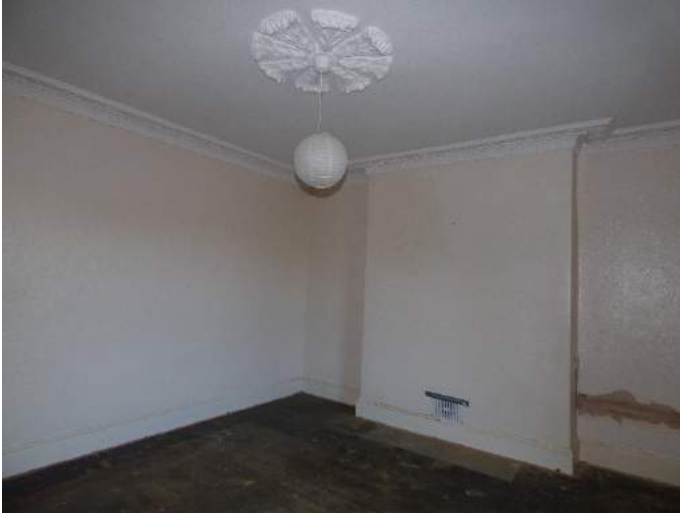
Left: Existing cornice is in excellent condition.

Existing architraves and skirtings to be retained and made good, where required.

Retain existing ceiling rose.

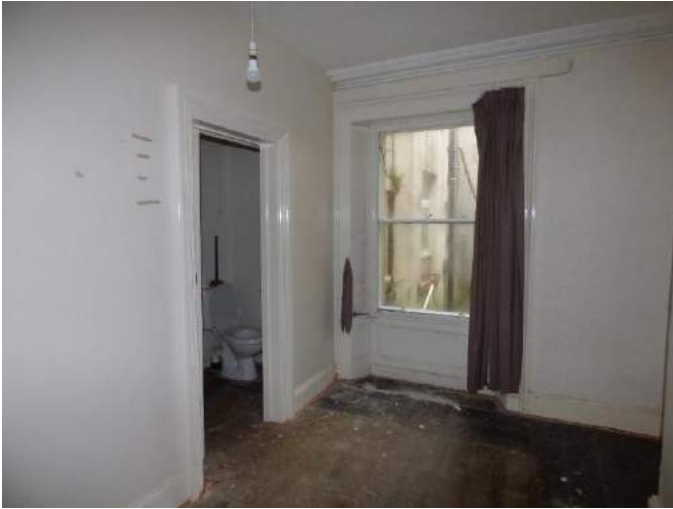
Left: In the existing dining room, the period features below and to the sides of the existing windows are in good condition, it is proposed to carefully refurbish the existing timber shutters.

Existing cornice to be made good in locations where redundant services are to be removed, here the stud partition to a bathroom has been installed and where hairline cracks have appeared.

Flush panel doors to be replaced with heritage style 4 panel timber fire doors to enhance the heritage asset.

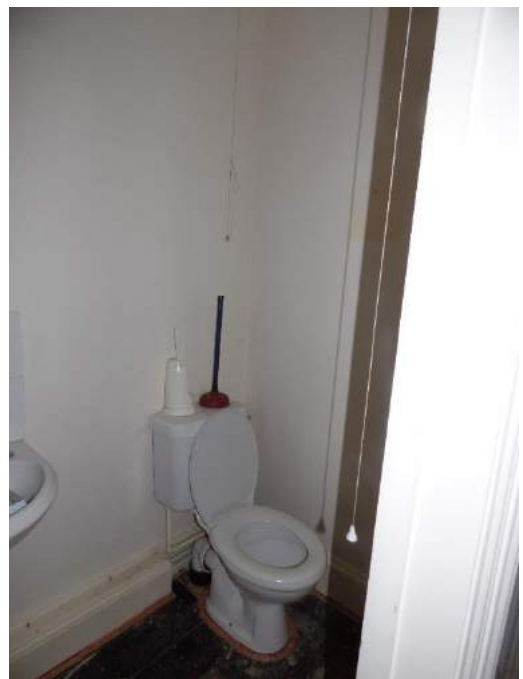
Left and below: Existing bathroom to be completely removed including stud partitions.

Cornices and skirtings to be made good where partitions removed.

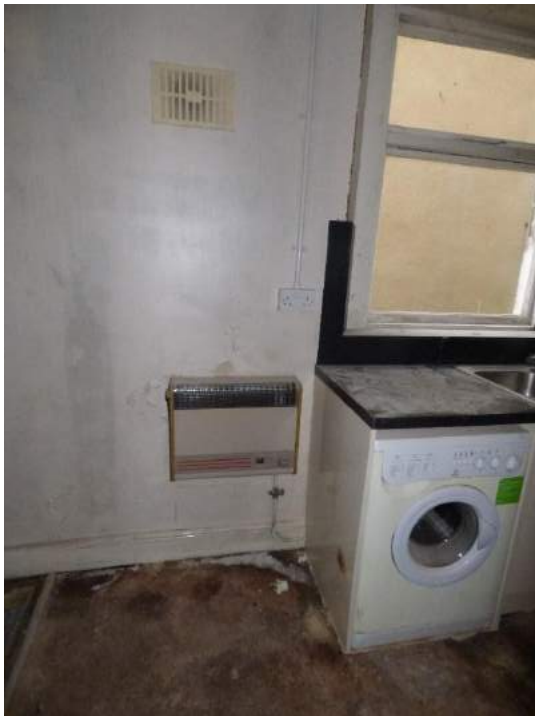
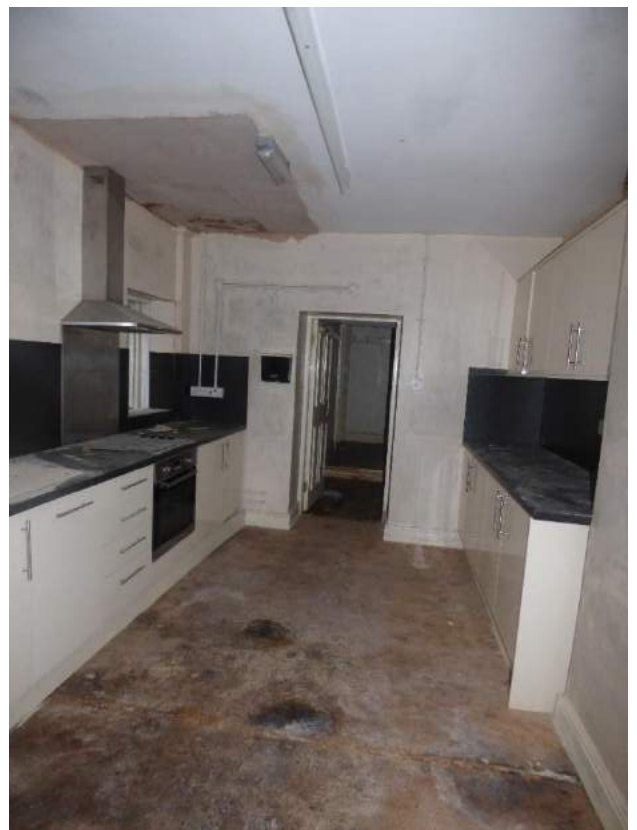
Left and below; In the existing kitchen, the existing kitchen will be completely removed. The existing modern single glazed windows will be removed and replaced with heritage painted double glazed sash windows. The existing floor has been over-boarded with a ply decking. It is proposed to lift the ply decking and examine the original floors. It is proposed to apply water resistant chipboard, subject to the sub floor and the condition of the joists etc which may require replacement.

Existing services to be removed and walls, and ceilings made good.

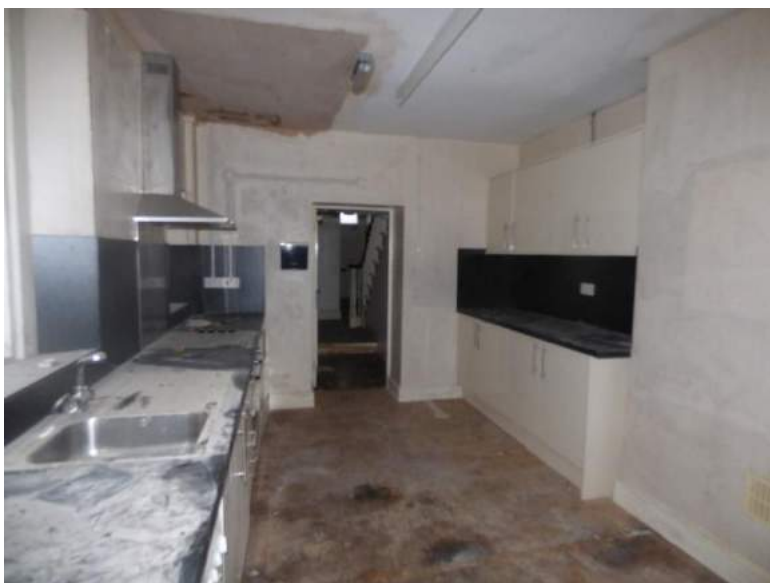
Above: Existing utility and WC to be reconfigured.

Blown plasterwork to be removed and reinstated with lime plaster and skim finish.

Apply an insulated plasterboard 62mm thick to underside of ceiling. The Laminated plasterboard and PIR has a vapour barrier incorporated so interstitial moisture would be prevented. New rooflights to be installed with flashing kit that mounts unit flush with the roof surface.
