HERITAGE STATEMENT

FULL RENOVATION OF EXISTING No 11 TERRACE HOUSES

St Bees, 1-11 Lonsdale Terrace, Parish Council, Cumbria

M.A.C Architects, Project Number: 2019:303

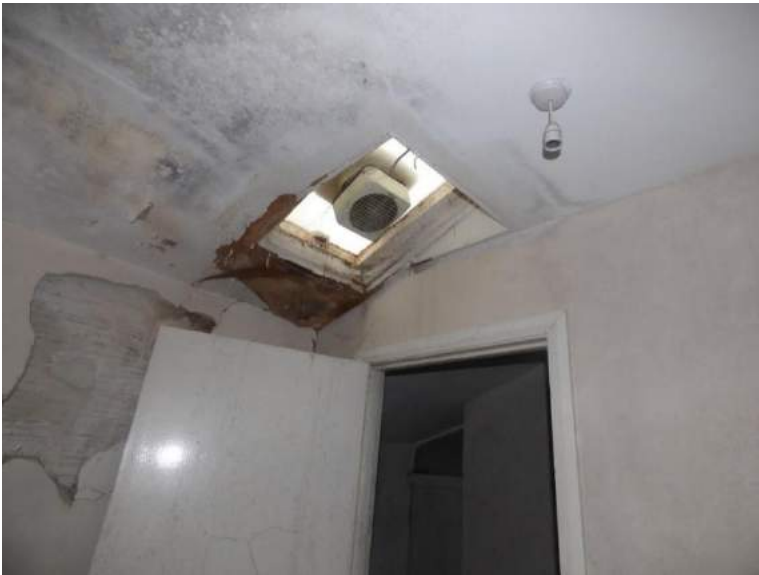
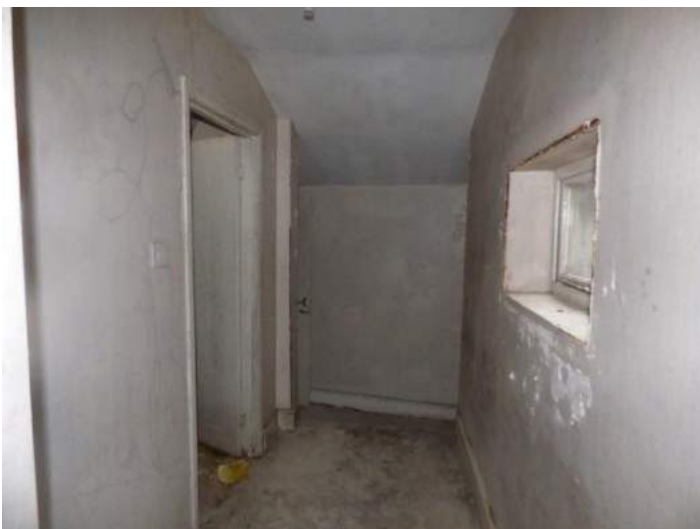
Below: Roof above utility and w.c. requires significant repairs to slate roof and to lead flashings (which require replacement). Blown plasterwork to be removed and reinstated with lime plaster and skim finish. (Solo lime plaster from Lime Centre).

Apply an insulated plasterboard 62mm thick to underside of ceiling. The Laminated plasterboard and PIR has a vapour barrier incorporated so interstitial moisture would be prevented. New rooflights to be installed with flashing kit that mounts unit flush with the roof surface.

All walls, floor, ceilings to be made good and prepared for full decoration.

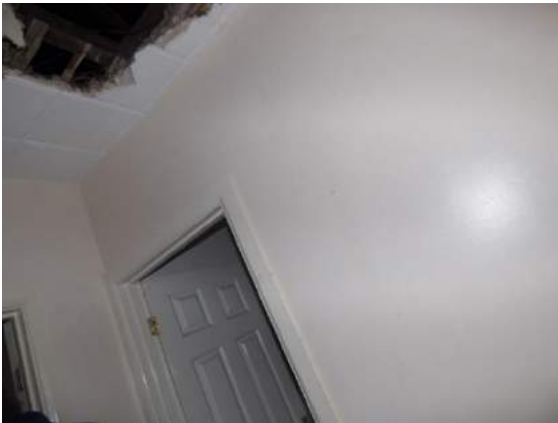
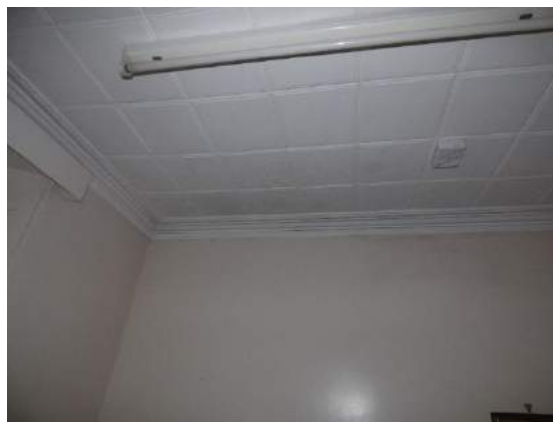
Above, left, and below: Existing bathroom. The existing ceiling finishes to be removed, and the ceiling to be made good including remediation of lath and plaster ceiling by specialist.

Existing floor is not original, so it is proposed to replace with moisture resistant chipboard.

Existing modern window to be removed and replaced with new painted timber double glazed heritage style Georgian sash window with obscure glazing.

Existing modern replica six panel door to be replaced with new traditional timber four panelled Georgian style door – bathroom door does not need to be a fire door.

All finishes to be made good, and cornice to be reinstated where currently removed and new skirtings to match the original to be installed.

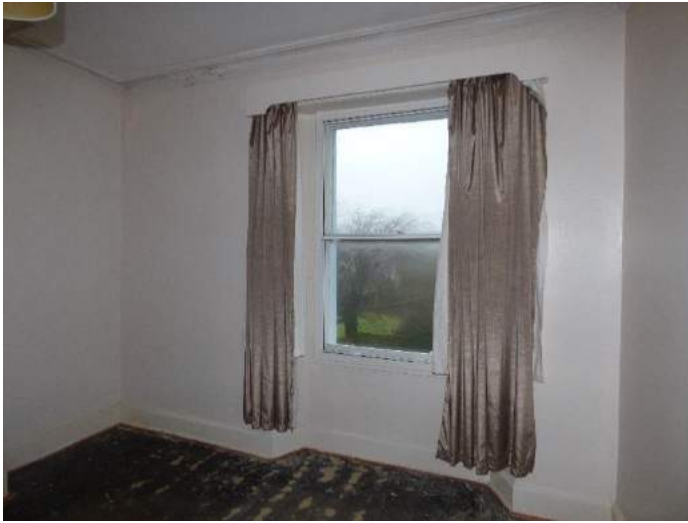
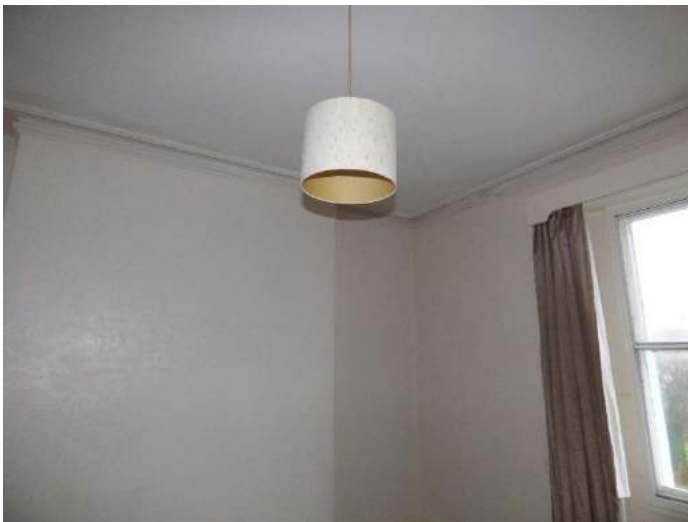
Left: Large front bedroom. Skirtings, cornices, and architraves to be retained and minor repairs where necessary. Existing flush panelled door to be replaced with new Georgian heritage style 4 panel door to be provided and installed by specialist joinery company such as Batty Joinery Ltd.

Existing floorboards in good condition.

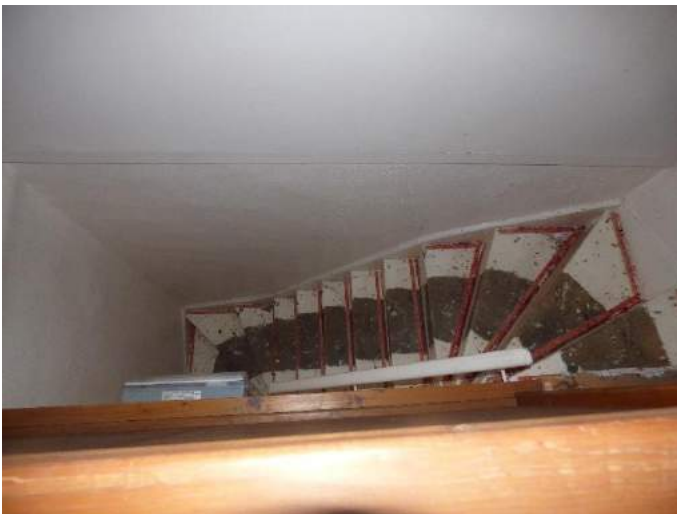
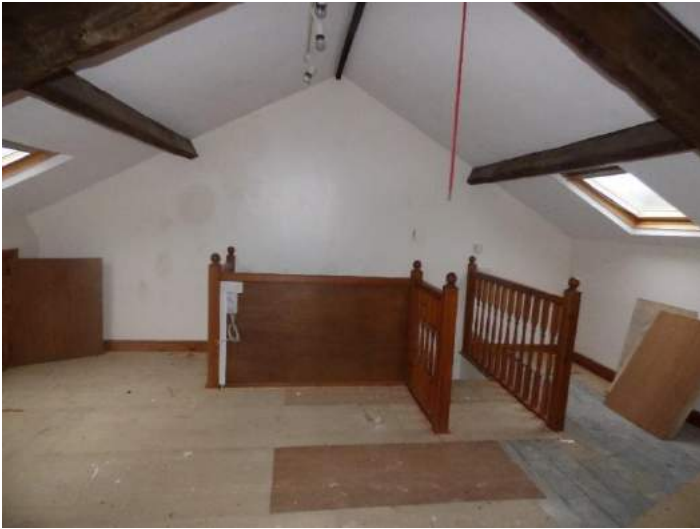
Existing attic space is proposed to be reconfigured to provide additional bedroom accommodation.

New plasterboard stud partitions to be installed to form new spaces.

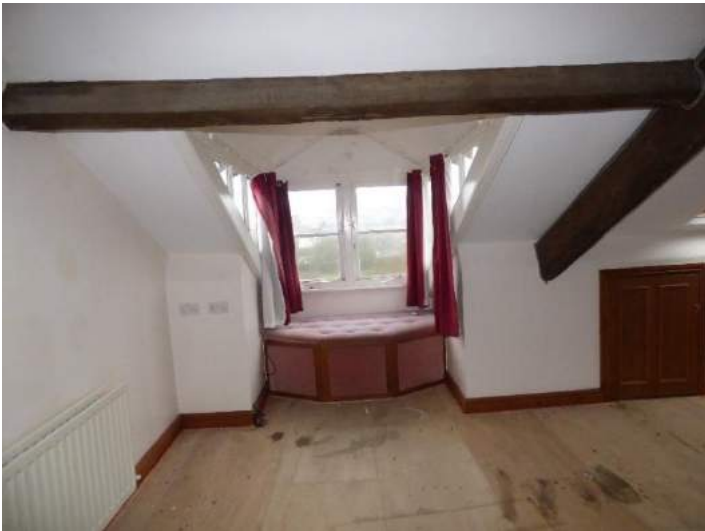
All damp and damaged/blown plasterwork to be repaired with lime plaster (Solo lime plaster from Lime Centre) and skim and decorate throughout.

Apply an insulated plasterboard 62mm thick to underside of ceiling. The Laminated plasterboard and PIR has a vapour barrier incorporated so interstitial moisture would be prevented. New rooflights to be installed with flashing kit that mounts unit flush with the roof surface.

Ttape and skim and undertake full decorations. Replace existing modern rooflights with new heritage style Velux rooflight (or Rooflight company equivalent).

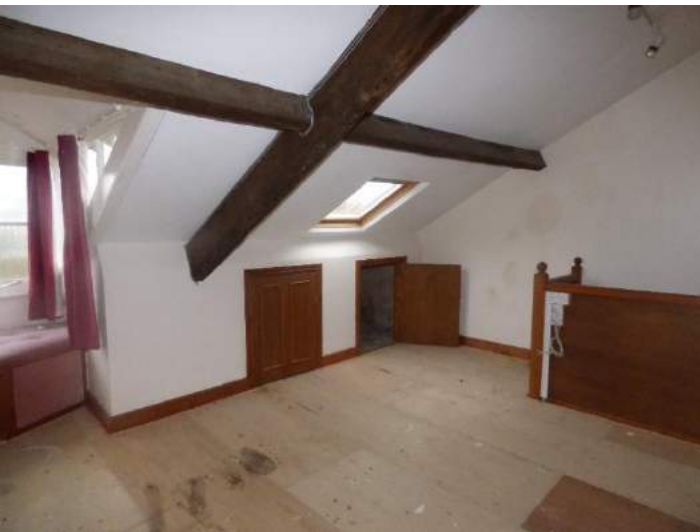
Floorboards are not the original and likely to have been installed due to water ingress. It is proposed to replace with softwood timber floorboards. The skirtings are not original, and it is proposed to remove them and replace with new soft wood skirtings to match the skirtings throughout the rest of the property.

New doors to be provided to newly formed rooms to be 4 panelled Georgian style timber doors to match the doors being reinstated throughout the rest of the property. Doors to be fire rated.

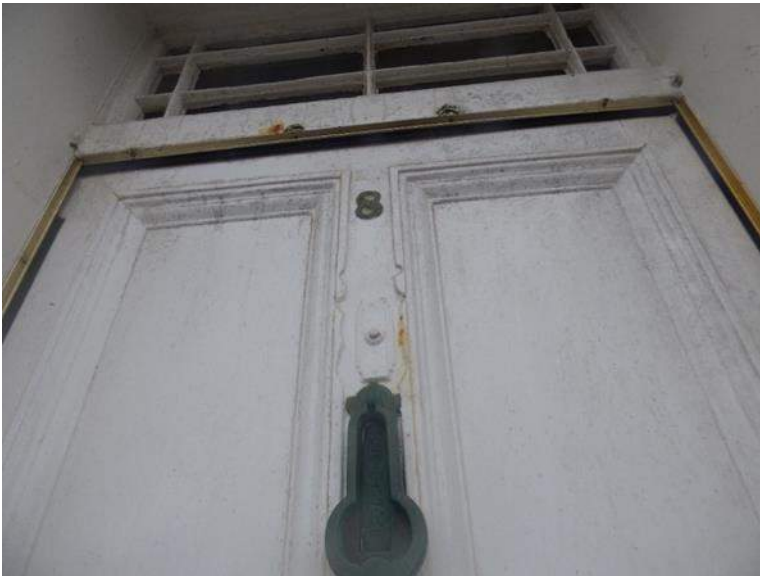
Existing door and fanlight to be retained and repaired.

All existing single glazed windows to be replaced with new white painted slim profile double glazed 'heritage windows to match the existing style by specialist supplier such as Batty joinery Ltd.

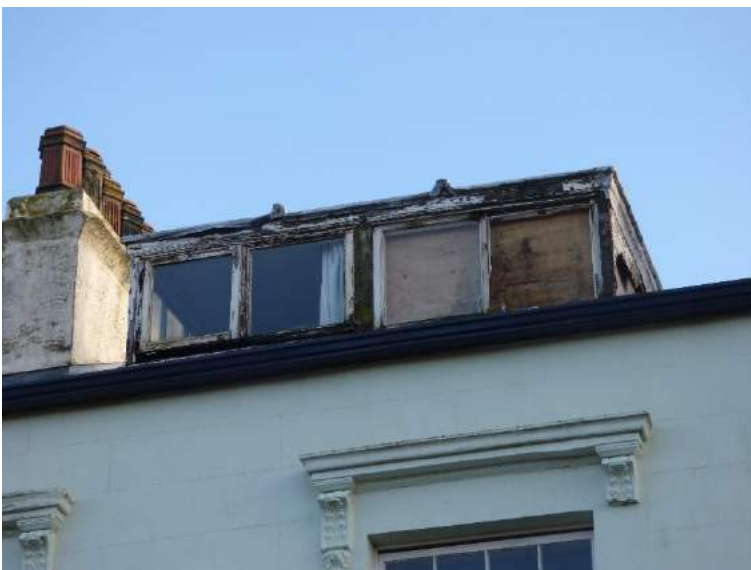
Left: Dormer windows to front of property have been damaged beyond repair, and it is therefore proposed to replace with a new dormer window, with painted timber heritage style double glazing.

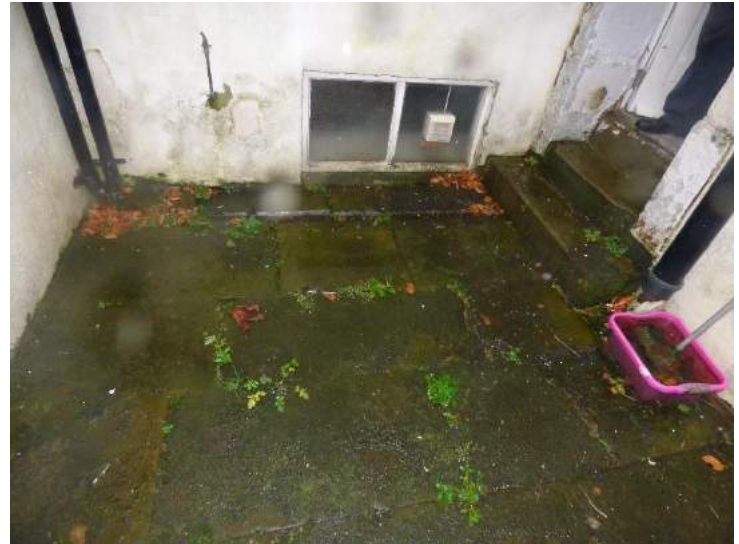
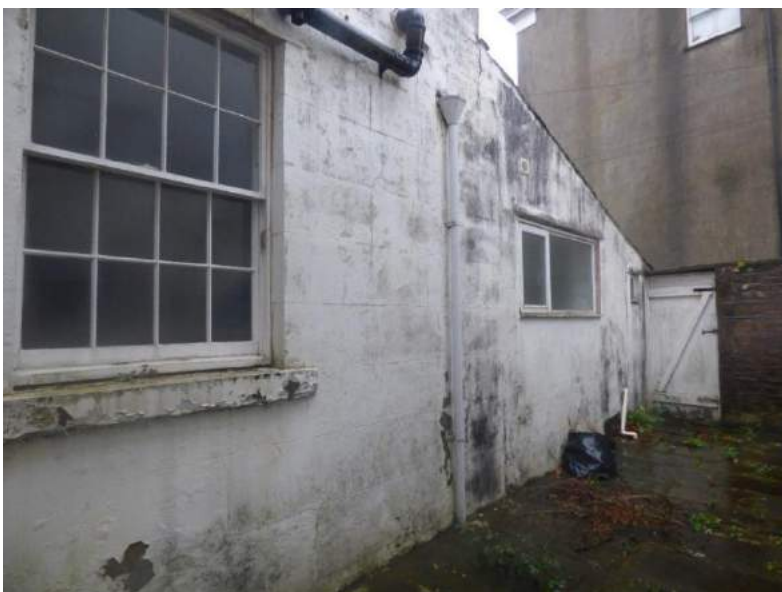
Rear of property – render to be repaired by specialist and decorated with off white render.

Windows to be replaced with new heritage style double glazed side hung casement windows - by specialist (such as Batty Joinery Ltd).

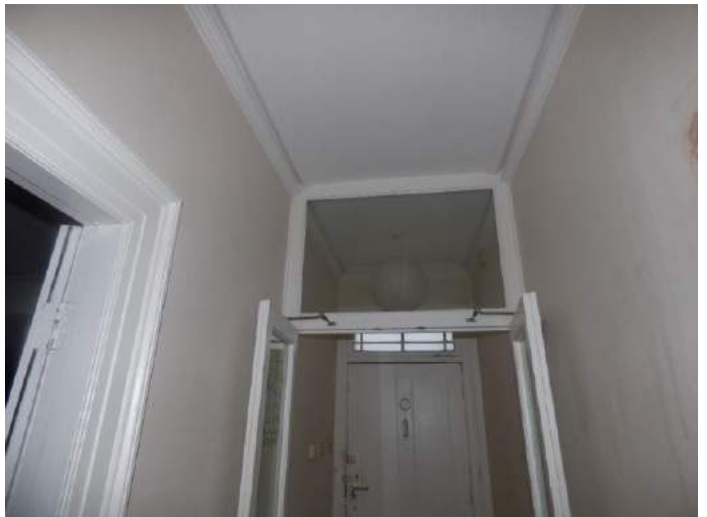
Left: Modern doors and clerestory glazing to be removed and walls, floor, and ceiling to be made good.

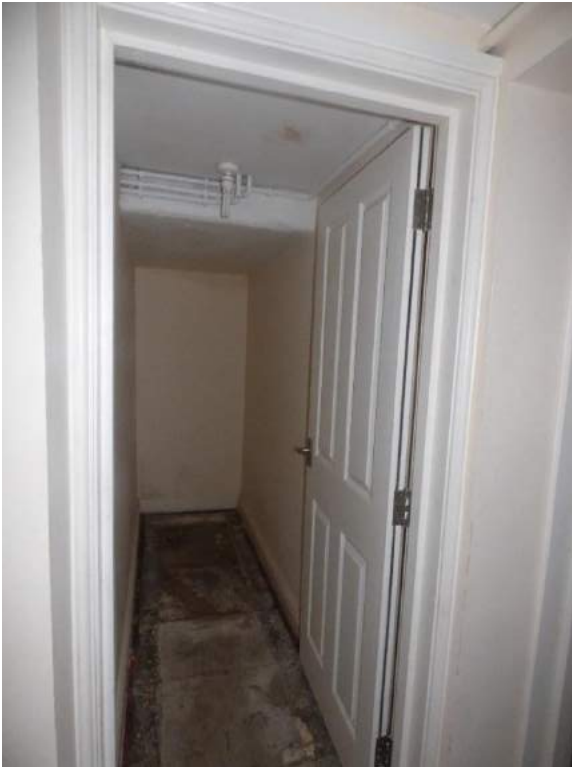
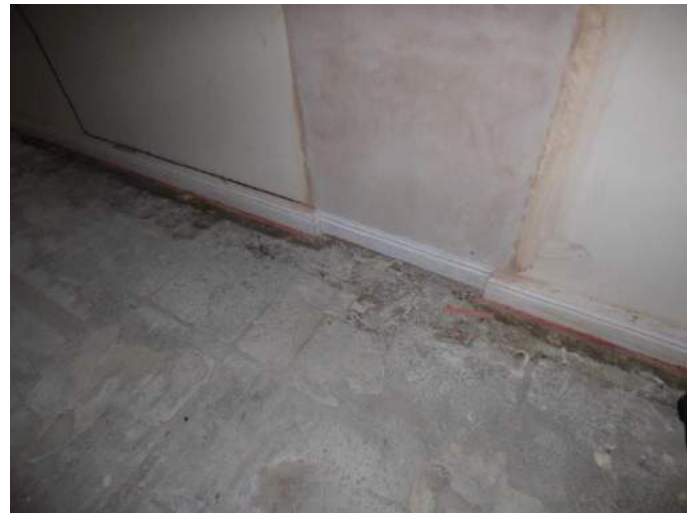
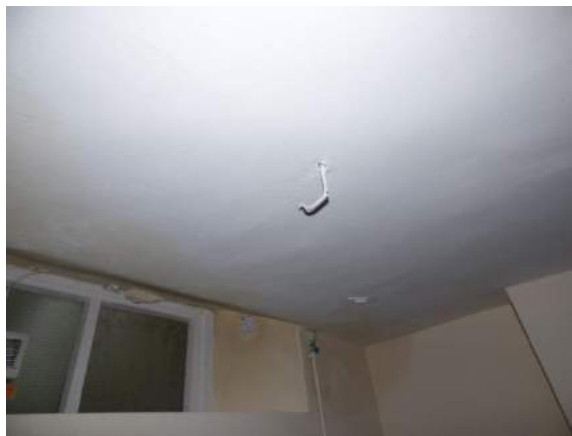
Views of existing basement.

Existing doors to be replaced with new heritage style four panelled Georgian style fire doors.

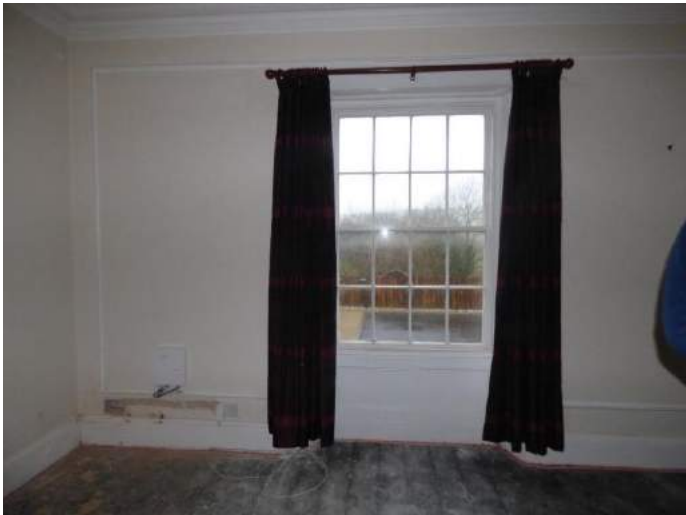
Above: In the existing front room, the features below and to the sides of the existing window are in good condition, it is proposed to carefully refurbish the existing timber shutters.

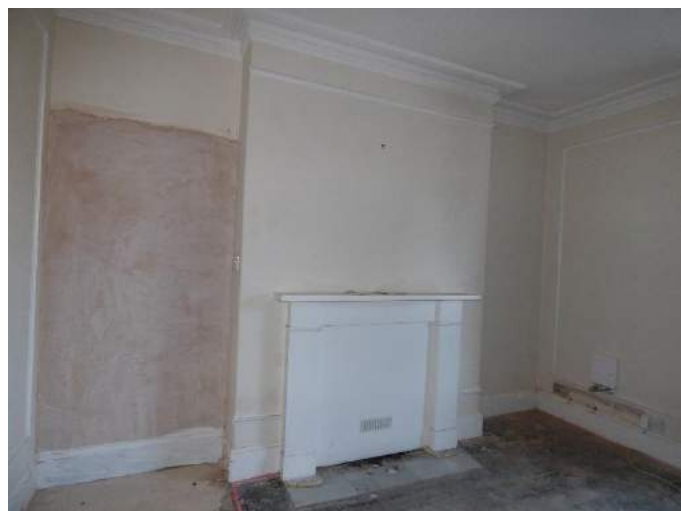
Left: Existing cornice to be retained and period features to walls to be retained and made good where required.

Existing architraves, and skirtings to be retained and made good.

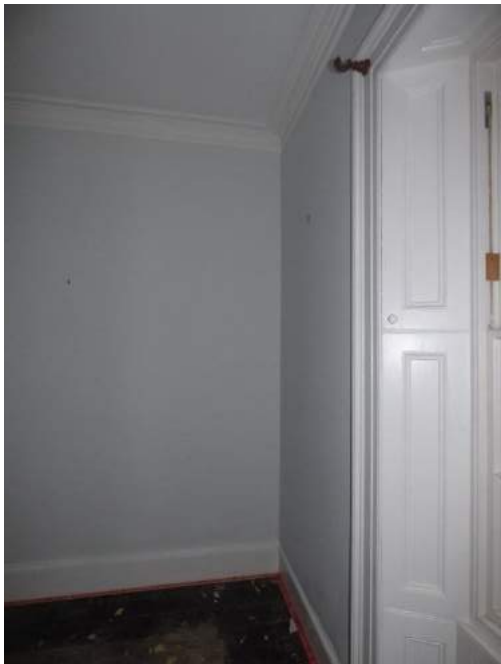
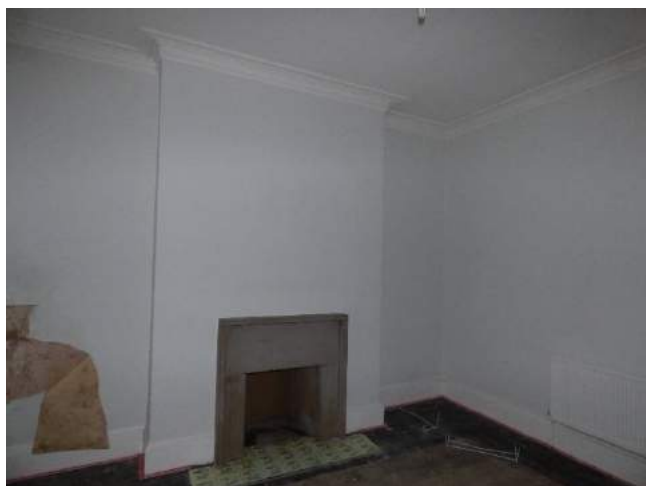
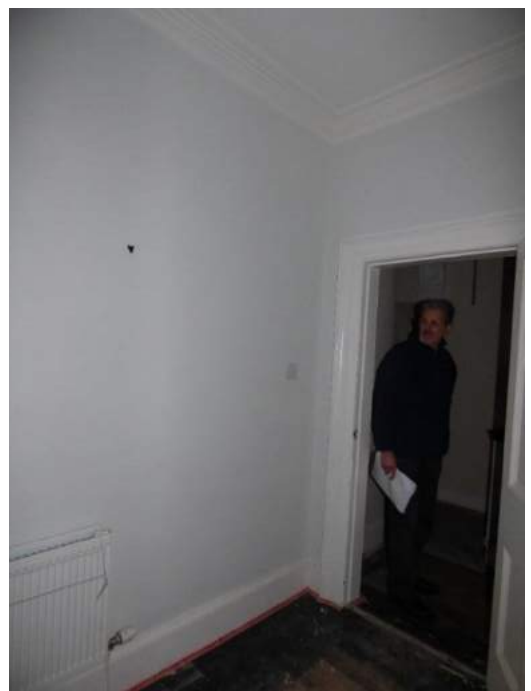
Left and below: In the existing dining room at the rear of the property, the period features below and to the sides of the existing window are in good condition, it is proposed to carefully refurbish the existing timber shutters.

Existing cornice to be made good in locations and where hairline cracks have appeared.

Here plasterwork has been damaged from damp ingress, blown plaster is to be removed, and reinstated with lime plaster finish.

Existing door to be replaced with heritage style four panel painted timber fire door to enhance the heritage asset.

Wall between dining and lounge to be opened (in the same style as the houses 1-5), to provide through living space to reflect the requirements of modern-day living.

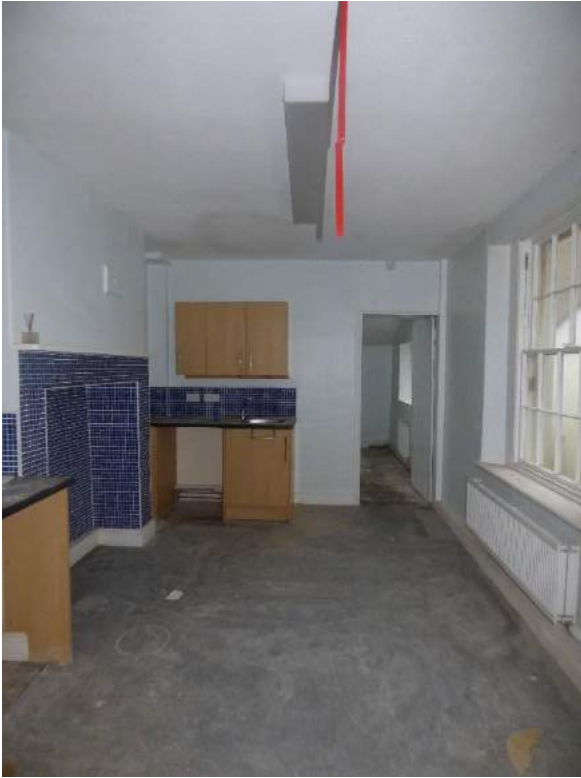
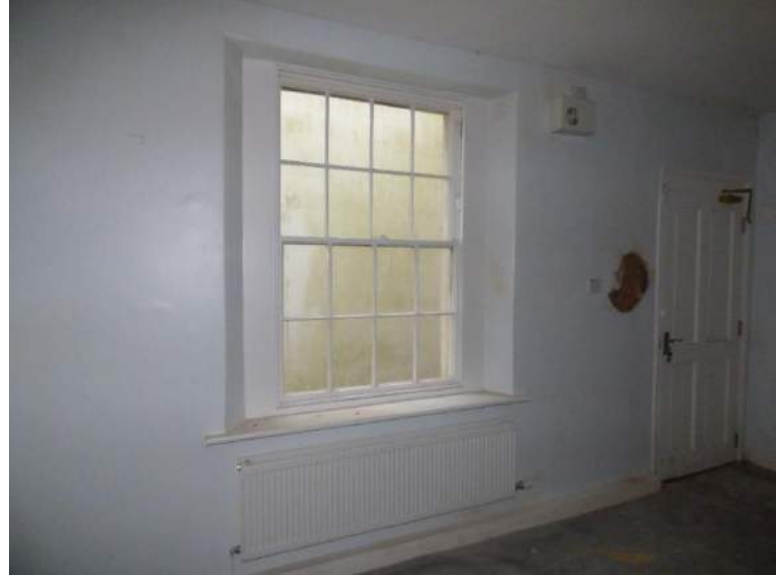
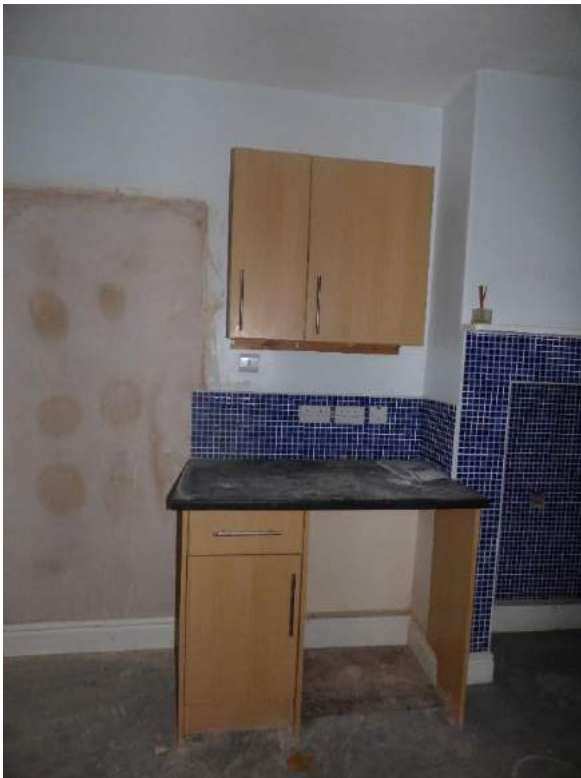
Above, left, and below: In the existing kitchen, the existing M&E services are to be removed and modern kitchen removed. Internal walls and ceilings to be made good.

Existing cornice to be made good in locations where redundant services are to be removed and where hairline cracks have appeared.

Existing architraves and skirtings to be retained and made repaired.

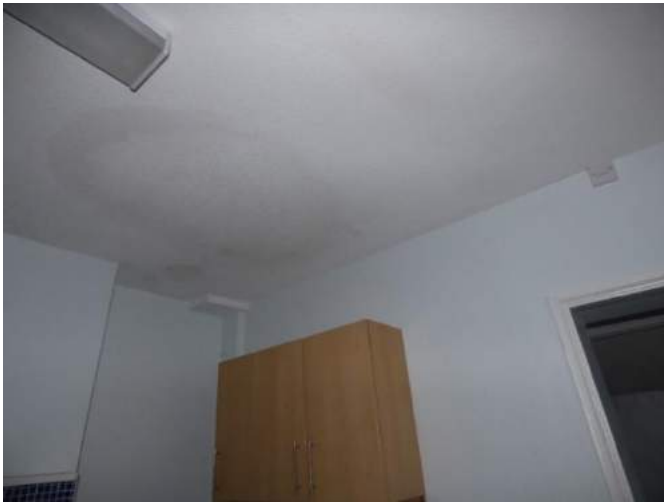
Left: Water ingress through the roof has damaged the existing ceiling.

Roof and ceiling to be repaired to match existing.

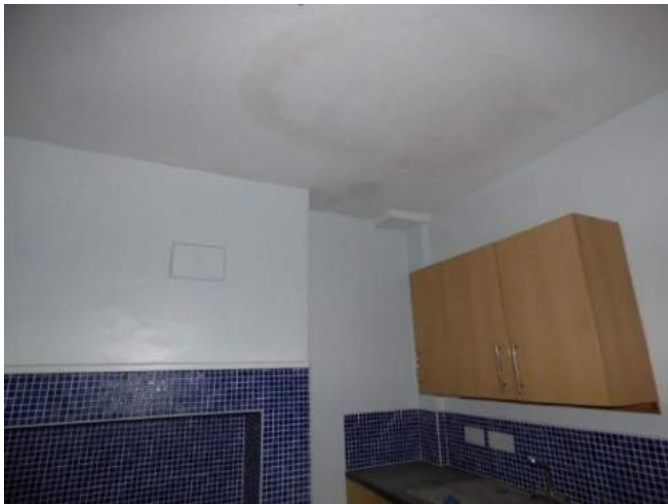
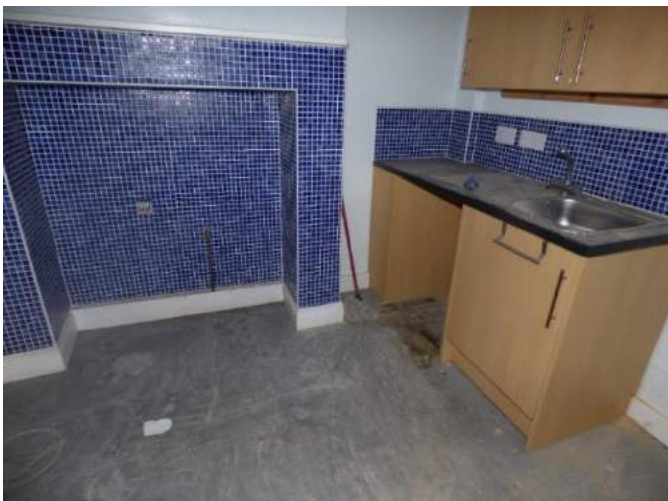
Left and below: The existing wc and utility area is to be reconfigured. All internal finishes to be stripped out and ceilings, walls, and floors to be made good.

Roof to be repaired and ceiling to receive new insulated plasterboard.

Apply an insulated plasterboard 62mm thick to underside of ceiling. The Laminated plasterboard and PIR has a vapour barrier incorporated so interstitial moisture would be prevented. New rooflights to be installed with flashing kit that mounts unit flush with the roof surface.

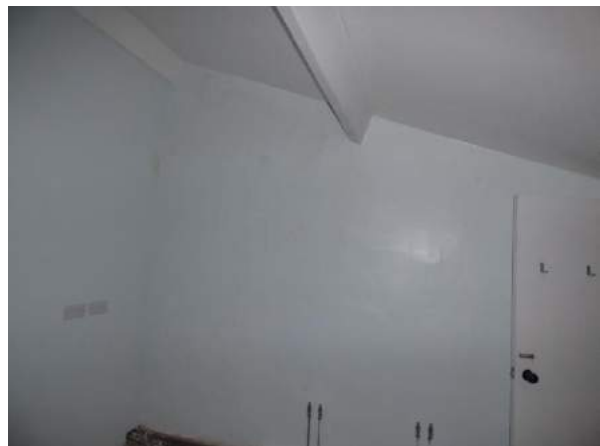
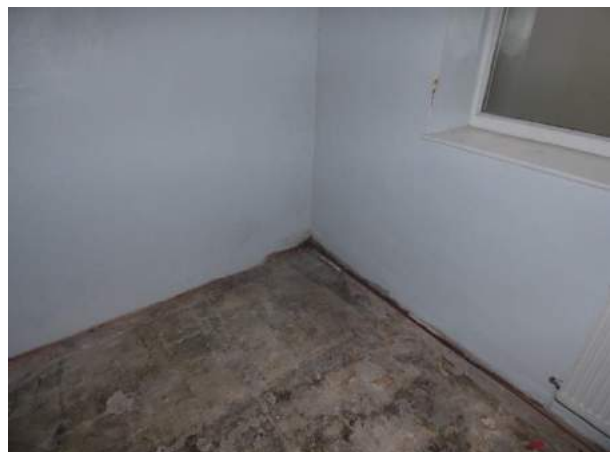
Left: Existing wc area to be reconfigured. Existing ceiling to be repaired.

Damp treatment is to be provided as Koster NB1 system.

Koster NB1 works by providing both a physical barrier against water ingress as well as providing a migratory crystal sealant that penetrates deep into the structure to seal micropores and cracks against water ingress.

Existing window (on rear boundary wall) to be walled up to match existing.

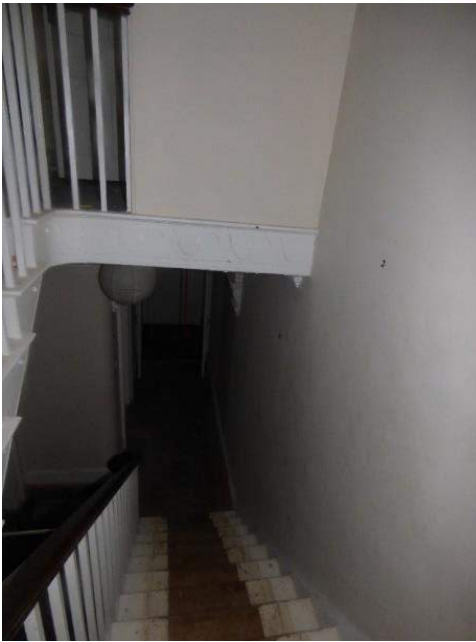
Retain original staircase, which is in good condition.

Handrail, balusters, and rails are original and are to be retained. Missing Baluster to be replaced with matching baluster and decorated to match existing.

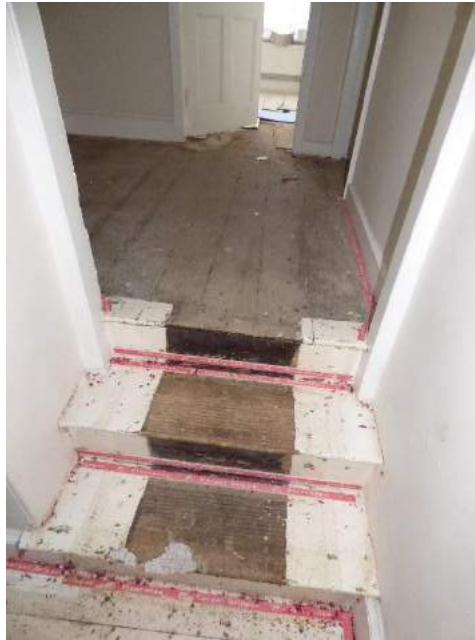
Left and above: Lobby to bathroom and existing wc to be reconfigured to make better use of space. Ceiling and walls to be repaired further to damp ingress damage.

Cornice to be provided where missing.

Existing non original fixtures and fittings to be removed and walls to be made good.

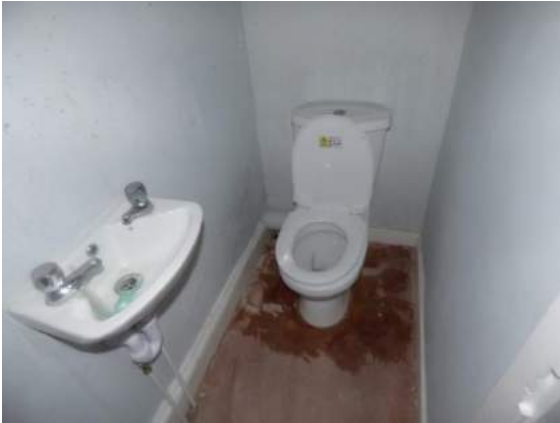
Left: Existing w.c. (not original) to be stripped out and space reconfigured. All skirtings and cornices to be reinstated to match existing.

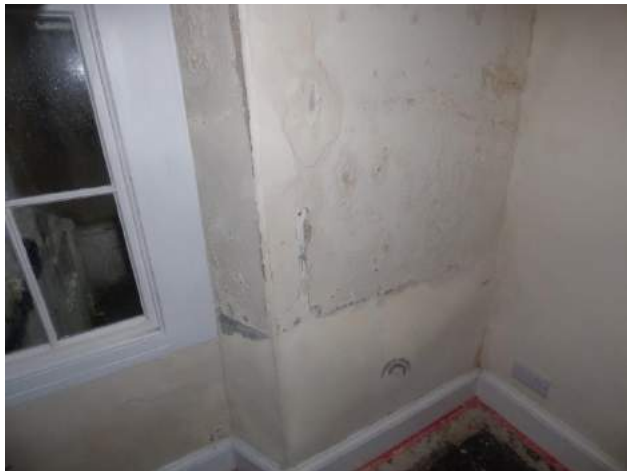
Left and below: Blown plasterwork to be repaired with lime plaster (Solo lime plaster from Lime Centre) below window.

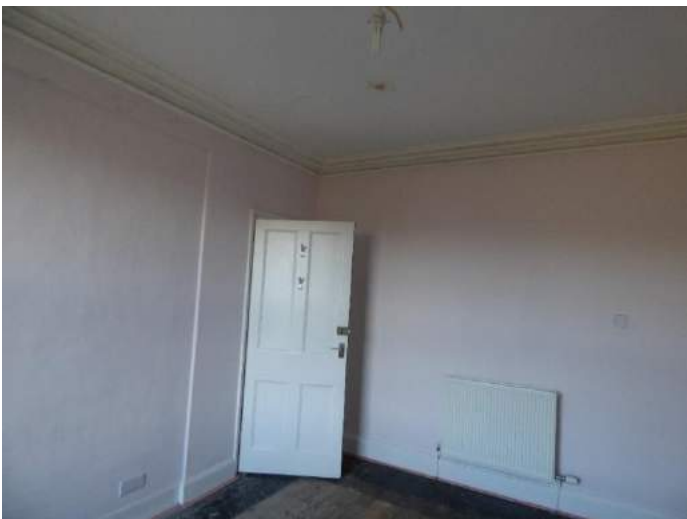
Large front bedroom, skirtings, covings, and architraves to be retained. Existing panelled door to be replaced with new Georgian heritage style four fire panel door.

Existing floorboards in good condition.

Fire surround to be retained.

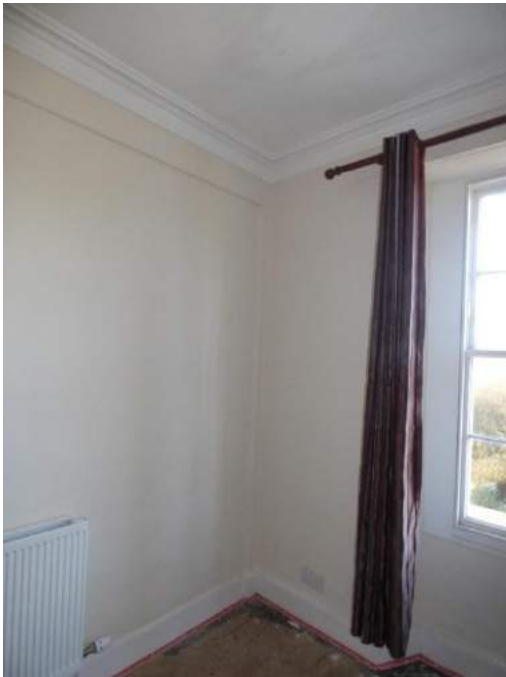
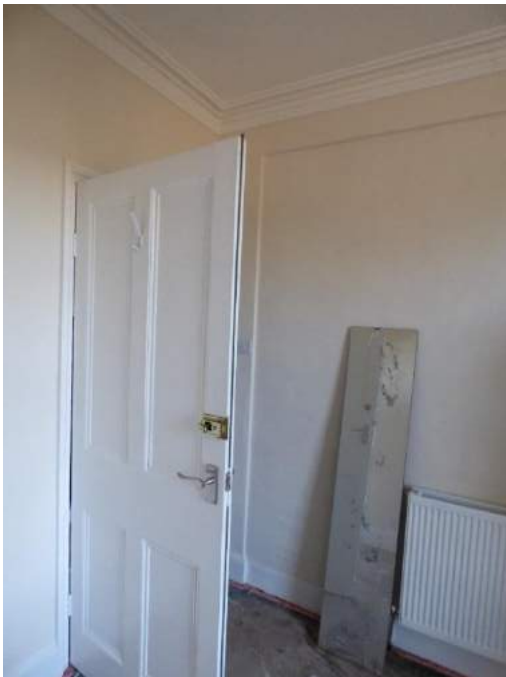
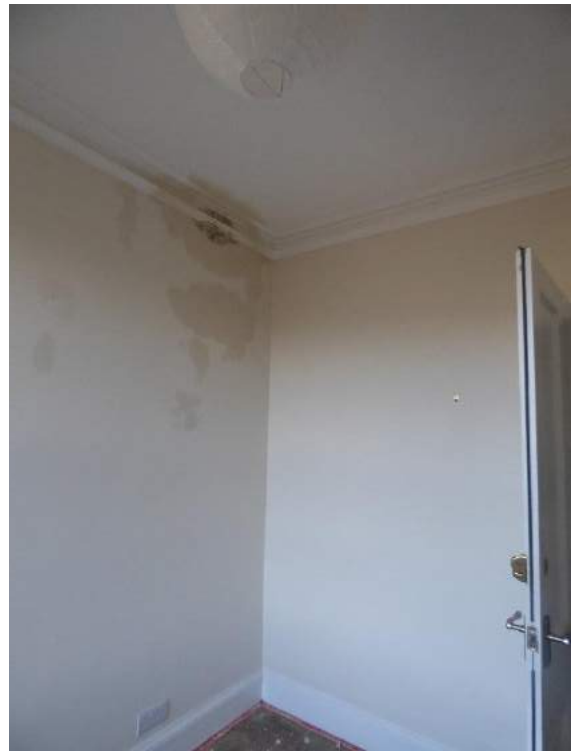
Existing small front bedroom - cornice, skirtings, and architraves to be retained. Existing door to be removed and new Georgian heritage style four panel door to be provided and installed by specialist joinery company such as Batty Joinery Ltd. In new location.

Existing doorway to be walled up to match existing.

Blown plaster to walls and ceiling to be replaced and repaired with lime plaster (Solo lime plaster from Lime Centre) all to match existing.

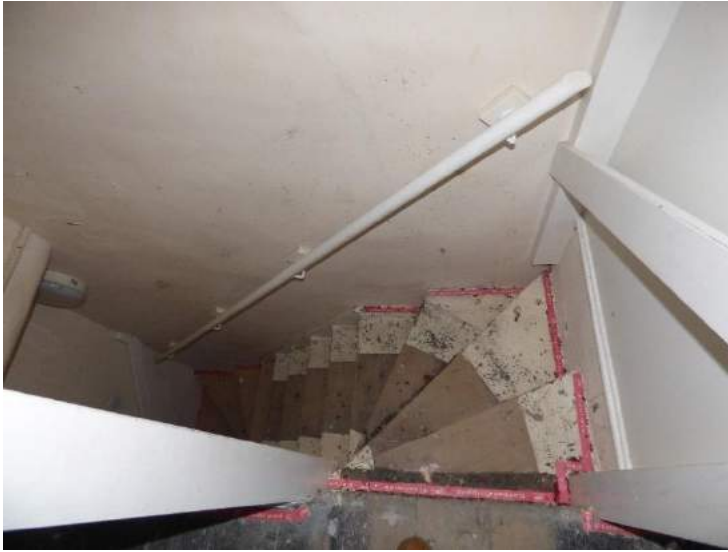
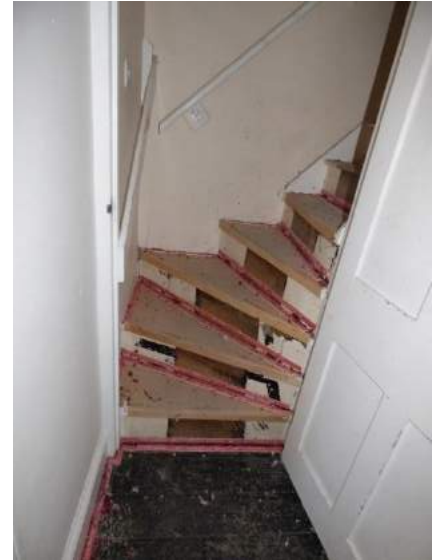
Above and left: Staircase to attic rooms.

Provide and install new Georgian style heritage four panelled fire door to match existing (refer also to D&A statement).

At the top of the staircase on the landing, remove all damp and damaged/blown plasterwork and repair with lime plaster and skim and decorate throughout.

Apply an insulated plasterboard 62mm thick to underside of ceiling. The Laminated plasterboard and PIR has a vapour barrier incorporated so interstitial moisture would be prevented underside of ceiling tape and skim and undertake full

Replace existing modern rooflights with new heritage rooflight windows (Velux or Rooflight company or similar) A with flashing kit that mounts unit flush with the roof surface).

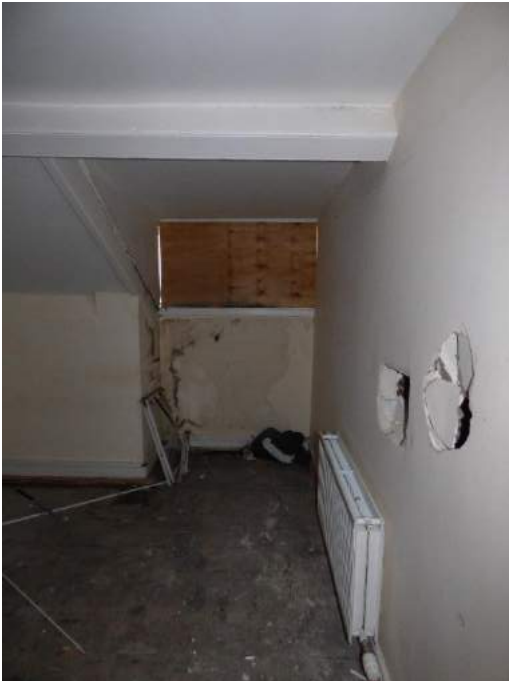
Left: Existing dormer glazed window no longer exists to the second bedroom, and the dormer cheeks are damaged beyond simply repairing them. A new dormer is proposed.

The existing bedroom partition is damaged. It is proposed to remove this wall and reconfigure the space.

In the bedroom remove all damp and damaged/blown plasterwork and repair with lime plaster and skim and decorate throughout.

Apply an insulated plasterboard 62mm thick to underside of ceiling. The Laminated plasterboard and PIR has a vapour barrier incorporated so interstitial moisture would be prevented tape and skim and undertake full decorations.

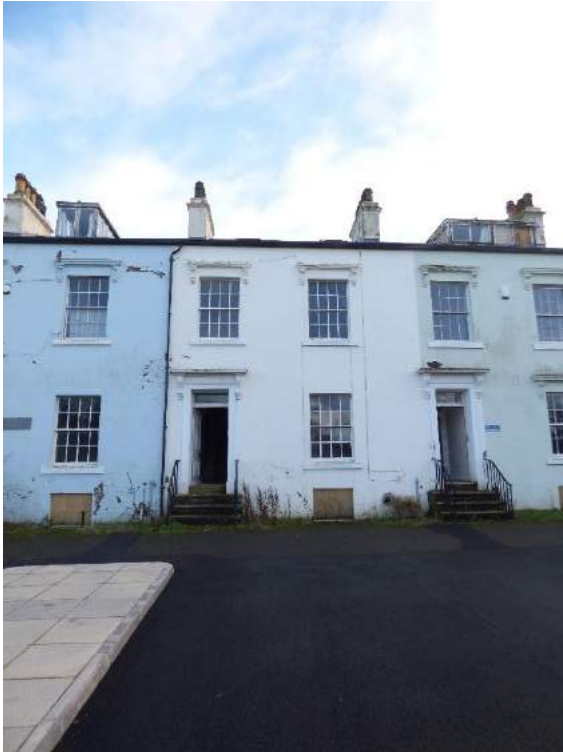
Left: The main entrance is mentioned in the listing text and is to be entirely retained.

Both front and rear elevations are currently rendered, with colour to the front and side and natural to the rear. All elevations require to be prepared for render repairs and redecoration by specialist using lime render and stucco (Parax LTD) to be applied by specialist.

The existing door and frame are to be retained and made good with the provision of new ironmongery. Once repaired full decoration will be undertaken.

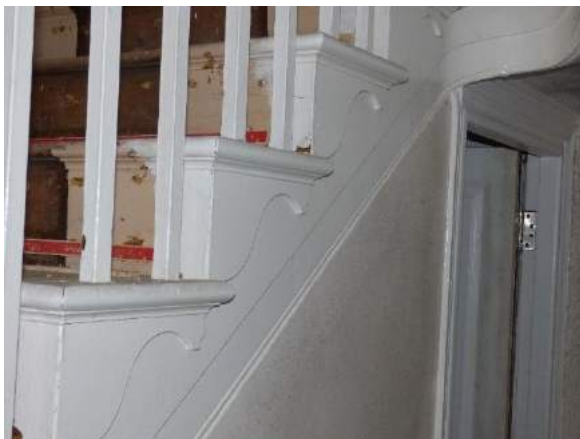
Existing staircase is original and is in excellent condition.

Below: Existing door and fanlight to be retained.

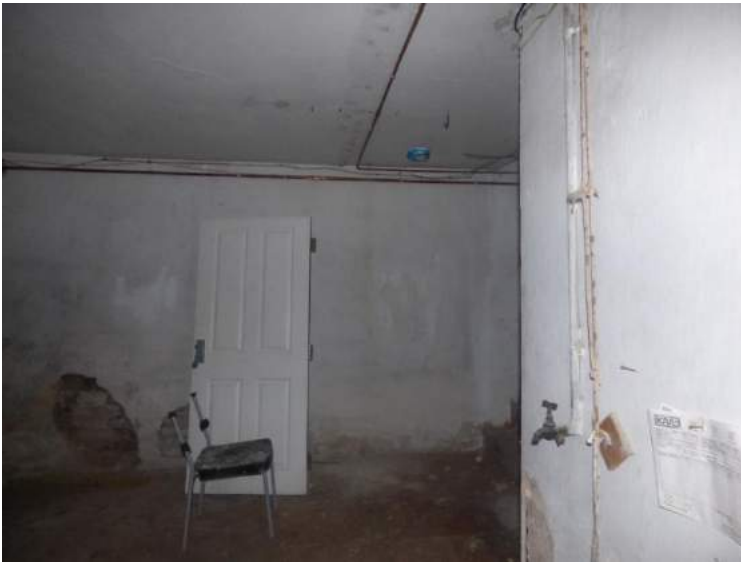
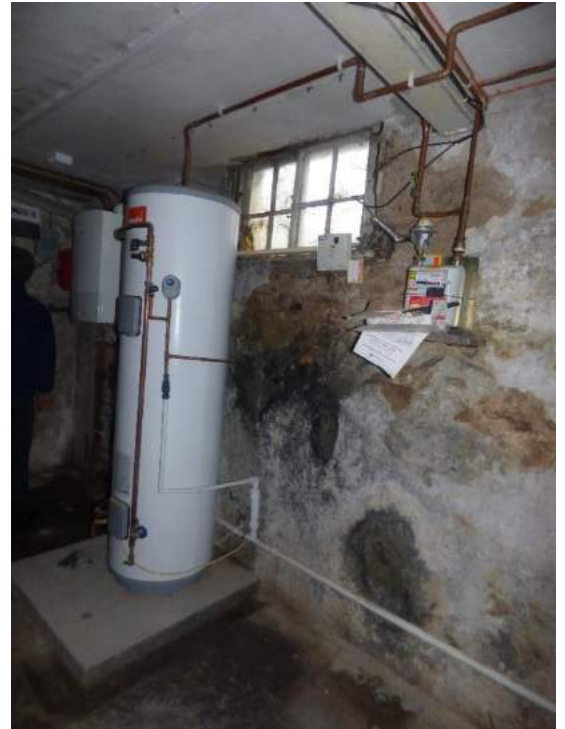
Left and above: New boiler installations have been undertaken prior to the sale of the properties.

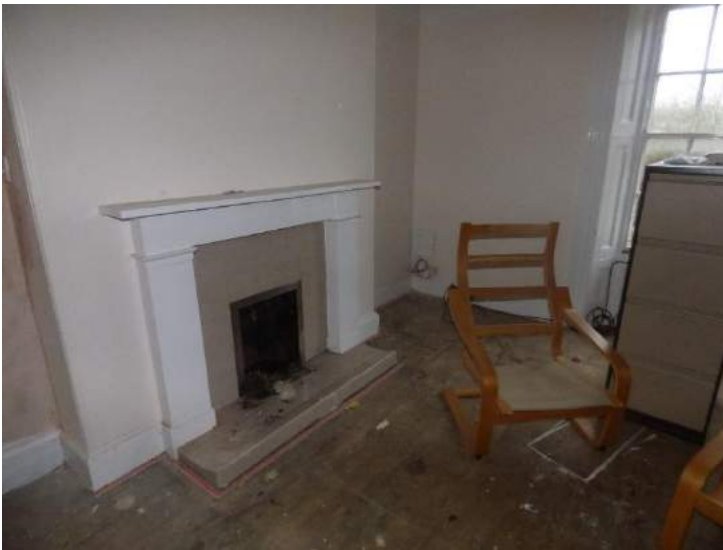
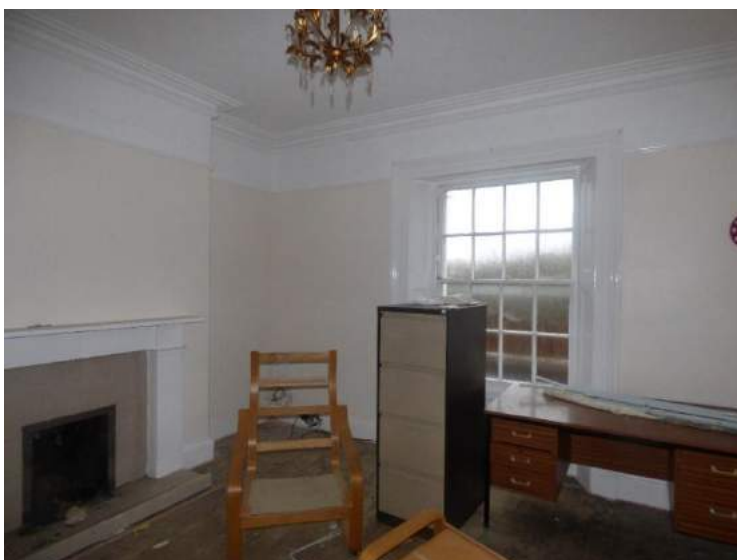
Left and below: In the existing front room, the period features below and to the sides of the existing window are in good condition, it is proposed to carefully refurbish the existing timber shutters.

Existing cornices, picture rail is all in excellent condition and are to be retained.

Existing architraves and skirtings to be retained and made good.

Existing doors to be replaced with heritage style four panel painted timber fire doors to enhance the heritage asset.

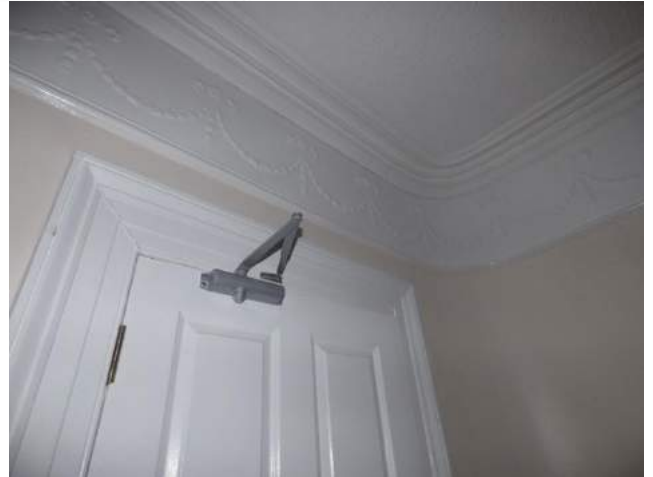
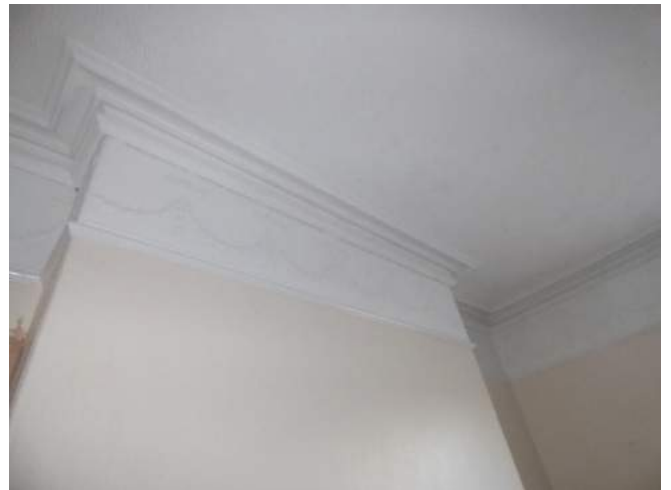
Right, above, and below: In the existing lounge at the front of the property, it is proposed to carefully refurbish the existing timber shutters.

Fireplace is not original and is not proposed to retain it.

Existing architraves and skirtings to be retained and made good.

It is proposed to form a new opening between lounge and dining to create a more open plan living environment. The new opening will be formed 300mm beneath the cornice to ensure cornice features are retained.

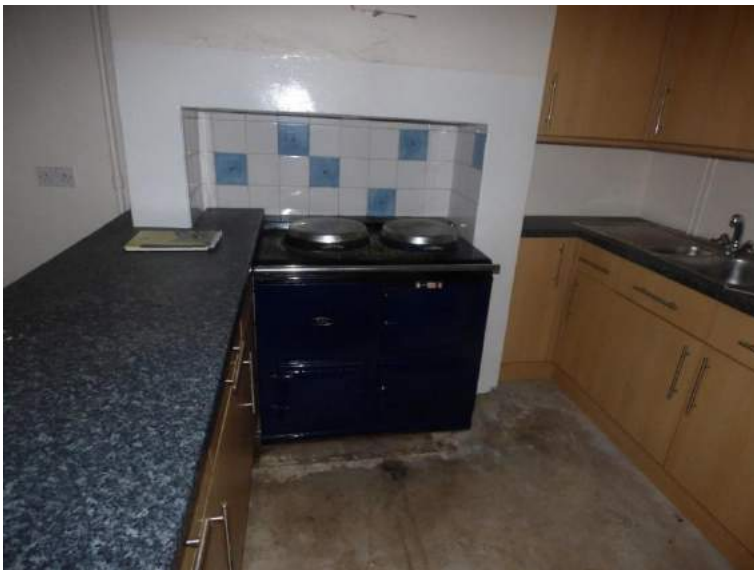
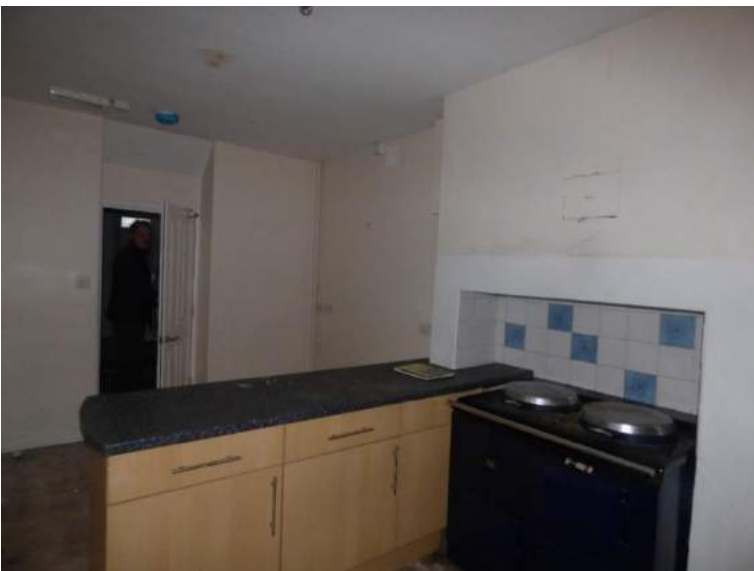
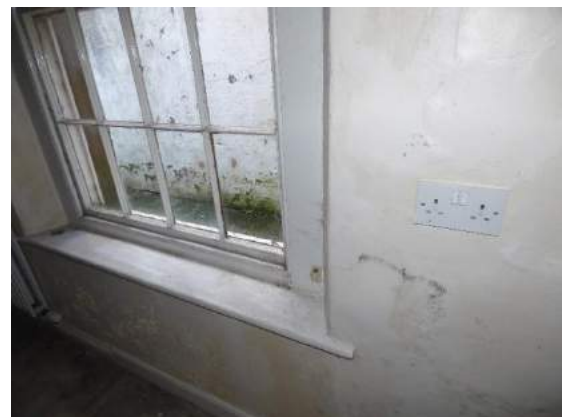
In the existing kitchen it is proposed to remove all fixtures and fittings.

Blown plaster to existing walls to be repaired with new lime paster and made good.

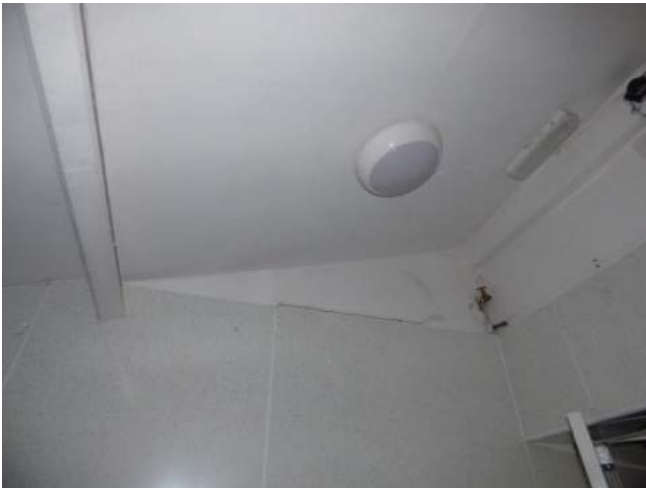
Left: The existing former shower area is to be reconfigured to provide a new utility and w.c. at ground floor.

The existing modern rooflight is proposed to be replaced with a new heritage style rooflight (Velux or Rooflight company or similar). New rooflights to be installed with flashing kit that mounts unit flush with the roof surface

Apply an insulated plasterboard 62mm thick to underside of ceiling. The Laminated plasterboard and PIR has a vapour barrier incorporated so interstitial moisture would be prevented to be taped and skimmed.
