HERITAGE STATEMENT

FULL RENOVATION OF EXISTING No 11 TERRACE HOUSES

St Bees, 1-11 Lonsdale Terrace, Parish Council, Cumbria

M.A.C Architects, Project Number: 2019:303

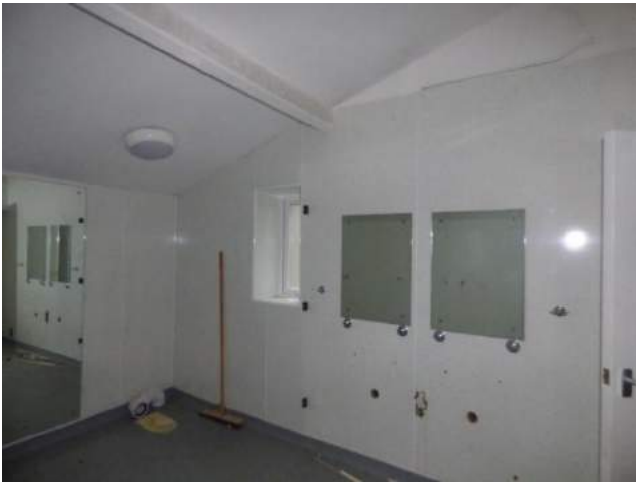
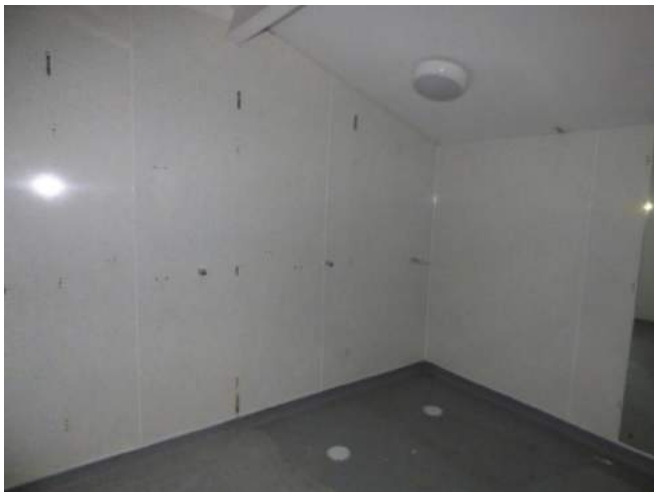
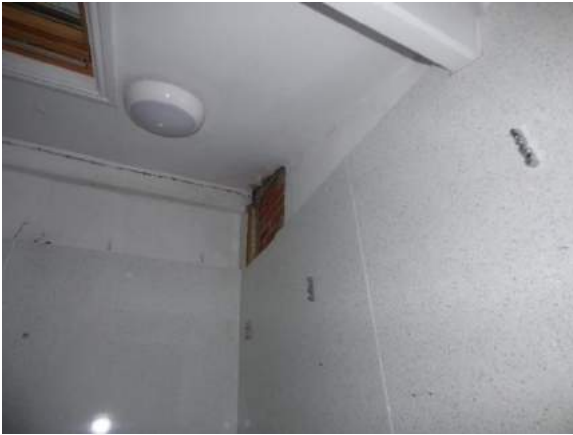
Left and below: The existing shower block to be reconfigured.

The roof may require some minor repairs to make watertight.

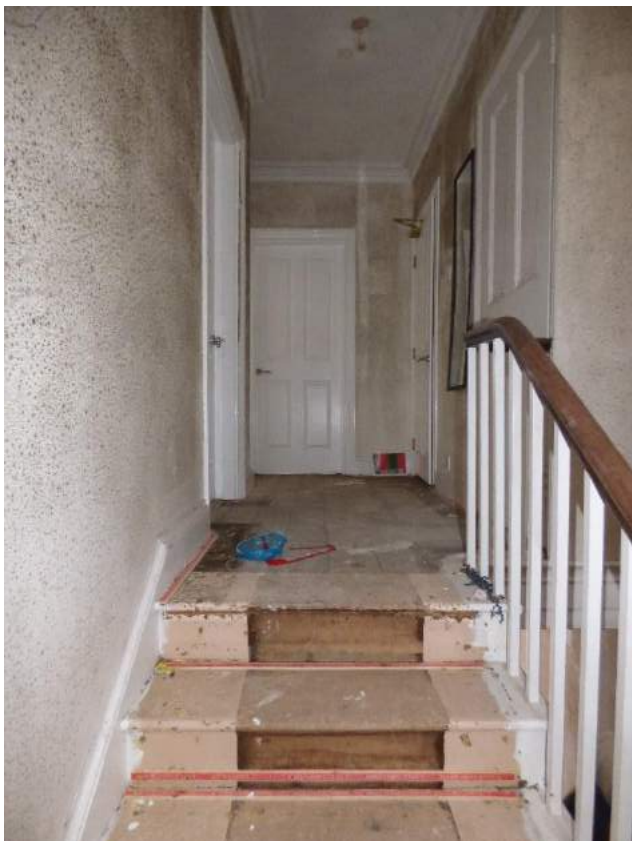
Left and above: Existing ceiling to be made good by removing mould and replacing blown plaster with lime plaster as required.

Glazing to new heritage style Georgian double glazed sash window to be obscure.

All finishes to be made good, and skirtings to match the original to be installed.

Existing cornices to be made good and skirtings to match existing to be reinstated.

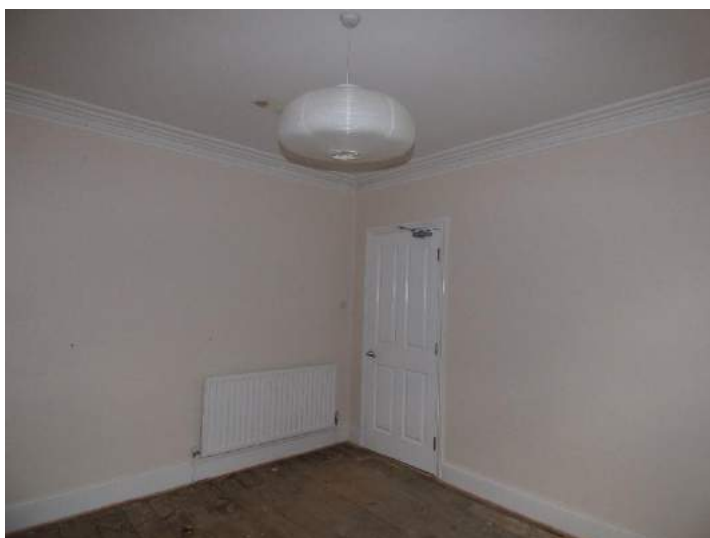
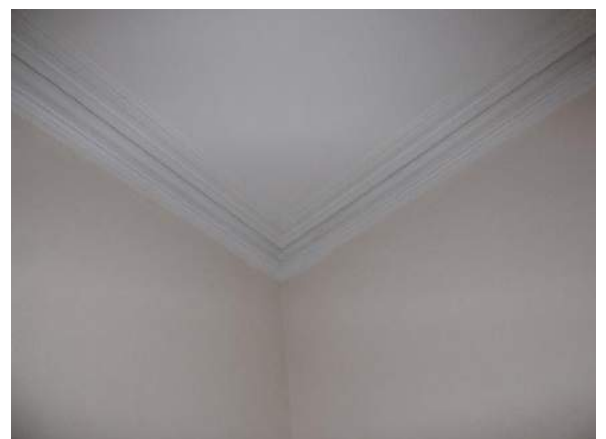
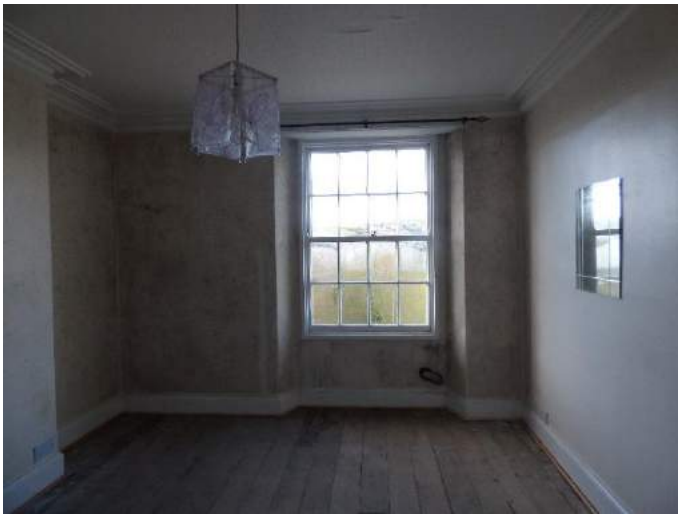
Large front bedroom, skirtings and architraves to be retained. Existing door to be replaced with new Georgian heritage style four panel door to be provided and installed by specialist joinery company such as Batty Joinery Ltd.

Damp ingress evident with mould to walls and ceiling.

Attic and roof to be made watertight.

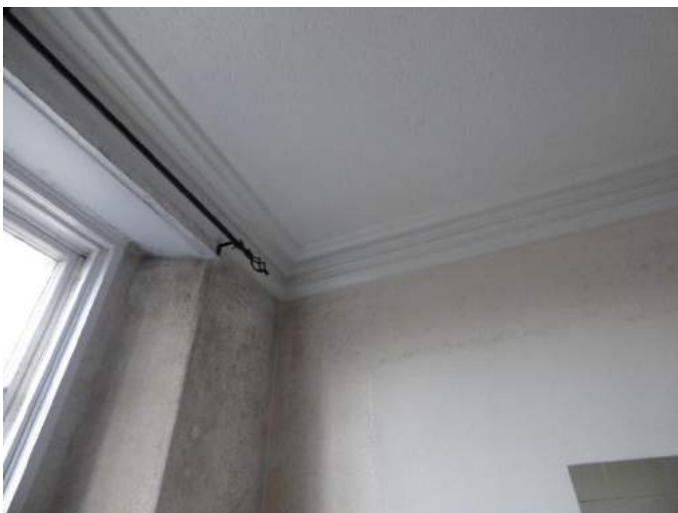
Existing floorboards in good condition

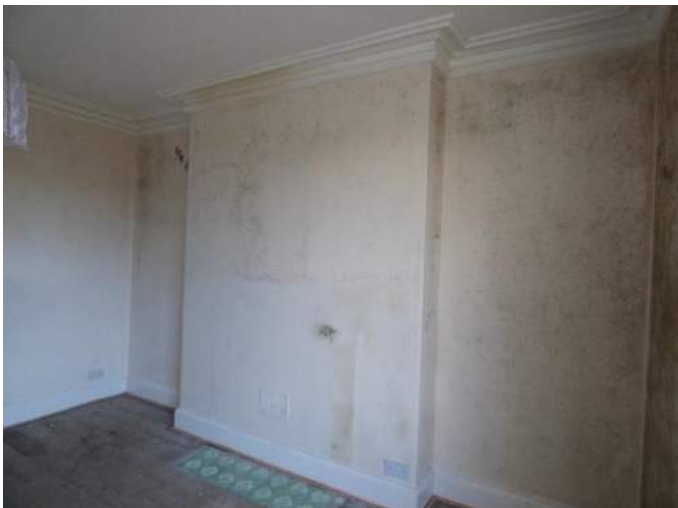
Existing small bedroom skirtings and architraves to be retained.
Existing door to be removed and new doorway from proposed master bedroom to be provided and installed with new Georgian heritage style four panel door to be provided and installed by specialist joinery company such as Batty Joinery Ltd.

Existing floorboards in good condition.

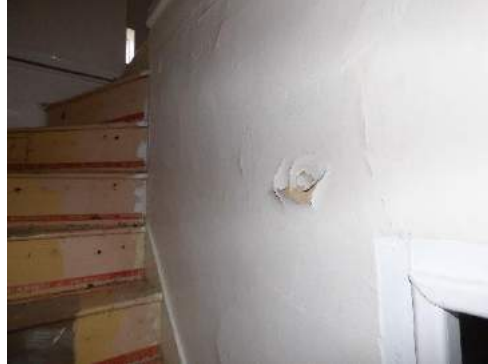
Existing staircase to attic. Existing walls require minor fabric repairs.

New four panelled fire door to be installed at first floor.

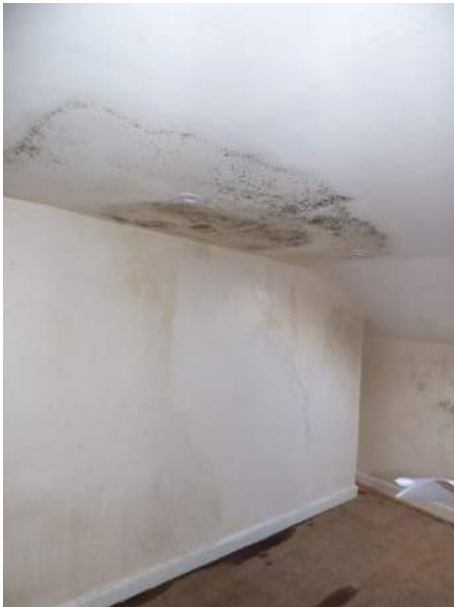
Left: Attic landing.

Existing window to be walled up.

Floorboards are in good condition (but require minor repairs).

Existing damaged plaster to be replaced and repaired with lime plaster (Solo lime plaster from Lime Centre)..

Apply an insulated plasterboard 62mm thick to underside of ceiling. The Laminated plasterboard and PIR has a vapour barrier incorporated so interstitial moisture would be prevented. New rooflights to be installed with flashing kit that mounts unit flush with the roof surface.

Provide and install new heritage rooflight windows (Velux or similar) to replace existing modern Velux rooflights.

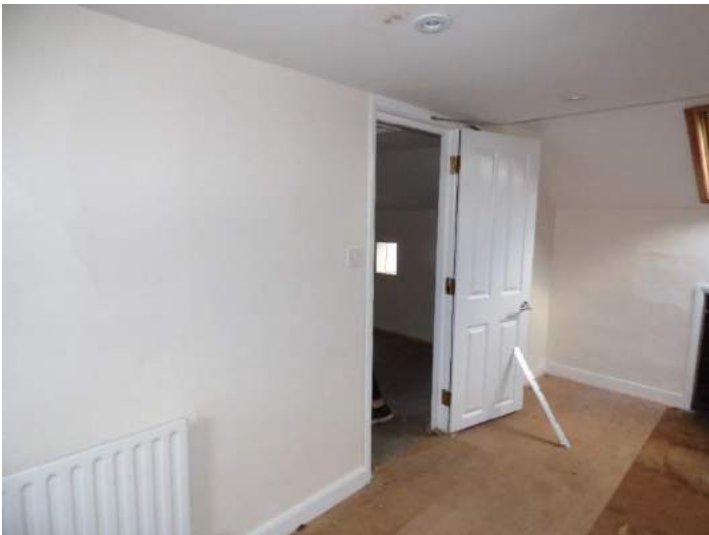
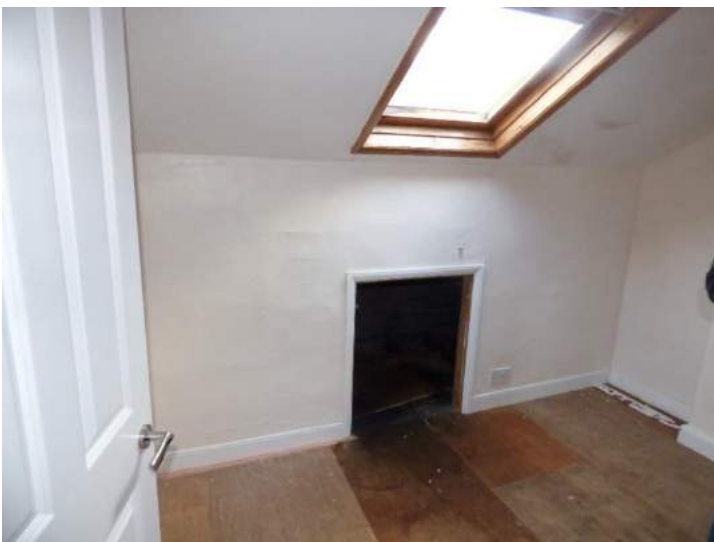
Left: Attic bedroom

The existing small attic bedroom will be reconfigured to maximise the space.

Floorboards are not original and it is proposed to replace with T&G timber floorboards

In the bedroom it is proposed to remove all blown plasterwork and repair with lime plaster and skim.

Apply an insulated plasterboard 62mm thick to underside of ceiling. The Laminated plasterboard and PIR has a vapour barrier incorporated so interstitial moisture would be prevented. New rooflights to be installed with flashing kit that mounts unit flush with the roof surface.

Existing doors are to be removed and replaced with new heritage style four panel fire doors.

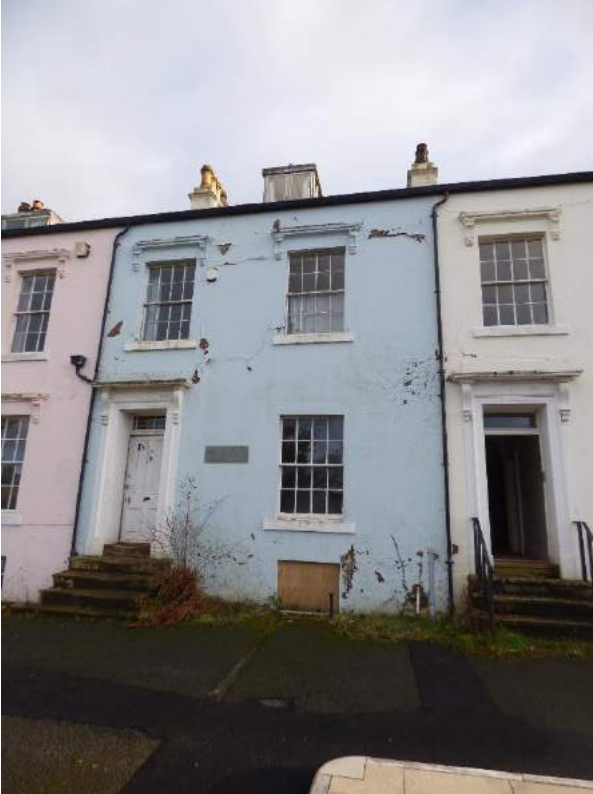
Left: The main entrance is mentioned in the listing text and is to be entirely retained.

Both front and rear elevations are currently rendered, with colour to the front and side and natural to the rear. All elevations require to be prepared for render repairs and redecoration by specialist using lime render and stucco (Parax LTD) to be applied by specialist.

The existing door and frame are to be retained and made good with the provision of new ironmongery. Once repaired full decoration will be undertaken.

Existing gutters and downpipes to be retained, repaired where necessary and decorated.

All existing single glazed windows to replace with new white painted slim profile timber double glazed 'heritage' windows to match the existing style by specialist supplier such as Batty Joinery, specialists in historic and listed building joinery works.

The existing stone steps to be cleaned up, and new painted metal handrails provided, that would have originally been installed to be reinstated – refer to D&A statement for details.

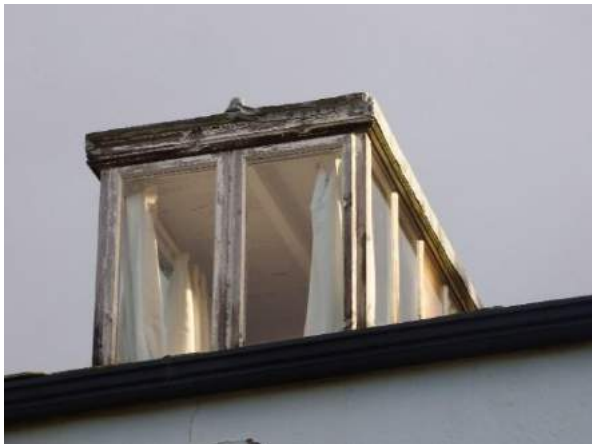
Existing dormer window is in extremely poor condition and it is proposed to completely reconstruct the dormer, in a style to match the other dormer windows on the adjacent buildings.

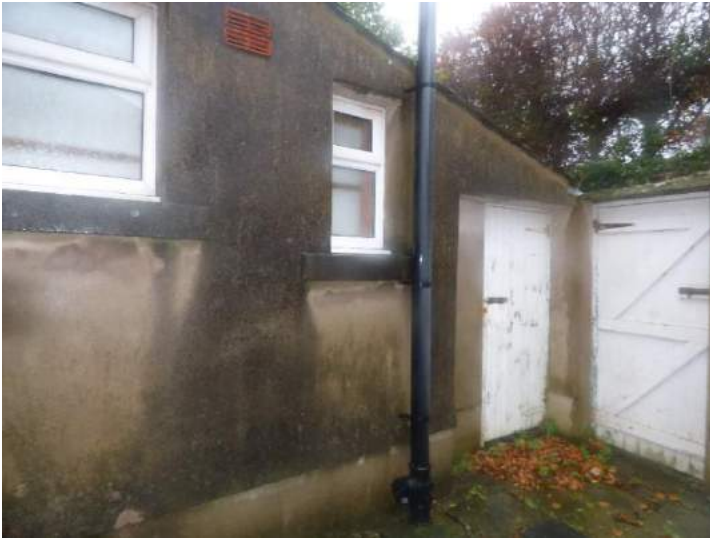
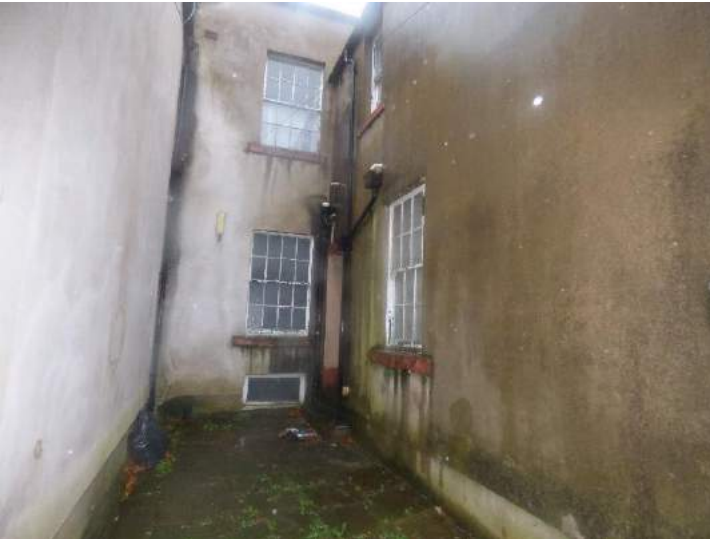
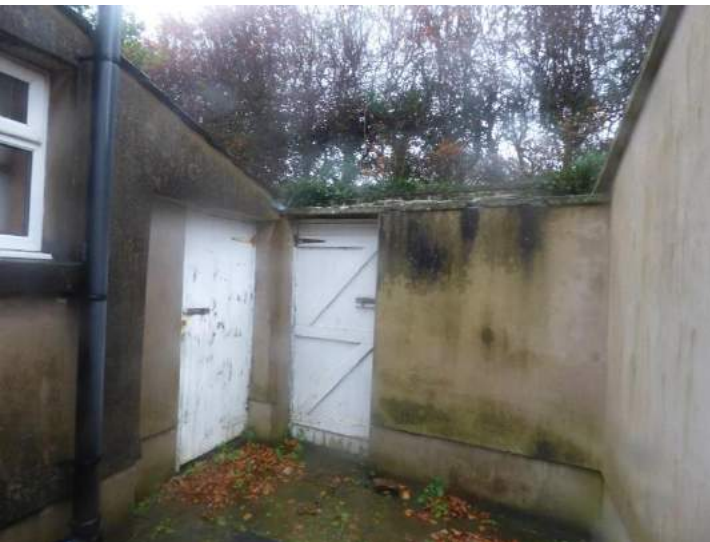
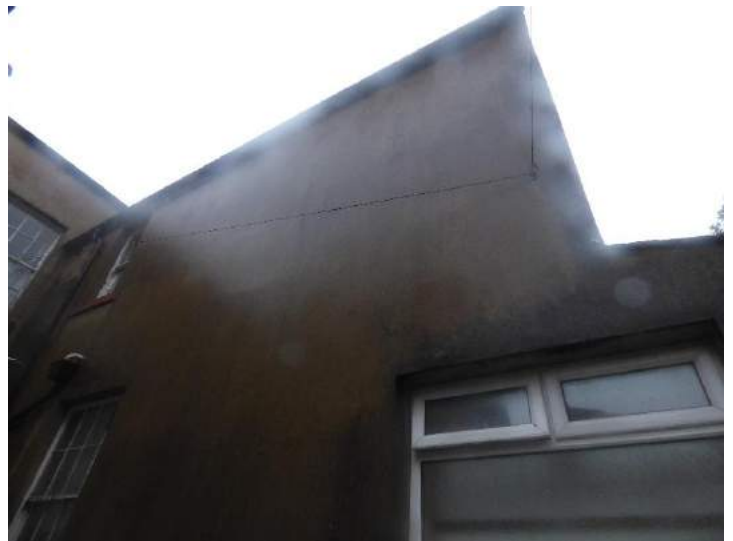
Rear of property – render to be repaired by specialist and decorated with off white render.

Modern windows to be replaced with double glazed heritage style sash windows to reflect the character of the period properties.

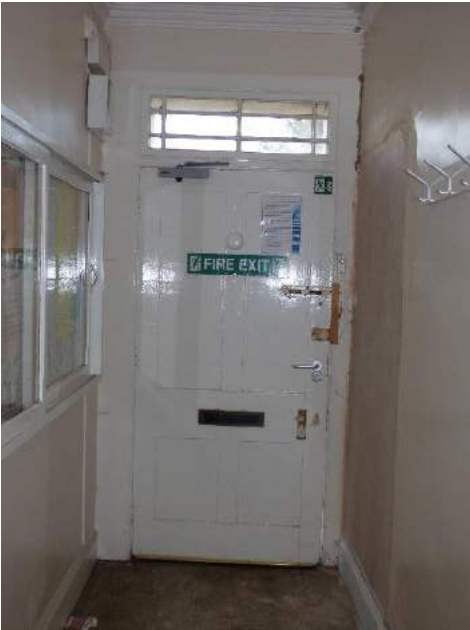
Left: The existing walls and floor are generally in good condition.

Handrail, balusters and rails to the staircase are original and to be retained.

Redundant M&E to be removed and wall/ceiling finishes made good, primed, prepared and fully decorated.

Doors to be replaced with heritage style four panel painted timber fire doors to enhance the heritage asset.

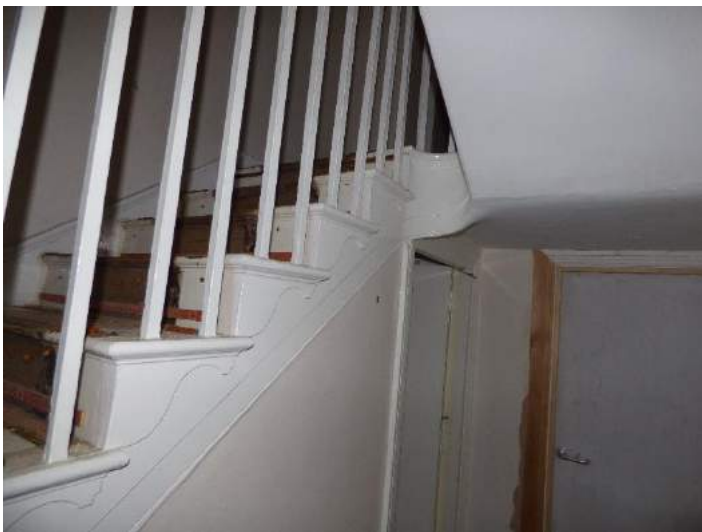
Left and below: The existing walls and skirtings and floor are generally in good condition.

Redundant M&E to be removed and wall ceiling finishes made good.

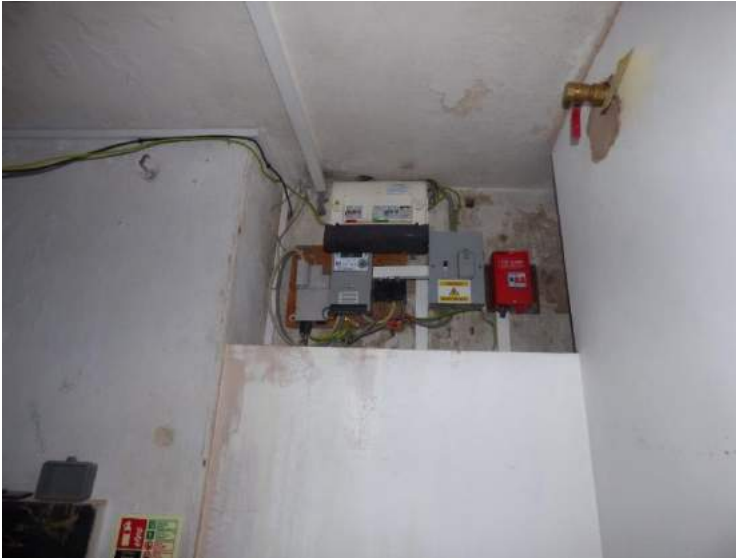
Left: The existing basement, the existing walls and floor are generally in sound condition so would be suitable for the application of damp proof slurry system.

Walls have been boarded over but not treated properly for damp, so it is proposed to remove the boards and apply waterproofing.

All existing paint and surface finishes must be removed and made good including all snots removed, and damage to existing surfaces, prior to the installation of a Koster Polysil NB1.

This migratory crystalline tanking slurry is used to seal below ground structures against water ingress.

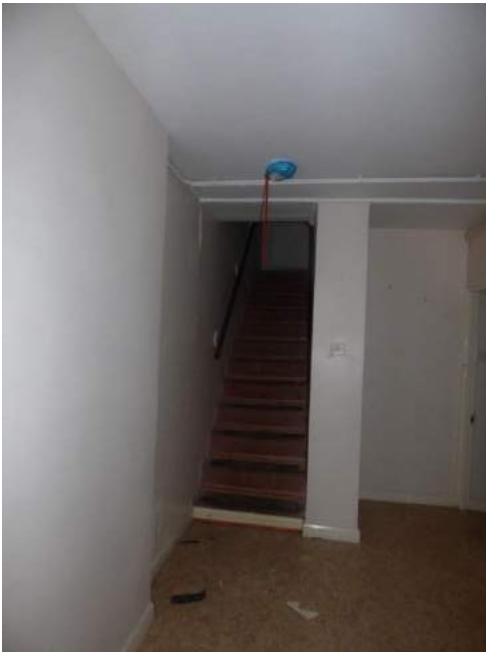
The walls down to the basement also require the full treatment.

In the basement all existing services are to be carefully stripped out and replaced with new compliant infrastructure.

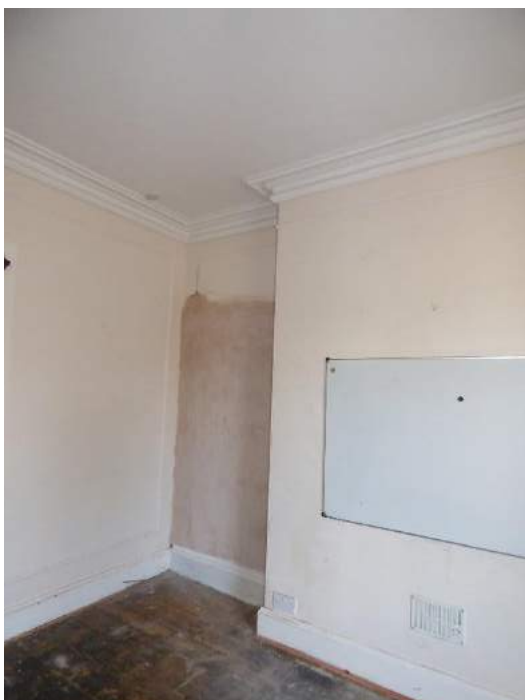
Left: Existing services to be stripped out and walls made good.

Architraves, skirtings, and cornices are all in good condition and are to be retained.

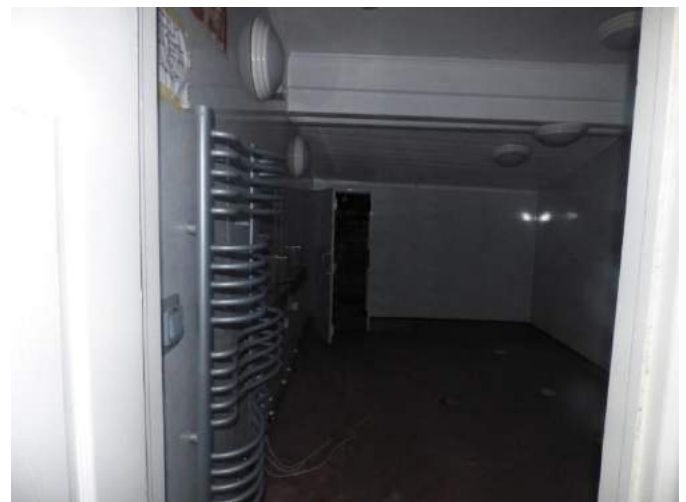
Above and right: The existing former shower block is to be converted back into a kitchen.

All the existing walls and floor finishes are to be stripped out and walls and floors made good. The existing window which has been boarded over will be reinstated with a new heritage style double glazed sash window.

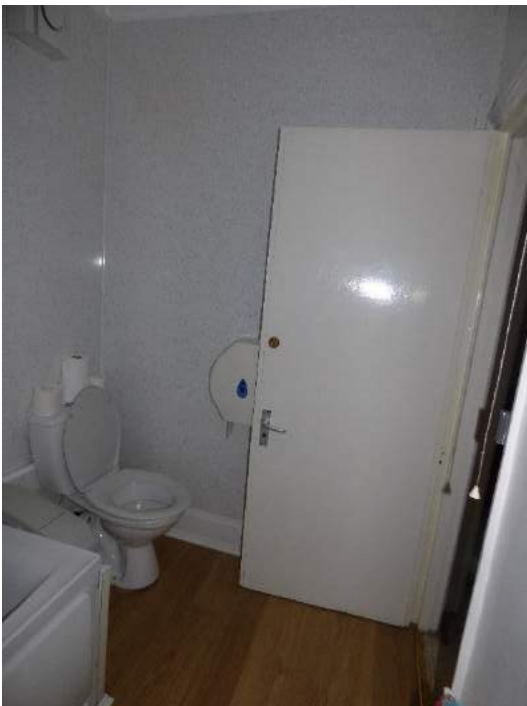
Above left; under stairs storage to be reconfigured to make better use of space.

Above and left: Existing bathroom to be stripped out and the existing walls to be removed to reconfigure this space to be more conducive to modern day living.

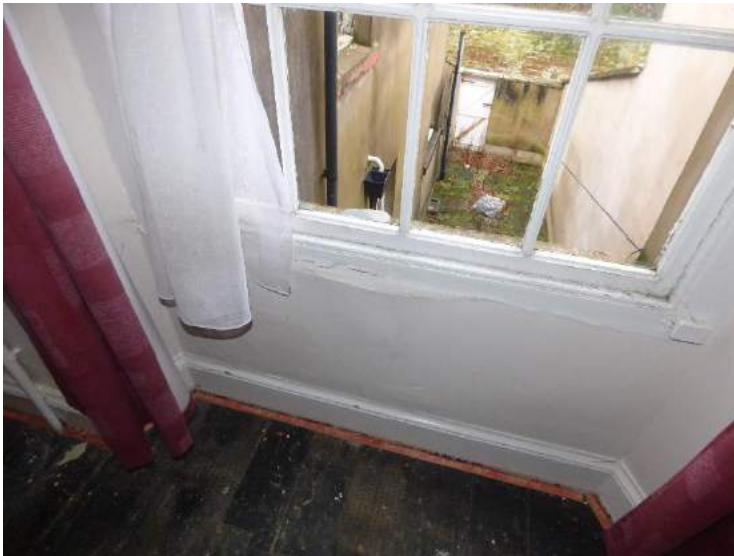
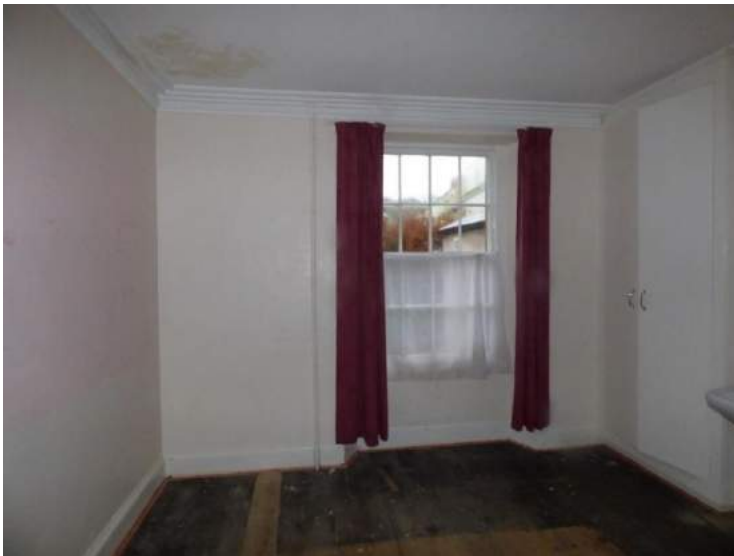
Rear bedroom skirtings and architraves to be retained. Existing flush panelled door to be replaced with new heritage style four panel door to be provided and installed by specialist joinery company such as Batty Joinery Ltd.

Existing floorboards in good condition.

Evidence of damp damage to ceiling and surrounding the existing window are to be repaired with lime plaster (Solo lime plaster from Lime Centre).

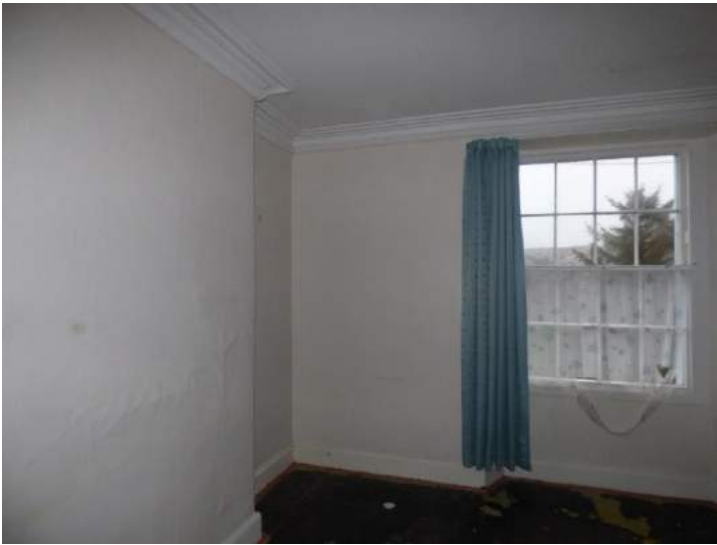
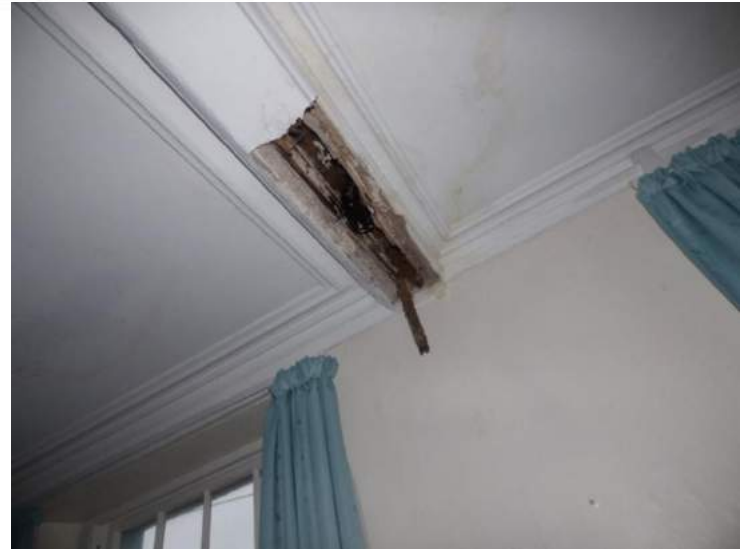
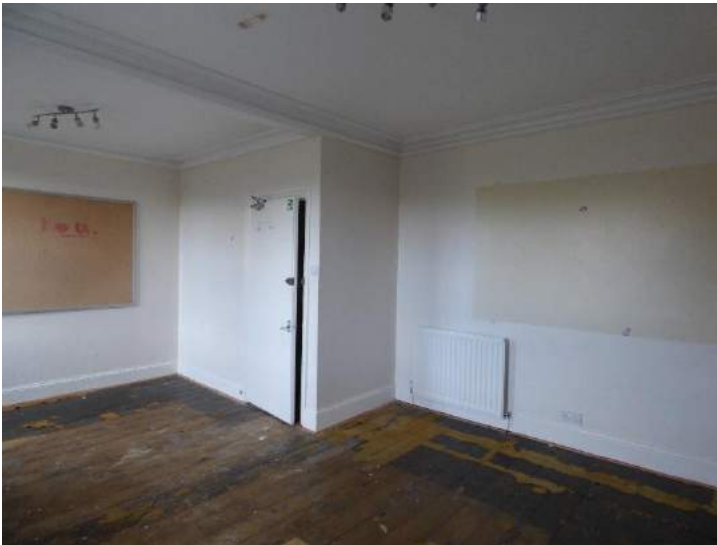
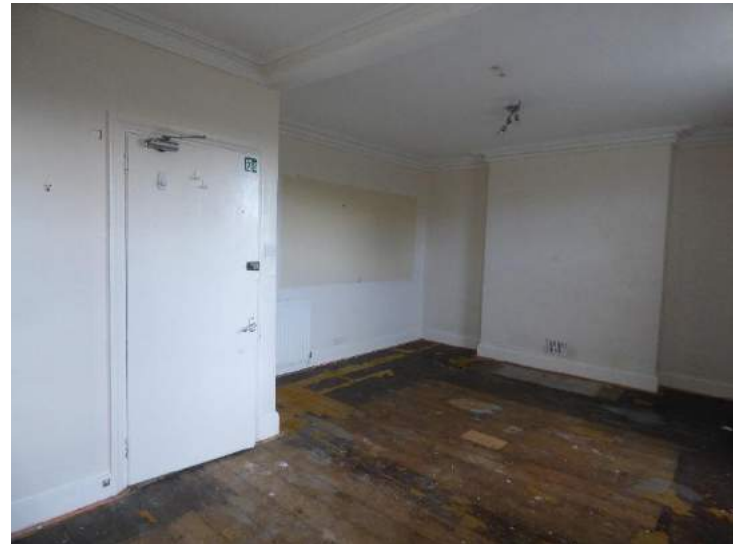
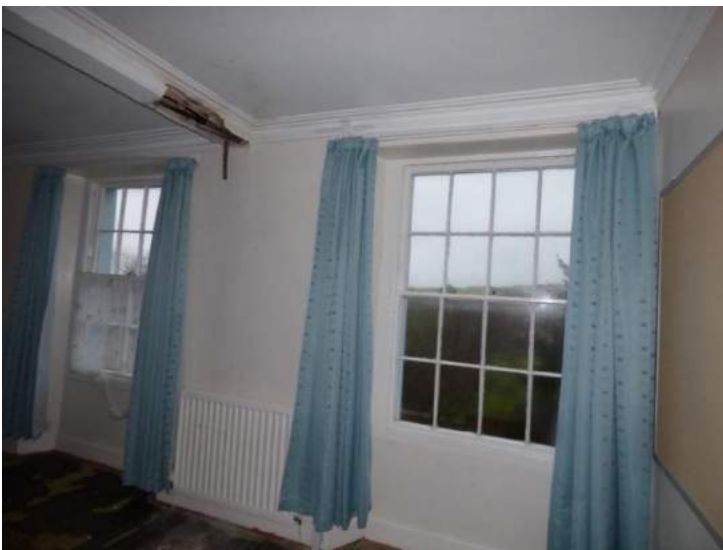
Front bedroom skirtings and architraves to be retained. Wall to be reinstated (where existing down stand is) between bedroom and new EnSite, and existing doorway to be walled up to where the small bedroom would once have been to form the en-suite.

Existing floorboards in good condition.

Existing flush panelled door to be replaced with new heritage style four panel fire door to be provided and installed by specialist joinery company such as Batty Joinery Ltd. In original location (has been walled up).

With architraves to match the existing.

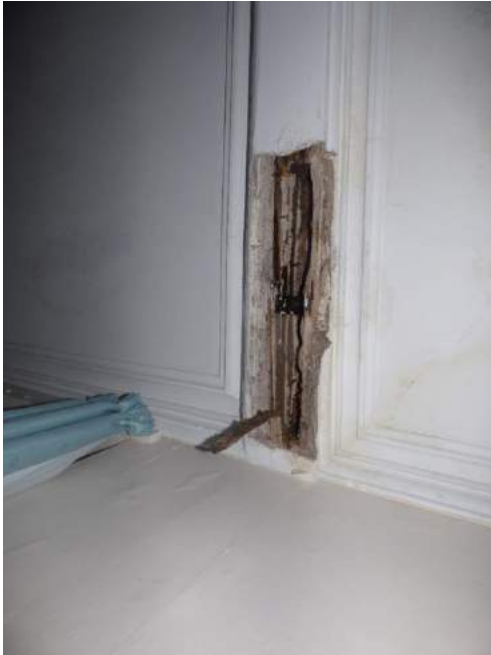
Damaged down stand timber beam to be replaced. Damaged cornice to be repaired and reinstated.

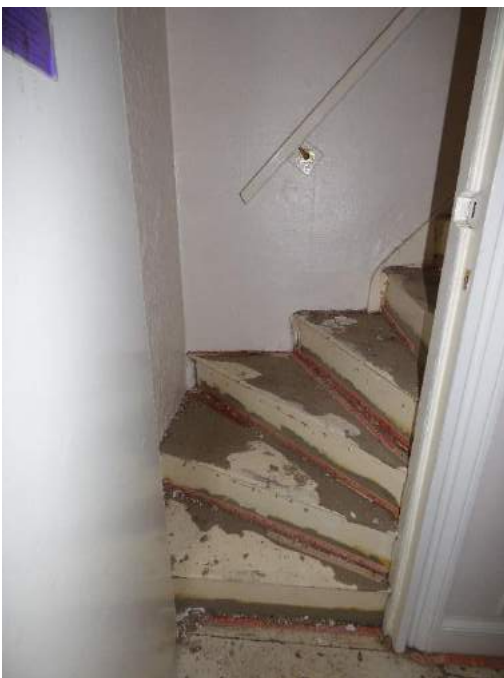
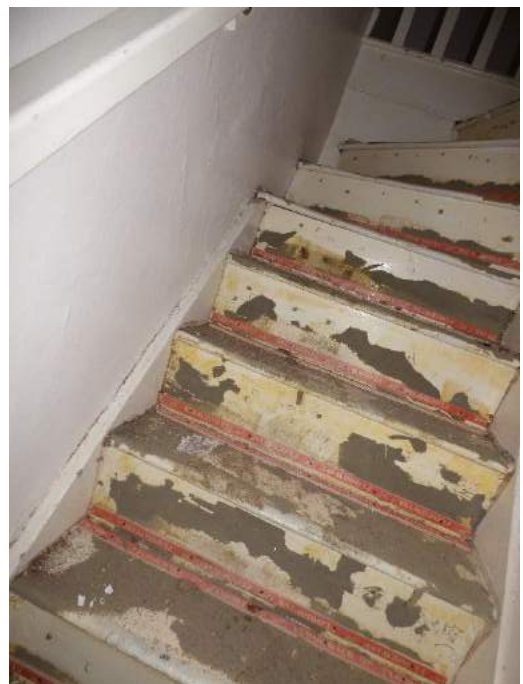
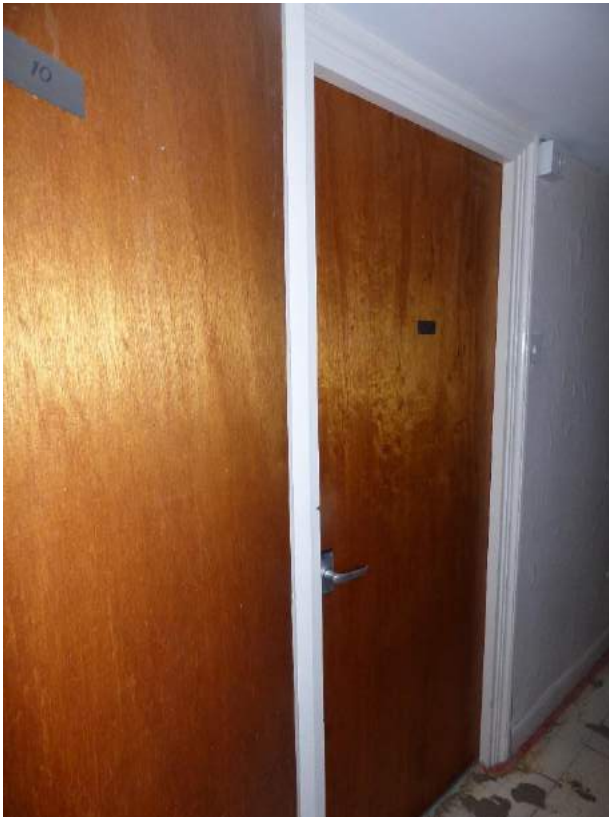
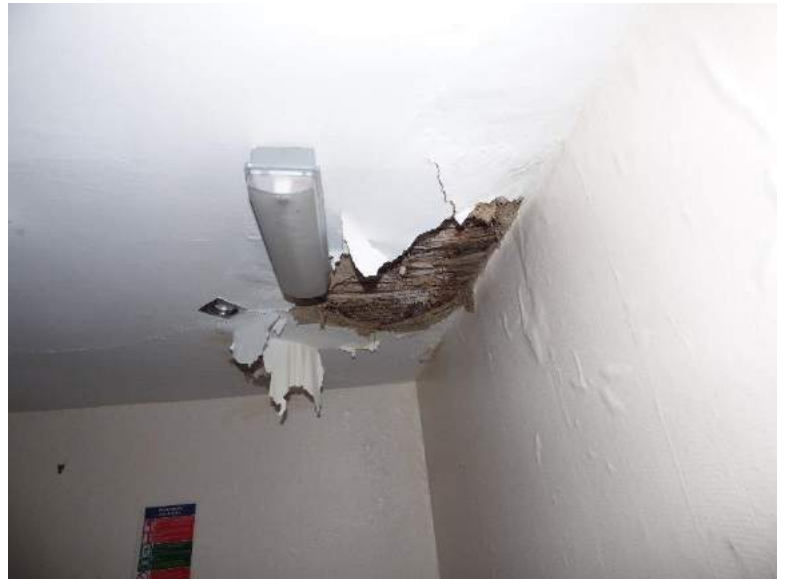
Existing staircase to attic rooms. New balustrade and handrail to be installed to match the existing at ground / first floor and at a height to comply with building regulations.

Apply an insulated plasterboard 62mm thick to underside of ceiling. The Laminated plasterboard and PIR has a vapour barrier incorporated so interstitial moisture would be prevented. Tape and skim and undertake full decorations.

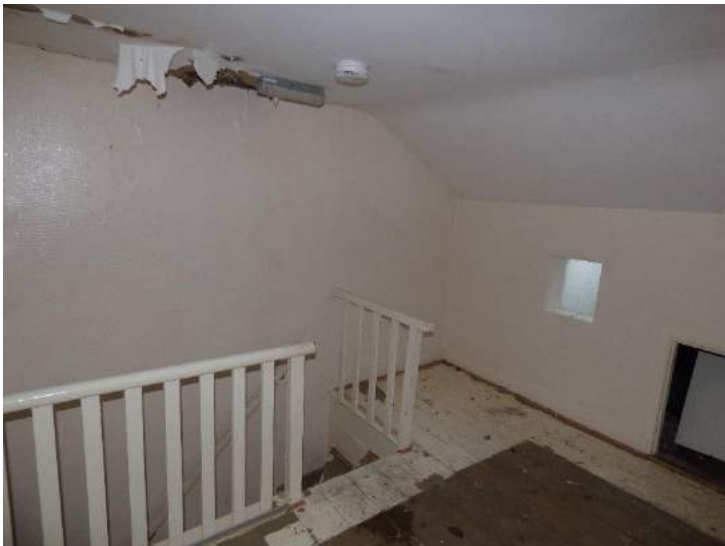
Existing Attic space is proposed to be reconfigured to maximise the space.

The modern doors are to be replaced with four panelled fire doors to match the rest of the property.

Damaged plaster to ceiling to be repaired with a lime plaster finish (Solo lime plaster from Lime Centre)..

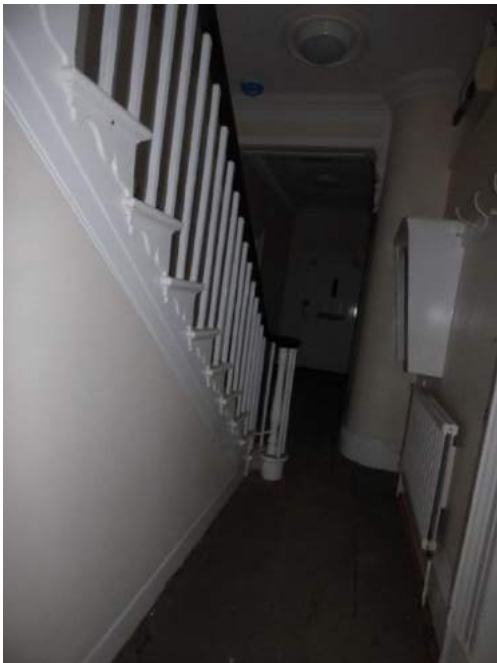
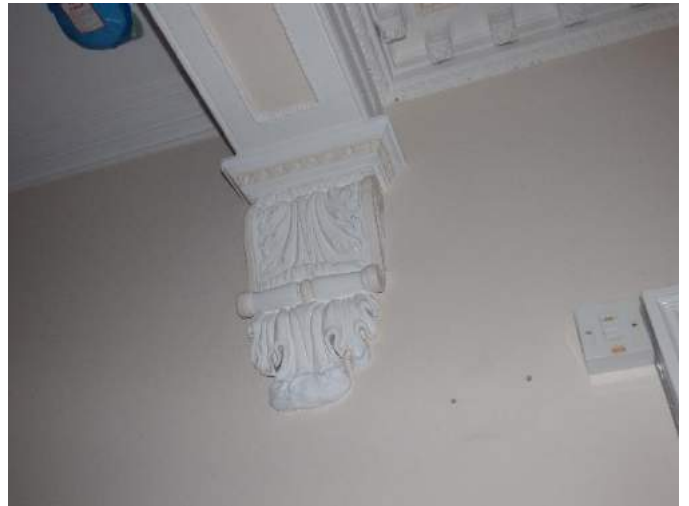
Period features are in extremely good condition and all are to be retained.

Ceiling to be repaired where existing light fittings are to be removed.

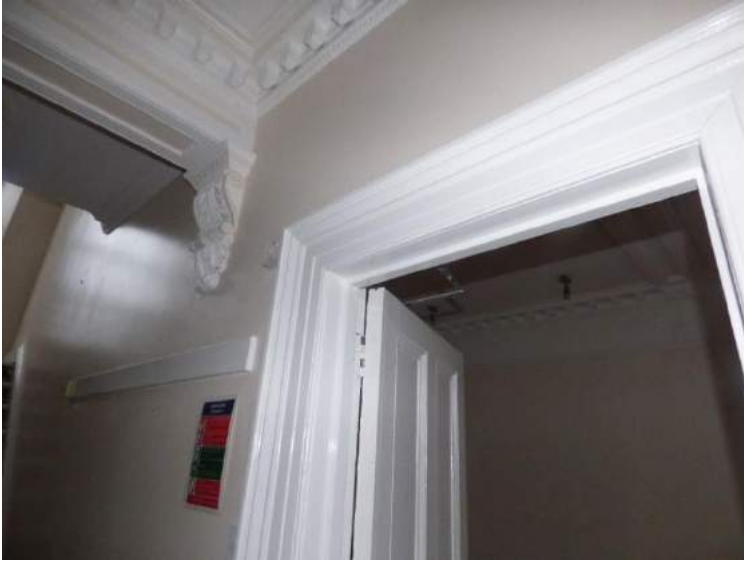
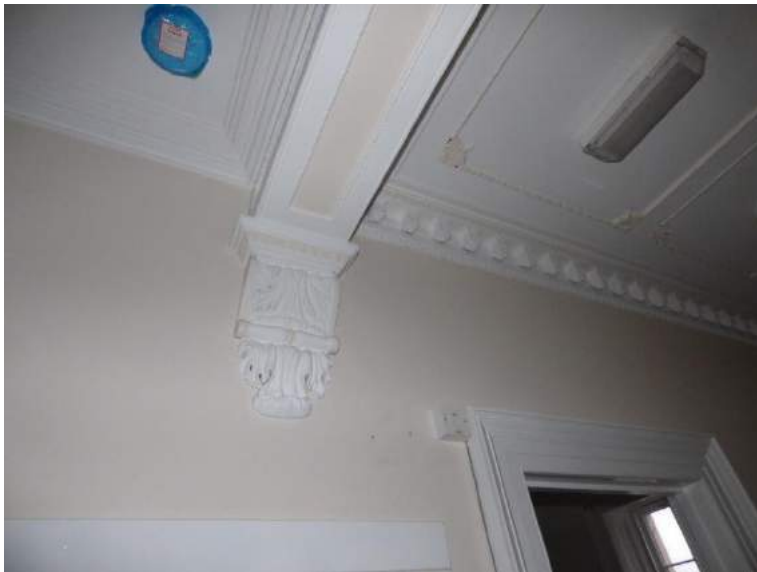
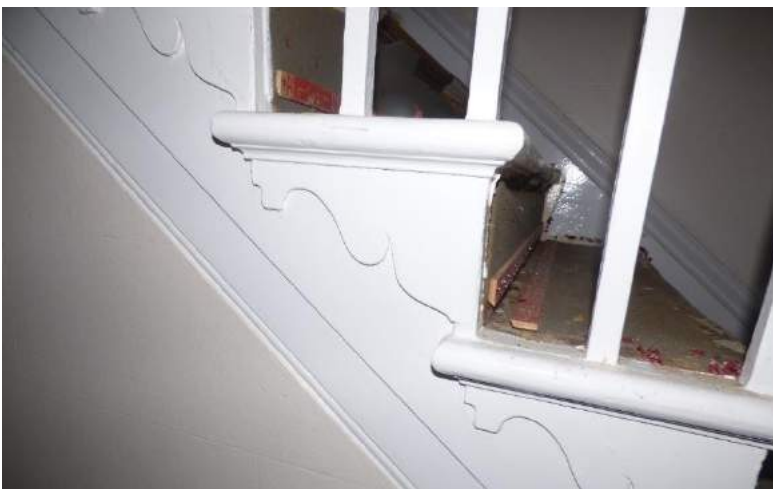
Left and below:
Joinery details to be retained.

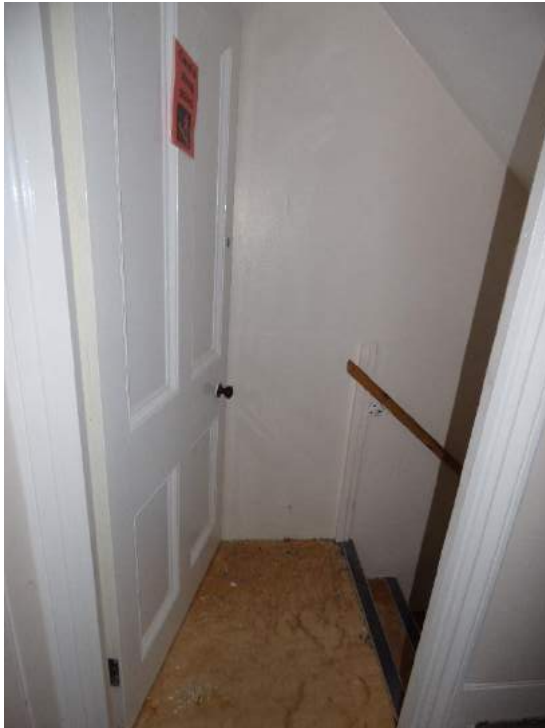
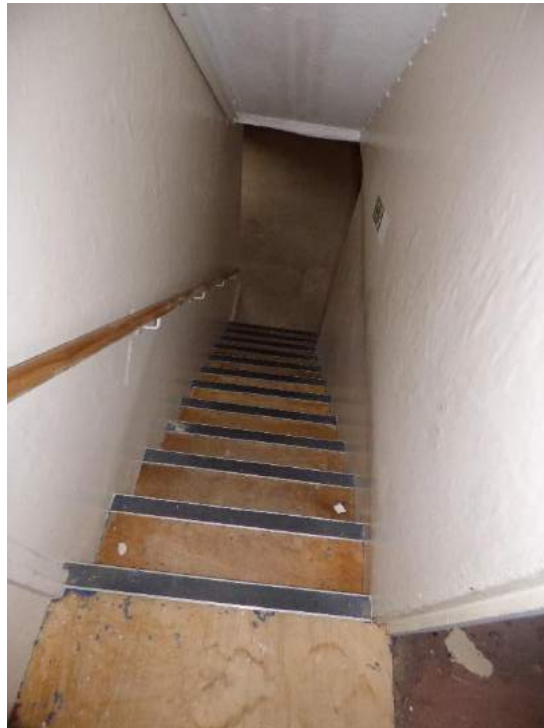
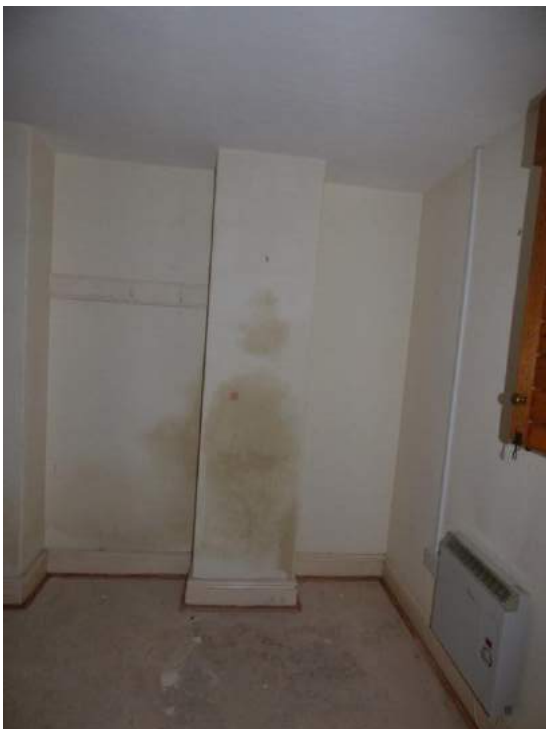
The existing basement. The existing walls and floor are generally in sound condition so would be suitable for the application of damp proof slurry system.

Some of the walls have been overboarded, but the basement has not been treated for damp and moisture is penetrating the walls that have been overboarded.

All existing paint and surface finishes must be removed and made good including all snots removed, and damage to existing surfaces, prior to the installation of a Kloster Polysil NB1. This migratory crystalline tanking slurry is used to seal below ground structures against water ingress.

Kloster NB1 is a breathable water proof system which will enhance the thermal value of the building without increasing the moisture content of the wall.

Koster NB1 is considered to be a Type A waterproofing system as defined by BS8102:2009 and is generally used to seal the inside face of basement structures, slabs and retaining walls.

Koster NB1 works by both providing a physical barrier against water ingress as well as providing a migratory crystal sealant that penetrates deep into the structure to seal micropores and cracks against water ingress.

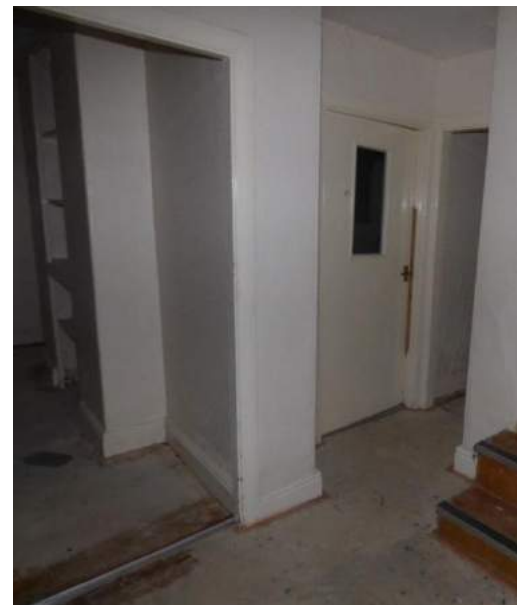
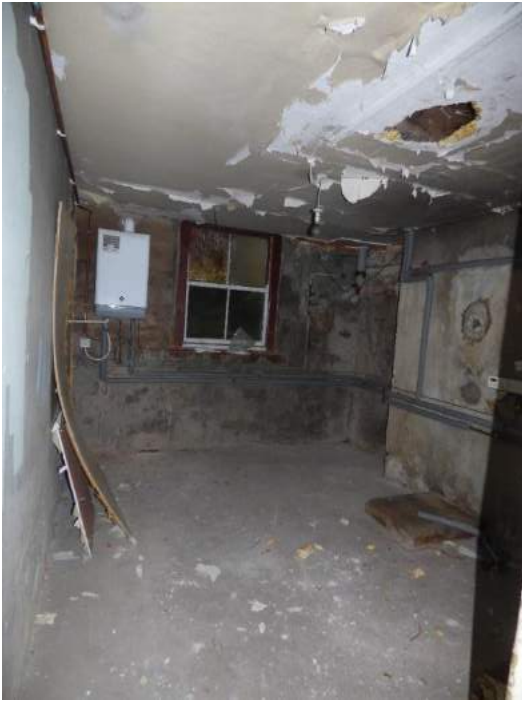
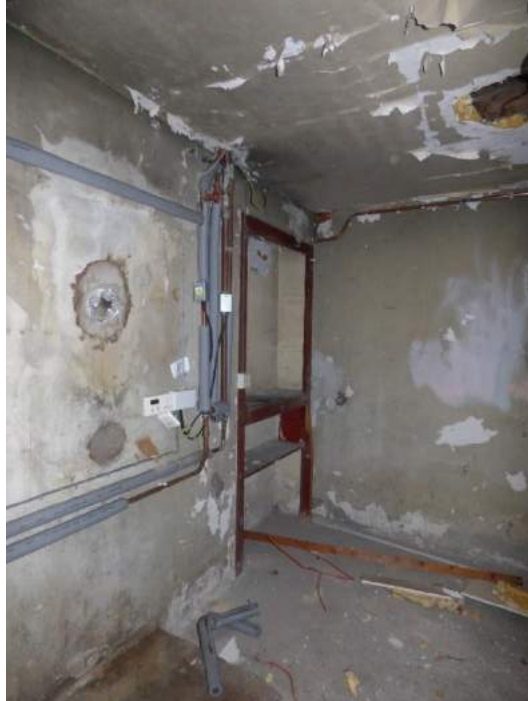
Damp affects the entire basement.

All redundant M&E, conduits and FF&E to be removed.

Ceiling to be repaired with fire resistant plasterboard.

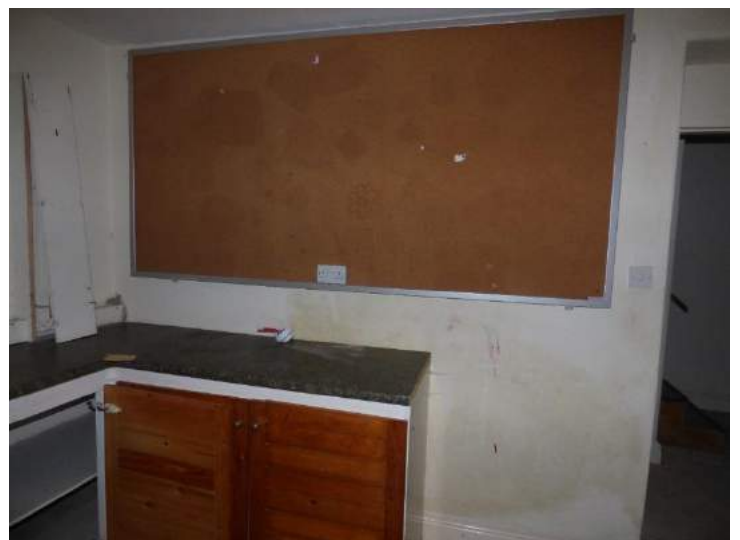
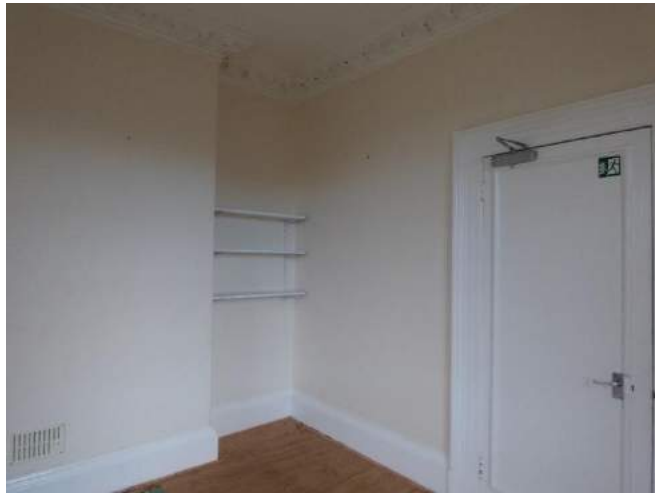
Existing front room requires minor damp treatment and walls to be made good following repairs.

Minor damp patch repair required to ceiling.

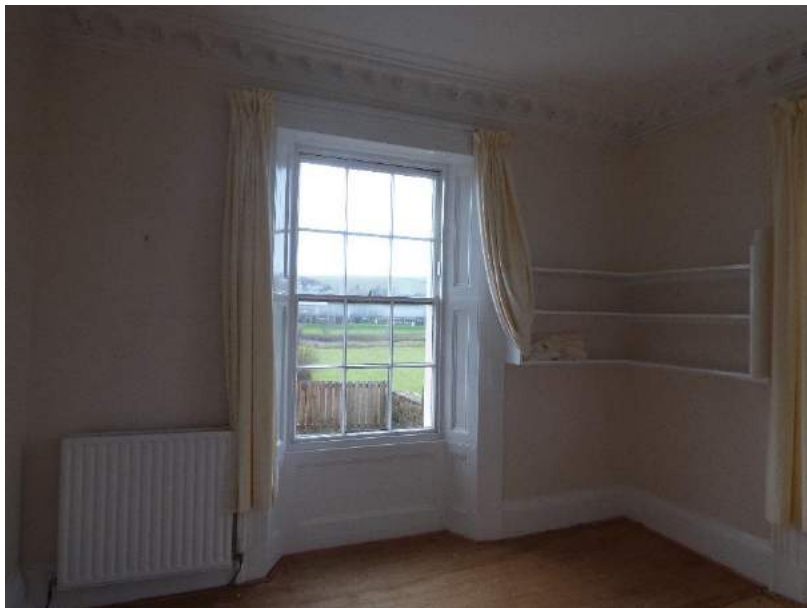
The period features below and to the sides of the existing window are in good condition, it is proposed to carefully refurbish the existing timber shutters.

Left: Existing cornice to be made good in locations where redundant services are to be removed and where hairline cracks have appeared.

Existing architraves and skirtings to be retained and made good.

Flush panel doors to be replaced with heritage style four panel painted timber fire doors to enhance the heritage asset.

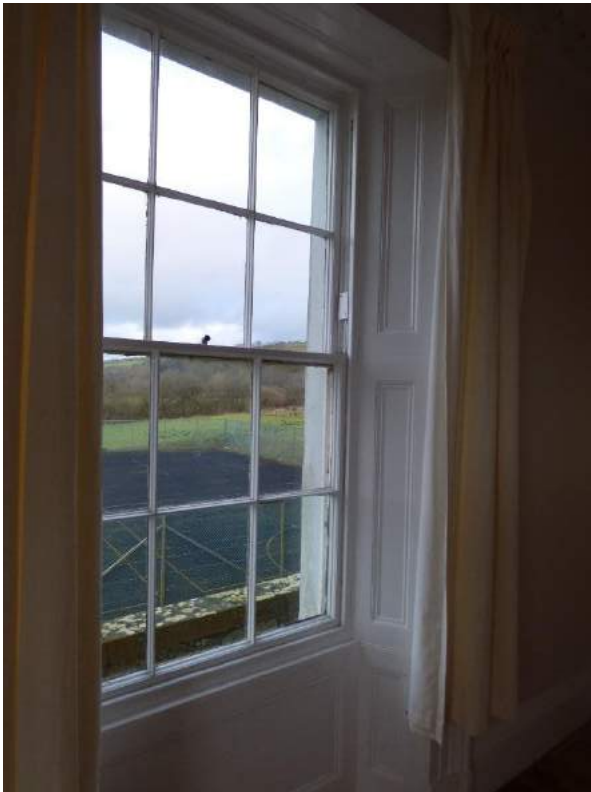
In the existing dining room at the rear of the property the period features below and to the sides of the existing window are in good condition, it is proposed to carefully refurbish the existing timber shutters.

Below: existing cornice to be made good in locations and where hairline cracks have appeared.

Existing architraves and skirtings to be retained and made good.
