HERITAGE STATEMENT

FULL RENOVATION OF EXISTING No 11 TERRACE HOUSES

St Bees, 1-11 Lonsdale Terrace, Parish Council, Cumbria

M.A.C Architects, Project Number: 2019:303

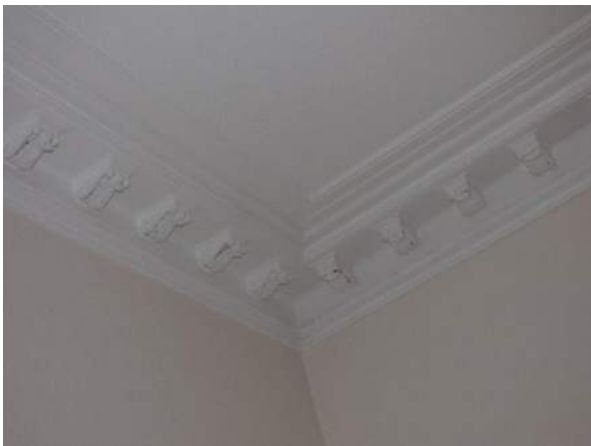
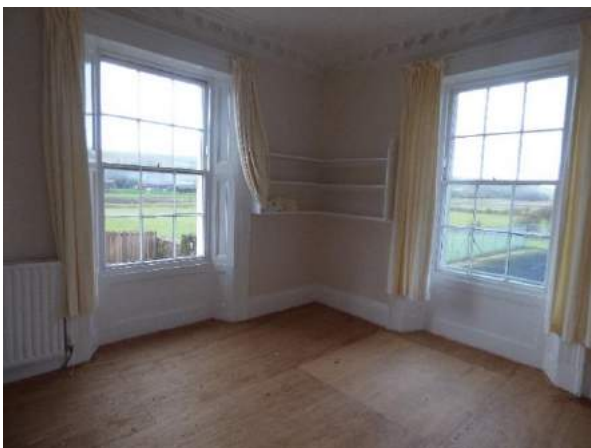
Above and below: In the existing through lounge, the period features below and to the sides of the existing windows both front and back are in good condition. It is proposed to carefully refurbish the existing timber shutters.

Existing cornice to be made good in locations where redundant services are to be removed and where hairline cracks have appeared.

The existing floor is not original and is plywood. It is proposed to lift the plywood boards and examine the existing joists to ensure that they are in good condition, and reinstate and repair as necessary.

Flush panel doors to be replaced with heritage style painted timber fire doors to enhance the heritage asset.

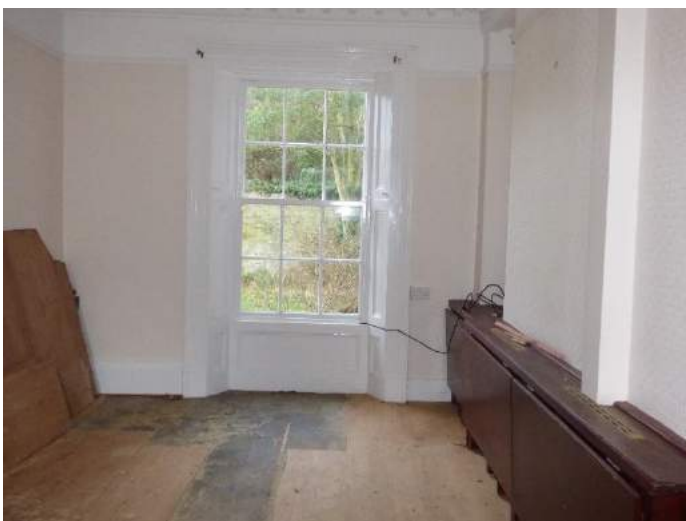
Existing cornice to be made good in locations where redundant services are to be removed and where hairline cracks have appeared.

Existing architraves and skirtings to be retained and made good.

Flush panel doors to be replaced with heritage style painted timber fire doors to enhance the heritage asset.

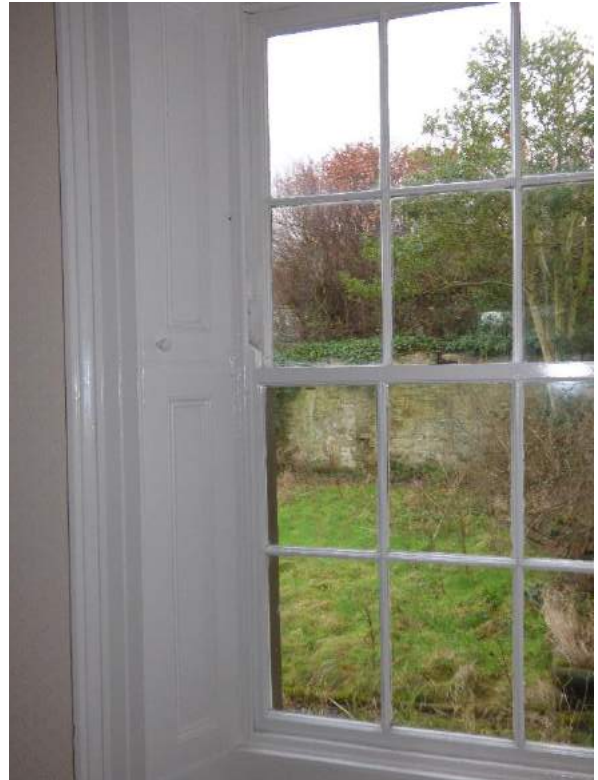
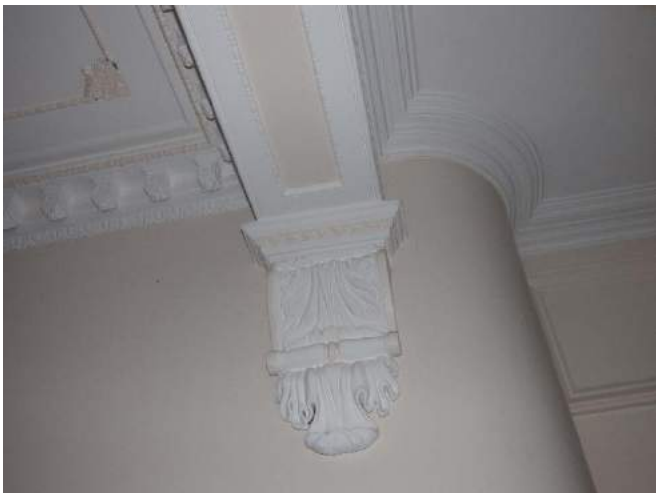
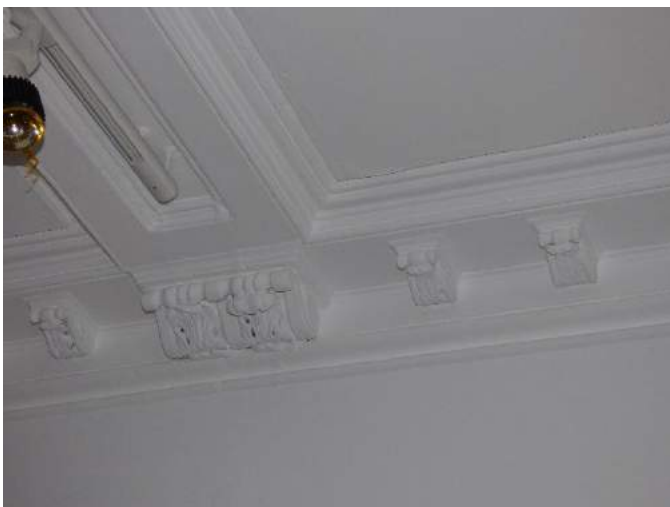
Above: Period features have remained in excellent condition and are to be retained.

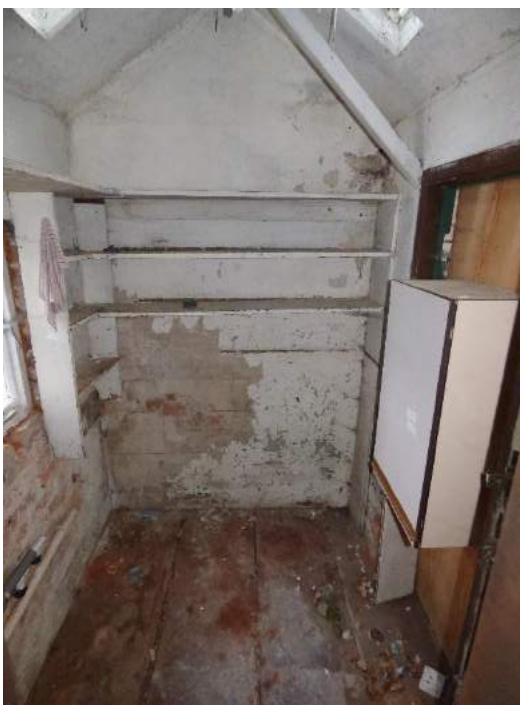
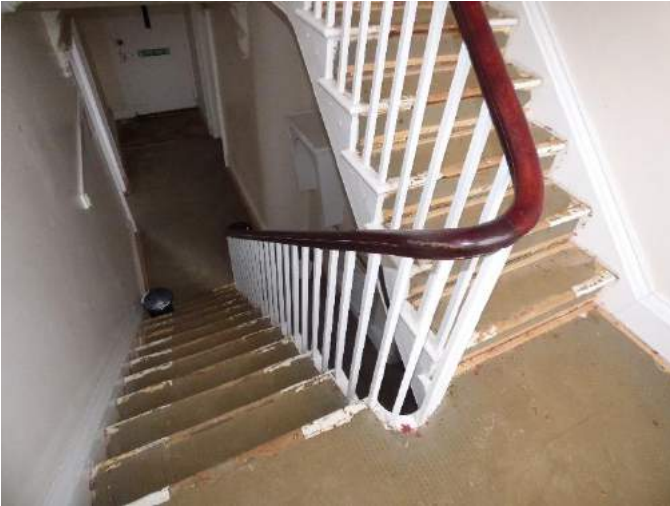
Retain the original staircase, which is in good condition.

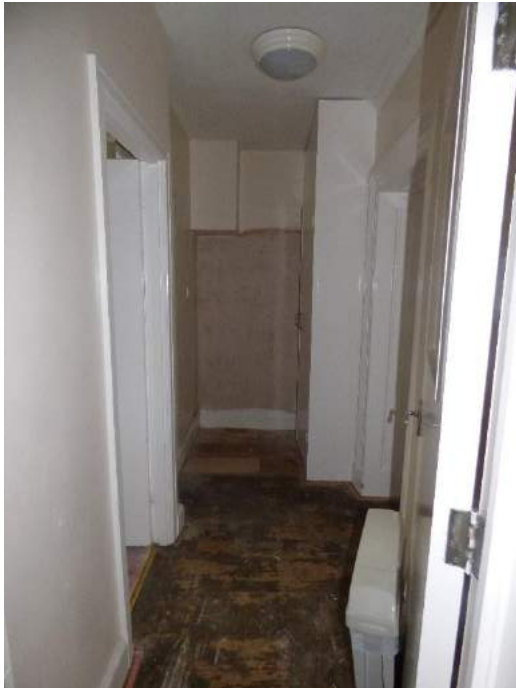
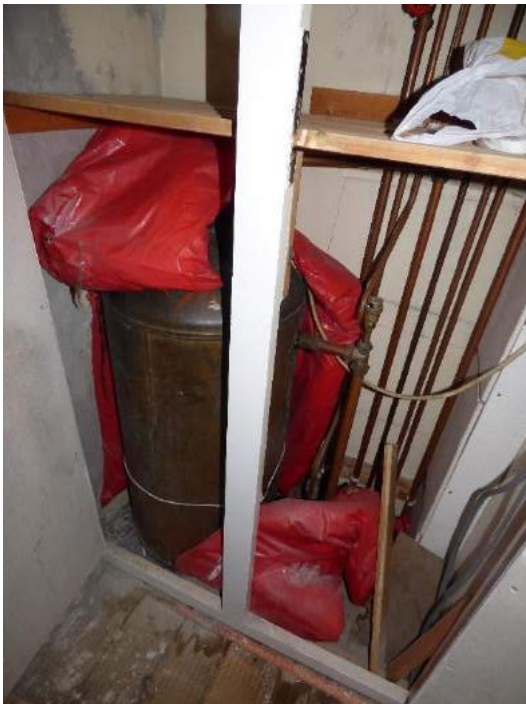
Existing bathroom area at first floor to be reconfigured, to make use as a house bathroom.

Ceiling to be made good following reconfiguration works.

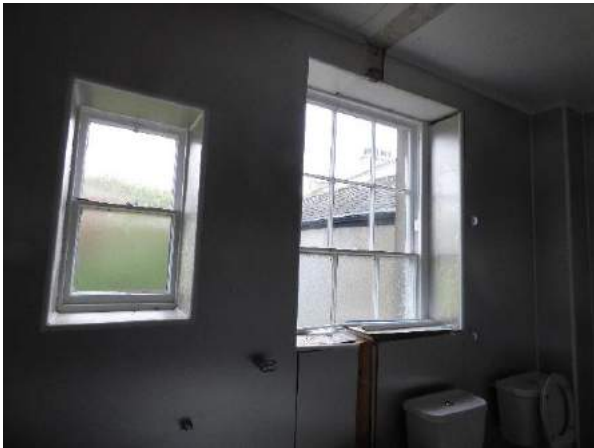
Existing bathroom to be made good and provide and install new extract fan linked back to light switch.

Glazing to be new heritage style Georgian double glazed sash windows to be provided with obscure glazing.

New bathroom door to be new four panelled door – bathroom door does not need to be fire rated door.

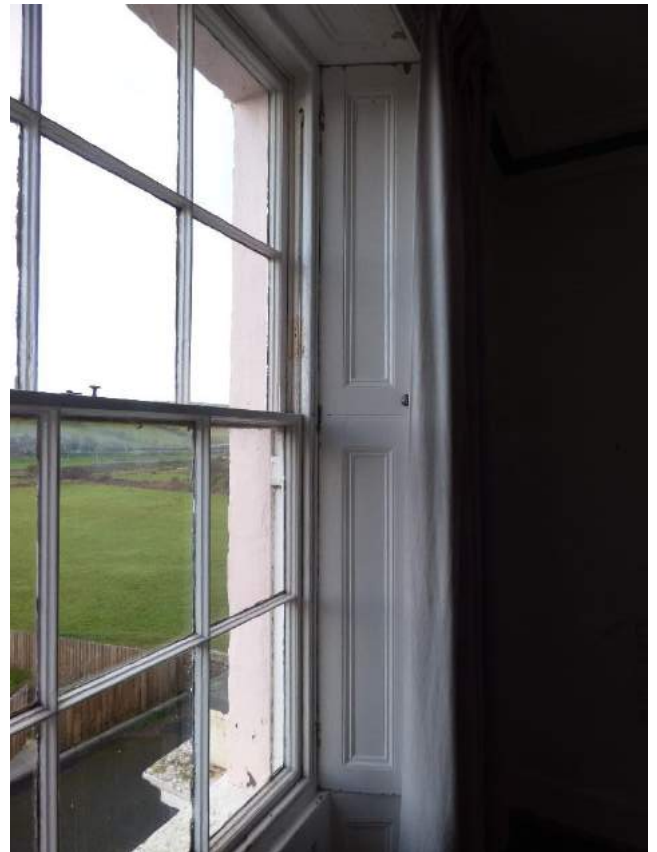
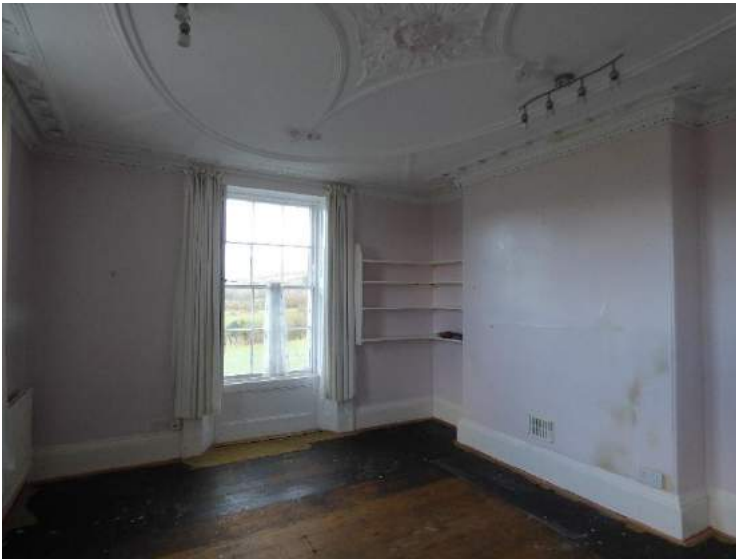
Front bedroom has stunning heritage features in excellent condition. Skirtings, cornices and architraves to be retained. Existing flush panelled door to be replaced with new Georgian heritage style four panel fire door to be provided and installed by specialist joinery company such as Batty Joinery Ltd.

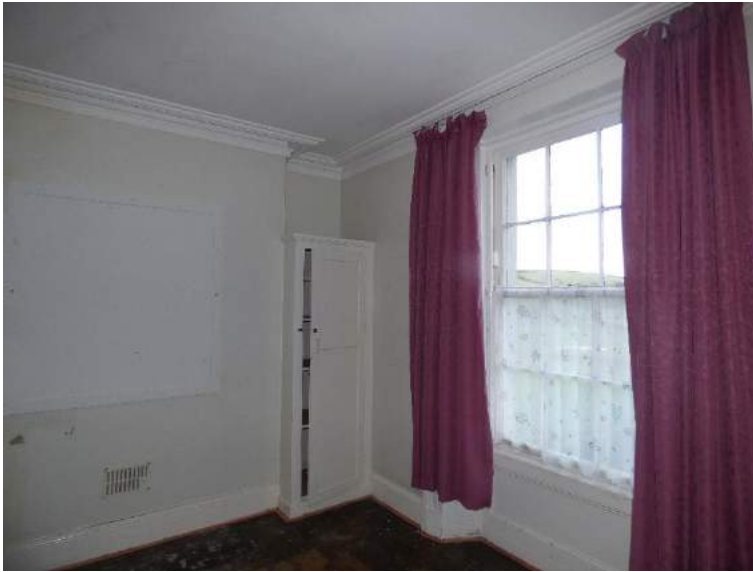
Front bedroom, skirtings, cornices and architraves to be retained. Existing flush panelled door to be replaced with new Georgian heritage style four panel door to provided and installed by specialist joinery company such as Batty Joinery Ltd.

Bedroom to become en-suite to master bedroom, so glazing to bathroom window to be obscure.

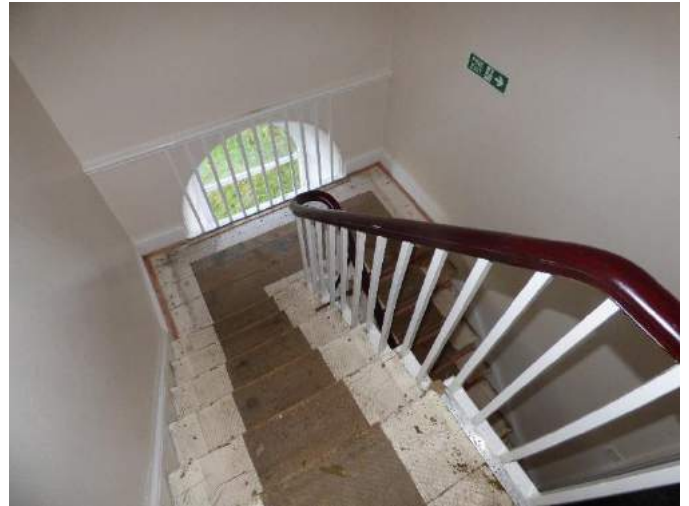
Handrail, balusters and rails are original and are to be retained.

Apply an insulated plasterboard 62mm thick to underside of sloping ceiling, tape and skim and undertake full decorations.

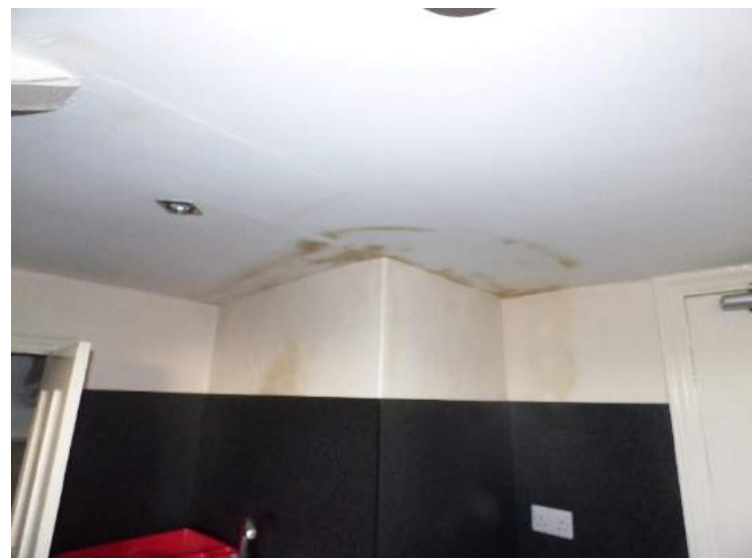
Existing flush panel fire doors to be replaced with four panel heritage style doors.

Apply an insulated plasterboard 62mm thick to underside of ceiling. The Laminated plasterboard and PIR has a vapour barrier incorporated so interstitial moisture would be prevented. New rooflights to be installed with flashing kit that mounts unit flush with the roof surface.
