Arboricultural Report
Hillcrest Avenue Jericho Plantation
Whitehaven
January 2025

1.2 The inspection commissioned to assess 3 No. semi mature Sycamore, *Acer pseudoplatanus*, and 1 No. semi mature Ash, *Fraxinus excelsior*, situated in an amenity woodland known as Jericho Plantation to the rear, east, of residential properties at Hillcrest Avenue, Whitehaven. CA28 6ST. The inspection being undertaken from ground level with no exploratory excavation works undertaken.

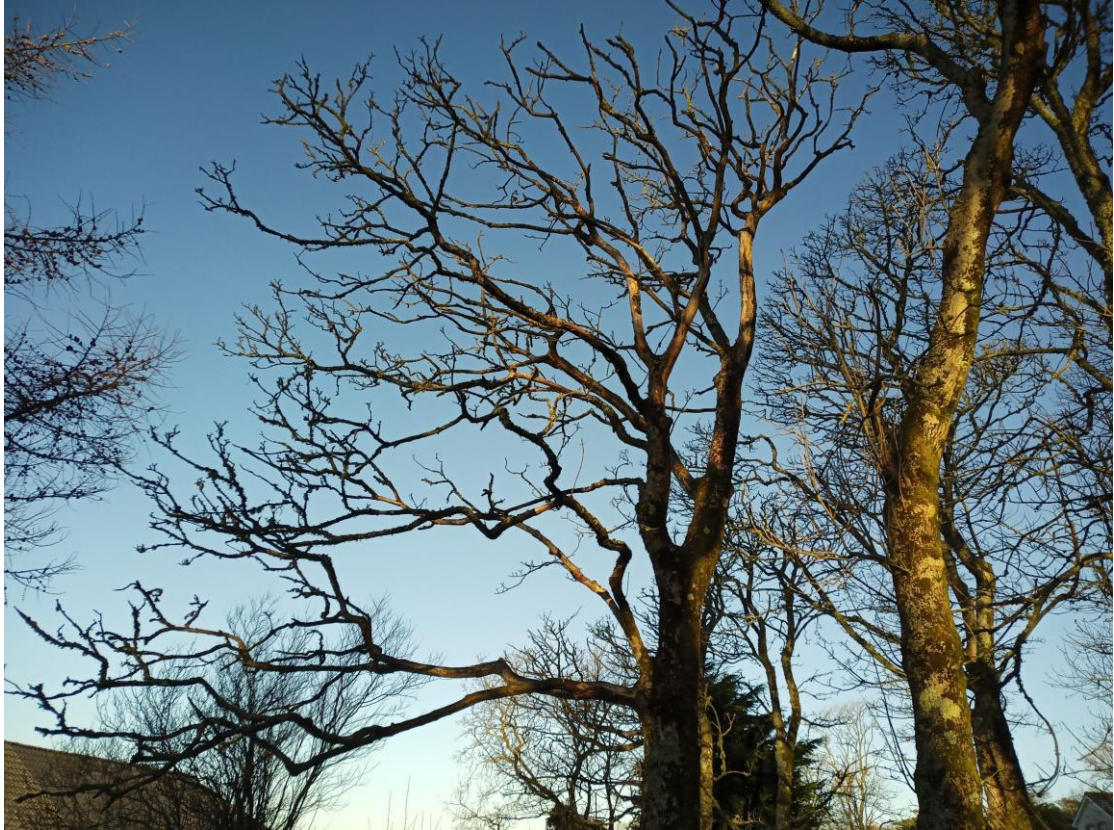
3.3 Brittle Cinder often establishes on tree specimens following damage / wounding to the stem and or rooting system and is particularly associated with Sycamore, *Acer pseudoplatanus*.

3.4 Generally regarded as a Soft Rot. Brittle Cinder degrades both lignin and cellulose. Lignin being the main cell structure associated with tree rigidity providing structure, support, and acts as a barrier to insects and pathogens. Cellulose is also a cell structure associated with tree and plant strength and rigidity.

3.5 The presence of Brittle Cinder is an indicator that the structural integrity of the infected tree specimen has been compromised. Fell is therefore recommended.

T4. Base of specimen with evidence of Brittle Cinder.
