Bat Survey

Former Natwest Bank, St George's Road, Millom

18th July 2024

Report No. 0724/4

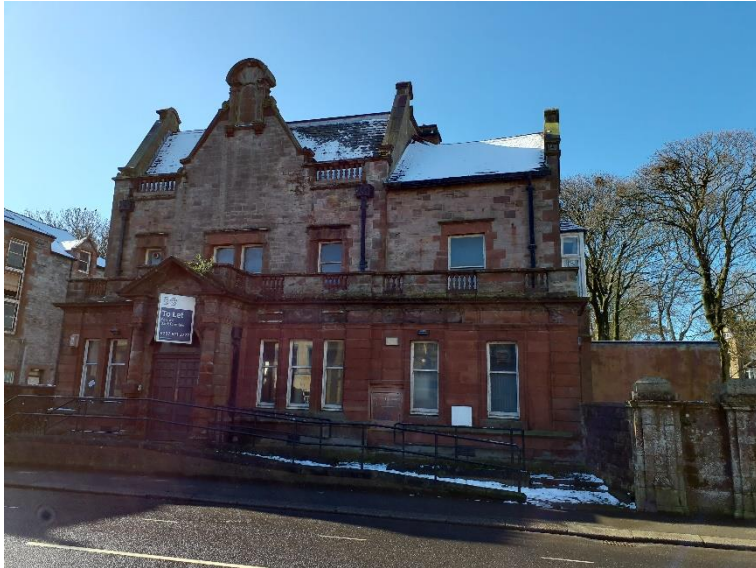
Image 1. Front (East) elevation of property.

Note the steep pitch of the upper roof on this elevation.

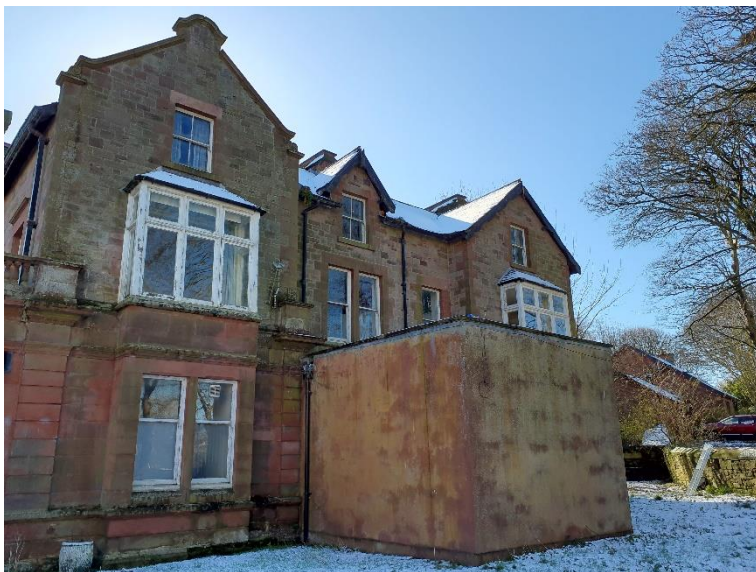
Image 2. Side (north) elevation of the property, showing extension on ground floor to house the safe.

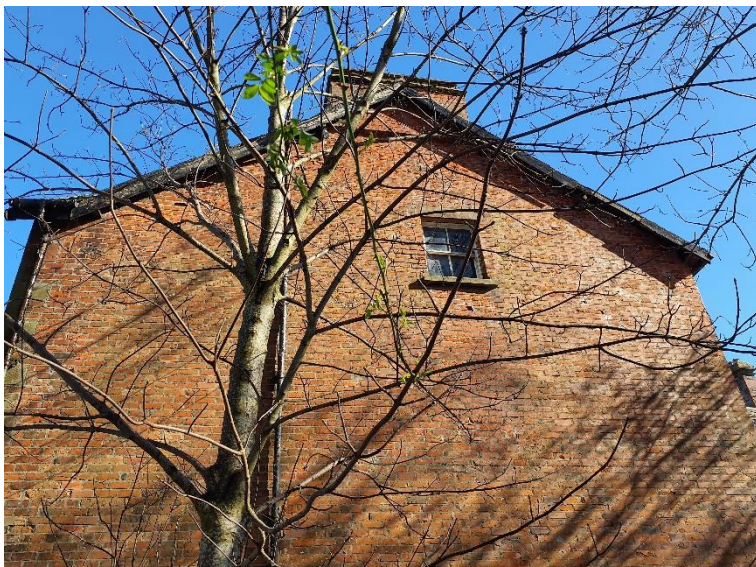
Image 3. Rear (west) elevation. No render over the brickwork.

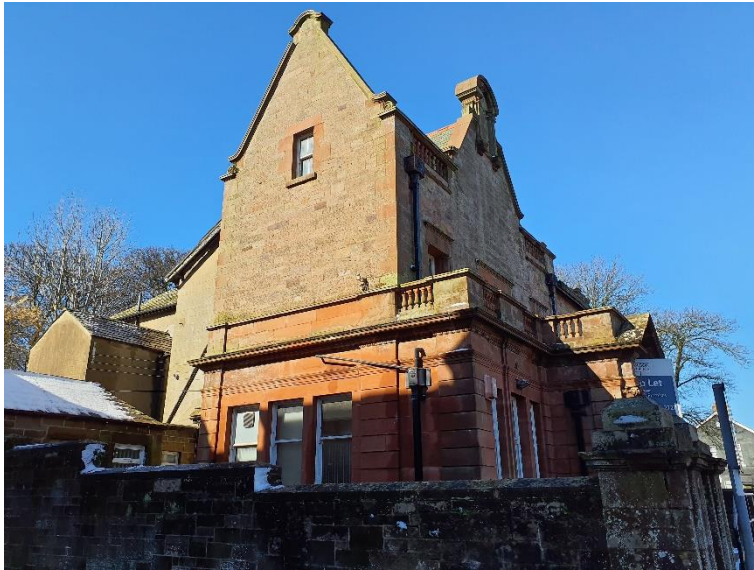
Image 4.
Side (south)
elevation, showing
the decorative
gables, and the
rendered walls
towards the rear of
the building.

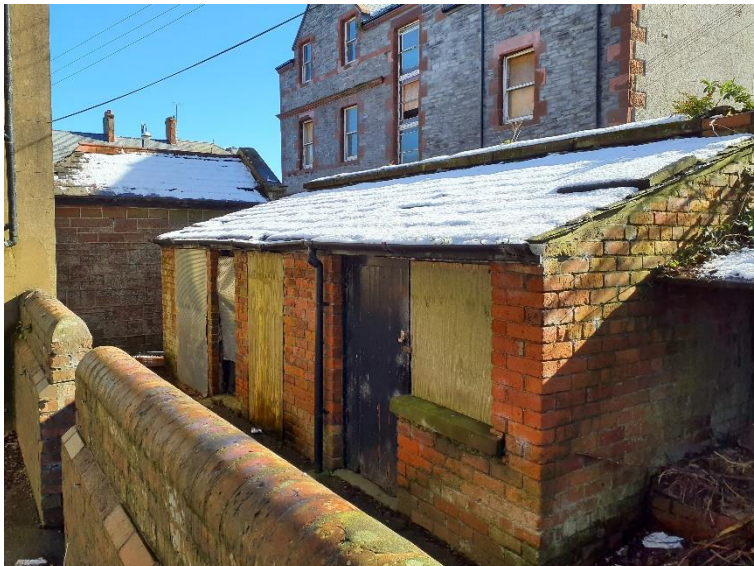
Image 5.
Two outbuildings
on the south
elevation.
Detached lean-to
against the
boundary wall in
foreground, and
stone building to
rear of image (male
toilets).

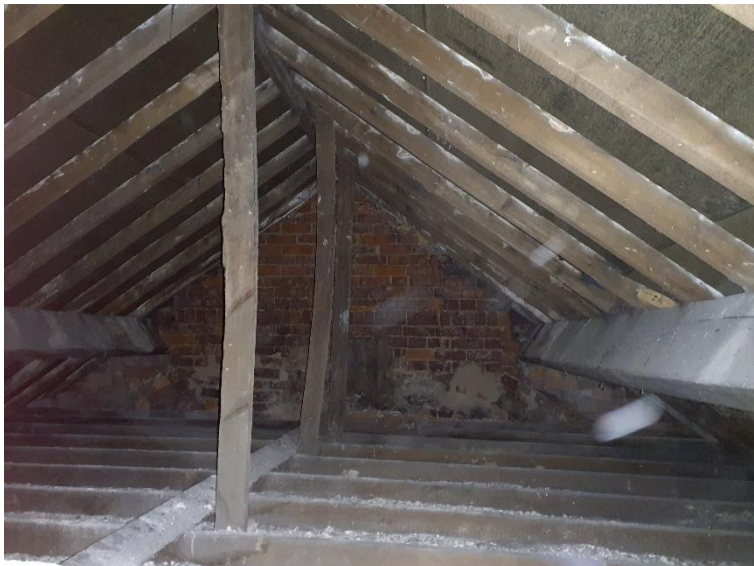
Image 11.
Interior of roof void at the rear of the building (looking west).
Empty void – no insulation or stored materials.

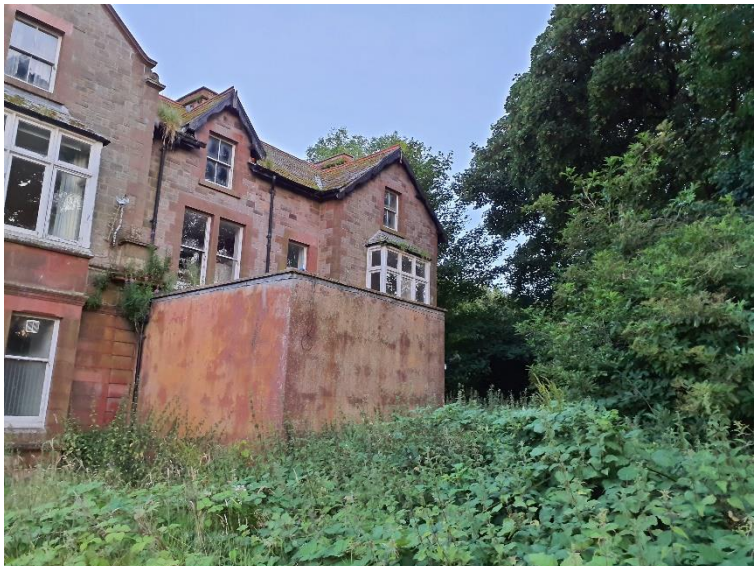
Image 14.
Image taken 16/7/24.
Showing the density of the mature trees alongside the building – which were well used by feeding bats.

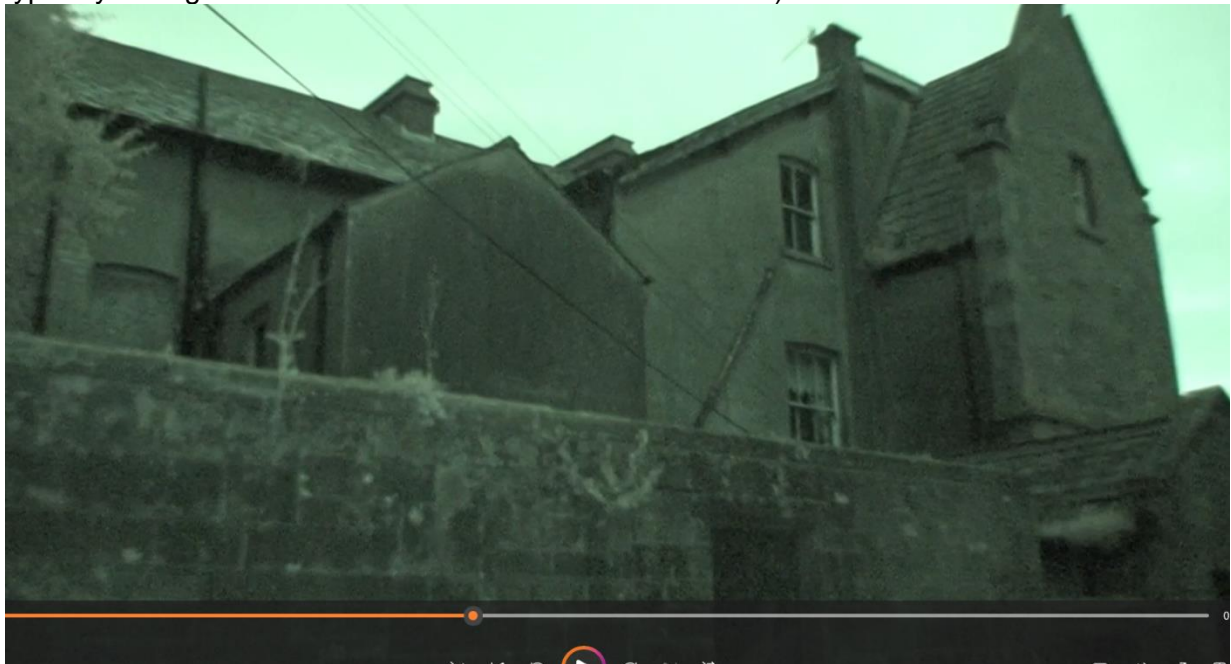
Image 17. View of the northern dormer with significant gaps around as seen through the thermal imager on both of the surveys.
