Ref: ENQ768104

SURVEY REPORT

PROPERTY ADDRESS
Old Whittles Building, 6 Duke Street
Whitehaven
Cumbria
CA28 7ER

Dampness to the walls
Fungal decay

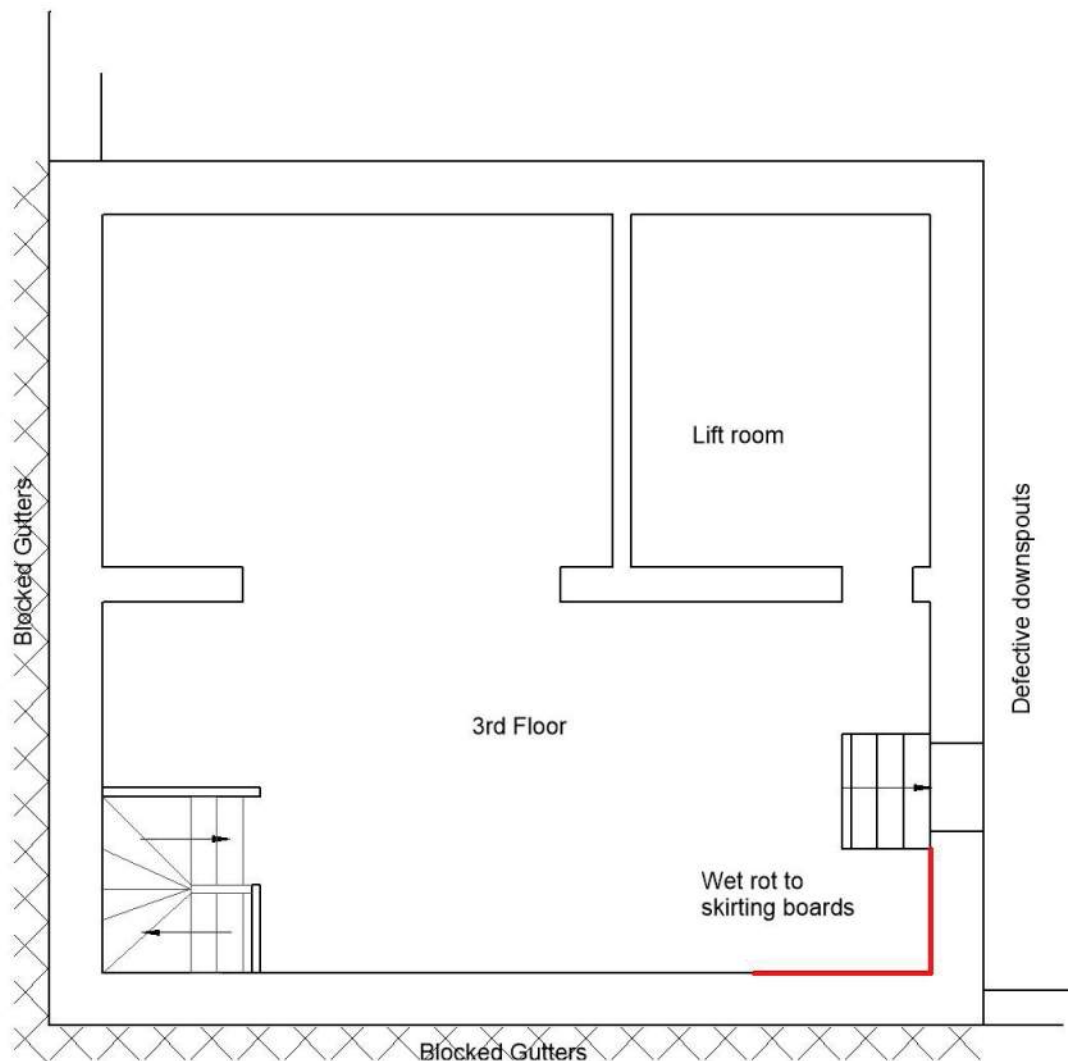
Decay by the wet rot fungus (*Coniophora puteanea*) is evident to the floor/ceiling joist, full length of the room, to the front elevation as same as the floor above.

The decay is most prominent to the front left hand corner and left hand section of the room.

Replacement joist ends will be bolted and connected to the remaining sections.

Bolt and connect repairs to front bearing ends
