# MINOR PLANNING AMENDMENTS TO APPROVED CONSENT

APPLICATION REF: 4/21/2242/0L1

# **FULL RENOVATION OF EXISTING No 11 TERRACE HOUSES**

St Bees, 1-11 Lonsdale Terrace, Parish Council, Cumbria

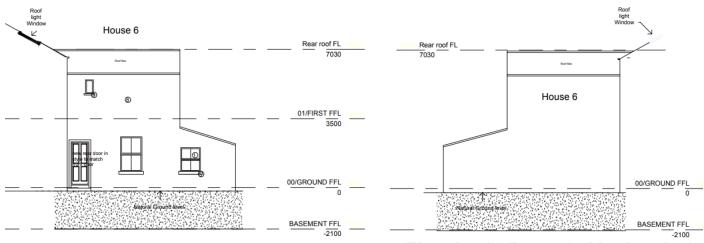
Elevation 6 (house 6 side elevation)

The roof is covered with a modern cement tile with a dry verge detail.

The current roof pitch is 15 degrees.

The proposal is to replace the rotten joists with new joists as recommended by the structural engineer as 45 x 95 C16 GR multi rafters.

The proposal is then to replace the roof itself as the detail attached, with a roof tile that is warrantied at 15 degrees. The proposal is then to apply a traditional wet verge.

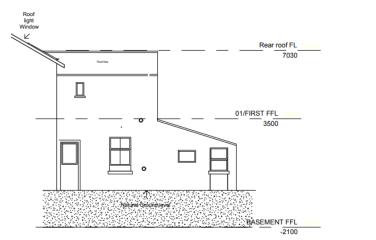
**Elevation 7 (house 7 side elevation)**

From the rear of house, no 7, a natural slate roof is the finish, however at 20 degrees – the absolute MINIMUM roof pitch, a slate roof is feasible, however the construction of this slate roof is not inaccordance with the Building Regulations as the British Standards Ref: BS 5534:2014 which require slates to be a min size of 500 x 225 with a 135mm head lap, hence why the roof is leaking and again the joists suffering considerable damage.

For the reasons outlined above the proposal is then to replace the roof itself as the detail attached with a roof tile that is warrantied at 20 degrees. The proposal is then to apply a traditional wet verge.

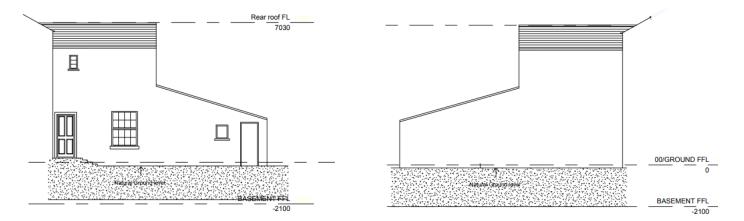
**Elevation 9 (House 9 side elevation)**

Now that they have been exposed, it is clear that the original joists have been replaced in most of the roof, unfortunately with new joists that are completely inadequate for the loads involved, and will require replacement with suitable sized joists.

It is also noted that this roof comprises a modern cement tile that is to be replaced with slate, so as to be consistent with the other rear extensions.

The pitch to this roof is also only 17 degrees, the low pitch not only been unsuitable for purpose but also a direct contributor to the damage identified. As this is a later extension, it is proposed to raise the pitch to the minimum required level, to prevent further issues. The change would not, however, be readily apparent, if at all.

For the reasons outlined above the proposal is then to replace the roof itself as the detail attached, with a roof tile that is warrantied at 20 degrees. The proposal is then to apply a traditional wet verge.

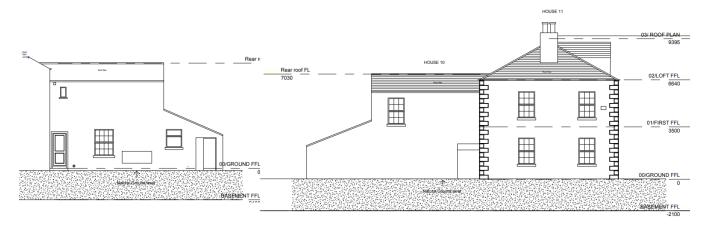
Elevation 10 (House 10 side elevation)

From the rear of house, no 10, a natural slate roof is the finish, however at 20 degrees – the absolute MINIMUM roof pitch, a slate roof is feasible, however the construction of this slate roof is not inaccordance with the Building Regulations as the British Standards Ref: BS 5534:2014 which require slates to be a min size of 500 x 225 with a 135mm head lap, hence why the roof is leaking and again the joists suffering considerable damage.

As identified previously, not only does the roof not conform with Building Regulations, but this has led to the issues identified, and the works required. In order to prevent them from reoccurring in the future, the proposal is to replace the roof itself as per our detail attached, with a roof tile that is warrantied at 20 degrees. The proposal is then to apply a traditional wet verge.

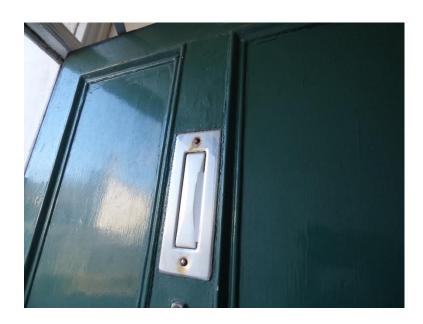
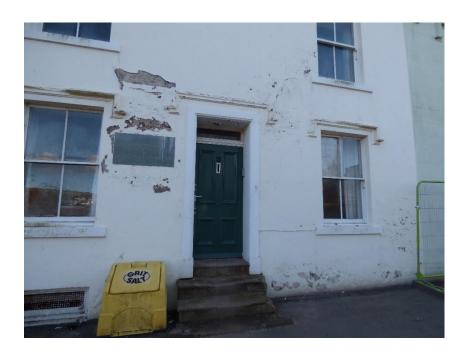
Like House no 2 - The letterbox to house no 3 is a completely impractical later addition. The proposal is to retain the position but lengthen and replace with heritage metal work.

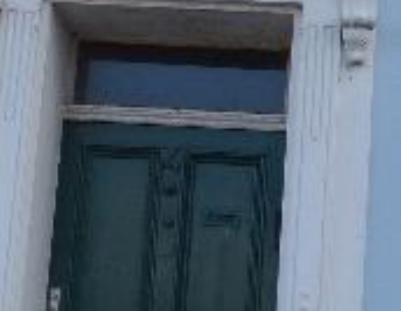
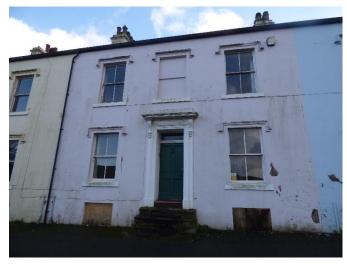
There is no letterbox to house no 5 – so a letterbox is required to be installed. The proposal is to restore the door to its previous condition and locate a new letterbox

in the mid rail as house no 1

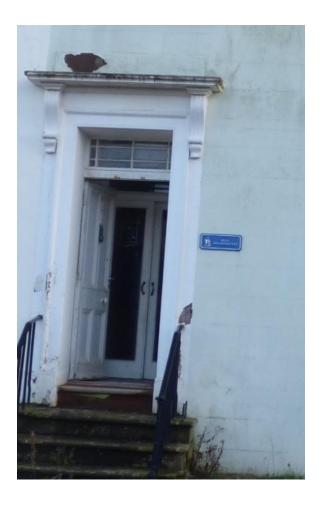
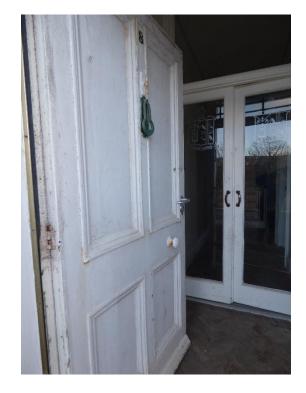
Like Houses no 2 and 3 - The letterbox to house no 9 is completely impractical as the aperture is too small for post. The proposal is to retain the position but replace the letterbox.

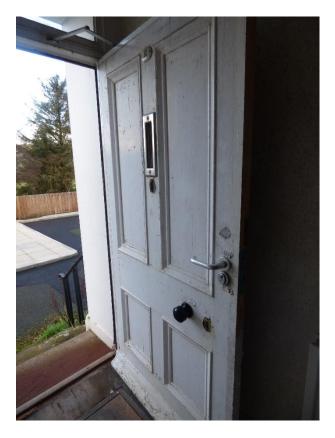
The existing letterbox is incredibly small – so while it is proposed to retain the Letterbox in its existing position – it is proposed to increase the aperture and a new letterbox to be provided to match the other houses in the street.

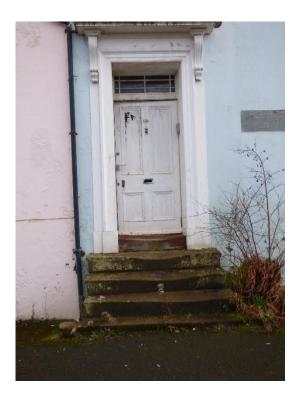
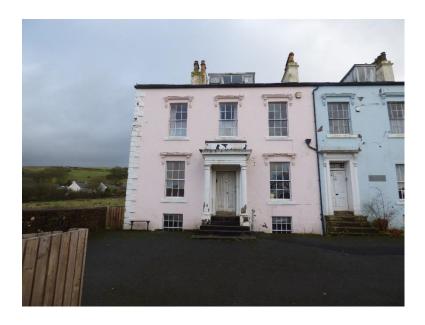
Like Houses no 2, 3 and 9 - The letterbox to house no 11 is completely impractical as the aperture is too small for post. The proposal is to retain the position but replace the letterbox.

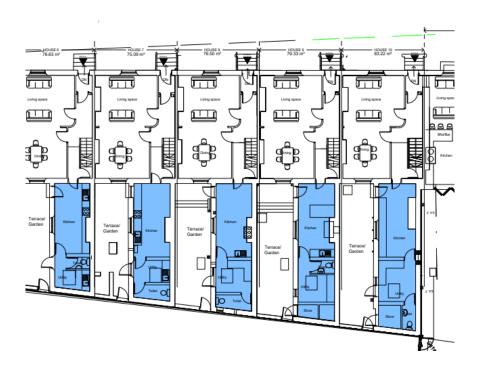
Once the existing tiled floor finishes were removed from the ground floor out rigger buildings, for properties 6,7, 8, 9 and 10 it was established that the floors were not only incredibly uneven but (following some very discrete investigation) only comprised 60mm of weak concrete laid on loose earth. Given that the extensions and concrete represent later additions, sensitive works to ensure their longevity are proposed below.

The approved layout plans with areas affected by the weak floor structure highlighted in blue.

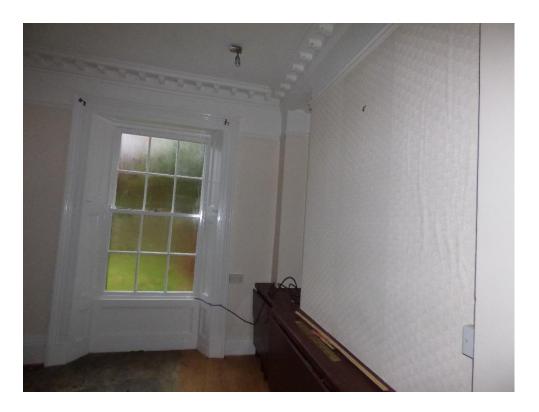
The existing window to no 11 which was originally granted consent to remove and replace with new bifold doors.

Permission was originally granted for new bi-fold doors to the rear of no 11, by replacing the original window and widening the opening, to create a new access to the garden at the rear. It is now proposed to retain the existing opening and introduce a pair of French doors instead. By doing this we retain more of the original historic fabric and more of the character of the property.
