**CCTV Inspection Report**

**FOUL AND SURFACE WATER OUTFALLS FROM SITE COMPOUND  
WEST CUMBERLAND HOSPITAL  
HOMWOOD ROAD  
WHITEHAVEN**

**11/02/2022**

**Job Number: SK-S 160/21 WCH GRAHAMS (updated 11/02/2022)**

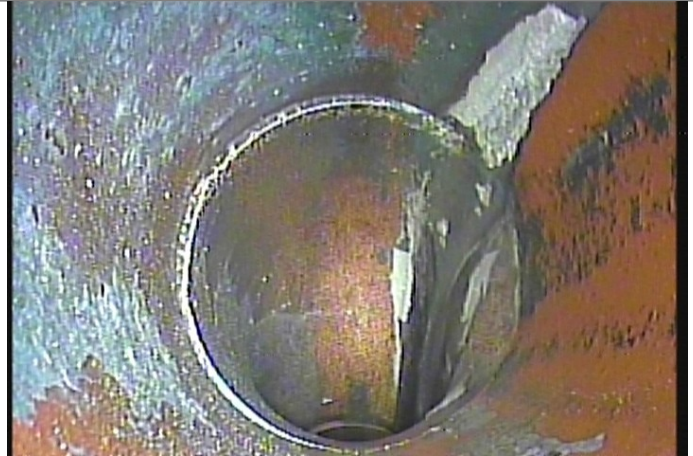
**Access problems:** MH06 U/S MH05 LIMITED ACCESS FOR CCTV

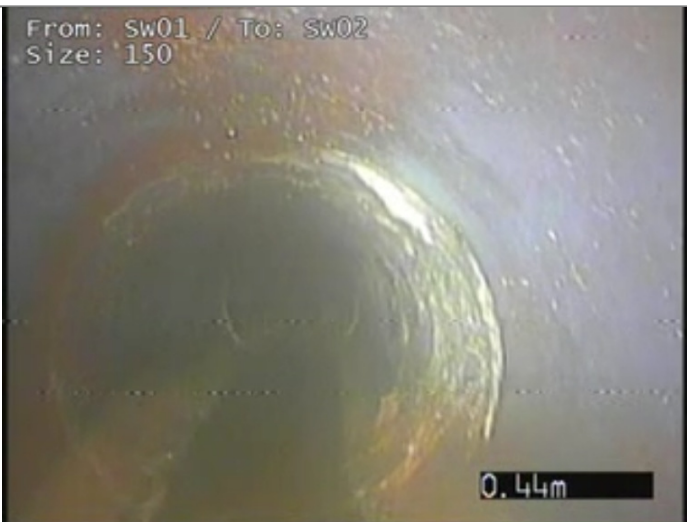
Attached deposits, encrustation from 10 to 5 o'clock 5% cross-sectional area loss, Start

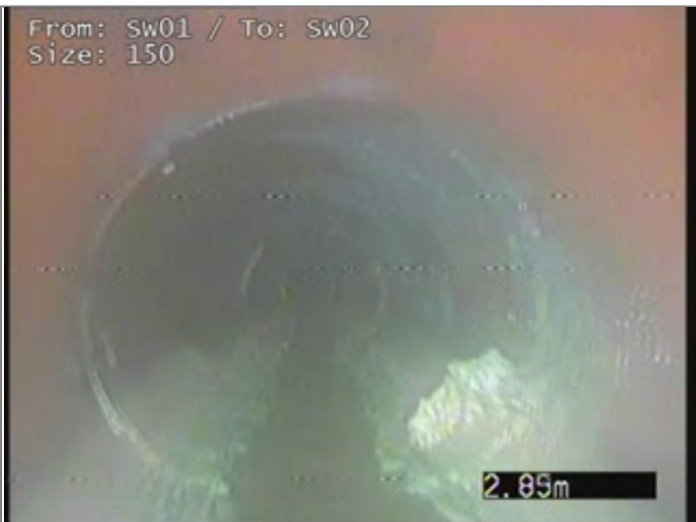
Attached deposits, encrustation at 5 o'clock 5% cross-sectional area loss at joint

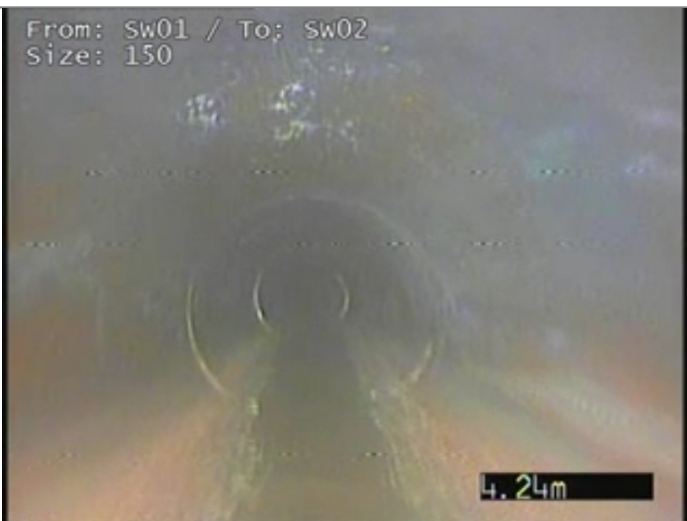
Attached deposits, encrustation from 10 to 5 o'clock 5% cross-sectional area loss, Finished

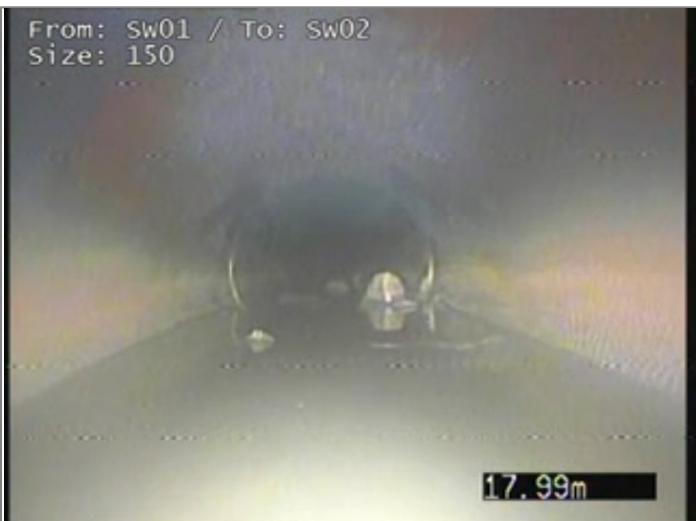
Settled deposits coarse 50% cross-sectional area loss, Start

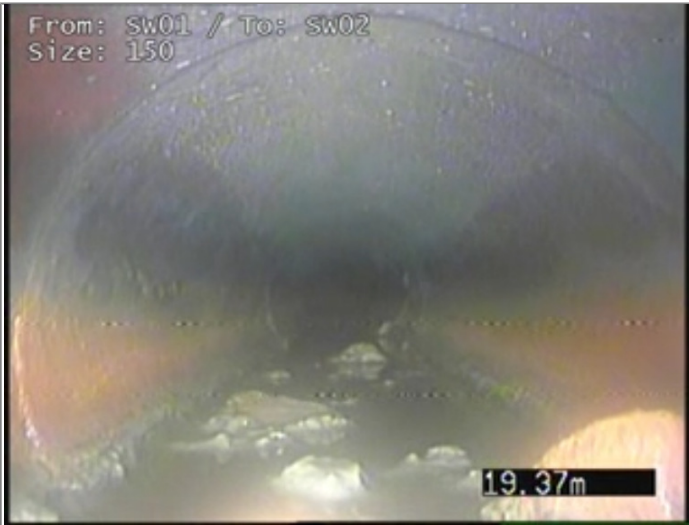
Settled deposits coarse 50% cross-sectional area loss, Finished

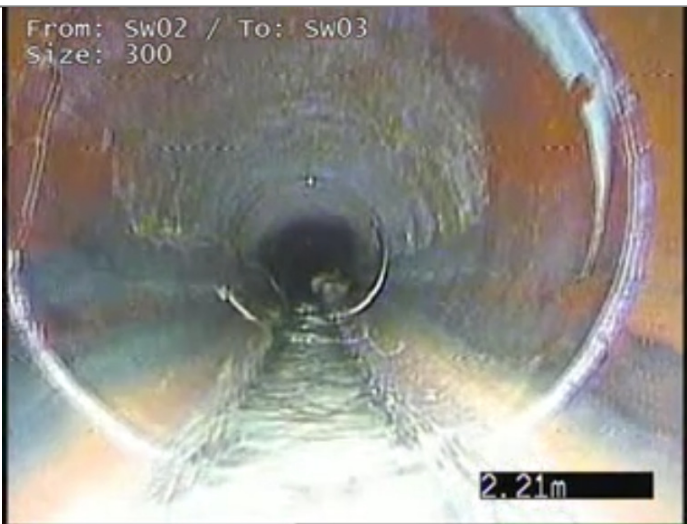
Crack circumferential from 9 to 11 o'clock at joint

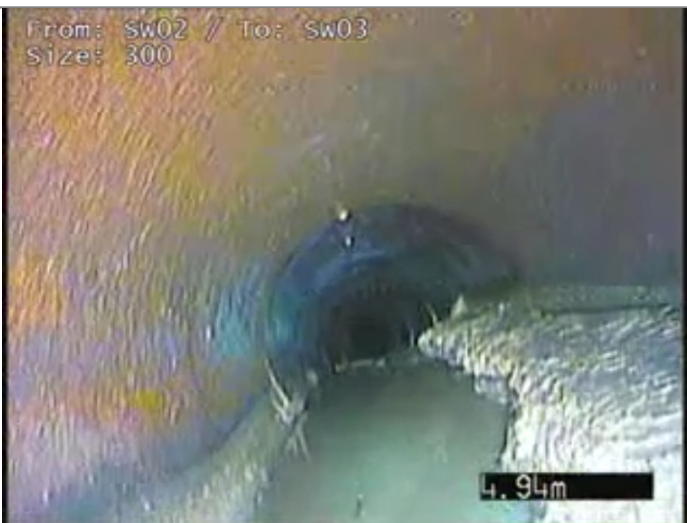
Attached deposits, encrustation from 4 to 6 o'clock 10% cross-sectional area loss, Finished

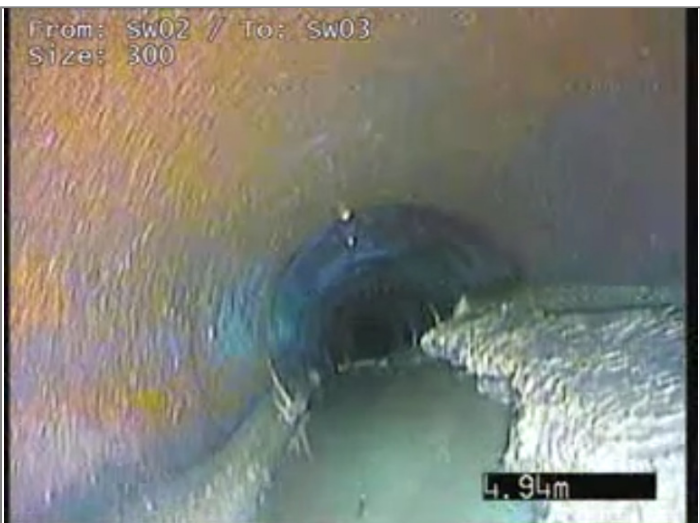
Attached deposits, encrustation from 3 to 6 o'clock 25% cross-sectional area loss, Start

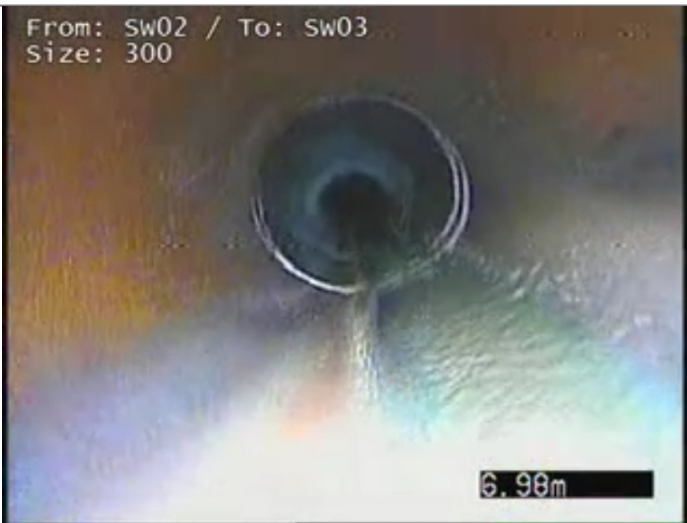
Attached deposits, encrustation from 3 to 6 o'clock 25% cross-sectional area loss, Finished

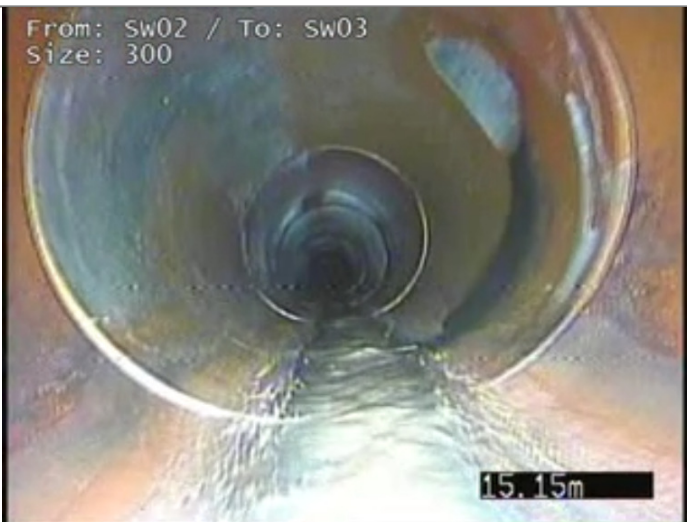
Crack circumferential from 1 to 3 o'clock at joint

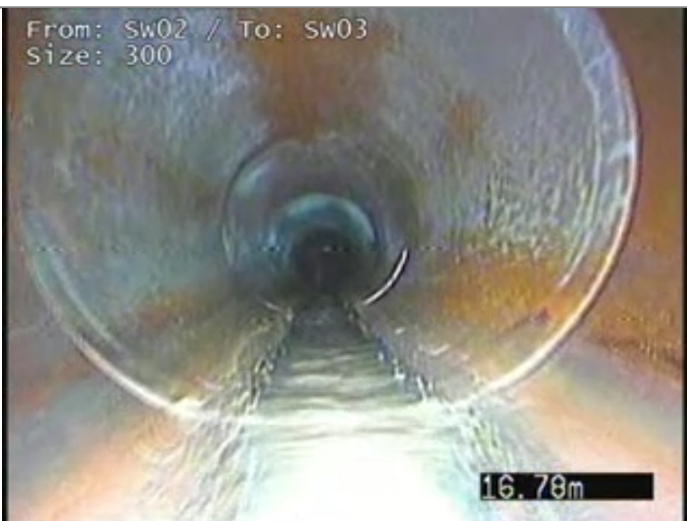
Crack circumferential from 1 to 4 o'clock at joint

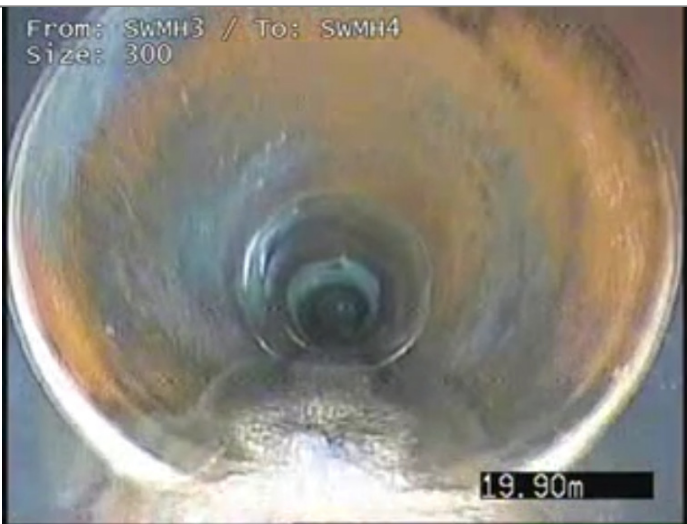
Crack circumferential from 2 to 5 o'clock at joint

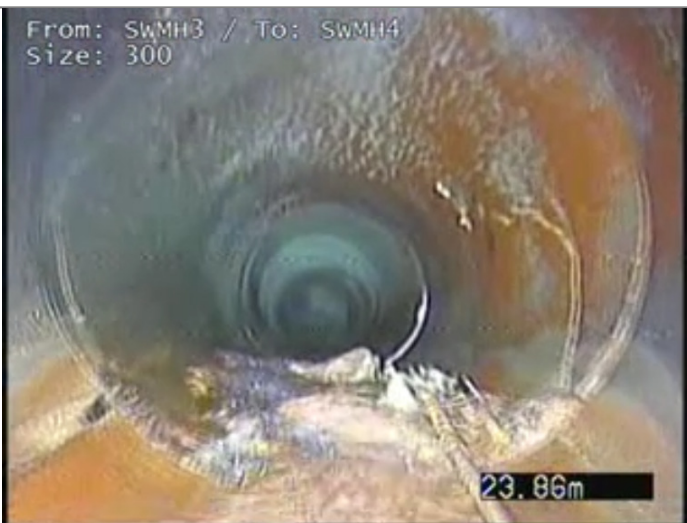
Roots mass 25% cross-sectional area loss at joint

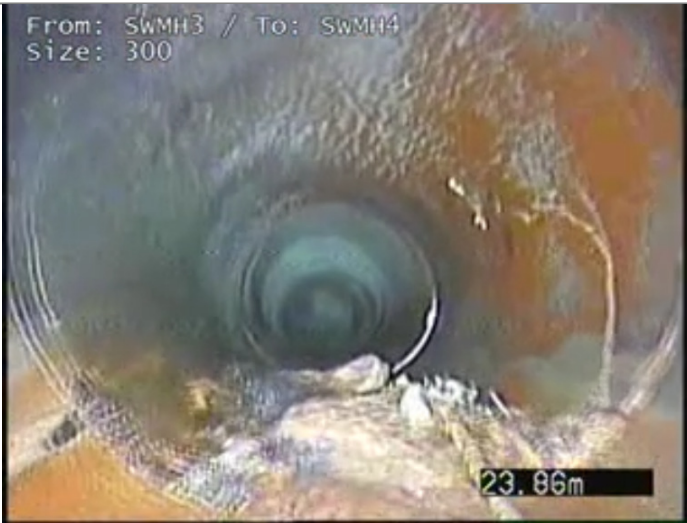
Crack circumferential from 8 to 10 o'clock at joint

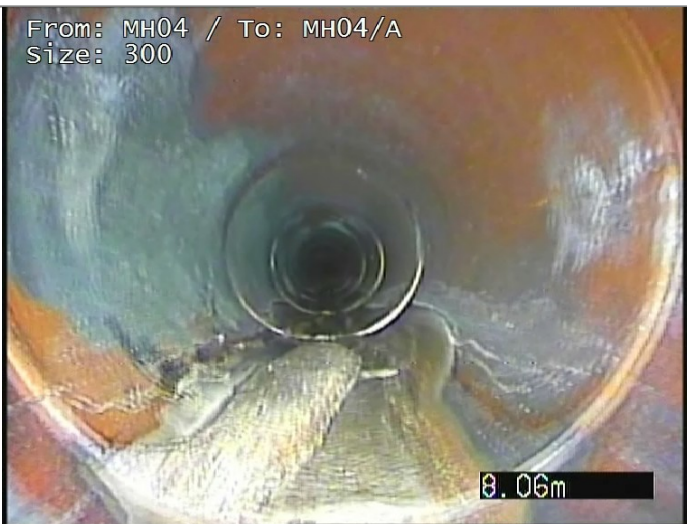
Attached deposits, encrustation at 7 o'clock 5% cross-sectional area loss

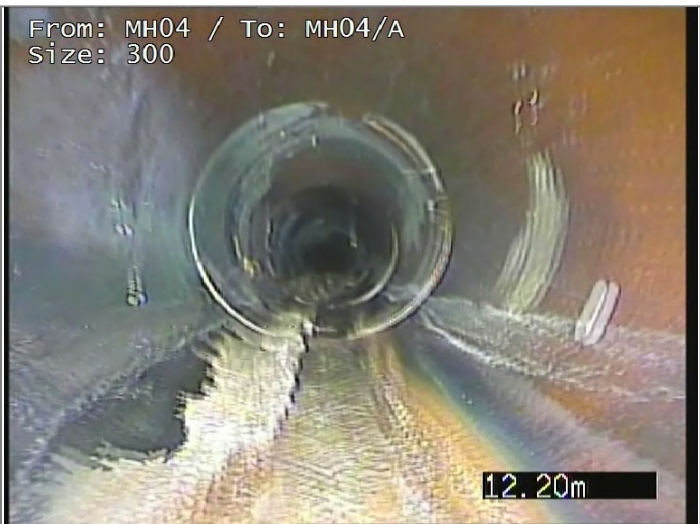
Attached deposits, encrustation at 7 o'clock 5% cross-sectional area loss, Start

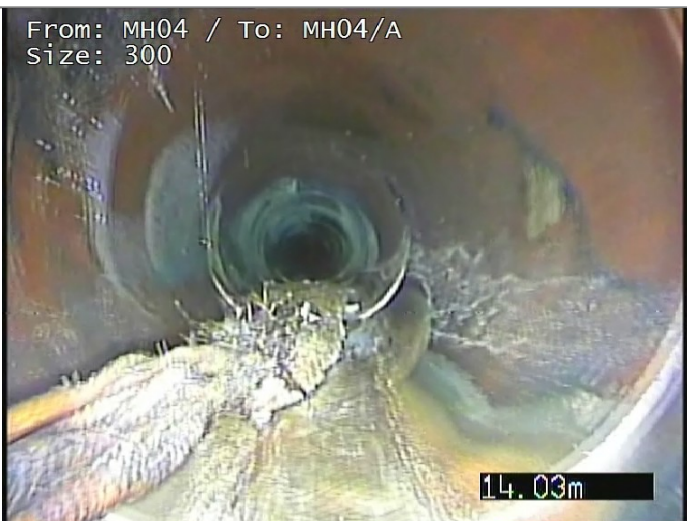
Attached deposits, encrustation at 7 o'clock 5% cross-sectional area loss, Finished

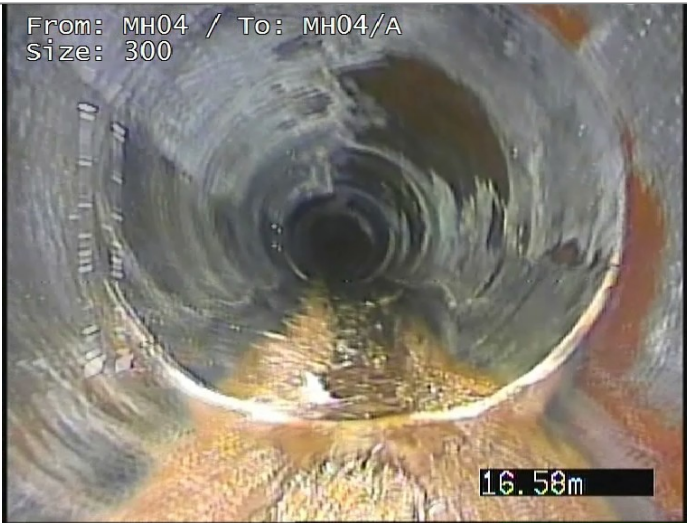
Roots mass 20% cross-sectional area loss, Finished

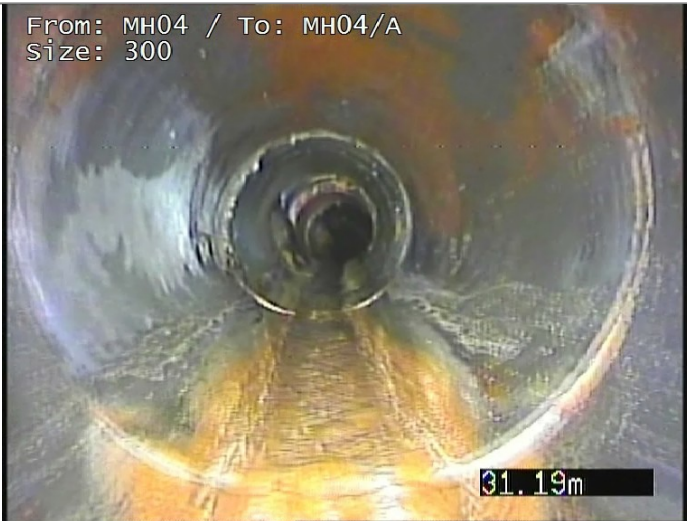
Fracture multiple from 12 to 12 o'clock, Finished

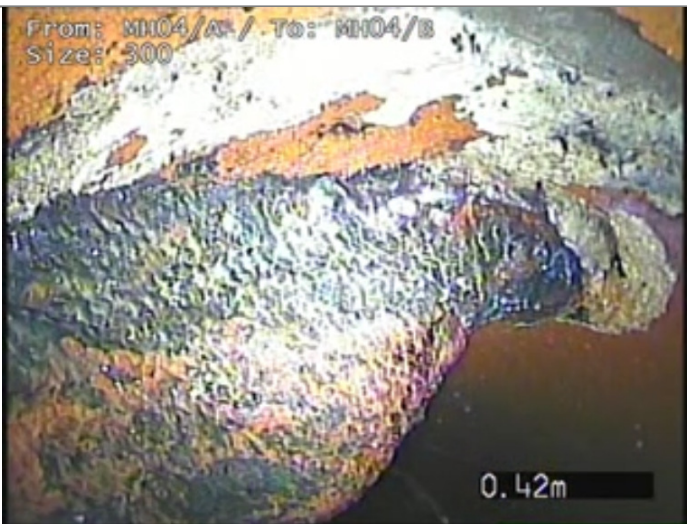
Attached deposits, encrustation from 6 to 12 o'clock 25% cross-sectional area loss

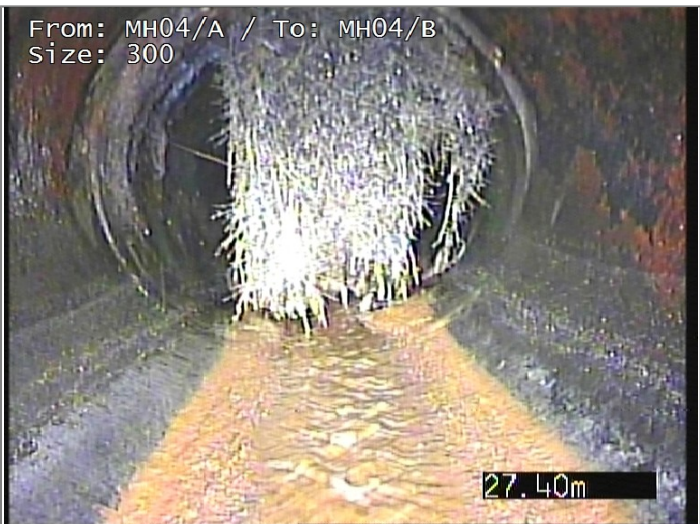
Roots mass 75% cross-sectional area loss

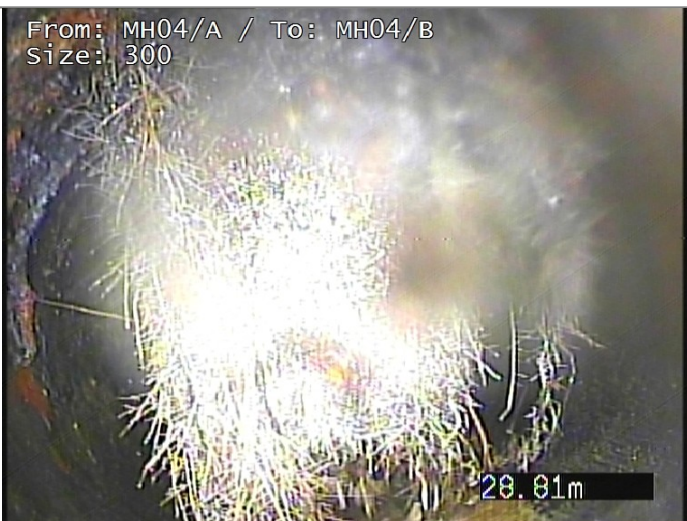
Survey abandoned - Remark: UNABLE TO PASS ROOT MASS

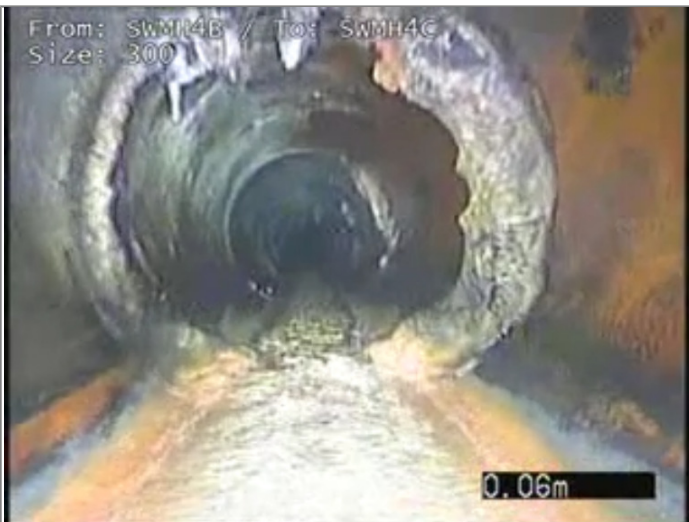
Attached deposits, encrustation from 12 to 6 o'clock 20% cross-sectional area loss at joint

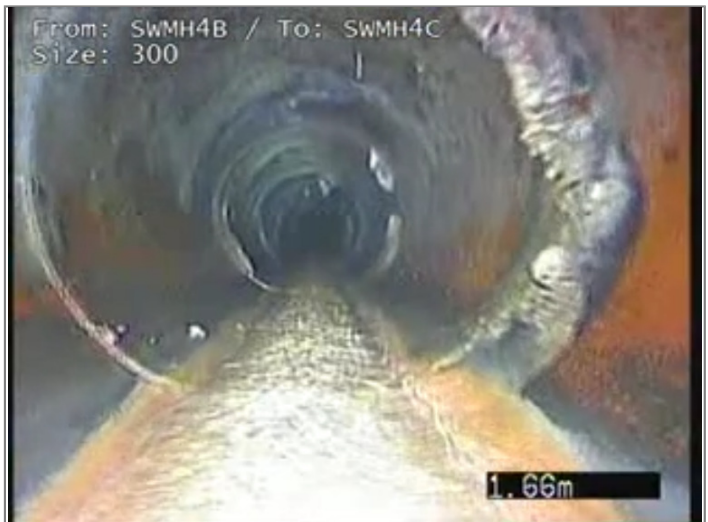
Attached deposits, encrustation from 12 to 6 o'clock 10% cross-sectional area loss at joint

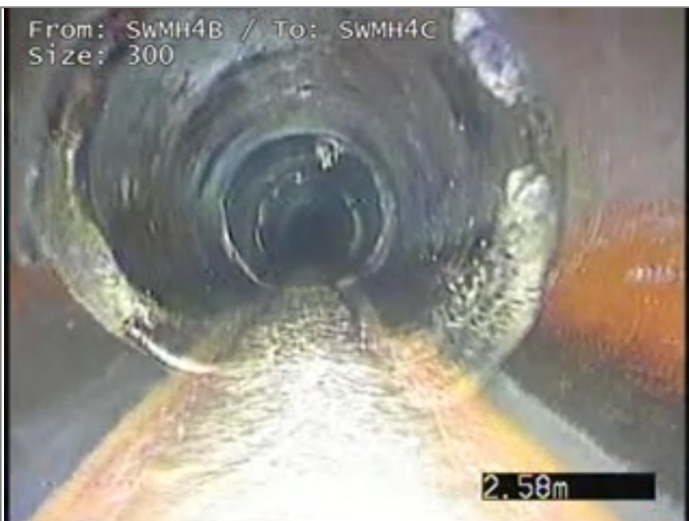
Attached deposits, encrustation from 1 to 9 o'clock 5% cross-sectional area loss at joint

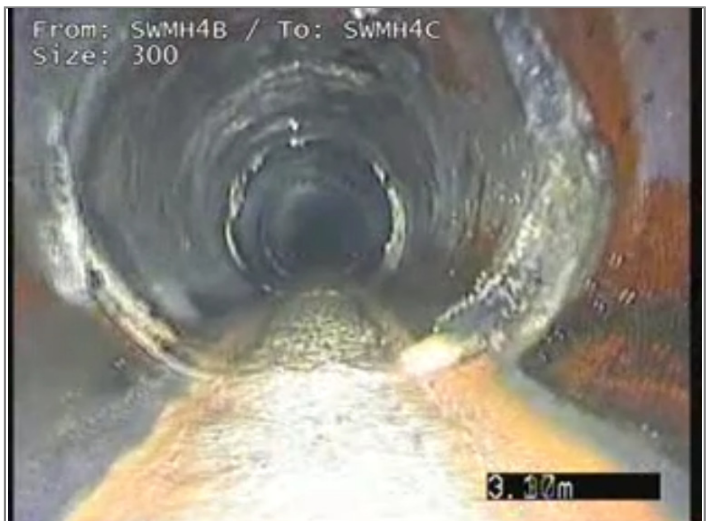
Attached deposits, encrustation from 1 to 6 o'clock 5% cross-sectional area loss at joint

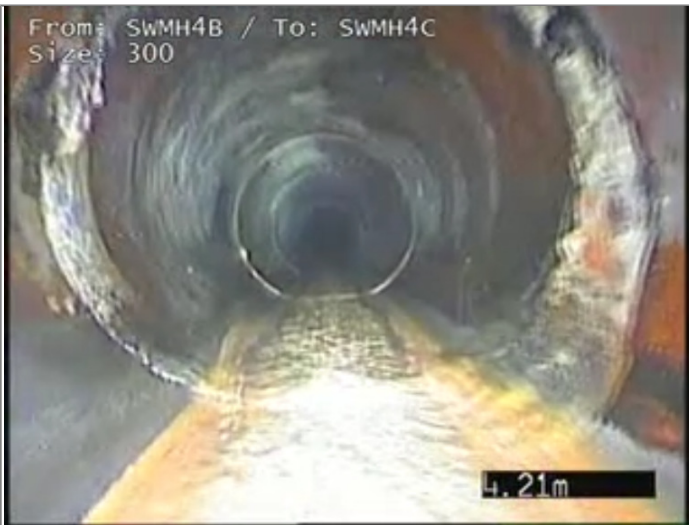
Attached deposits, encrustation from 1 to 6 o'clock 5% cross-sectional area loss at joint

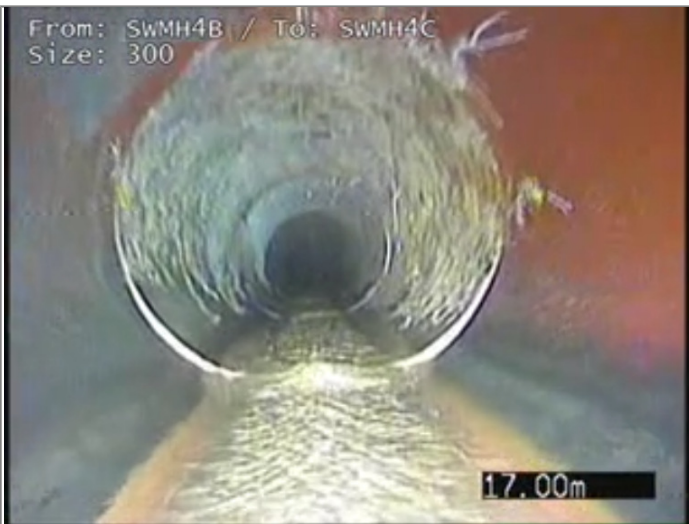
Roots fine at joint

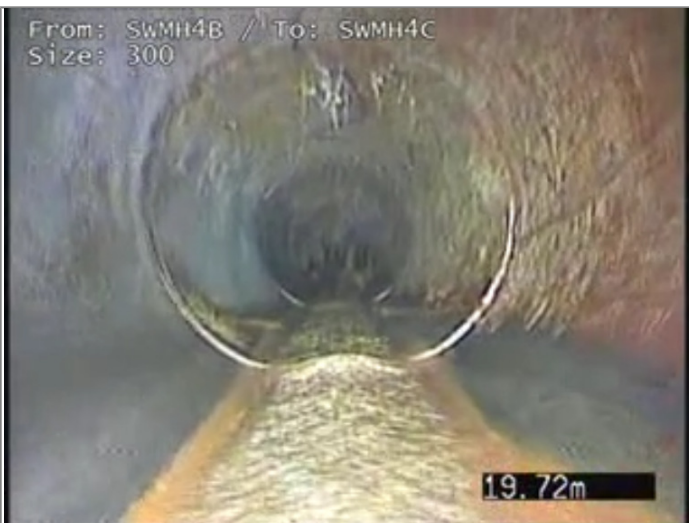
Roots fine at joint

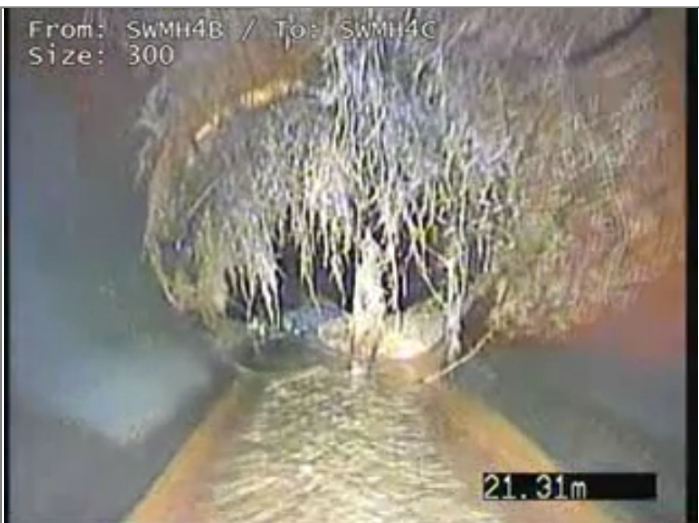
Roots mass 50% cross-sectional area loss at joint

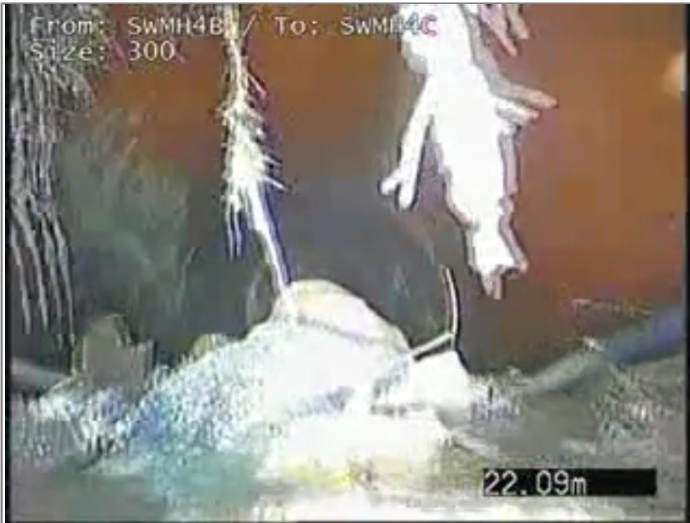
Other obstacles, other from 4 to 8 o'clock 40% cross-sectional area loss -  
Remark: DEBRIS OR SIMILAR RESTRICTING FLOW.

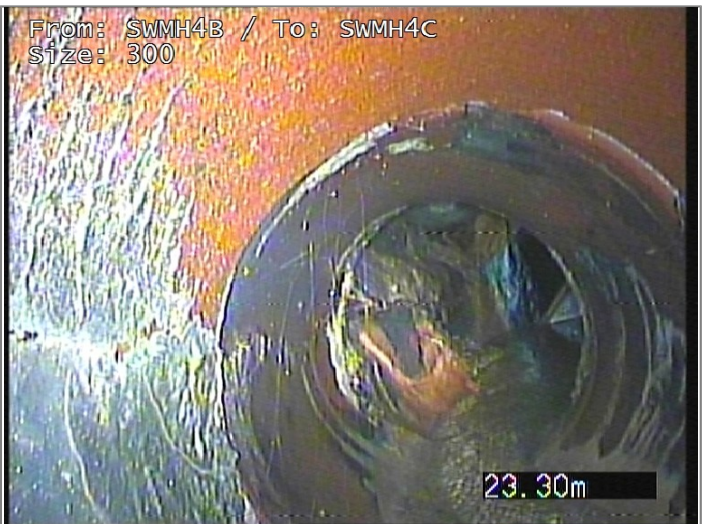
Survey abandoned - Remark: UNABLE TO PASS DEFECT

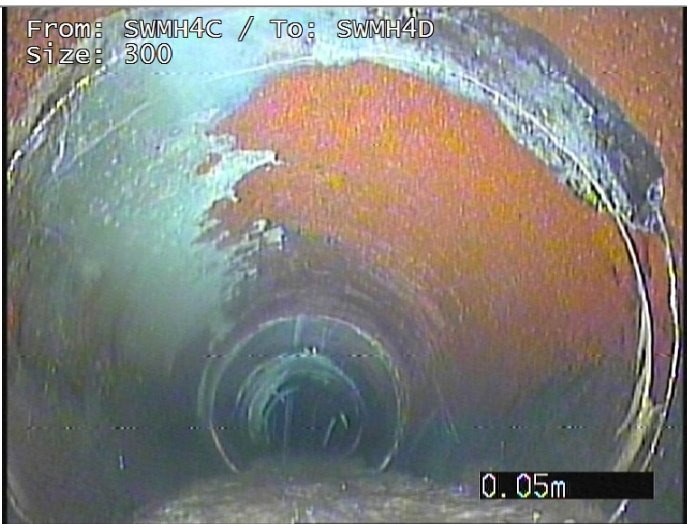
Fracture multiple from 12 to 12 o'clock

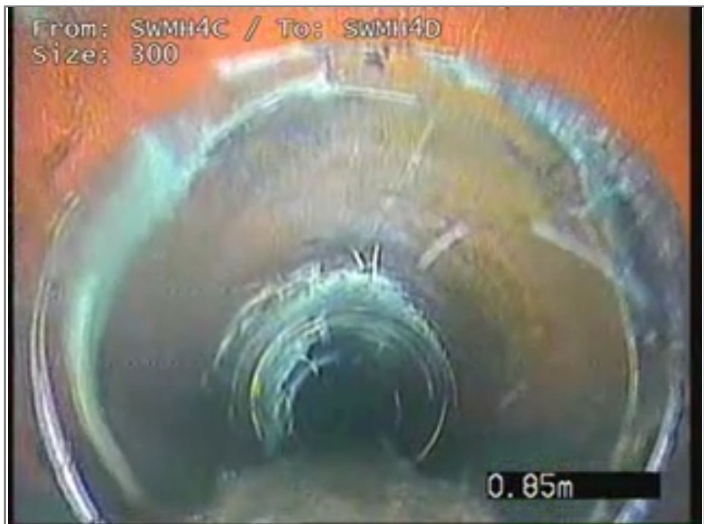
Fracture circumferential from 12 to 6 o'clock at joint

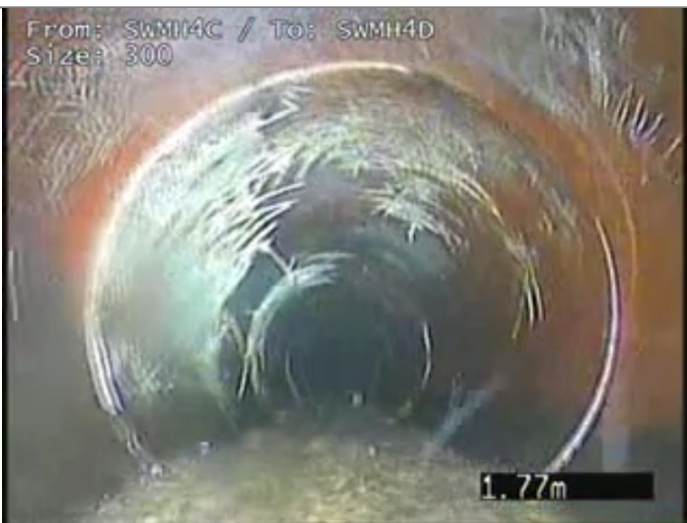
Roots fine at joint

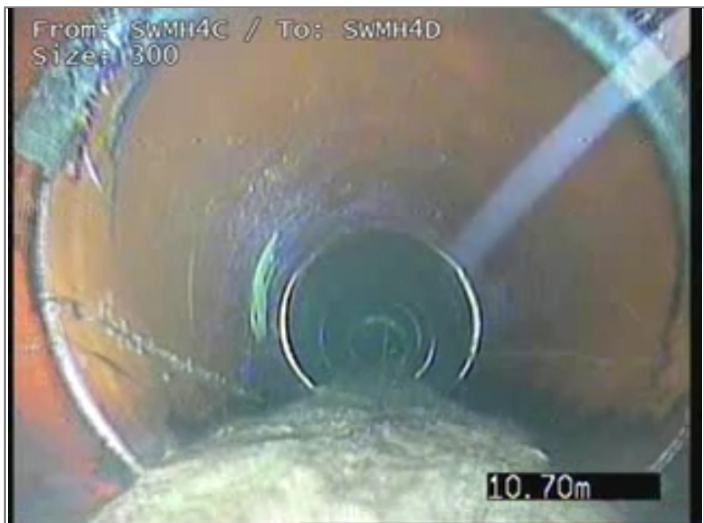
Fracture longitudinal at 8 o'clock

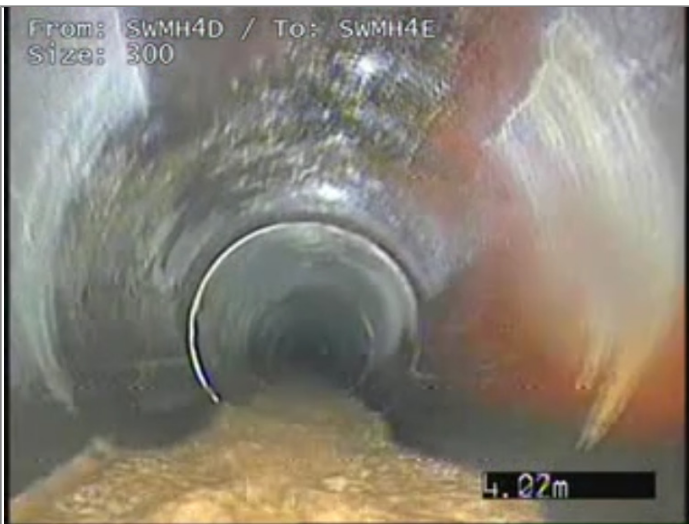
Fracture longitudinal at 2 o'clock

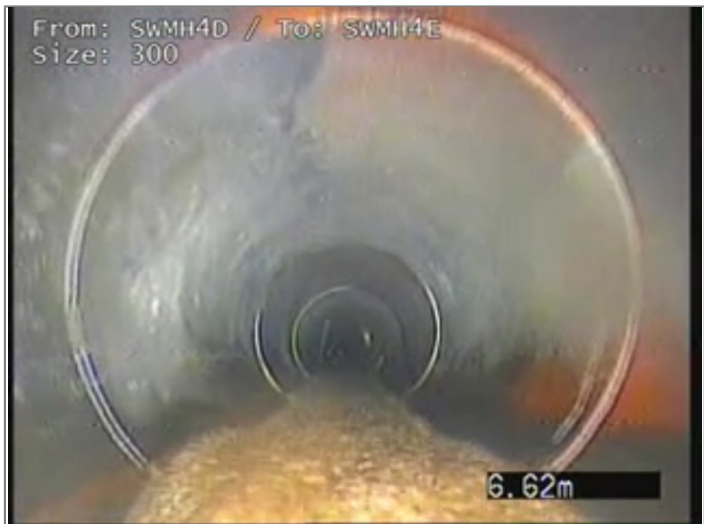
Crack circumferential from 2 to 5 o'clock at joint

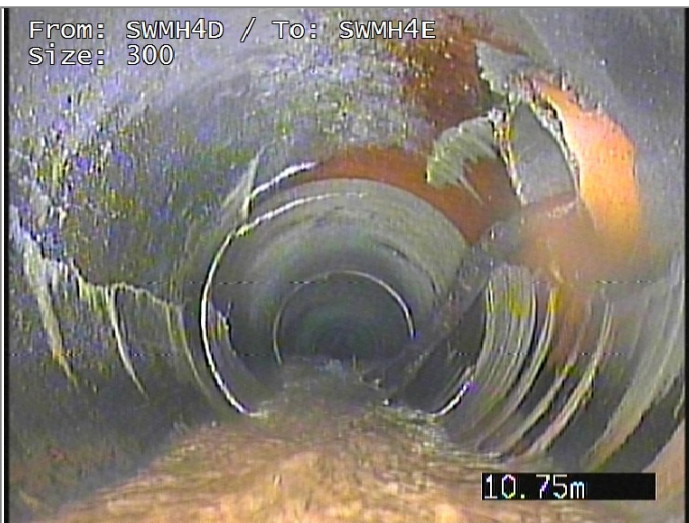
Fracture multiple from 12 to 12 o'clock

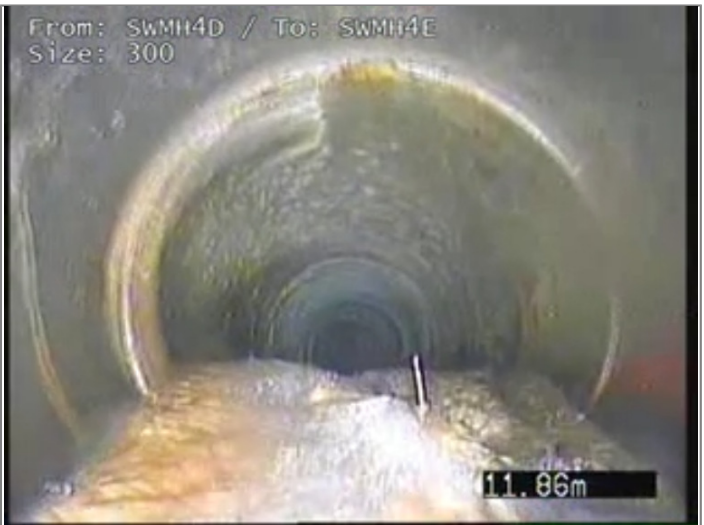
Fracture circumferential from 7 to 10 o'clock

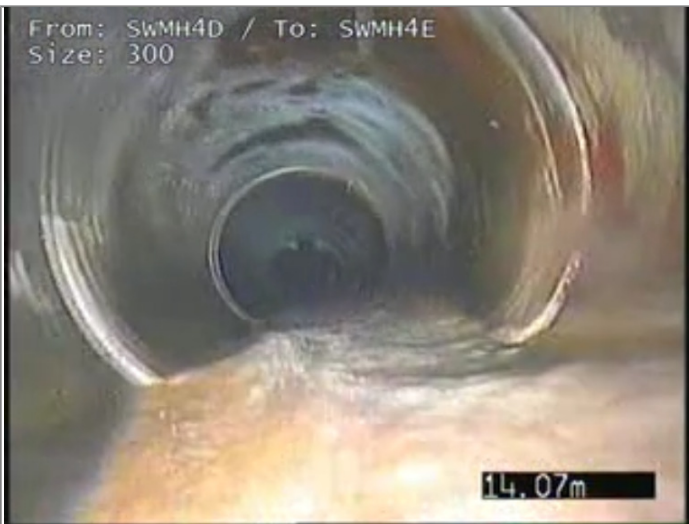
Fracture circumferential from 2 to 5 o'clock at joint

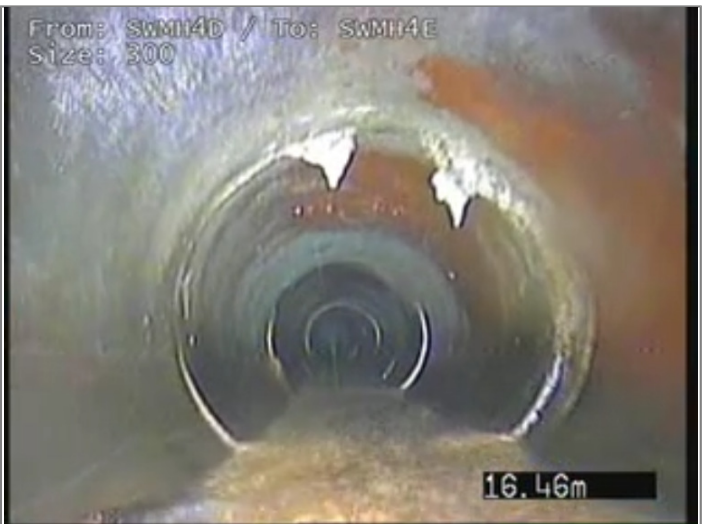
Roots fine at joint

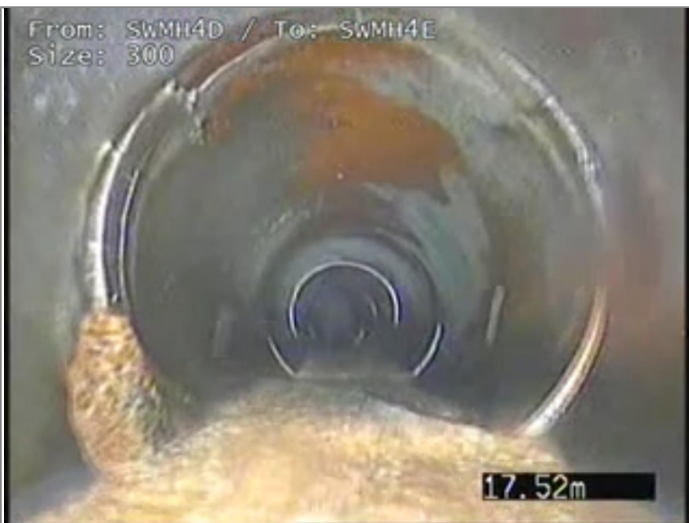
Attached deposits, encrustation from 6 to 9 o'clock 5% cross-sectional area loss at joint

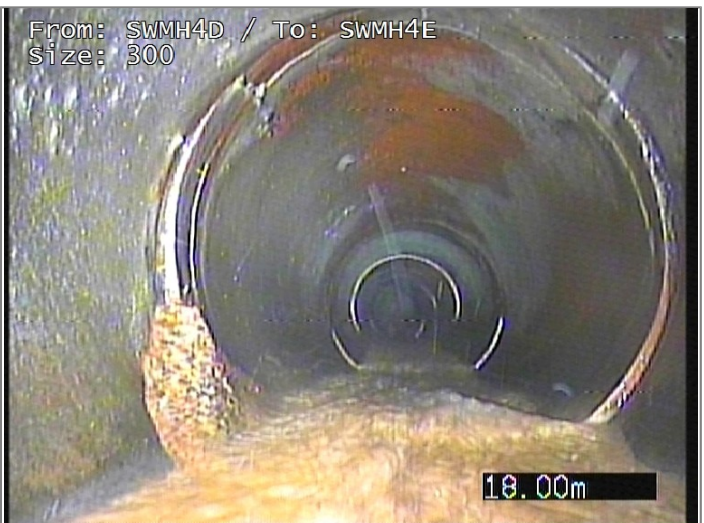
Fracture multiple from 12 to 12 o'clock

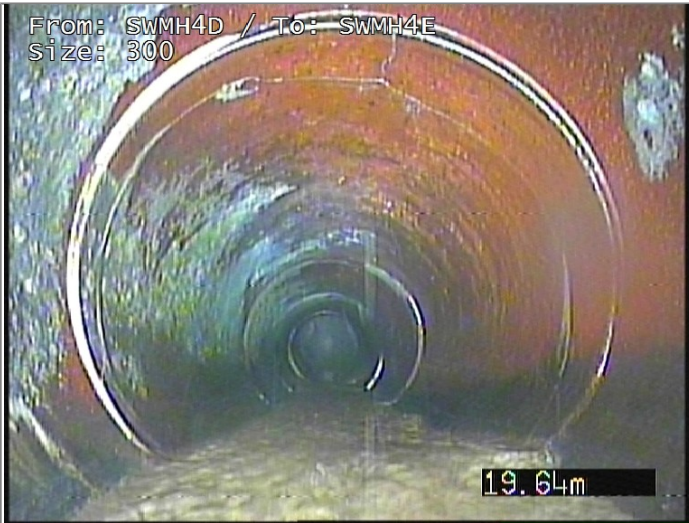
Fracture multiple from 12 to 12 o'clock

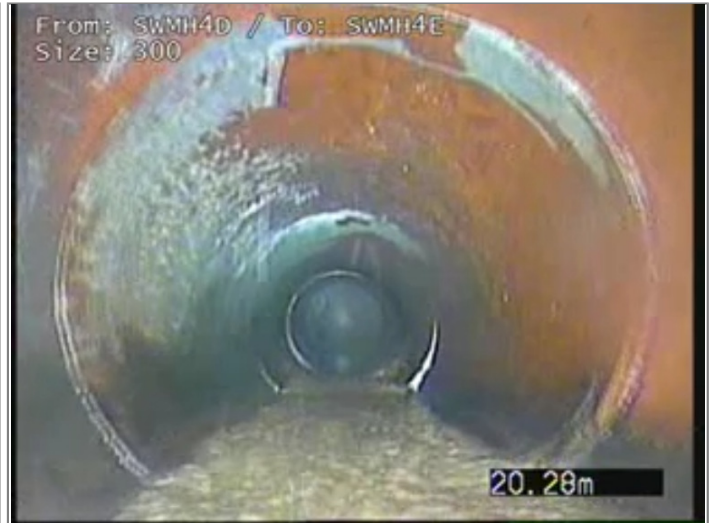
Crack circumferential from 12 to 2 o'clock at joint

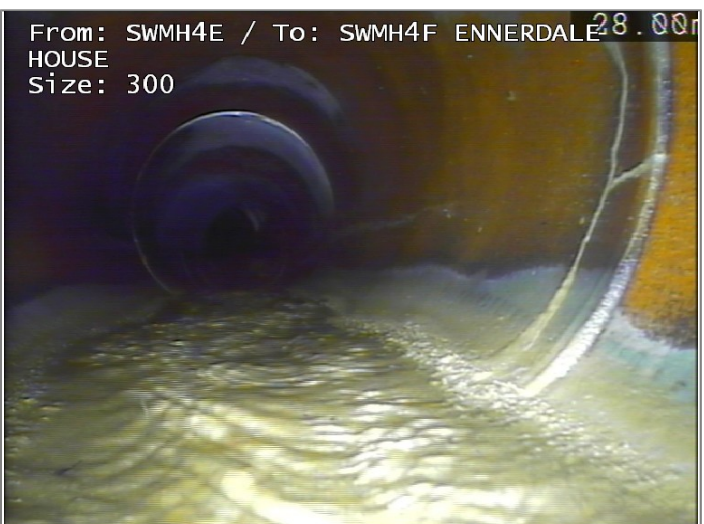
Fracture circumferential from 1 to 6 o'clock, at joint

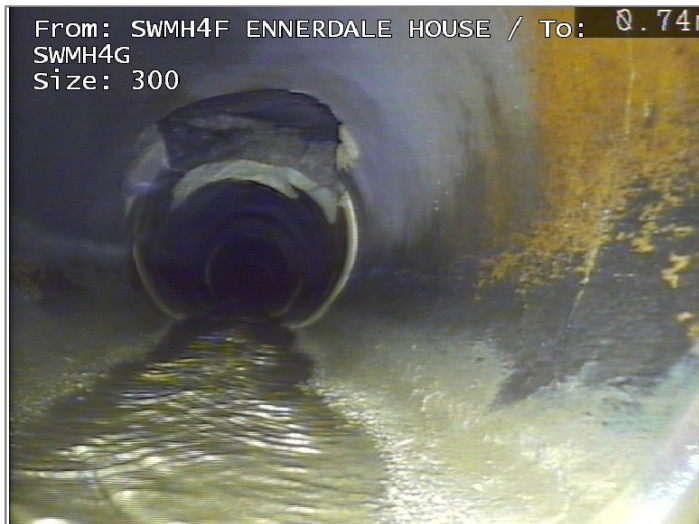
Hole in drain/sewer from 10 to 2 o'clock

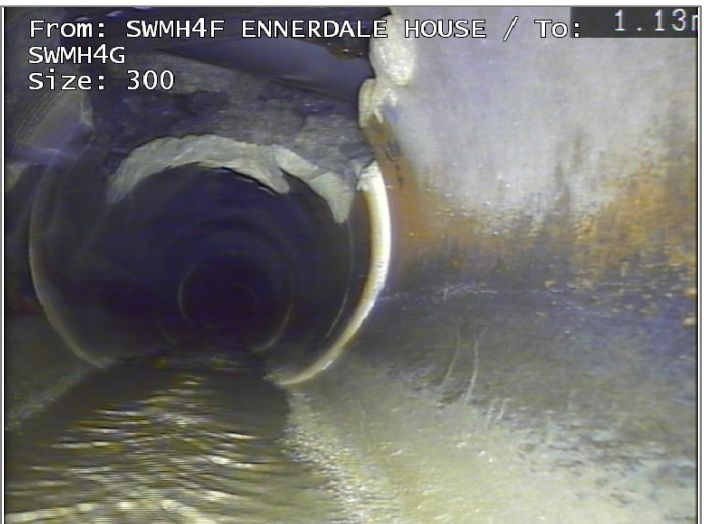
Fracture circumferential from 12 to 6 o'clock

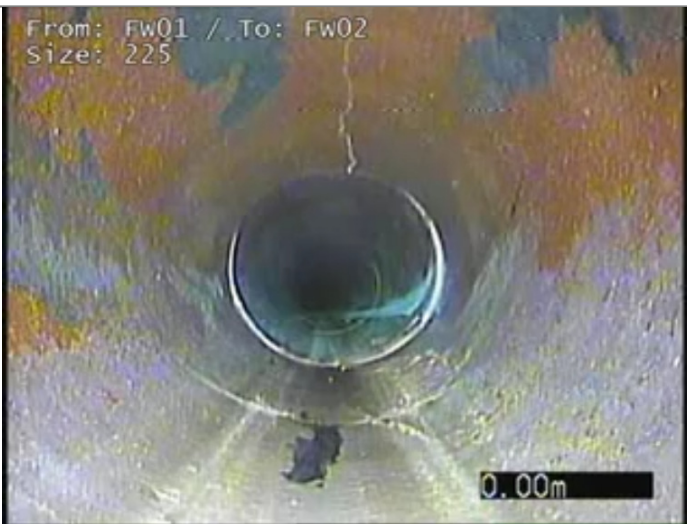
Crack longitudinal at 12 o'clock

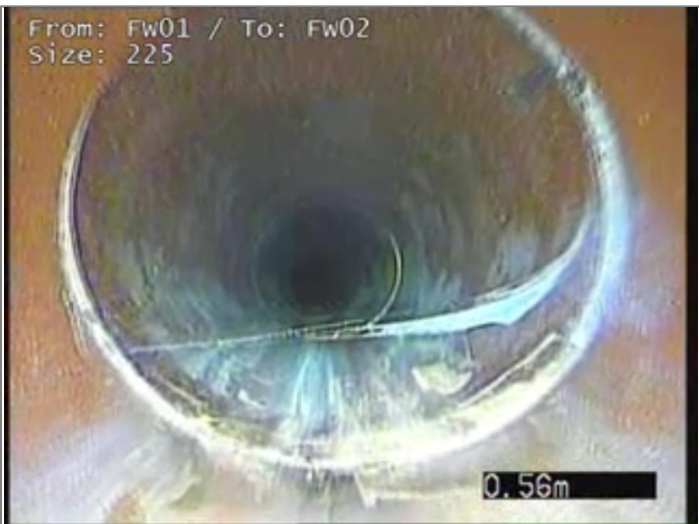
Crack circumferential from 4 to 7 o'clock at joint

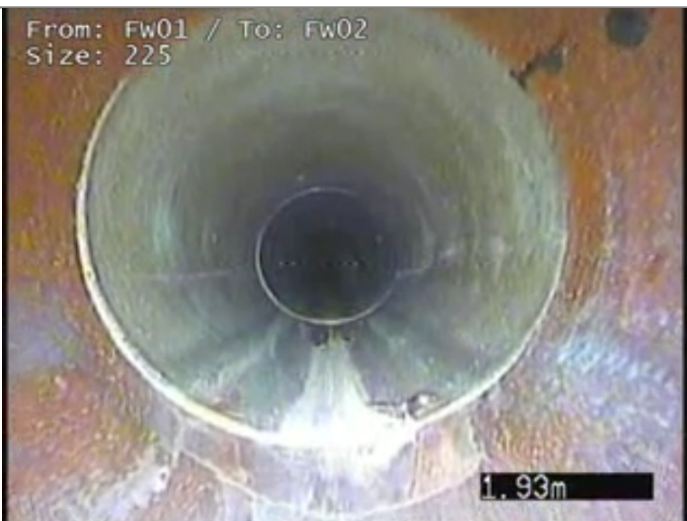
Crack circumferential from 5 to 7 o'clock at joint

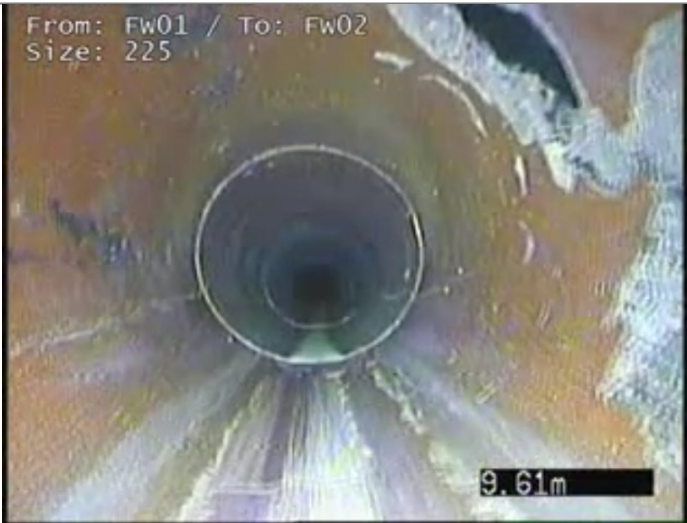
Hole in drain/sewer from 12 to 3 o'clock

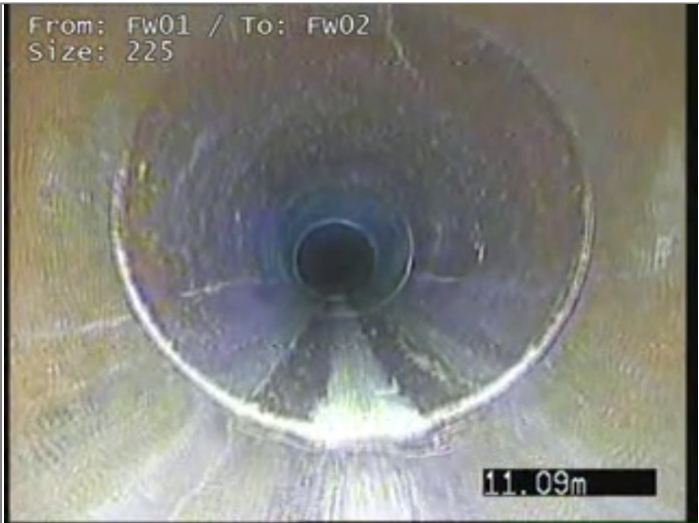
Crack longitudinal at 12 o'clock

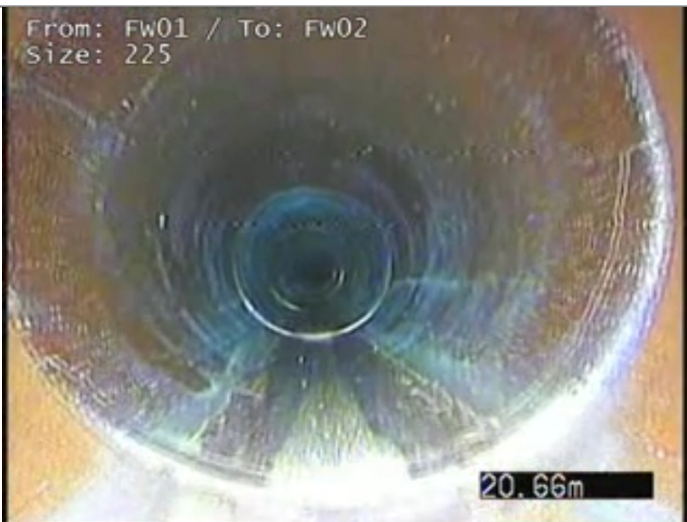
Crack circumferential from 3 to 6 o'clock at joint

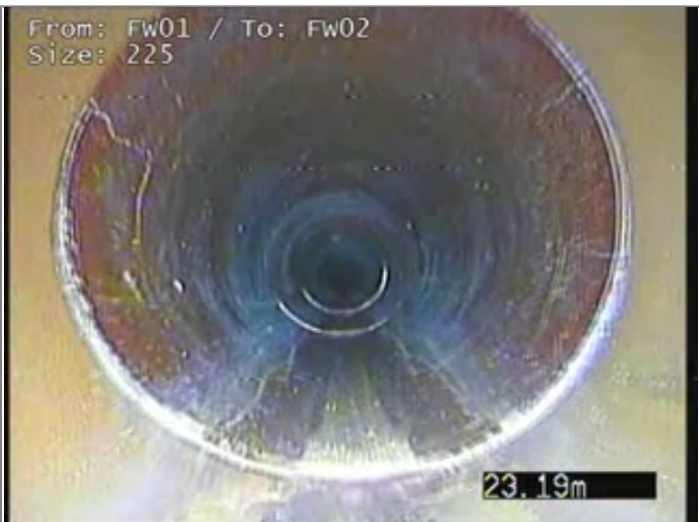
Crack radiates from 9 o'clock

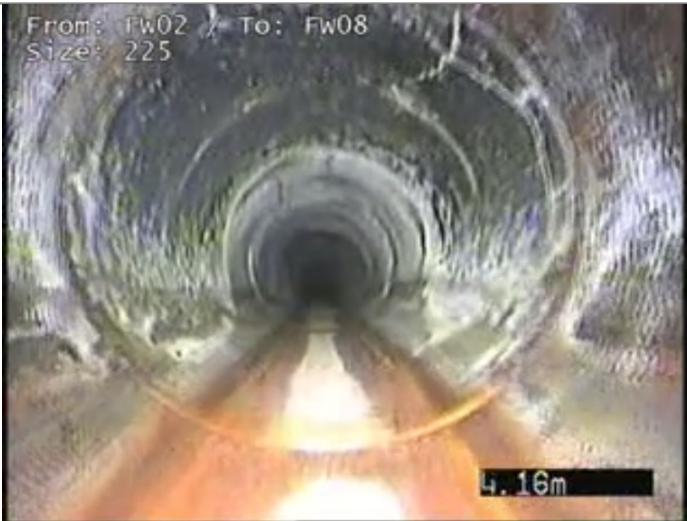
Fracture circumferential from 12 to 3 o'clock at joint

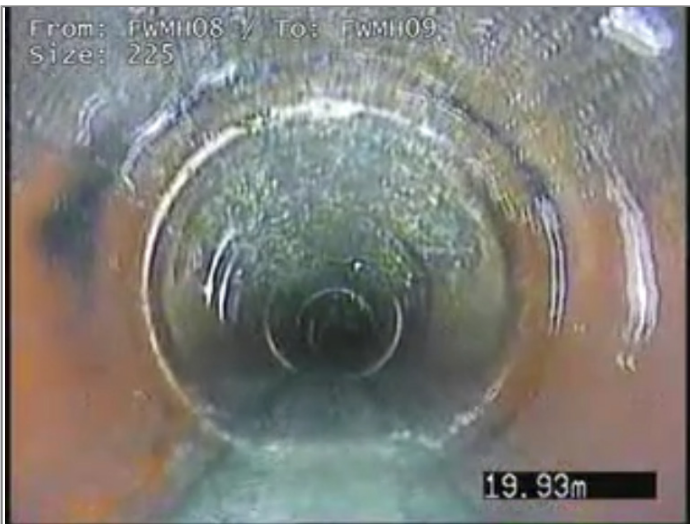
19.93	FC	Fracture circumferential from 2 to 4 o'clock	6032546	Structural / 3
22.64	RFJ	Roots fine at joint	6032547	Service / 2
24.66	WL	Water level 50% height/diameter	6032548	Comment / 0
26.68	SA	Survey abandoned - Remark: LINE REQUIRES TANKER HPWJ	6032545	Comment / 0

Fracture circumferential from 2 to 4 o'clock

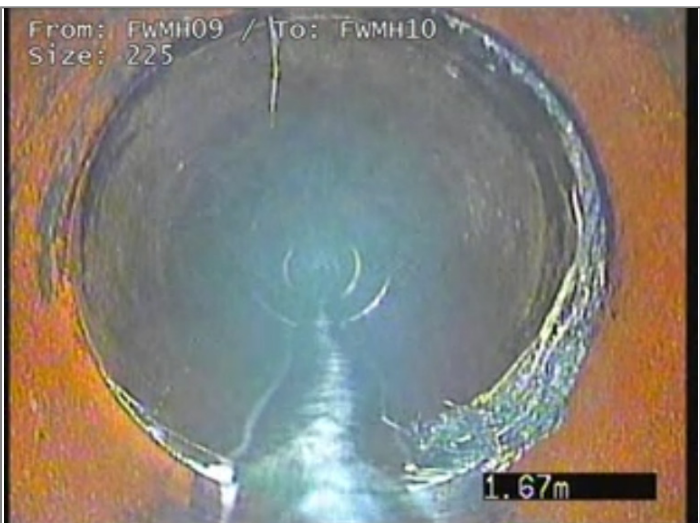
Roots fine at joint - Remark: ROOT REMAINING POST ROOT CUTTING.

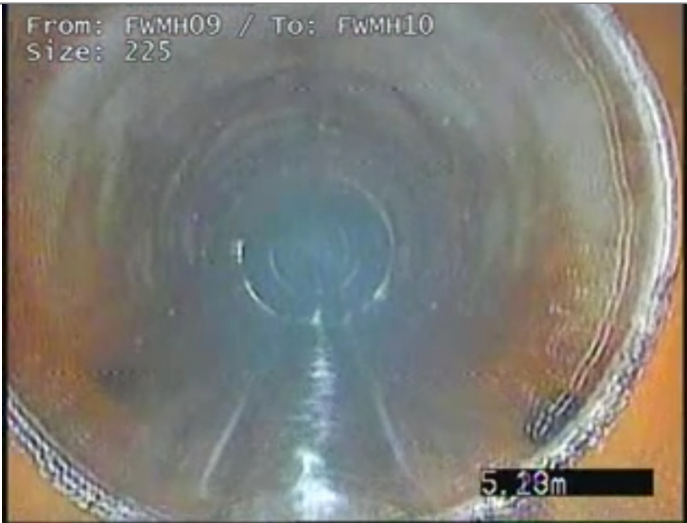
Crack circumferential from 1 to 5 o'clock at joint
