**CCTV Inspection Report**

**FOUL AND SURFACE WATER OUTFALLS FROM SITE COMPOUND  
WEST CUMBERLAND HOSPITAL  
HOMWOOD ROAD  
WHITEHAVEN**

**11/02/2022**

**Job Number: SK-S 160/21 WCH GRAHAMS (updated 11/02/2022)**

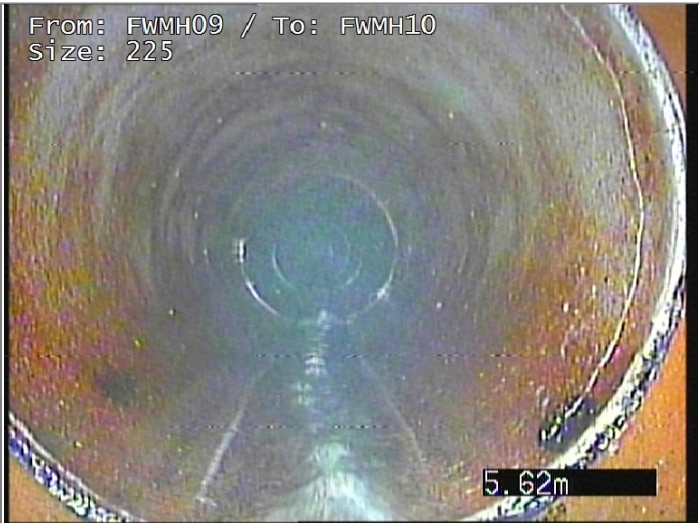
Fracture circumferential from 12 to 5 o'clock

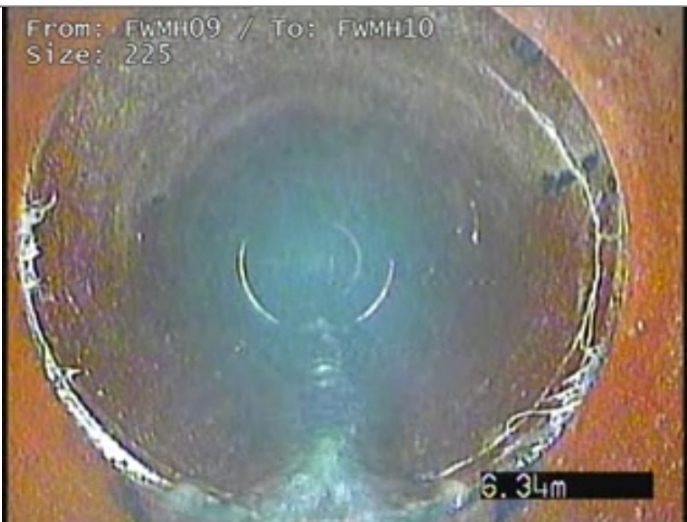
Roots fine at joint - Remark: FINE ROOTS REMAIN POST ROOT CUTTING

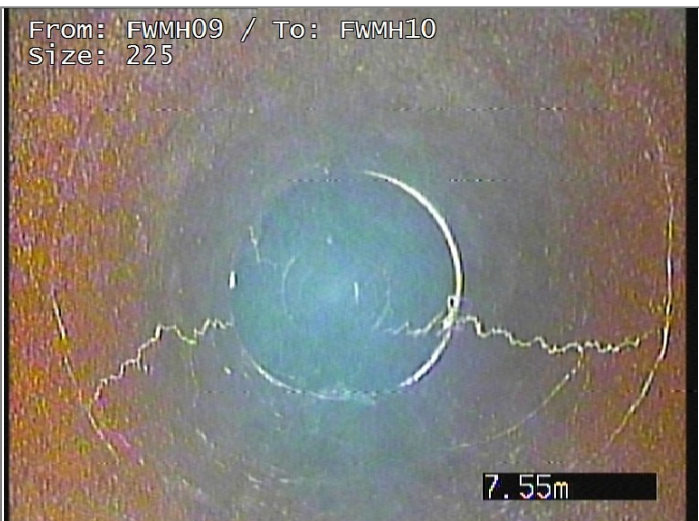
Fracture multiple from 12 to 12 o'clock, Start

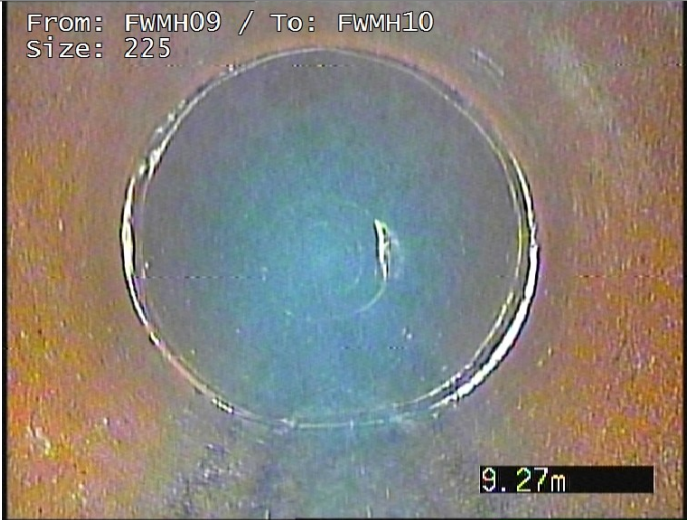
Fracture multiple from 12 to 12 o'clock, Finished

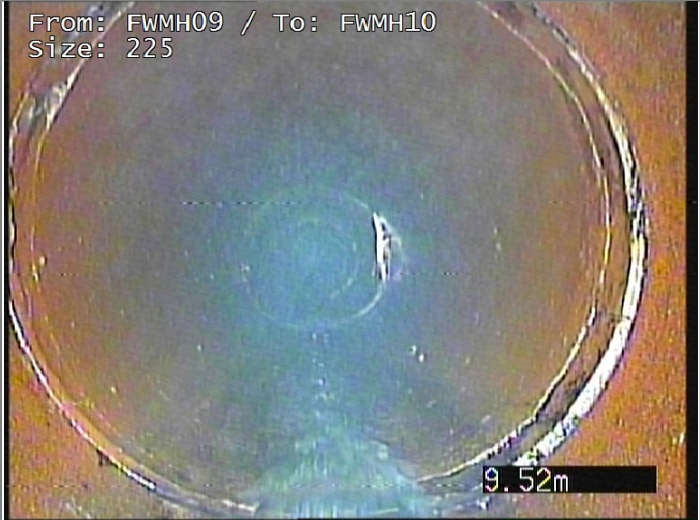
Fracture circumferential from 12 to 12 o'clock

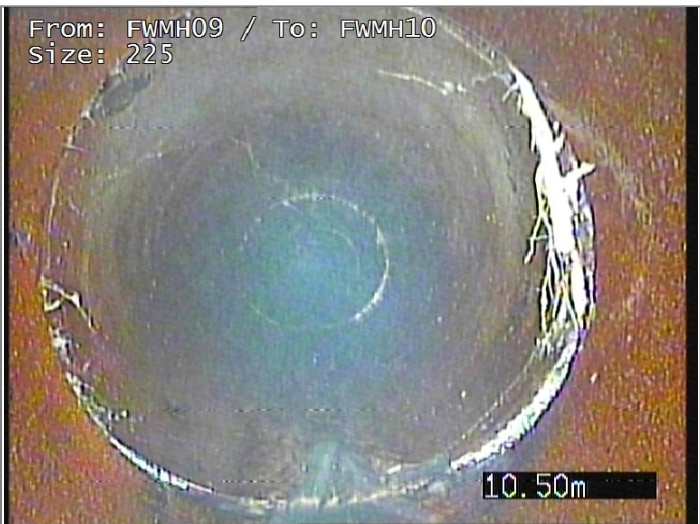
Fracture multiple from 12 to 12 o'clock

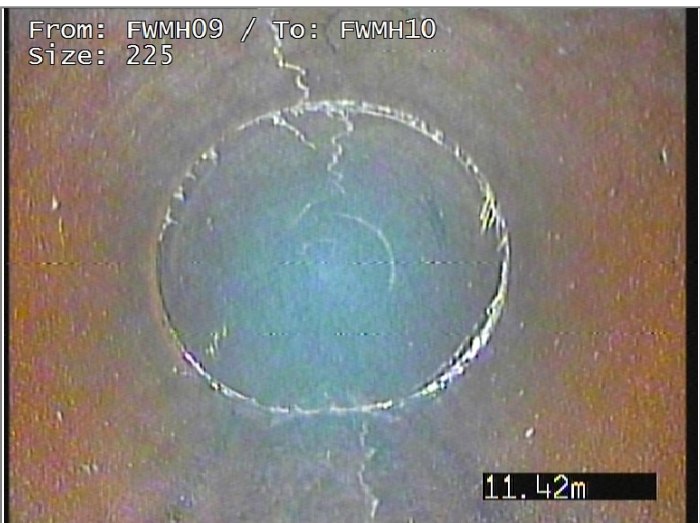
Fracture multiple from 12 to 12 o'clock, Start

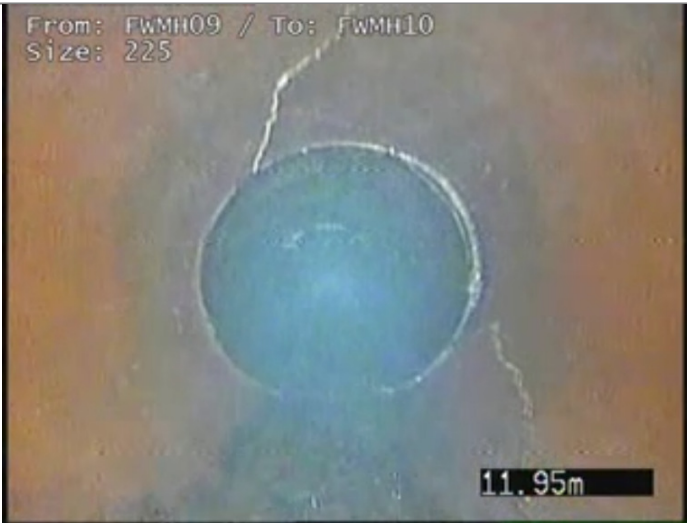
Fracture longitudinal at 4 o'clock

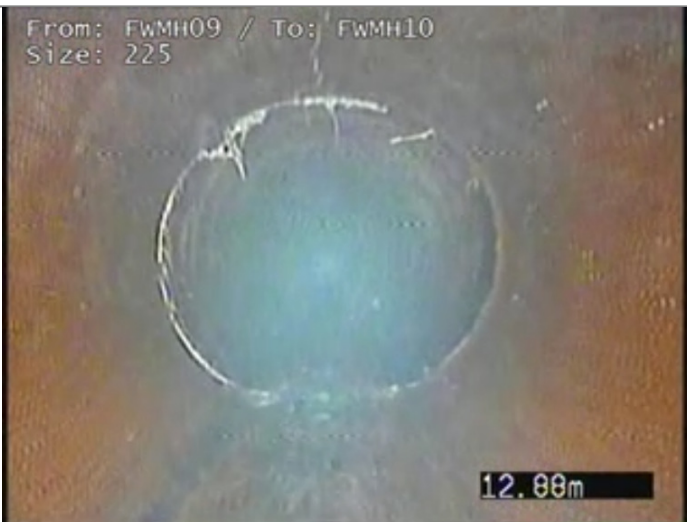
Fracture longitudinal at 12 o'clock

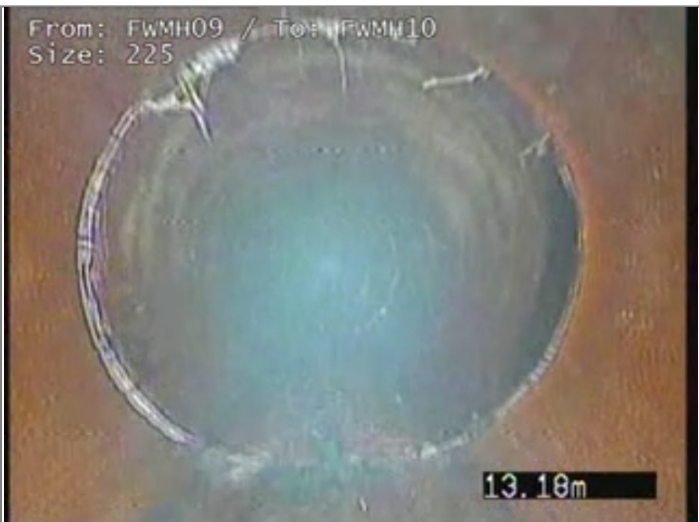
Roots fine at joint - Remark: FINE ROOTS REMAIN POST ROOT CUT.

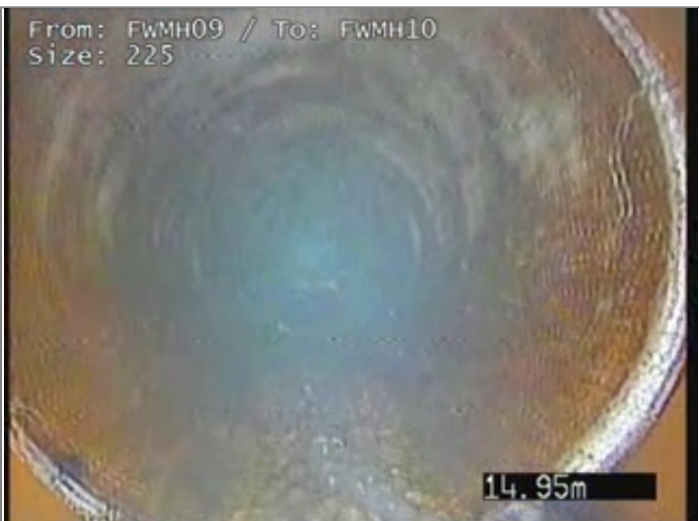
Crack circumferential from 2 to 3 o'clock at joint

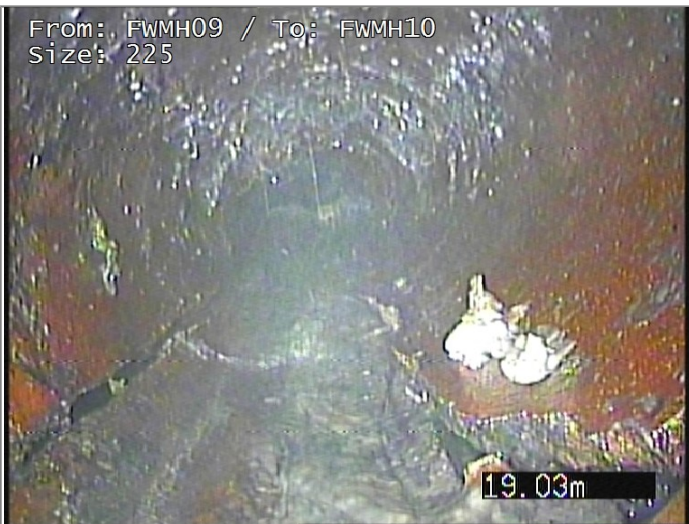
Broken pipe from 3 to 9 o'clock

20.00	SA	Survey abandoned - Remark: <b>UNABLE TO CONTINUE WITH ROOT CUT AND CCTV REPAIRS WILL NEED TO BE MADE TO LINE</b>	6032404	Comment / 0

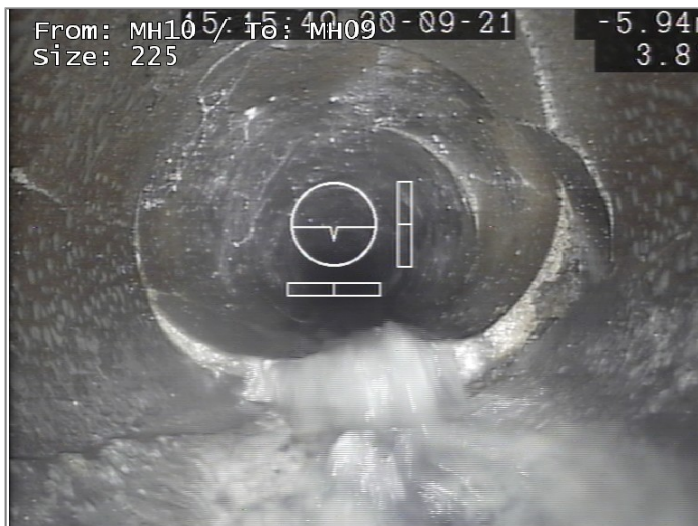
Broken pipe from 12 to 11 o'clock

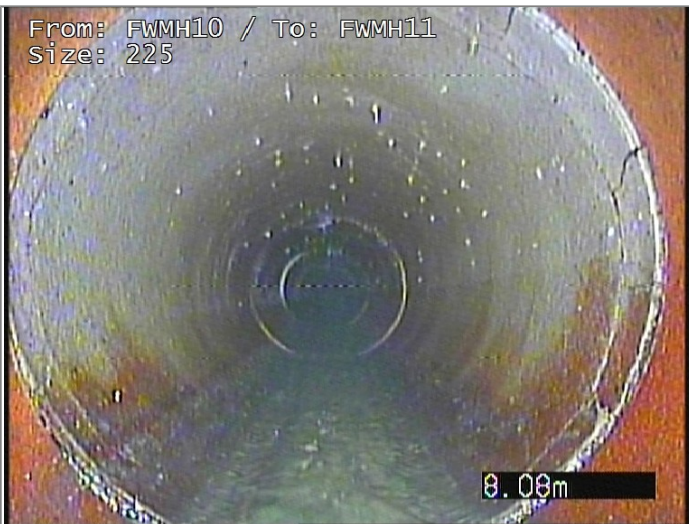
Fracture multiple from 12 to 6 o'clock

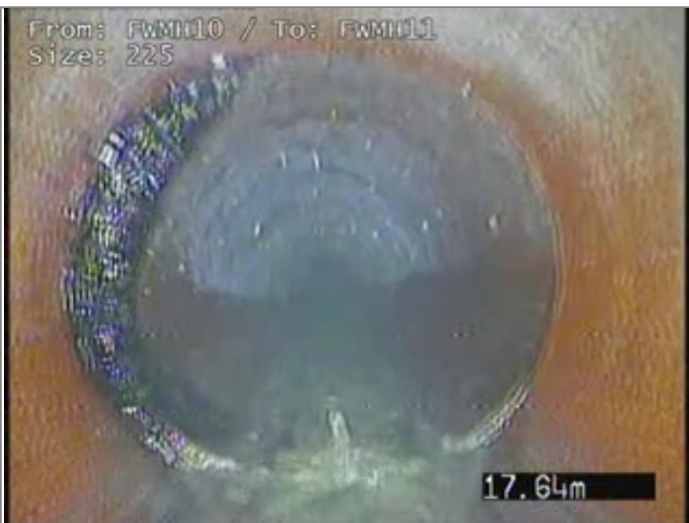
Attached deposits, encrustation from 6 to 11 o'clock 5% cross-sectional area loss at joint

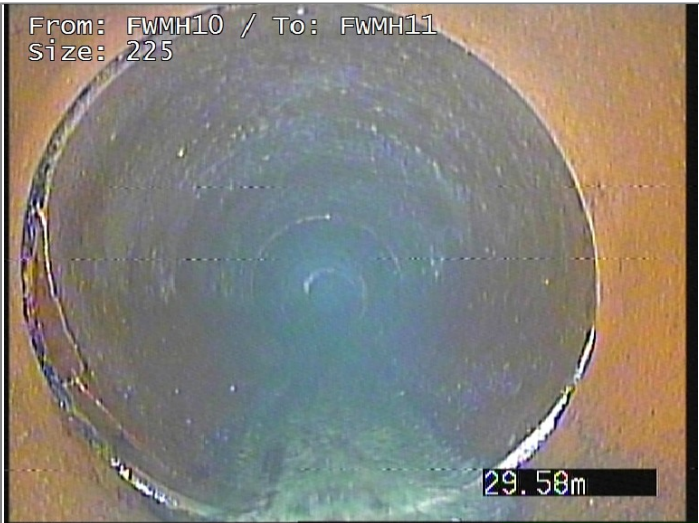
Fracture circumferential from 7 to 10 o'clock

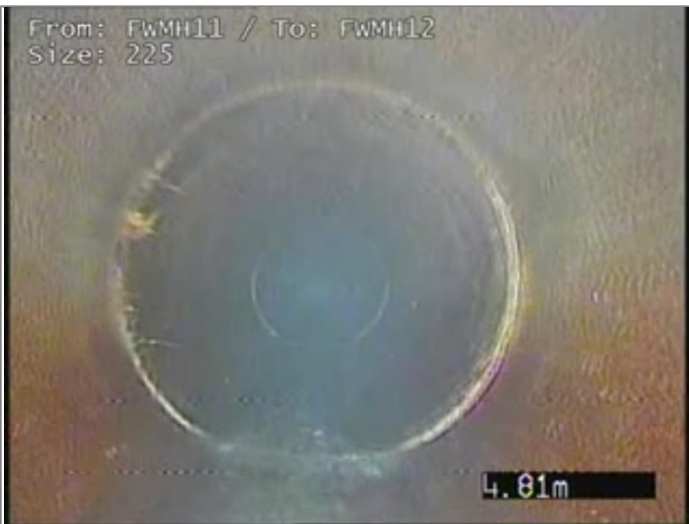
Roots fine at joint

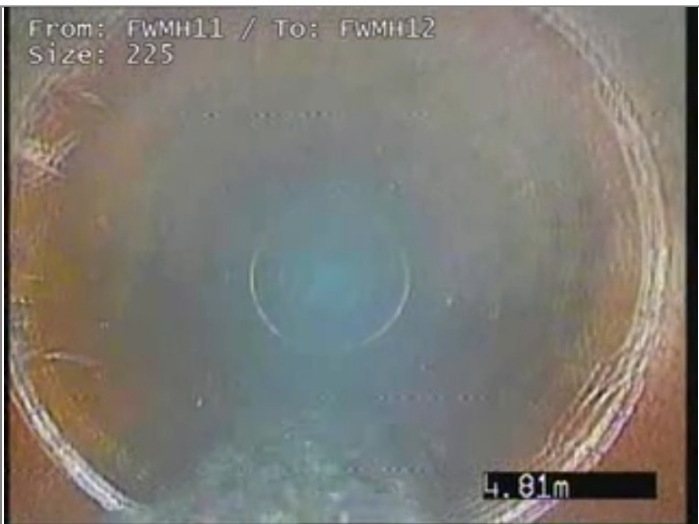
Crack circumferential from 4 to 5 o'clock at joint

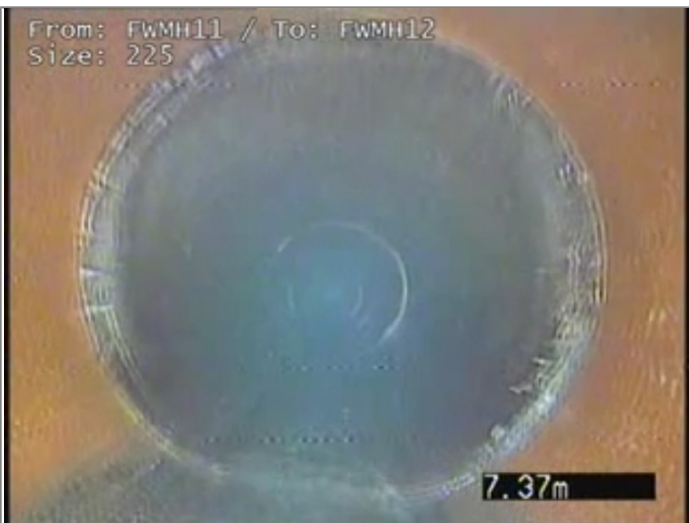
Roots fine at joint

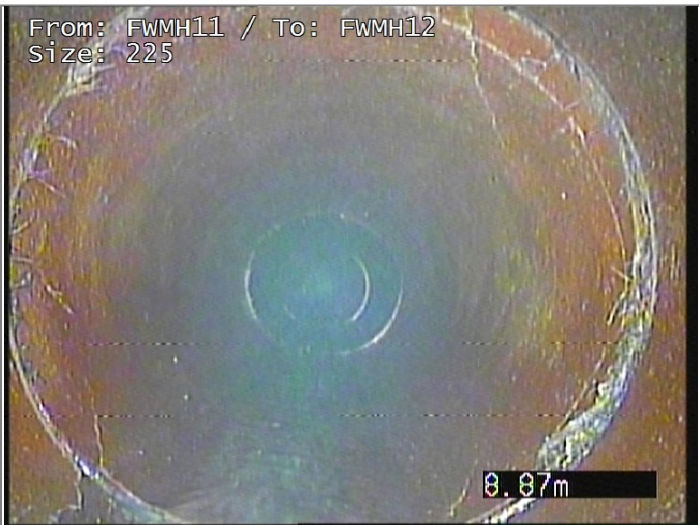
8.35	RFJ	Roots fine at joint	6032487	Service / 2
8.35	CCJ	Crack circumferential from 12 to 4 o'clock at joint	6032488	Structural / 2
8.87	FC	Fracture circumferential from 12 to 3 o'clock	6032475	Structural / 3

Fracture circumferential from 12 to 3 o'clock

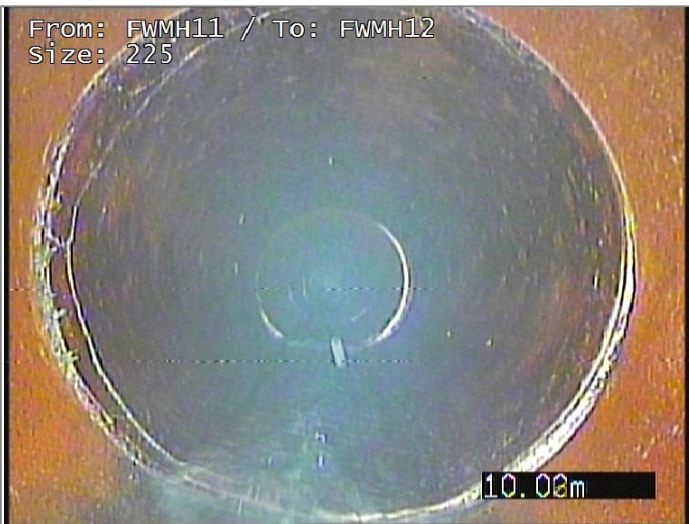
10.00	FC	Fracture circumferential from 6 to 12 o'clock	6032476	Structural / 3
10.27	FCJ	Fracture circumferential from 4 to 8 o'clock at joint	6032489	Structural / 3

Fracture circumferential from 6 to 12 o'clock

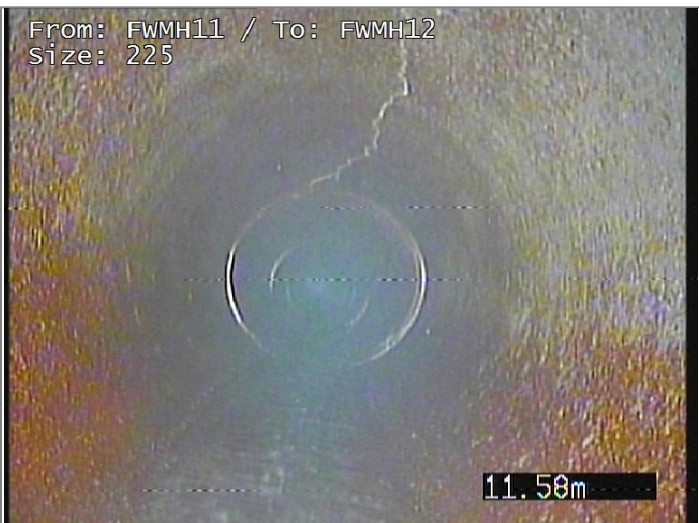
Fracture longitudinal at 12 o'clock

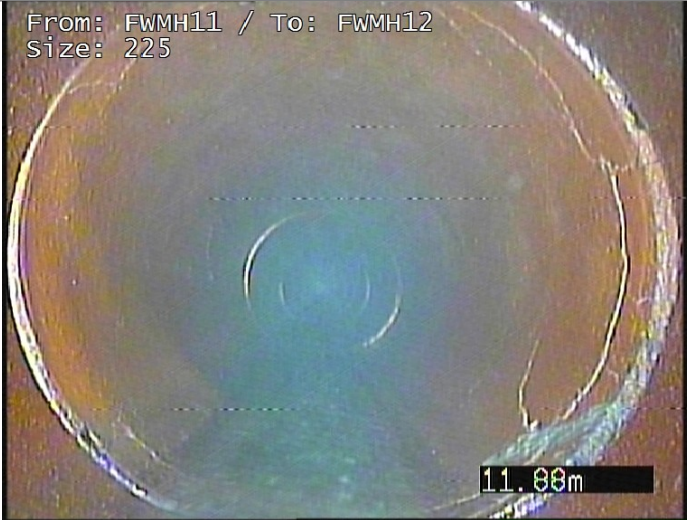
10.99	FL	Fracture longitudinal at 12 o'clock	6032490	Structural / 3
11.58	FL	Fracture longitudinal at 12 o'clock	6032477	Structural / 3
11.88	FM	Fracture multiple from 12 to 12 o'clock	6032478	Structural / 4

Fracture multiple from 12 to 12 o'clock

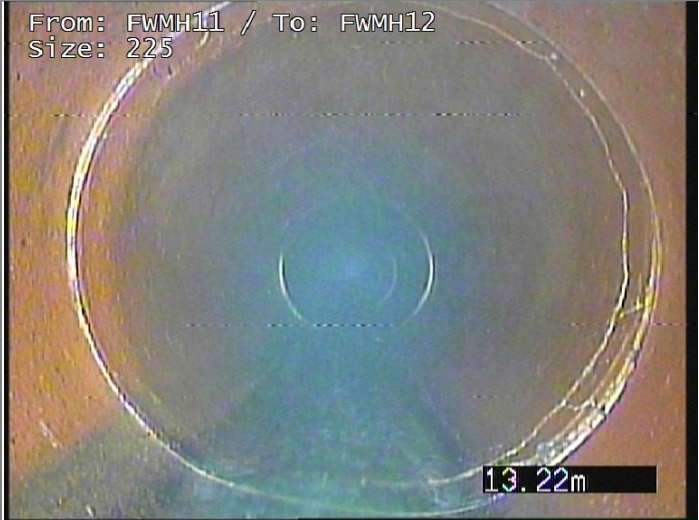
13.22	FC	Fracture circumferential from 12 to 6 o'clock	6032479	Structural / 3
16.65	FM	Fracture multiple from 6 to 12 o'clock	6032480	Structural / 4
19.83	FM (S01)	Fracture multiple from 12 to 12 o'clock, Start	6032481	Structural / 4

Fracture circumferential from 12 to 6 o'clock

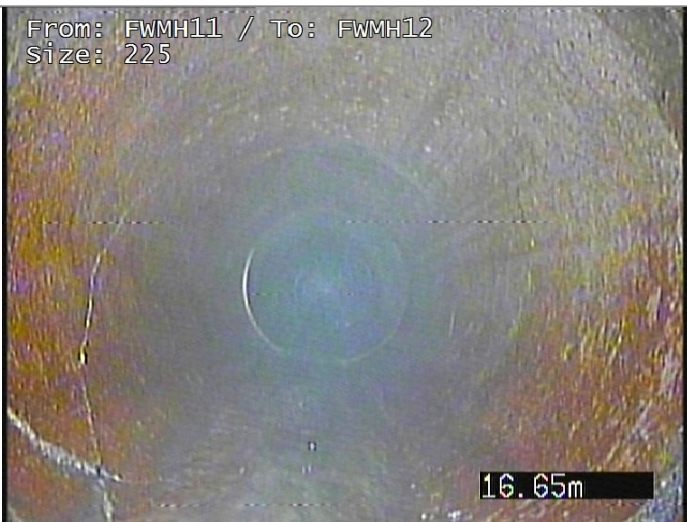
Fracture multiple from 6 to 12 o'clock

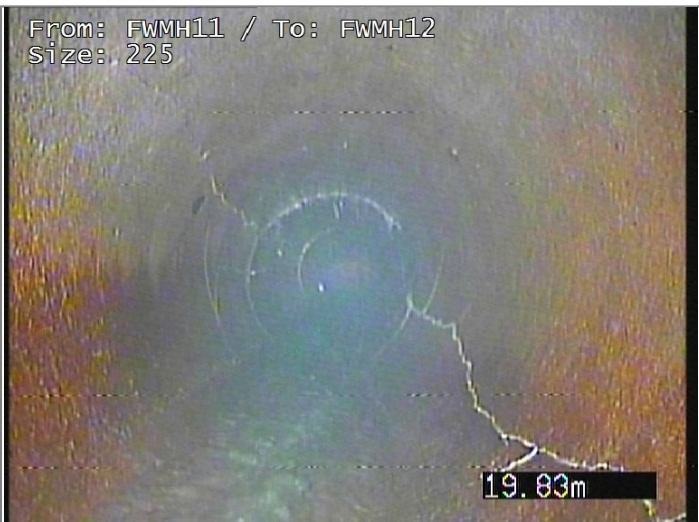
Fracture multiple from 12 to 12 o'clock, Start

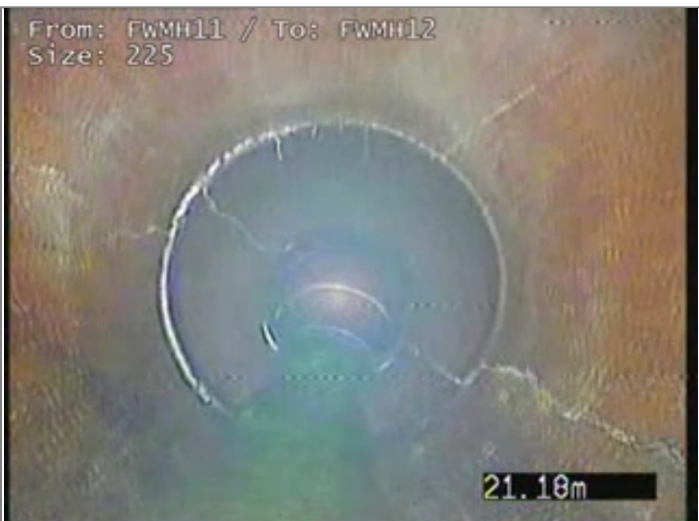
20.34	RFJ	Roots fine at joint	6032491	Service / 2
21.18	FL	Fracture longitudinal at 4 o'clock	6032492	Structural / 3
21.62	FL	Fracture longitudinal at 10 o'clock	6032493	Structural / 3

Fracture longitudinal at 4 o'clock

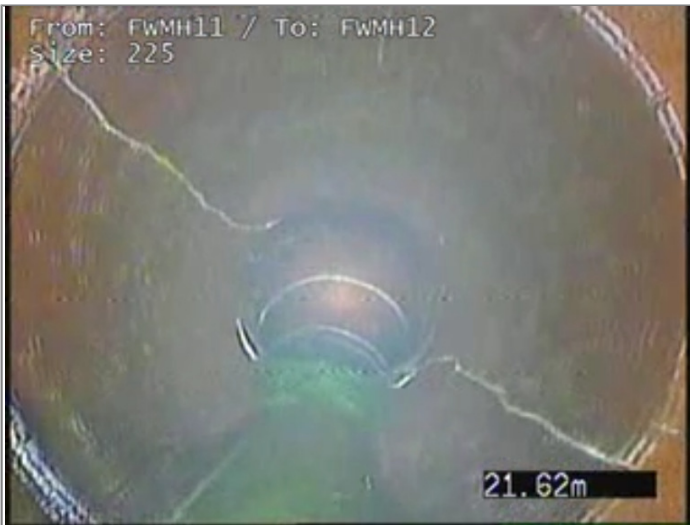
Fracture longitudinal at 10 o'clock

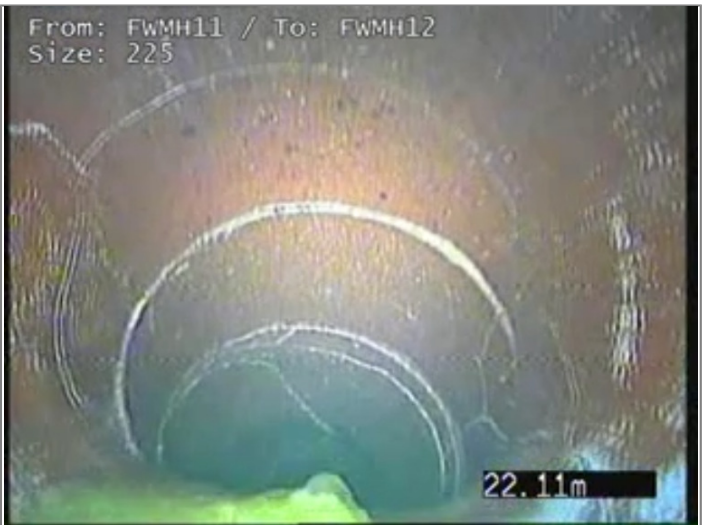
22.11	FC	Fracture circumferential from 7 to 5 o'clock	6032494	Structural / 3
22.63	LD	Line of drain/sewer deviates down BENDS DOWN TO THE NEXT MANHOLE.	6032495	Comment / 0

Fracture circumferential from 7 to 5 o'clock

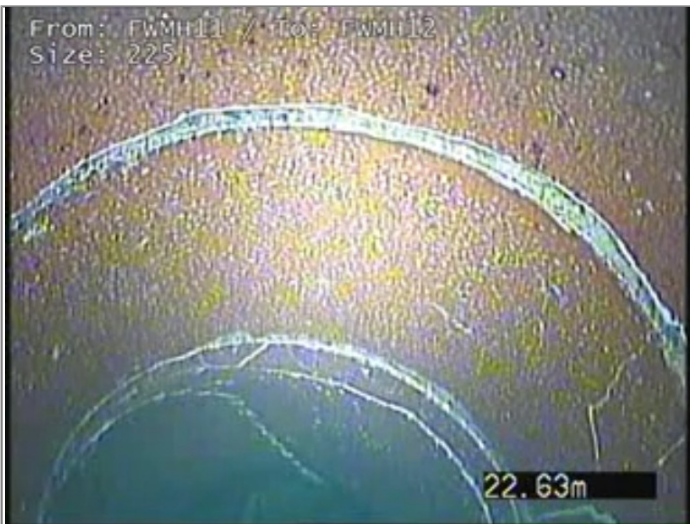
Line of drain/sewer deviates down BENDS DOWN TO THE NEXT MANHOLE.

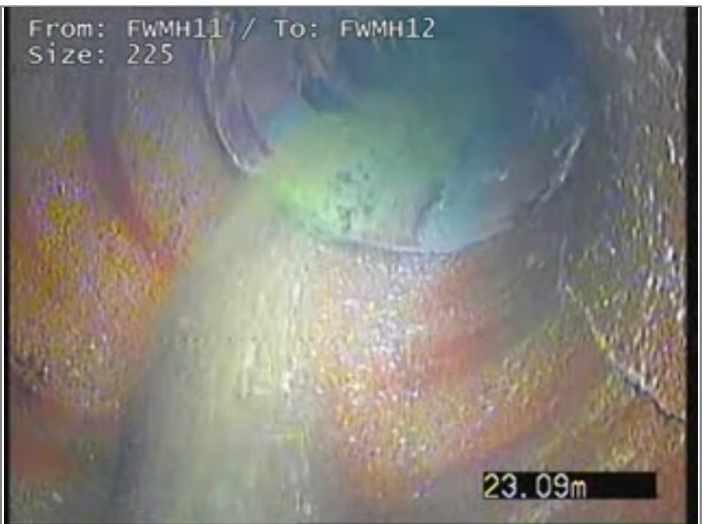
23.09	FL	Fracture longitudinal at 4 o'clock	6032496	Structural / 3
23.51	RM	Roots mass 10% cross-sectional area loss - Remark: IN MANHOLE	6032497	Service / 3

Fracture longitudinal at 4 o'clock

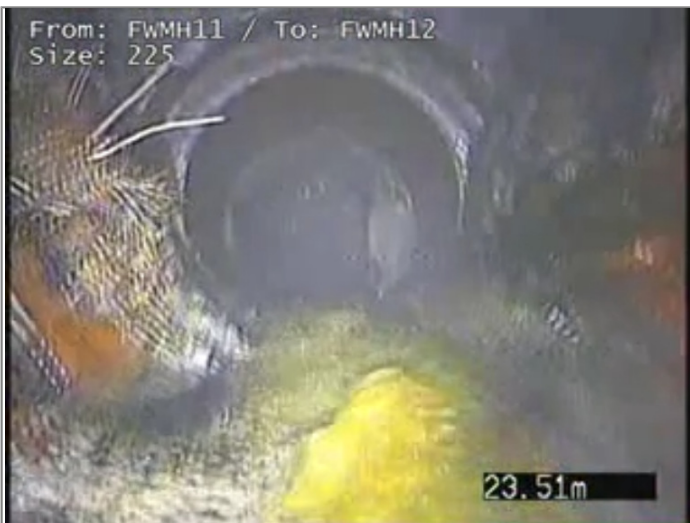
Roots mass 10% cross-sectional area loss - Remark: IN MANHOLE

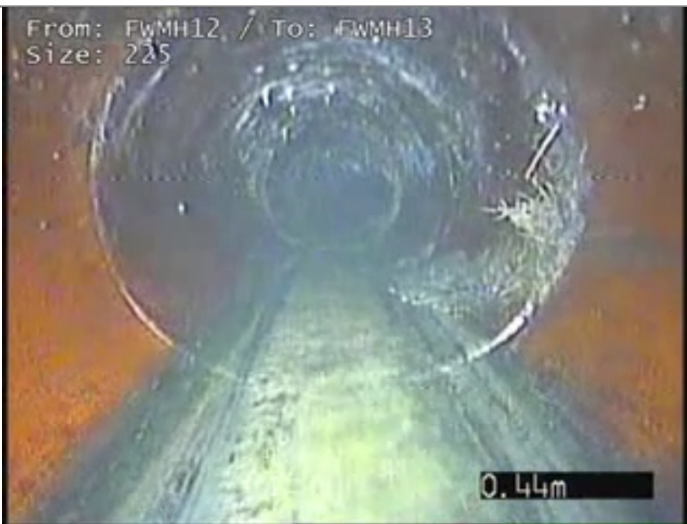
Roots fine at joint

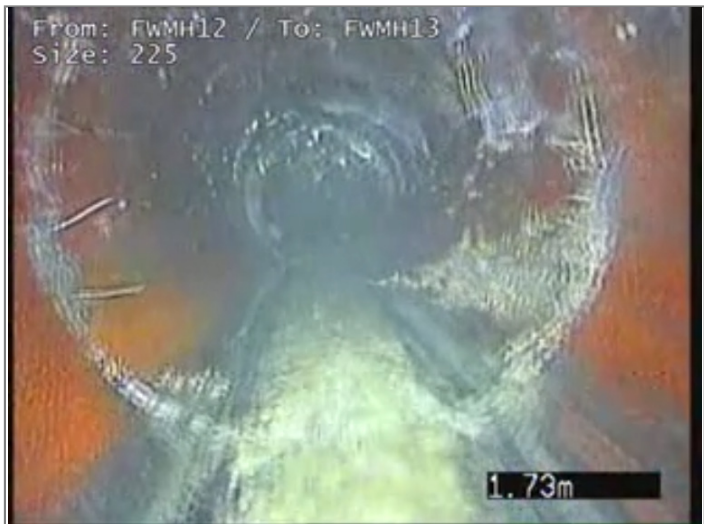
Roots fine at joint

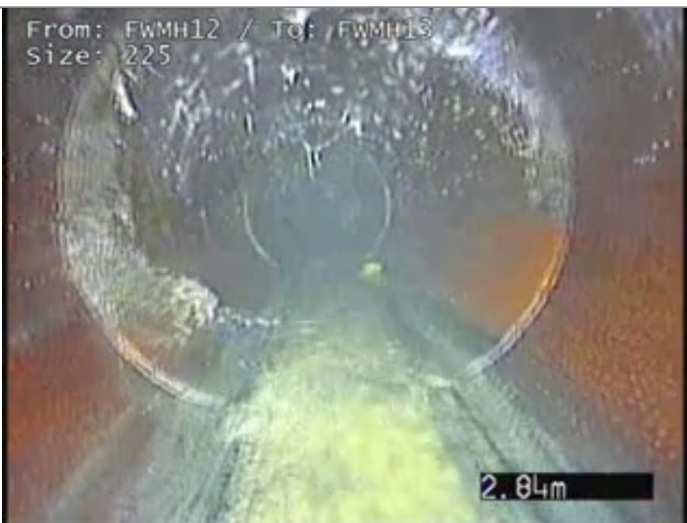
Roots mass 5% cross-sectional area loss at joint

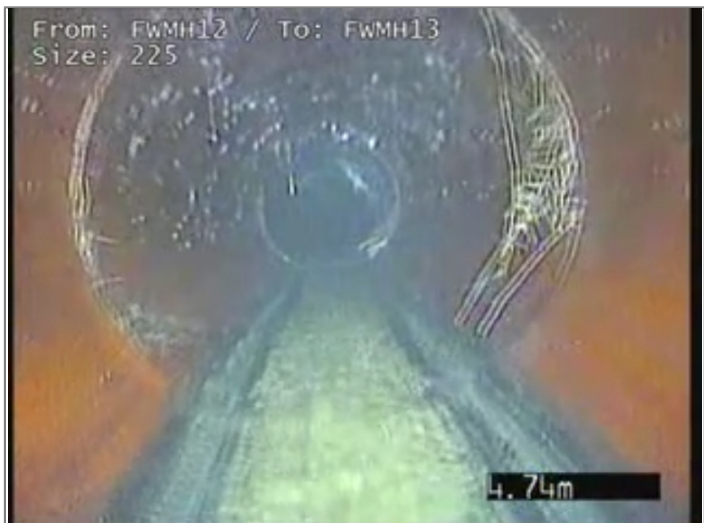
Roots fine at joint

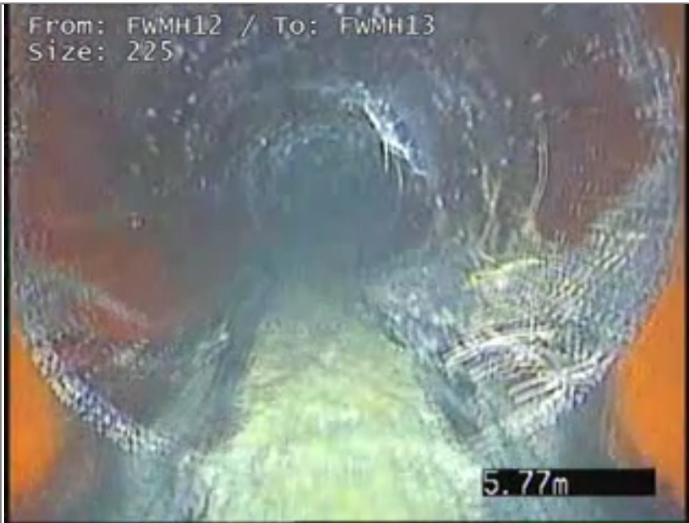
Roots mass 5% cross-sectional area loss at joint

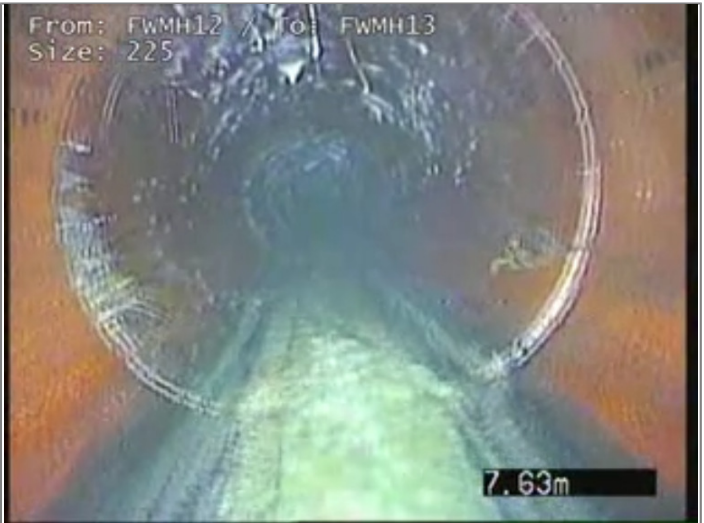
Roots fine at joint

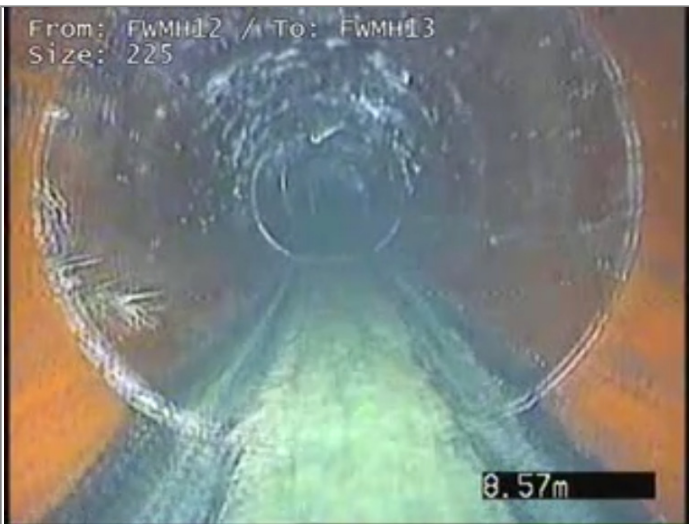
Roots fine at joint

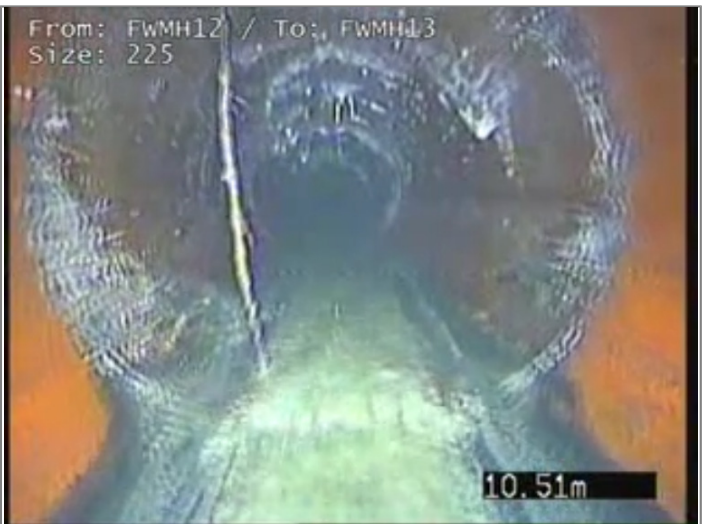
Roots mass 5% cross-sectional area loss at joint

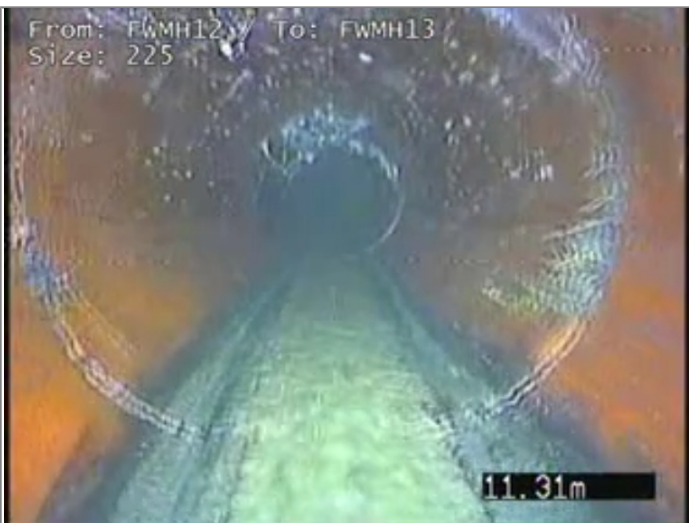
Roots fine at joint

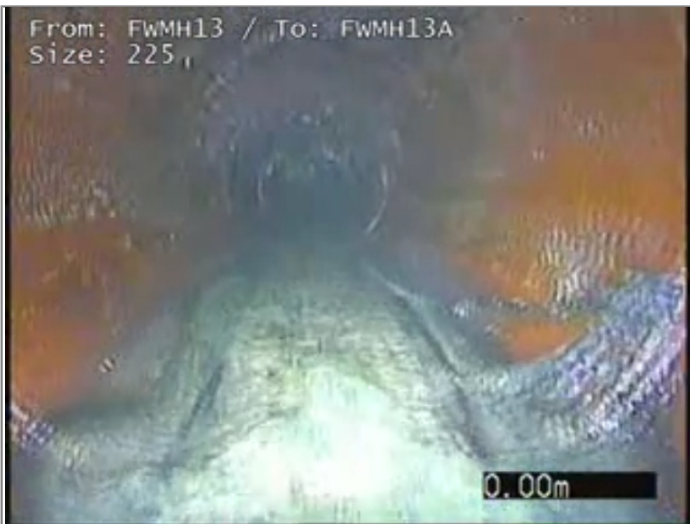
Roots fine at joint

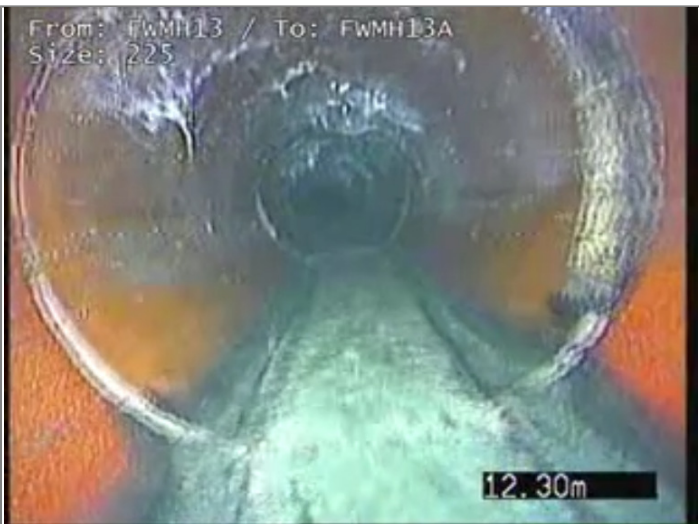
Attached deposits, encrustation from 12 to 4 o'clock 5% cross-sectional area loss at joint

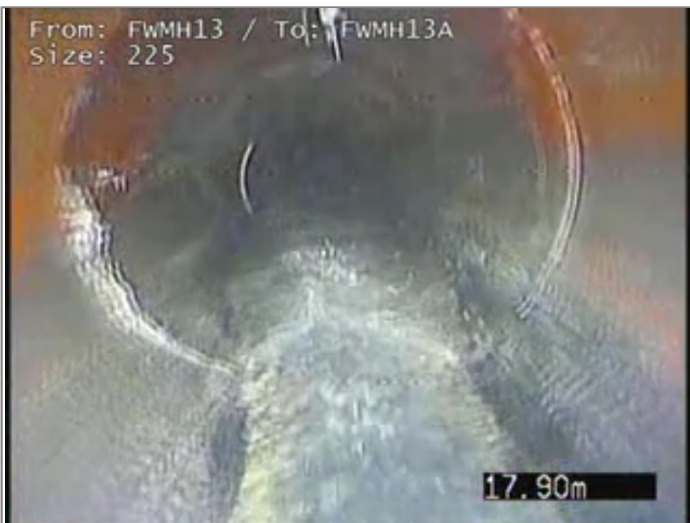
Attached deposits, encrustation at 9 o'clock 5% cross-sectional area loss at joint

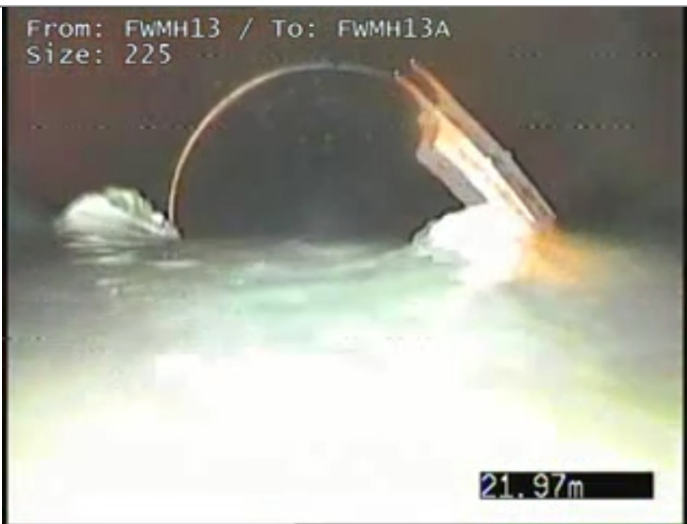
Other obstacles, other from 3 to 9 o'clock 50% cross-sectional area loss -  
Remark: UNKNOWN OBSTRUCTION RESTRICTING FLOW.

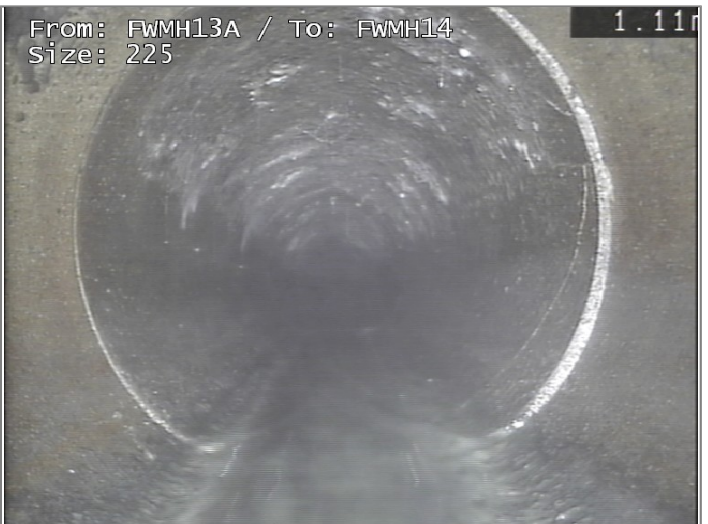
Crack circumferential from 2 to 6 o'clock, at joint

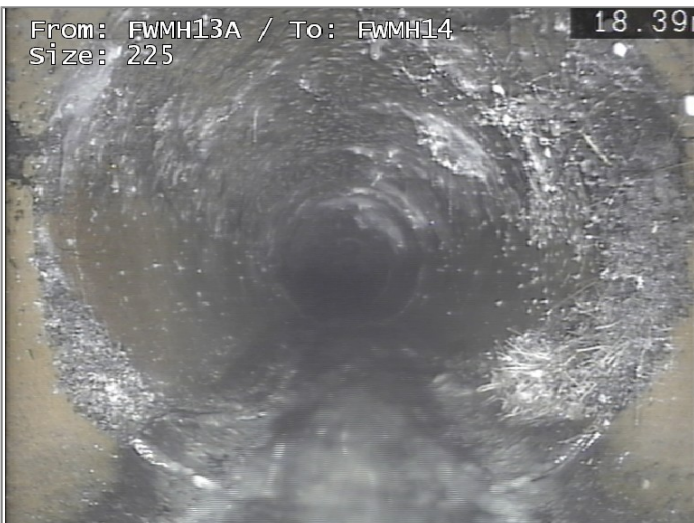
Roots mass 25% cross-sectional area loss

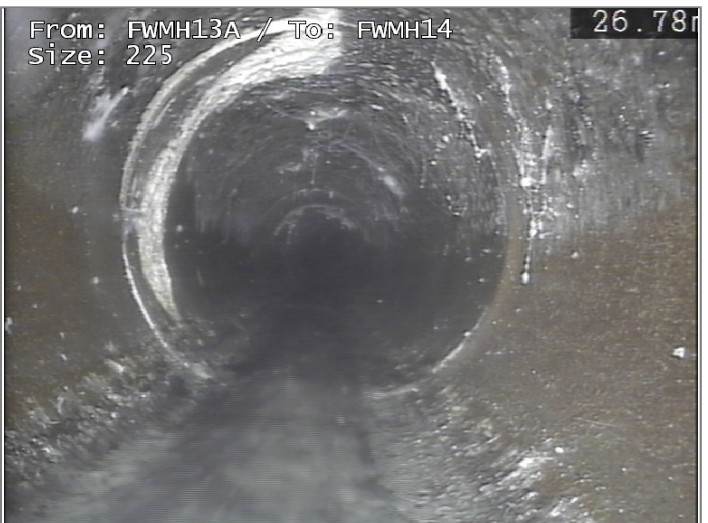
Attached deposits, encrustation from 9 to 12 o'clock 5% cross-sectional area loss, at joint
