**VISUAL STRUCTURAL INSPECTION**

**LONGLANDS FARMHOUSE & COTTAGE  
GOSFORTH  
CUMBRIA**

**AVISON YOUNG**

**Reference - WDS/05/7082/REP01  
Date - 02/06/2021**

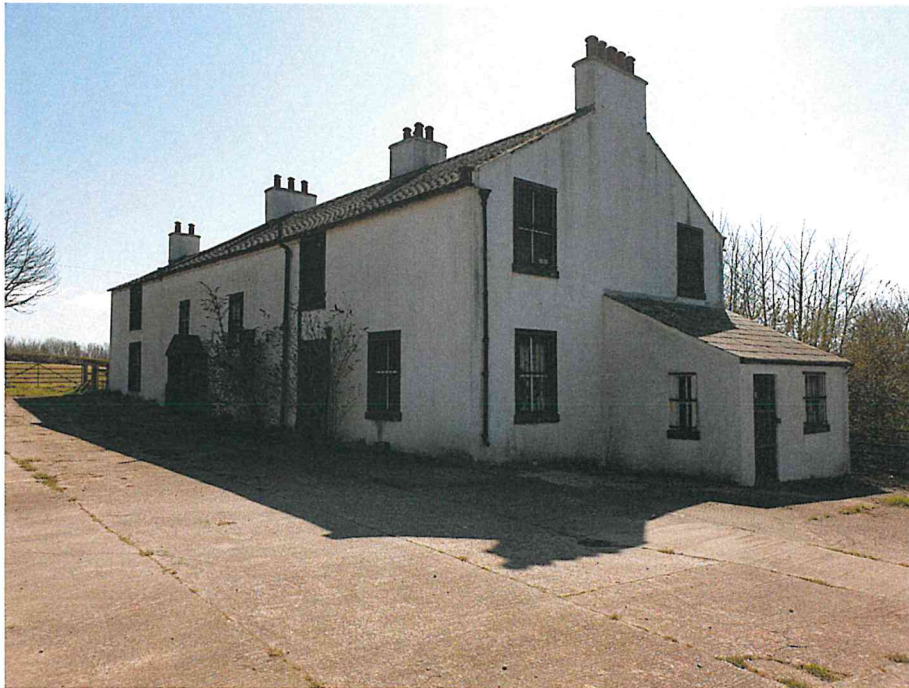
**2.4** Vegetation growth is prevalent around the property with tree saplings and bushes growing near to the house walls. If left these will cause damage to the property and their roots may lead to foundation issues. (See photograph 01)

- The vegetation needs cleaned out from around the property with all bushes and tree saplings removed to a minimum of 10m from the building walls.
- Suitable signage needs erected to warn anyone accessing the property in the future of the dangerous floor to the ground floor area and first floor as noted above. Alternatively the floors can be replaced in a like for like manner where affected.
- A timber specialist needs appointed to inspect the timbers throughout the property to check for active wood worm and rot. Where required suitable treatment should be applied to protect the timber structures from deterioration.
