## **Tree Survey at Croft Lodge Beckermeth**

**3rd June 2022**

**Matthew Jones  
Bsc (Honours) For, Cert.Arb (RFS)**

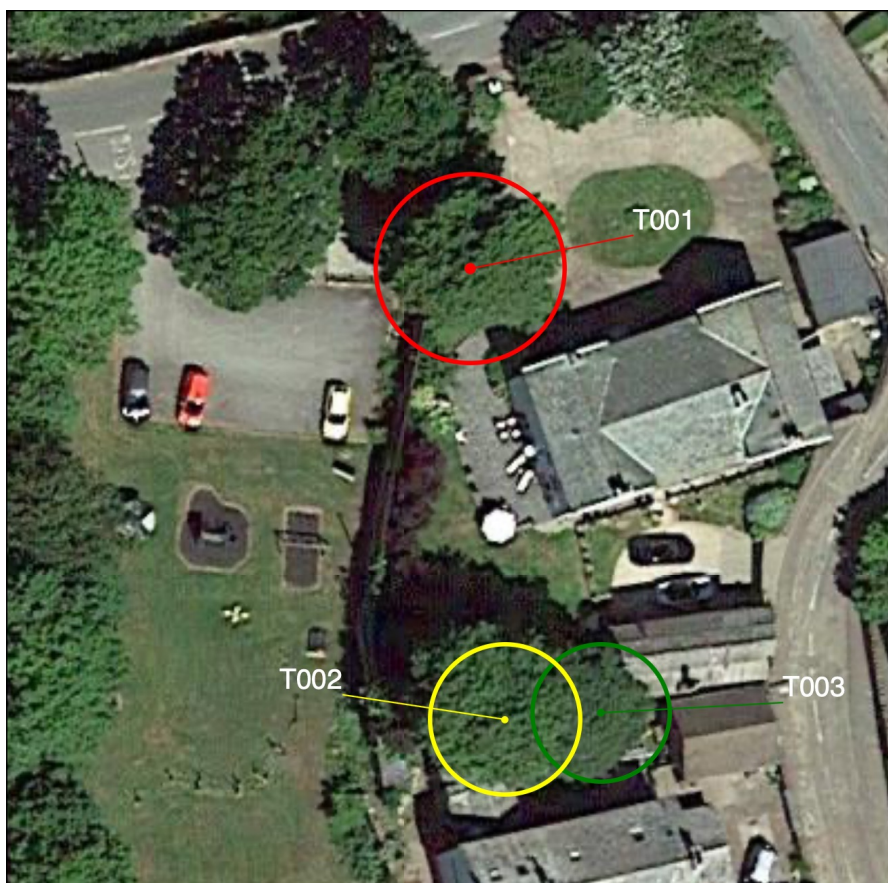
The tree locations can be seen below on the map. The colour is in reference to their risk of harm rating that is co-ordinated throughout the report.

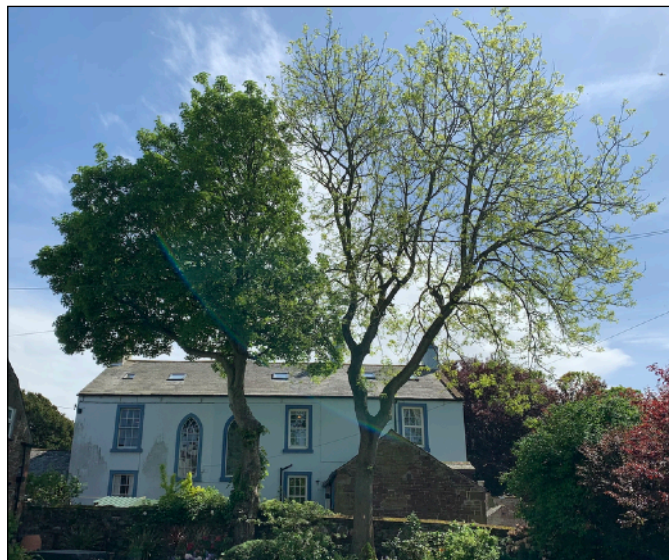
Two other trees were surveyed, an Ash and a Sycamore growing on the southern boundary adjacent the boundary wall. The Ash has been infected by die back, this is caused by a fungus that causes death to shoots leading to a drop in vitality over time. Nearly all trees in Cumbria have been infected within the last three to four years and some of these trees have died. This tree although infected still has a reasonable amount of vitality, there is some dead wood in the canopy that has been recommended for removal due to its proximity to the outbuilding on the neighbouring property. Some light pruning has been recommended to reduce back some of the over hanging branches and to maintain its current size.

The Sycamore is growing adjacent the Ash on the southern boundary and shows little signs of ill health or disease. There are some wounds on the main stem caused by previous removal of the lower branches that have some superficial decay but this is minor and in no way affects the structural integrity of the tree.

The Ash measured 17.5 m with a spread of 6 m and a stem diameter of 560 mm.

The Ash is growing at the bottom of the boundary wall and will have its roots restricted by the foundations.

Figure 8 - Ash and Sycamore on southern boundary

Some minor pruning has been recommended for this tree also concentrating on pruning back some of the over hanging branches.

T002	Ash	<i>Fraxinus excelsior</i>	175	56	6	Mature	Average	Fair	Target # - dwelling. Target # - garden	Ash die back - significant. Dead wood 25mm - 110mm. Splaying at base near wall due to inhibited rooting the wall is also boxing out due root and trunk expansion of tree to South and small retaining wall to North for flower bed has crack in it.	Property(5) £200 - £20	Property	PoF(1) 1/1 - 1/10	1/30K	Remove dead wood, reduce canopy by 1.5m and reduce back overhanging branches by 2-2.5m.
T003	Sycamore	<i>Acer pseudoplatanus</i>	165	60	5.5	Mature	Good	Fair	Target # - dwelling. Target # - garden	Decay on stem old pruning wound, superficial at 45m west, decay in old pruning wounds on neighbours side at 45m, some decay in crown at 9m wound wood development present.	Property(6) £200 - £20	Property	PoF(6) 1/100K - 1/1M	1/3B	Reduce canopy by 1.5m and reduce back overhanging branches by 1.5-2m.
