VISUAL STRUCTURAL INSPECTION

**BARNS ADJACENT TO
MOWBRAY FARM
FRIZINGTON
CUMBRIA**

RC CIVILS

Reference - WDS/05/9202/REP01

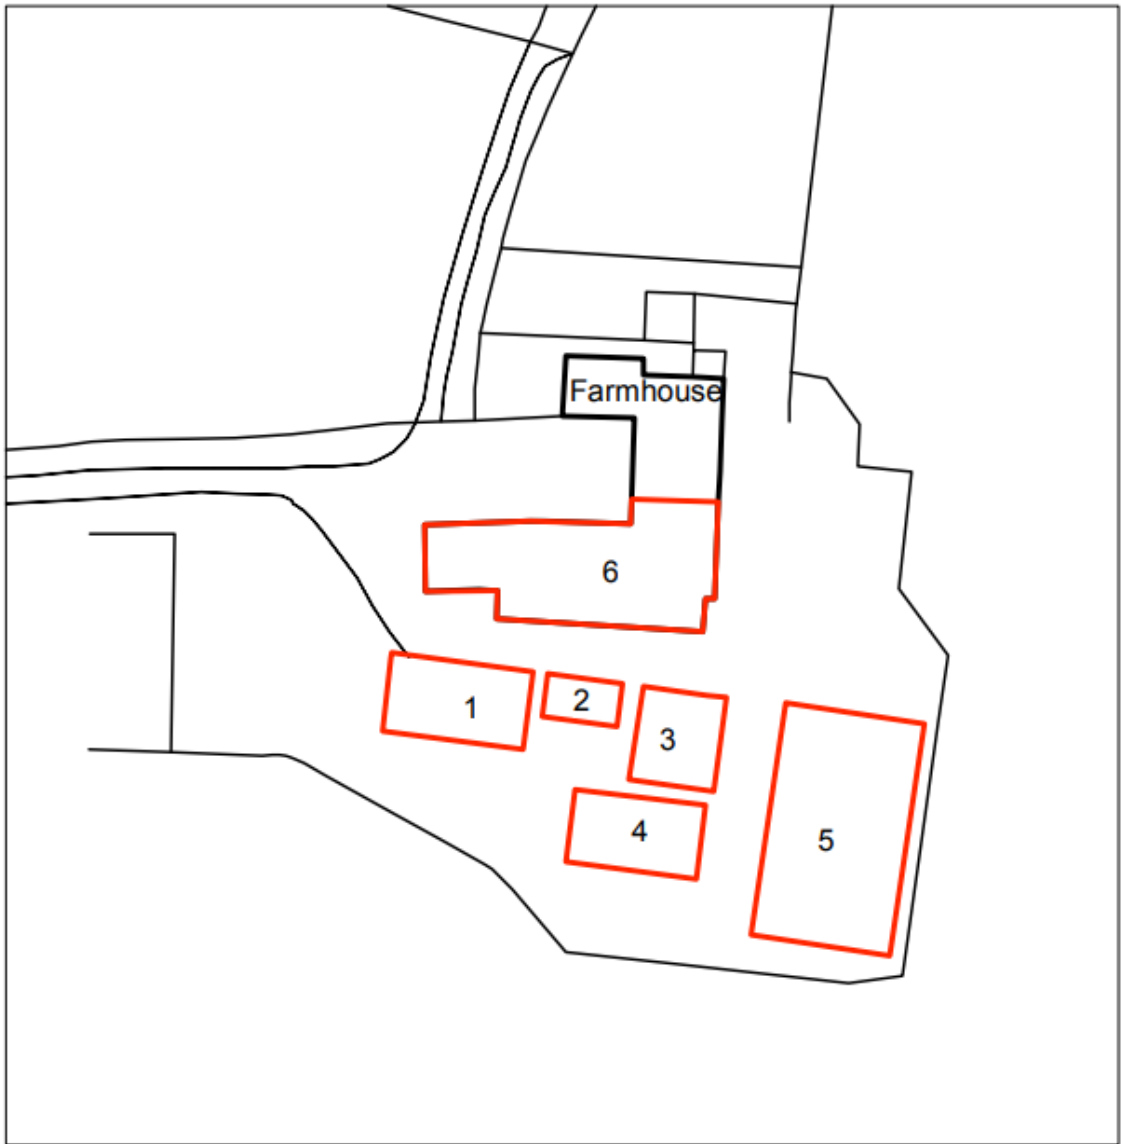
SISKETCH 01 SITE PLAN

- 1.2** There are six barns adjacent to the farmhouse, see attached sketch 01 in the Appendix for the plan layout. Barns 1 and 5 comprise cladded steel framed portal structures (see photographs 01 -04 attached), barn 4 comprises a block built single storey structure with a cladded steel trussed roof structure(see photographs 05 & 06 attached), barn 6 comprises a single and two storey attached building (see photograph 07 & 08) constructed from a combination of rubble filled random stone, clay brick and concrete block masonry walls which support a traditional timber truss and purlin roof. Barns 2 and 3 are to be demolished and have therefore not been inspected or considered in this survey.

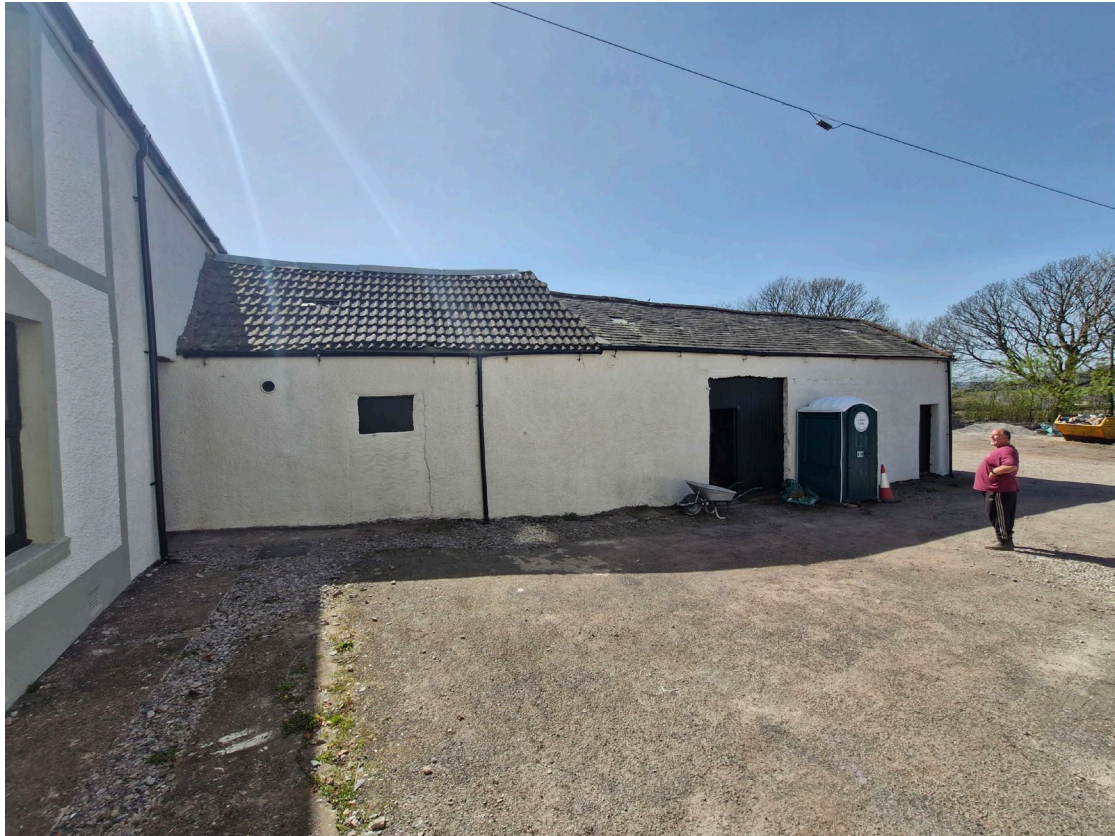
PHOTO 07 BARN 6 FRONT SINGLE STOREY EXTENT

- 2.3** Barn 6 is generally in poor condition due to a lack of maintenance. The walls have numerous cracks and there a numerous rotten/woodworm infested inset timber lintels. The walls to the single storey extent are out of plumb especially to the front and left hand flank walls. There is evidence of separation cracking to the two storey extent gable wall although this appears due to historic movement. The roof structure to the single storey extent is in a poor condition and needs removed; the roof to the two storey extent is in a better condition and could be retained with some strengthening works. See photographs 10-11 attached.
