Project Name: 2021_01_26 Westakes Edge

Inspection Standard: MSCC5 Sewers & Drainage GB (SRM5 Scoring)

CCTV Drain Survey - West Strand Whitehaven

Investigate existing surface and combined drains around the Wellington car park on West Strand for a proposed activity centre.

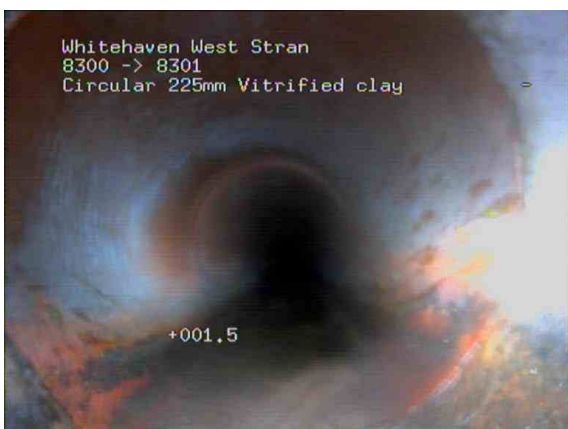
8301X_1da98fdd-661f-4ab8-b1e9-04d584876fa6_20210126_1
03901_309.jpg, 00:00:00, 0.80 m

Start node type, inspection chamber, reference number: 8300,

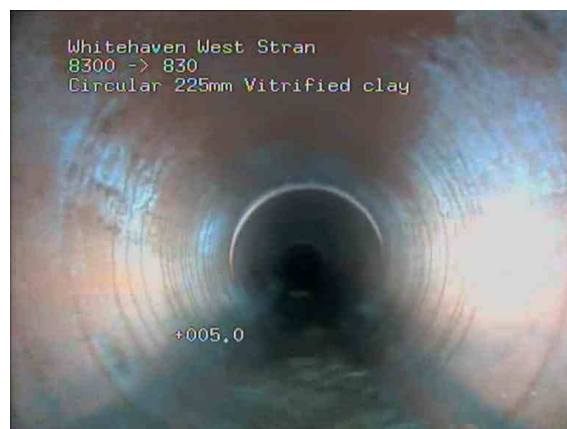
8301X_aa2d6c8e-9fed-46e9-a24e-f756ea440e7b_20210127_
114507_795.jpg, 00:01:18, 5.00 m

General photograph taken at this point, Condition

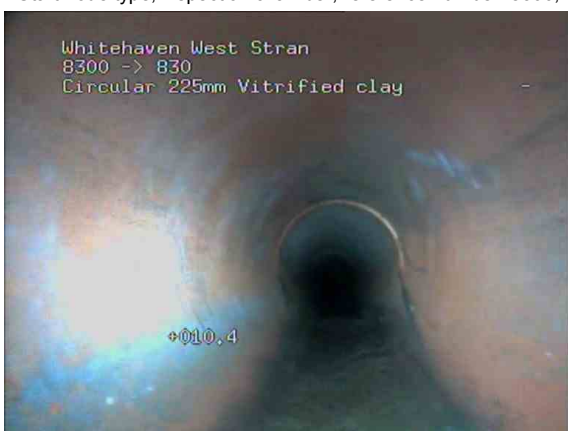
8301X_3151ad97-63fc-41c6-8164-e88e63f17644_20210127_
114637_476.jpg, 00:02:11, 10.40 m

General photograph taken at this point, Condition

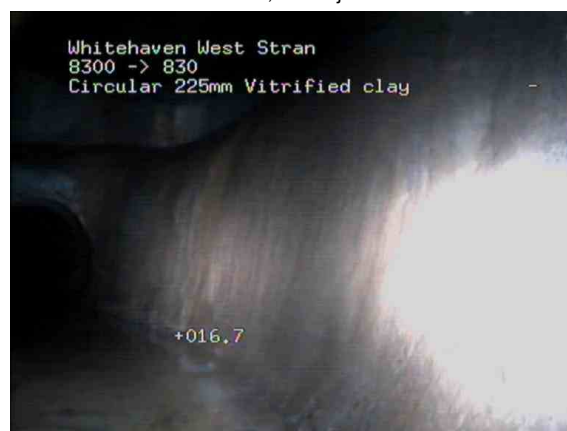
8301X_9bceea9f-0cab-4101-b9a0-6ba34ffe39a2_20210126_1
04320_173.jpg, 00:03:22, 16.70 m

Finish node type, inspection chamber, reference number: 8301,

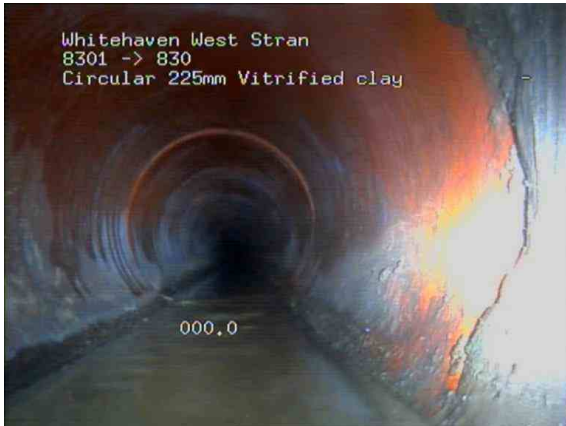
8302X_4badc144-3f9f-4f42-8869-63380eace53e_20210126_1
04617_262.jpg, 00:00:00, 0.00 m

Start node type, inspection chamber, reference number: 8301

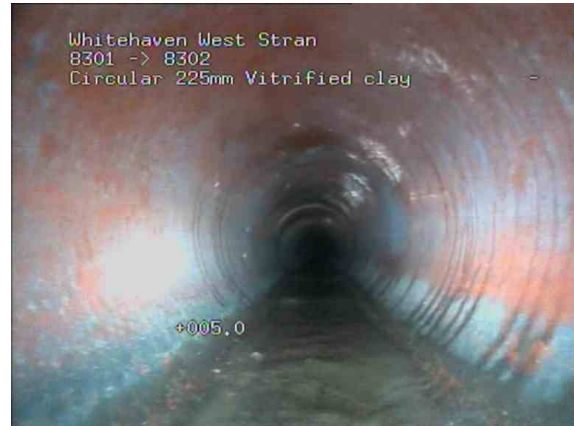
8302X_922f4a4c-8ee1-4808-aaaa-3bfa3a809fd8_20210127_1
15306_921.jpg, 00:00:52, 5.00 m

General photograph taken at this point, Condition

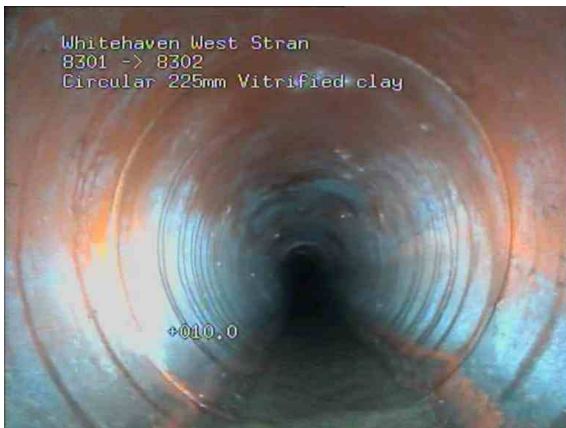
8302X_ccdf0247-59c6-44ff-9753-ed91a7579fb4_20210127_1
15435_871.jpg, 00:01:47, 10.00 m

General photograph taken at this point, Condition

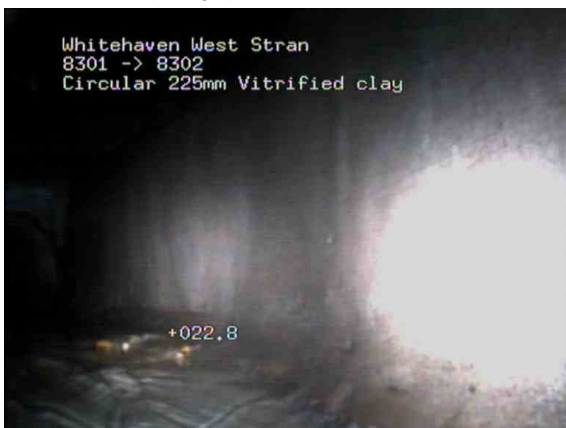
8302X_bed0a4b6-edeb-4f87-aaed-e52f4edcbde4_20210127_1
115915_541.jpg, 00:04:05, 22.00 m

Finish node type, manhole, reference number: 8302, End of

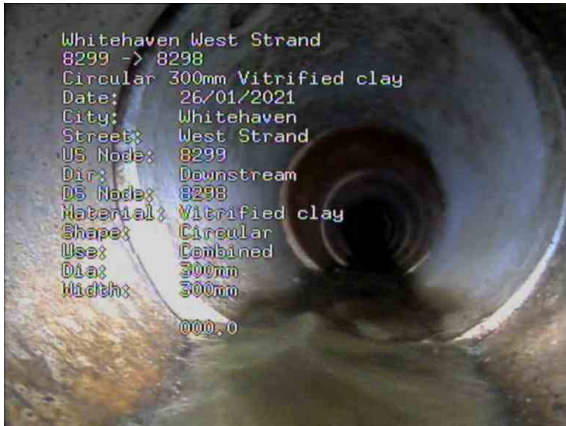
8299X_1344ac32-634a-49b2-b580-d77ae9ad10a9_20210127_133605_212.jpg, 0.00 m

Start node type, manhole, reference number: 8299, By Lamp
