# HERITAGE IMPACT ASSESSMENT

BARN AT BARWICKSTEAD,  
BECKERMET — 22 February 2022

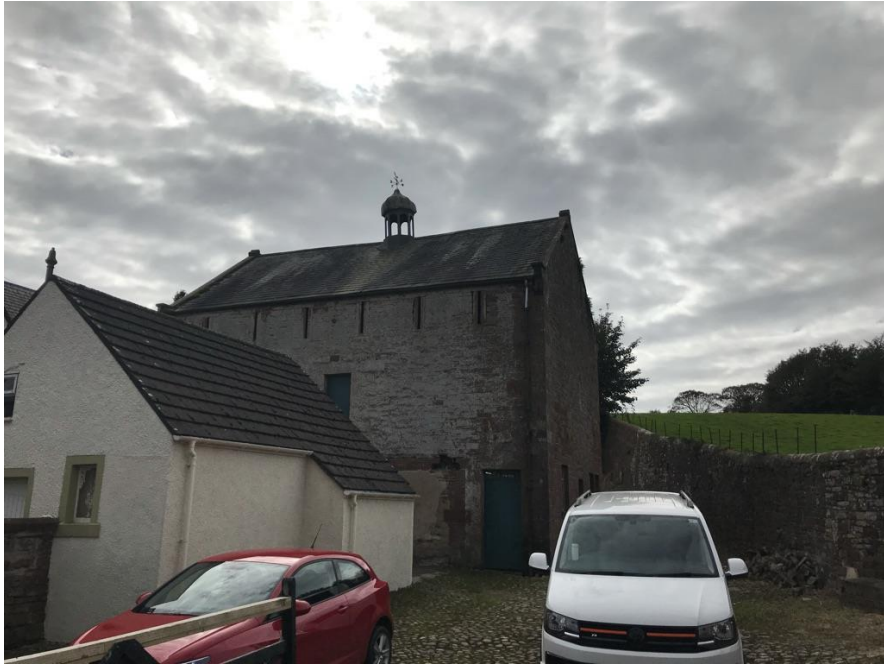
Street frontage with pitching door part obscured by modern garage

The lower ground floor elevation to the street are in part obscured by the modern detached garage, and this will remain. There is evidence however of alterations to this façade and the location of previous lean-to buildings now removed. This elevation in part has lime wash and render applied to the sandstone face obscuring the stone face. There are several areas of dislodged / or removed stonework and part of this works these areas will be re-instated with stone already on site.

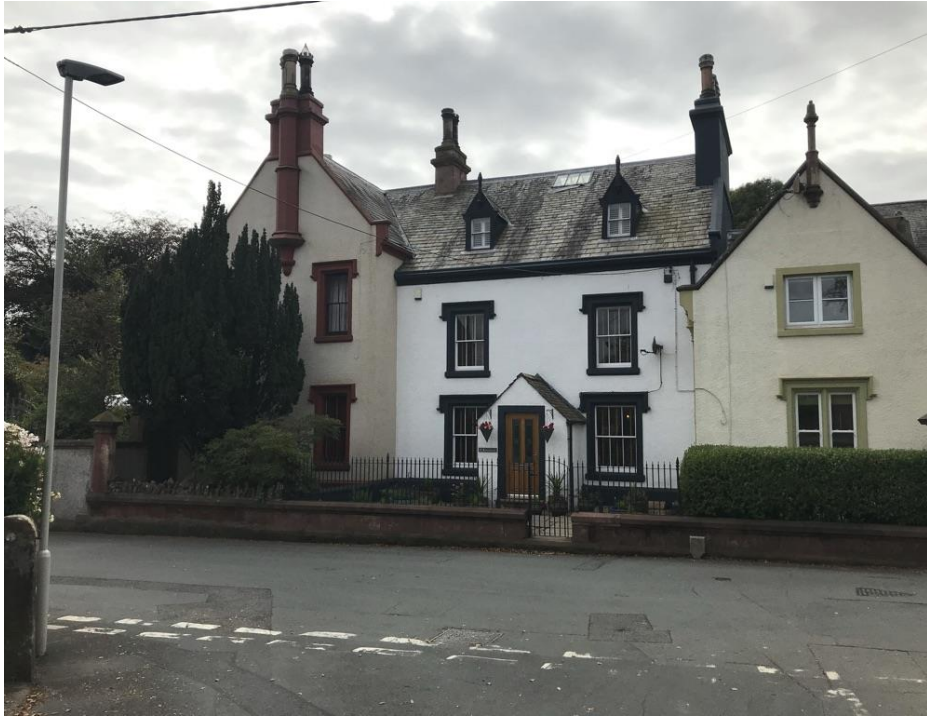
Main House ( now subdivided ) at Barwickstead - high level rooflight on main house replicated on barn with less formality - proposed use of dormers not appropriate for a conversion scheme.

In addition to the above it is proposed to insert conservation rooflights into the roof plane on the front façade. The purpose here is to introduce natural daylight ( morning light ) into the main living space. Whilst the preference would have been to introduce new windows the sensitivity and simplicity of the front elevation is recognised and therefore this insertion is felt to be

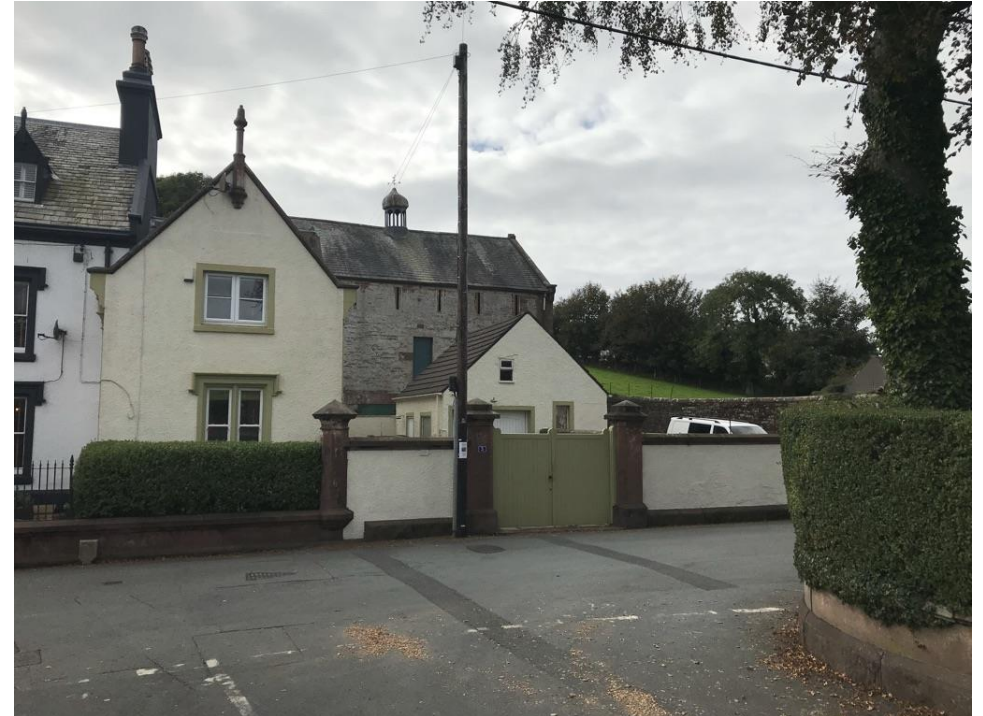
View of barn to rear of site and partially obscured by modern detached garage. View taken from adjacent road junction, views from highway reduced due to existing boundary wall heights and location of garage.

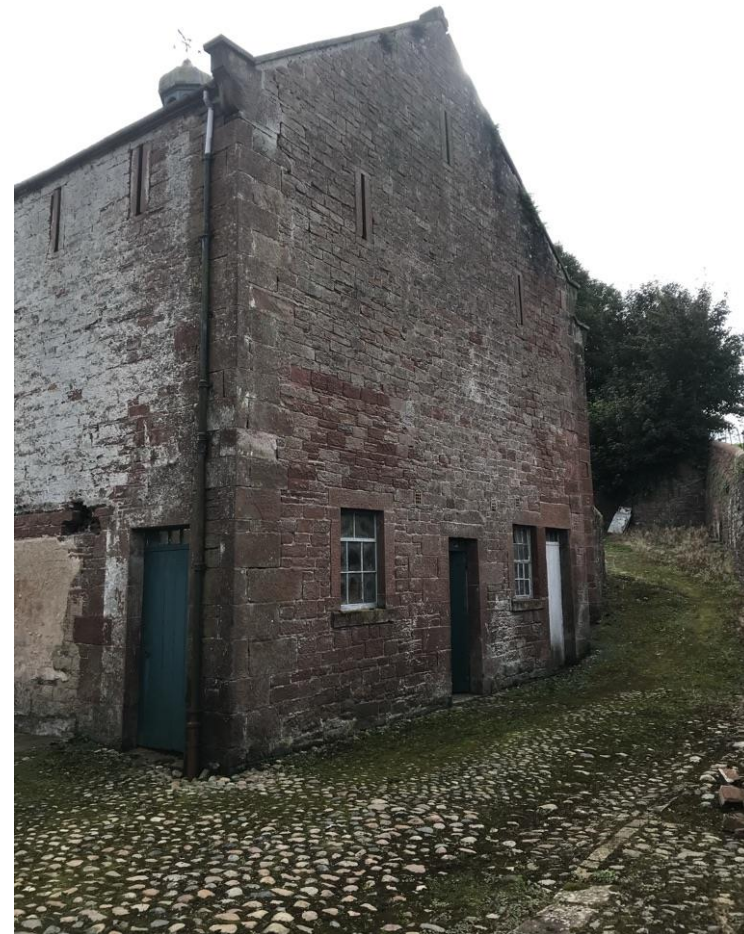
North Gable elevation with retained cobbled paving, upper floor new windows designed to reflect detailing of the lower ground floor windows

To create suitable internal daylight it is proposed to insert four new windows within the sandstone gable of the building. To upper floor windows are enlargements of the original ventilation slots, these remain and repeat across the main façade.

Below these two further windows are introduced, given the regularised nature of the barn, these apertures mirror the upper windows in scale and proportion. In acknowledgement of the detailing below these have sandstone heads and cills to match. It is acknowledged that this alteration does see a variation to the original building and indeed on a visible elevation. The scale and proportion of the windows does align with the original building intent and with windows recessed into the walling the shadowing provides the appropriate setting for these windows.

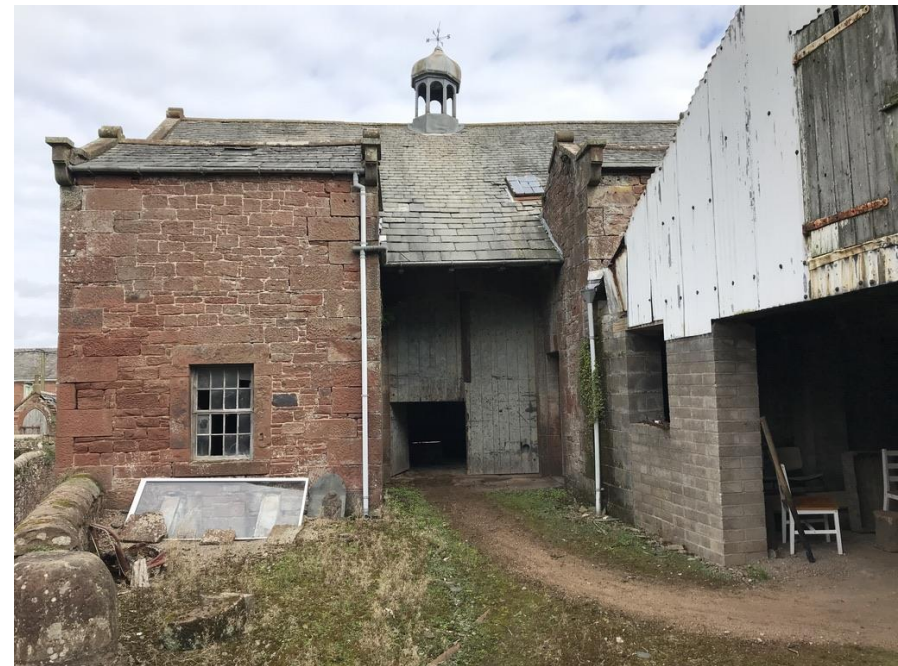
View looking East, modern gin house wall to be moved back to allow view of existing symmetrical turreted sandstone rear outriggers

Decay and rot to the current gin house structure has been identified and repairs to the original timber structure is beyond repair. The proposal seeks approval for reducing the depth of the gin house by a single bay and therefore sees the removal of the modern steel frame and block work structure to the front bay. Alongside this the corrugated metal façade will be removed and replaced with a more sympathetic timber elevational treatment.

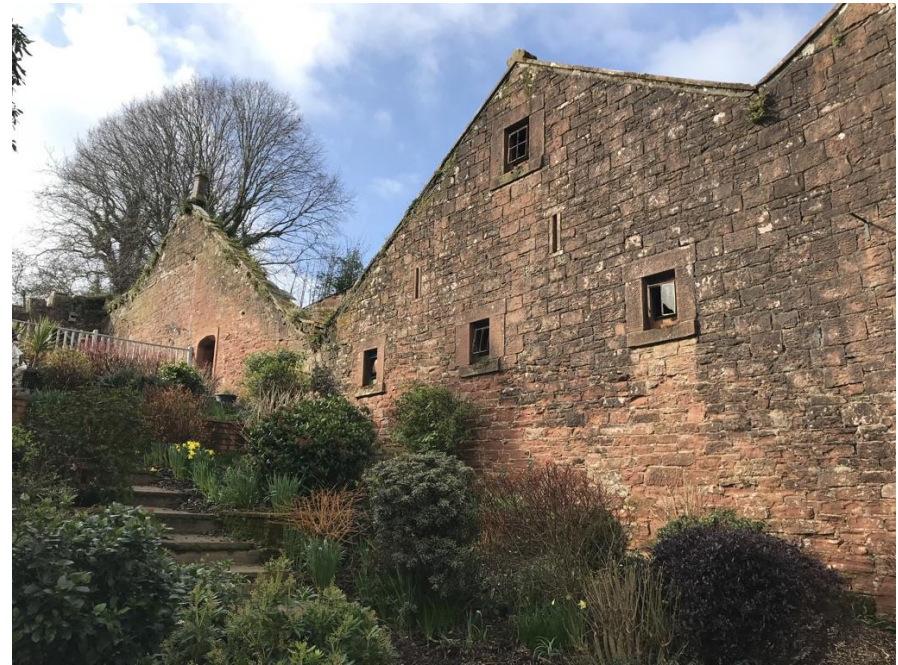
Gable wall to South, garden to Barwickstead with profile of the gin house shown central. The Western gable forms the stabling / boiler house and is to remain unaltered

This design now allows for full retention of the gable profile of the gin house bounding Barwickstead. It also sees the removal of the modern gable elevation. Due to the extent of decay in the timbers the current timber beams, pillars and truss are due to be

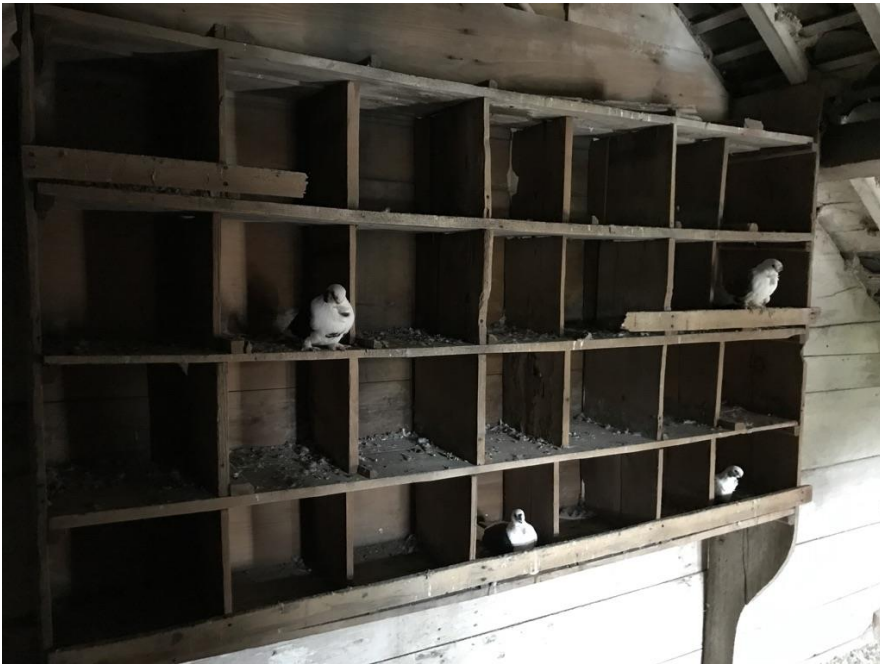
Original photo 2019 prior to access stair becoming unsafe

The upper ground floor is a double height space with high level pigeon loft to the southern gable, which is accessed by a winding timber staircase which is in part collapsed due to woodworm infection.

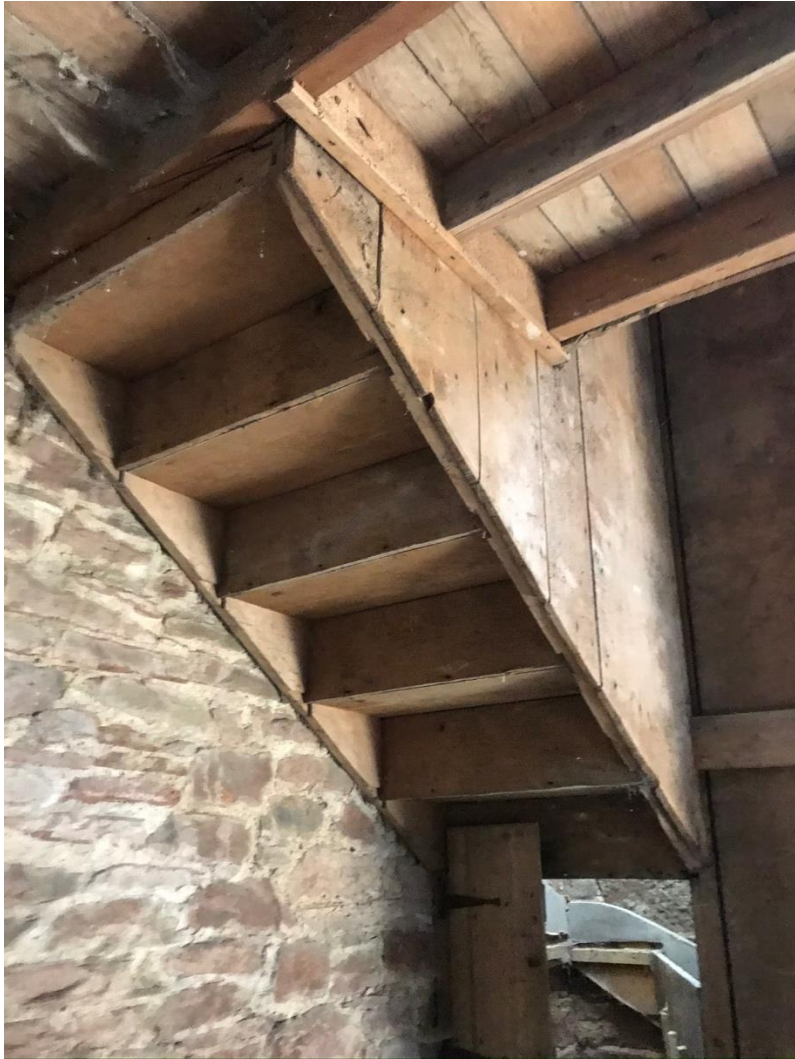
Access stair to pigeon loft - collapsed winder stair shown preventing access to loft level

To the south gable the current pigeon loft will be repaired / re-instated when safe access is gained, to allow this a full replacement winder stair is required to be re-constructed. This will remain as designed floating within the loft area of the barn and siting on the bottom chord of the king post truss.

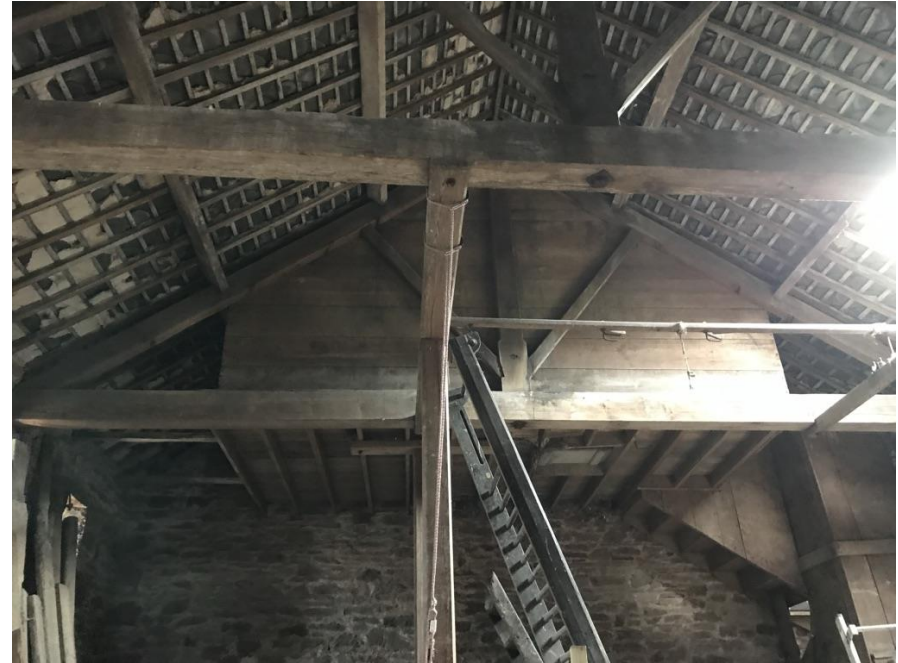
Double height barn with kingpost truss and pigeon loft bearing on truss chord

3. Roof Truss - the existing king post trusses will be retained within the building and exposed as a feature - all timbers will be retained and treated for woodworm following a high level inspection. It is the intention to retain similarly the purlins forming between the trusses ( in contradiction to the SE report ), this was required due to the additional loadings placed upon the structure as a result of the thermal upgrade, however as the barn is now a Listed Building the thermal upgrade can be limited to within tolerance of the current roof structure.

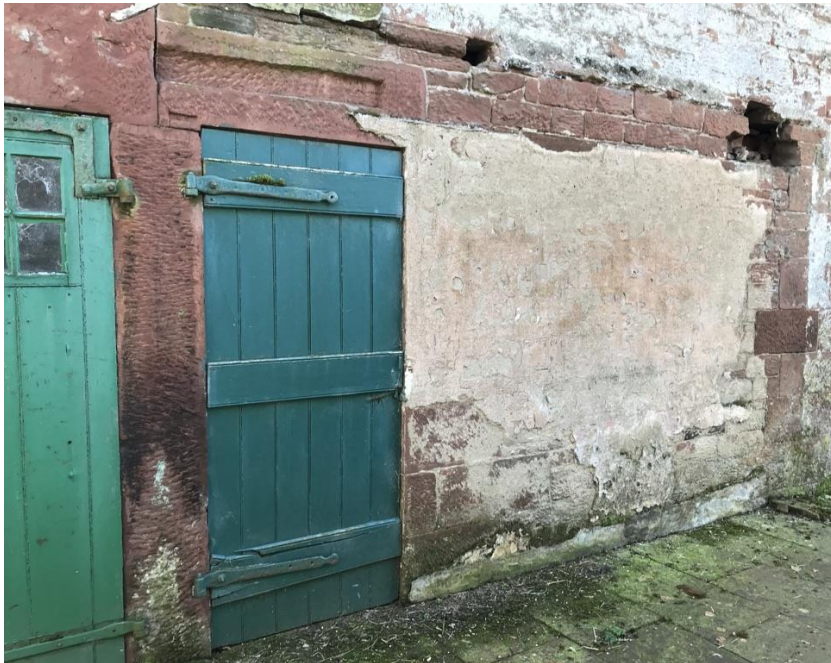
Limewash to existing wall in area of previous structure. Stonework to be patched into existing wall and sourced from sandstone on site

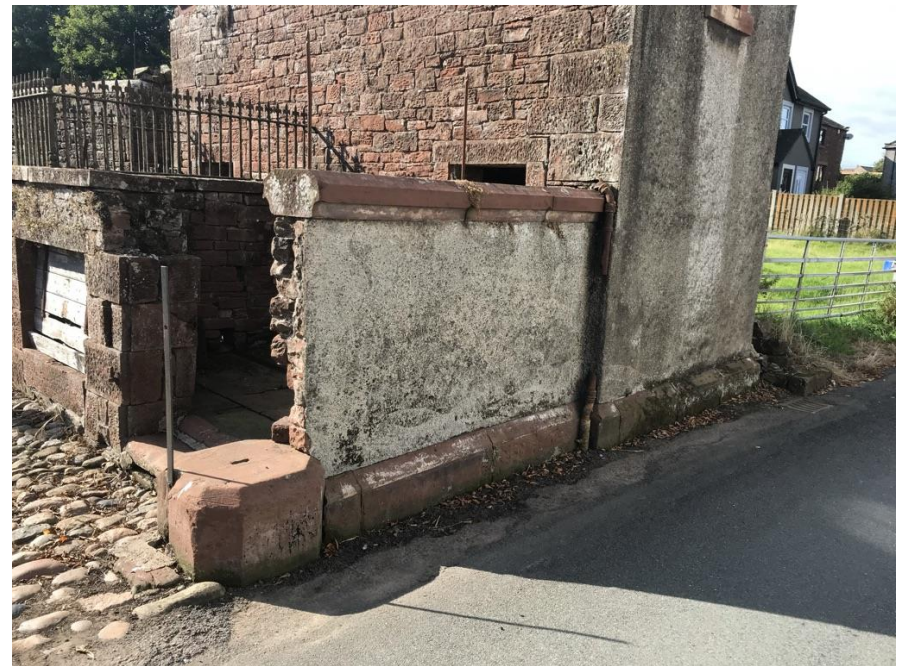
Former gate stoop to North corner of site - matching gate stoop to South corner of gate now lost as part of earlier entrance widening

The barn sits behind a high rendered stone wall with copings, this shows significant sign of distress and requires localised repairs. Originally two octagonal stone gate stoops formed the entrance to the site, this has been removed to allow improved access into the site which has limited visibility to the highway. Evidence of the right hand gate stoop remains on site.

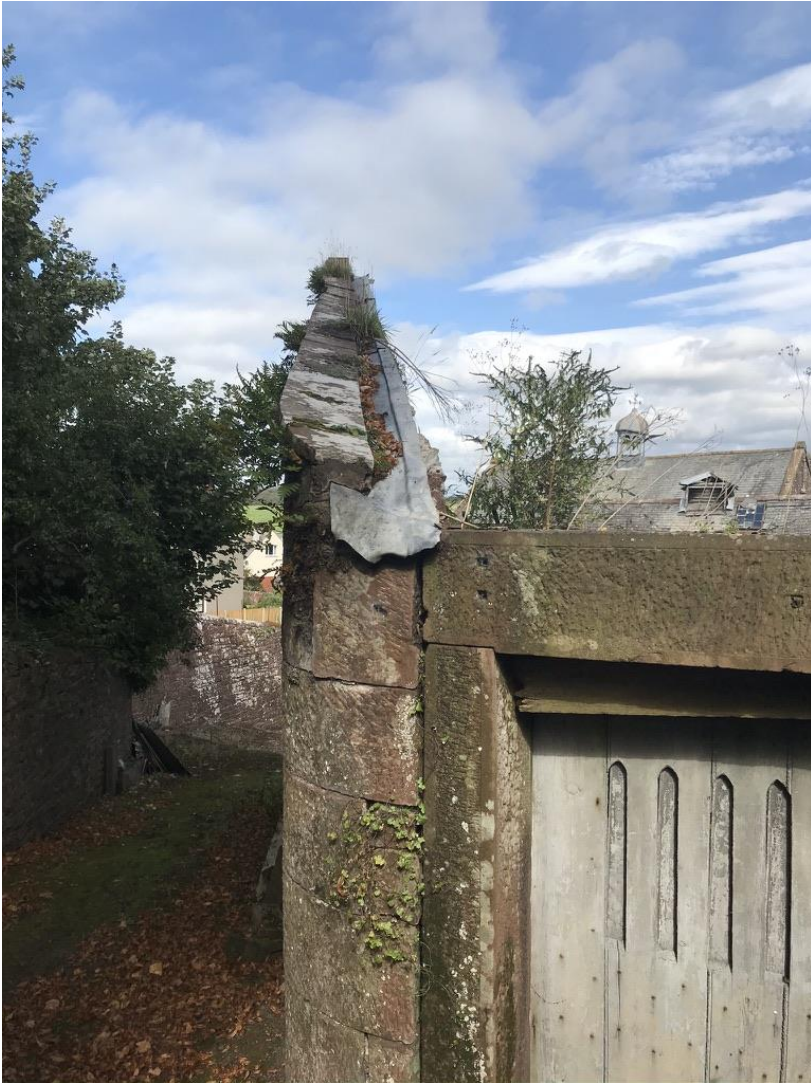
Remaining elements of the stable / boiler house with parapet and leadwork in tact, roof has been collapsed for over twenty years. Works will stabilise the wall and allow long term retention of the built form.

To the West of the gin house, existing outbuildings remain believed to be stabling and boiler house, with roofs removed it is not intended to complete further works in this area beyond clearing out the collapsed roofs and vegetation to open up the space. This may be reviewed if significant evidence is uncovered of further interesting historical materials within this area and referred back to the Conservation Officer.

The existing timber doorway openings between the gin house and stabling will be re-formed as part of the works and the structure stabilised. There are no proposed plans for re-roofing / re-building of this building and works will be limited to sealing / making good to wall tops to prevent further water ingress and potential wall spread, this forms standard builder works. There is no requirement to provide further survey / structural report to this area as no works are proposed.
