## **PROPOSED RESIDENTIAL DEVELOPMENT, RAILWAY TERRACE, SEASCALE**

### **FLOOD RISK ASSESSMENT**

## Flood Investigation Report 31

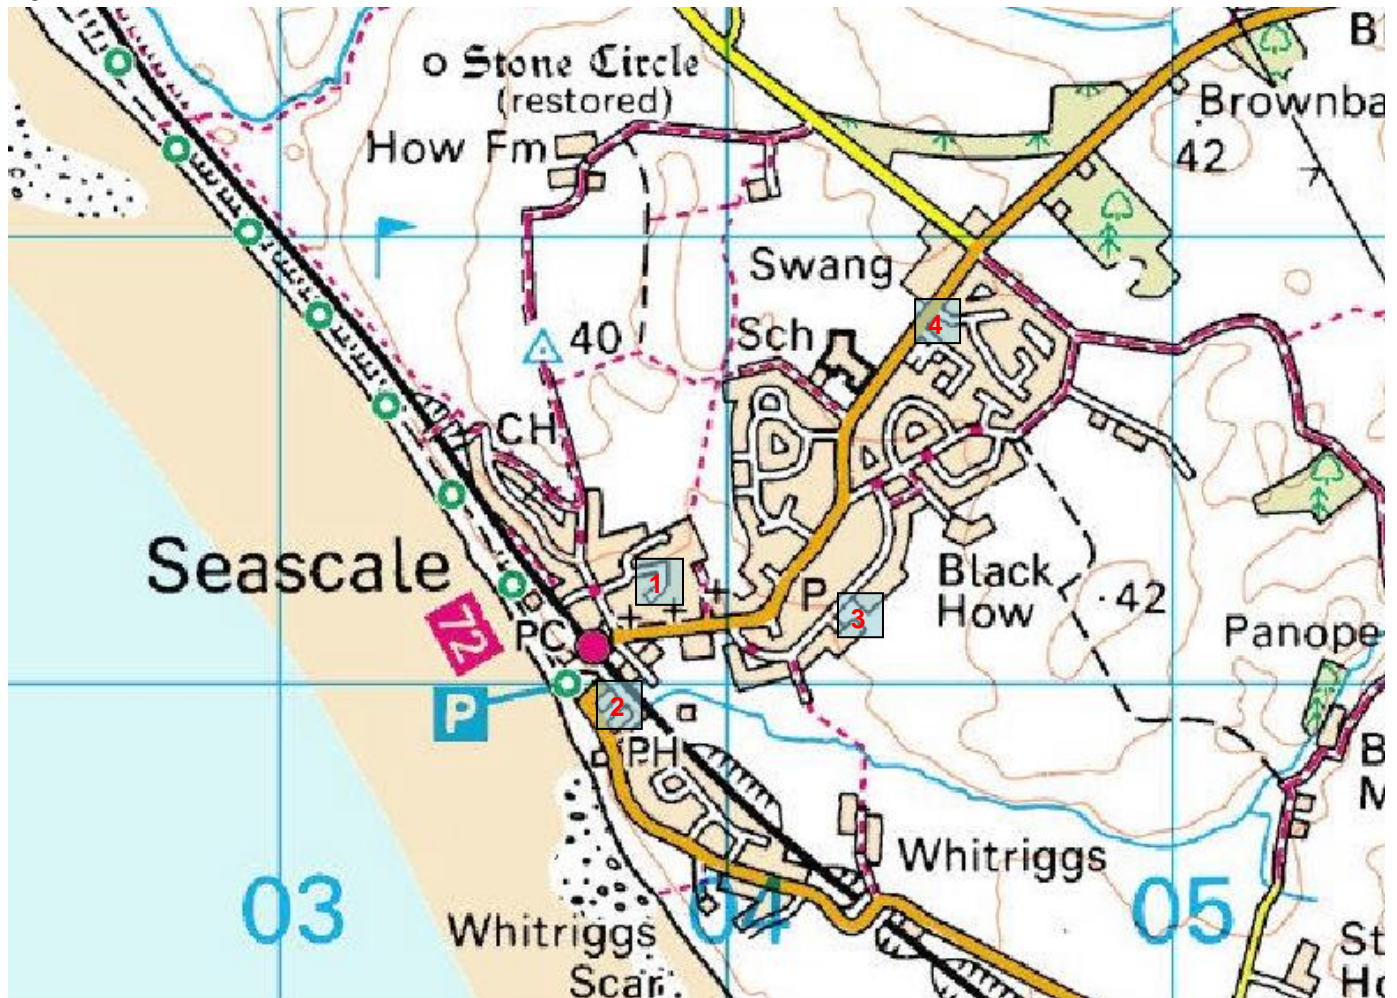
Figure 1. Map showing the location of the flood areas.

1. The Fairways
2. Railway Terrace
3. Santon Way
4. Swang Farm

Figure 1 illustrates the locations affected during the heavy rain that occurred on the 30<sup>th</sup> August 2012.

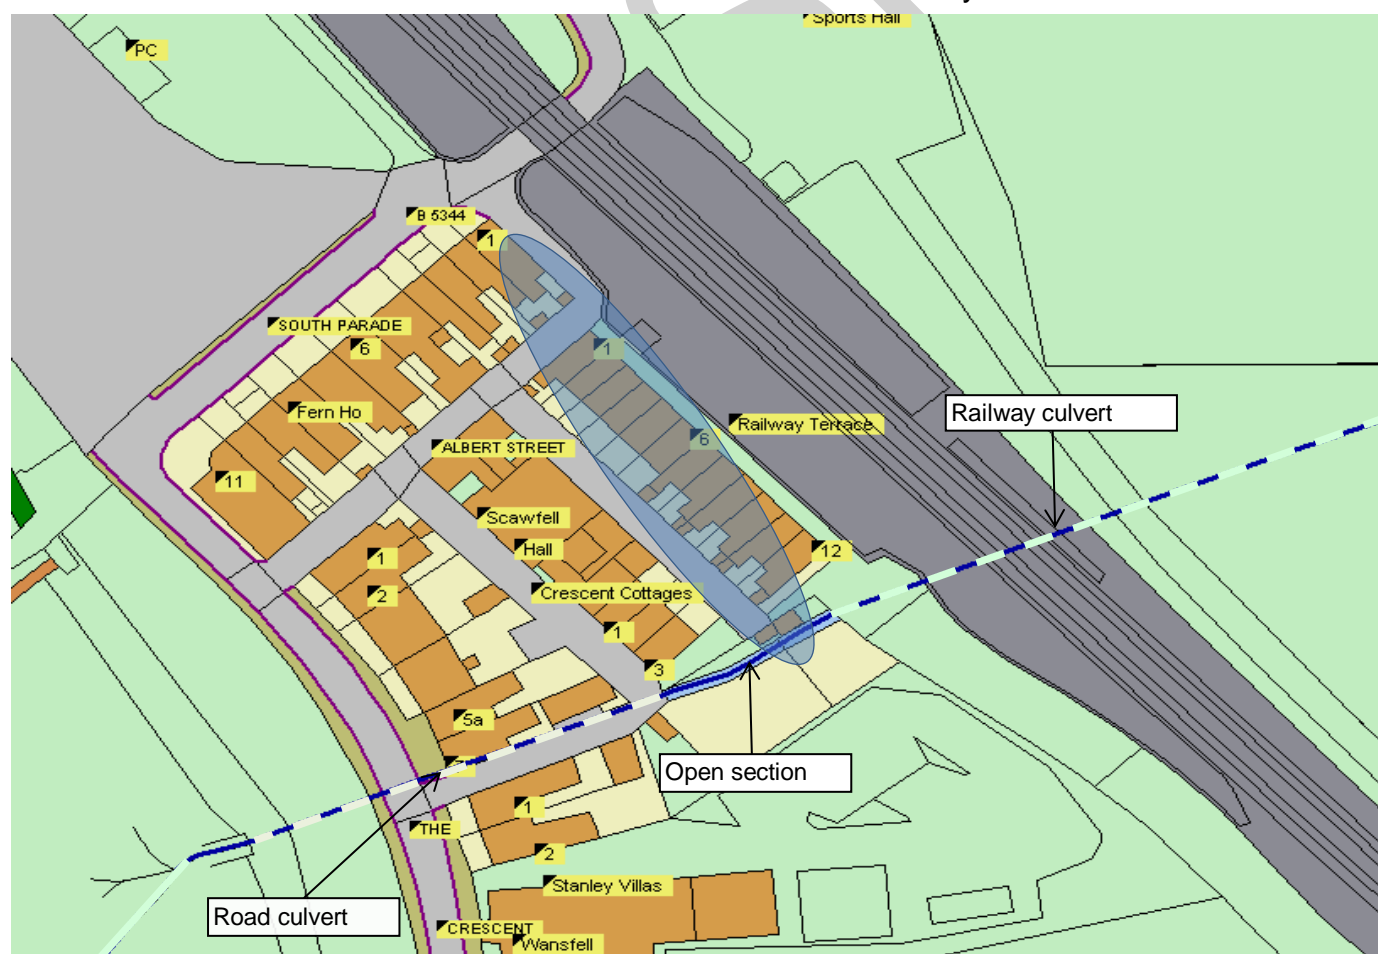
**Figure 5** Plan of the Railway Terrace and Albert Street area showing the line of the culverts and the location of the flooding.

through an extended culvert under a BMX track and under the railway embankment. In the yard of 12 Railway Terrace, the beck is partly in culvert but also in open channel bounded by a wall. The wall has drainage holes made by residents to drain highway areas in normal rainfall conditions. This arrangement was reversed during the flood event. The beck surcharged and water came through holes, over the small wall and flooded adjacent properties. Whitriggs Beck then runs through a further culvert under Drigg Road and outfalling into the sea 80m downstream.

The road culvert is an arch 1.59m high x 1.28m wide while the railway culvert is a 1m high x 1.16m wide box (at the other side of the embankment it is a 1.2m diameter pipe so it is smaller at the outlet than at the inlet). Residents have concerns that it is not cleared on a regular basis. A CCTV survey was carried out to check the condition of the road culvert. While there is some rock in the culvert, it must carry bedload as well as water.

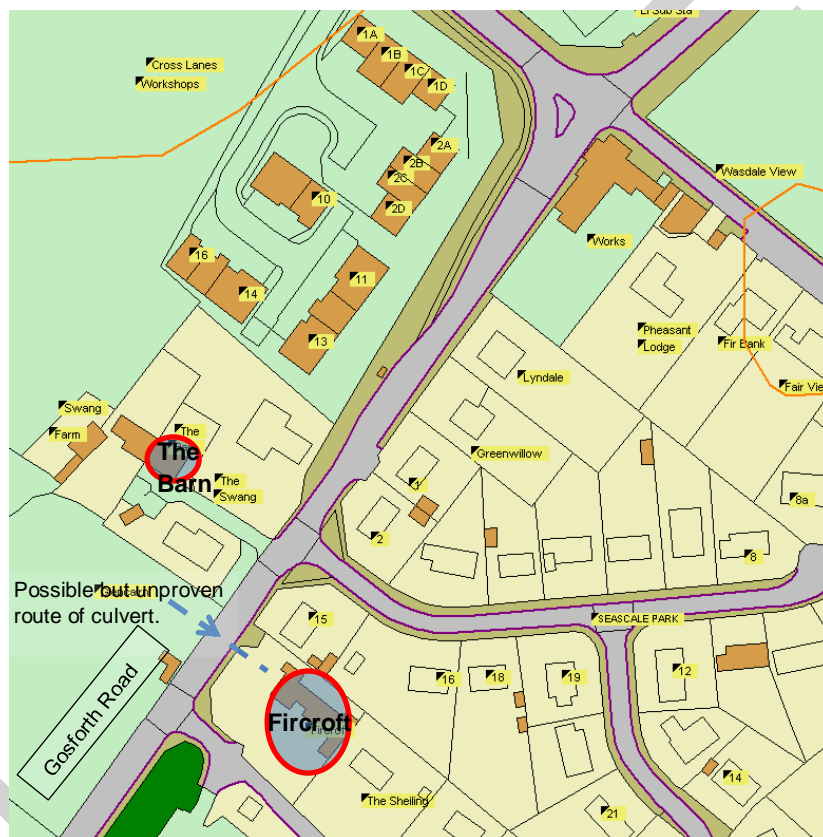
**Figure 7 Location of the two properties reported to have suffered flooding in the Swang Farm area**

Two properties at the northern end of the village were reported to have suffered from flooding. There are no mapped watercourses in this area, although there is a suspected culvert near 'Fircroft'. The general slope direction, and therefore the route surface water, is from the fields to the northwest of Gosforth Road towards the southeast.

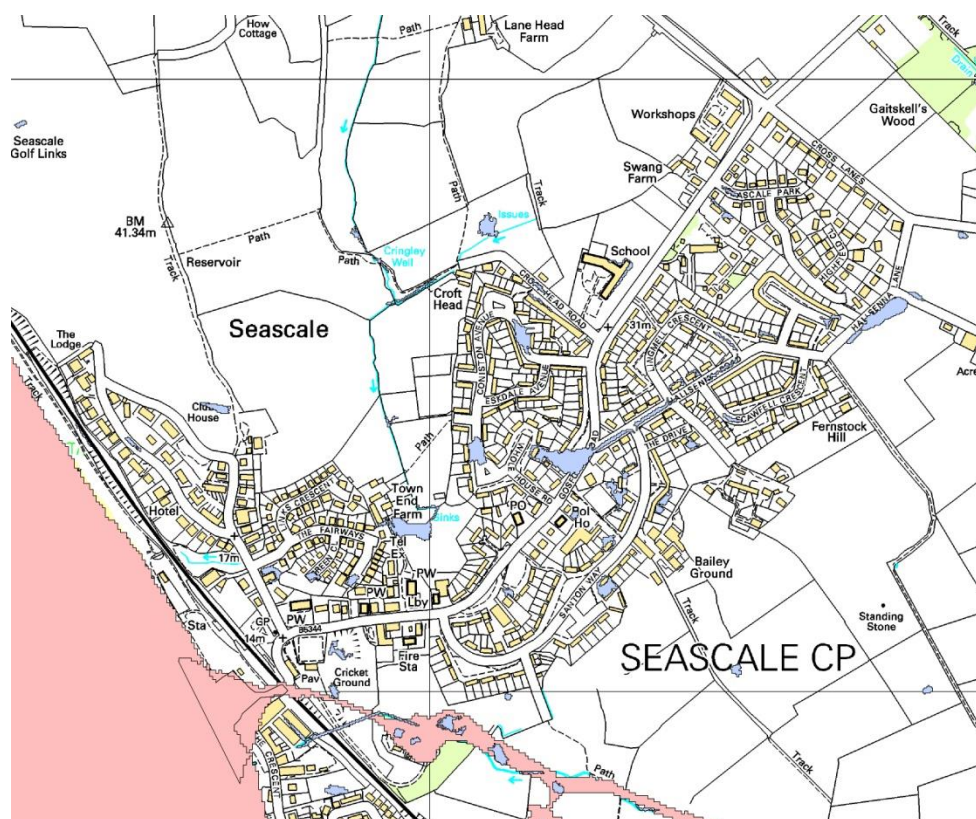
**Environment Agency flood mapping: Zone 3 and surface water flooding from a 1 in 100 year rainfall event.**

Pink hatching shows Flood Zone 3 where rivers have a greater than 1% chance of flooding in any one year. The dark blue zone indicates susceptibility to surface water flooding from a 1:100 year rainfall event. Parts of The Fairways, Santon Way and Railway Terrace all fall within the more severe and frequent surface water flooding zones.
