## Appendix D: - Drain Alert Drainage Investigation Report

**Reference: - JN3884 Sneakyeat Industrial Estate.**

**Project****Project Name:** 2023\_06\_15 33884 Sneakeat Industrial Estate**Project Description:** CCTV Drainage Survey**Project Number:** 33884**Project Status:** Complete**Project Date:** 6/15/2023**Inspection Standard:** MSCC5 Sewers & Drainage GB (SRM5 Scoring)

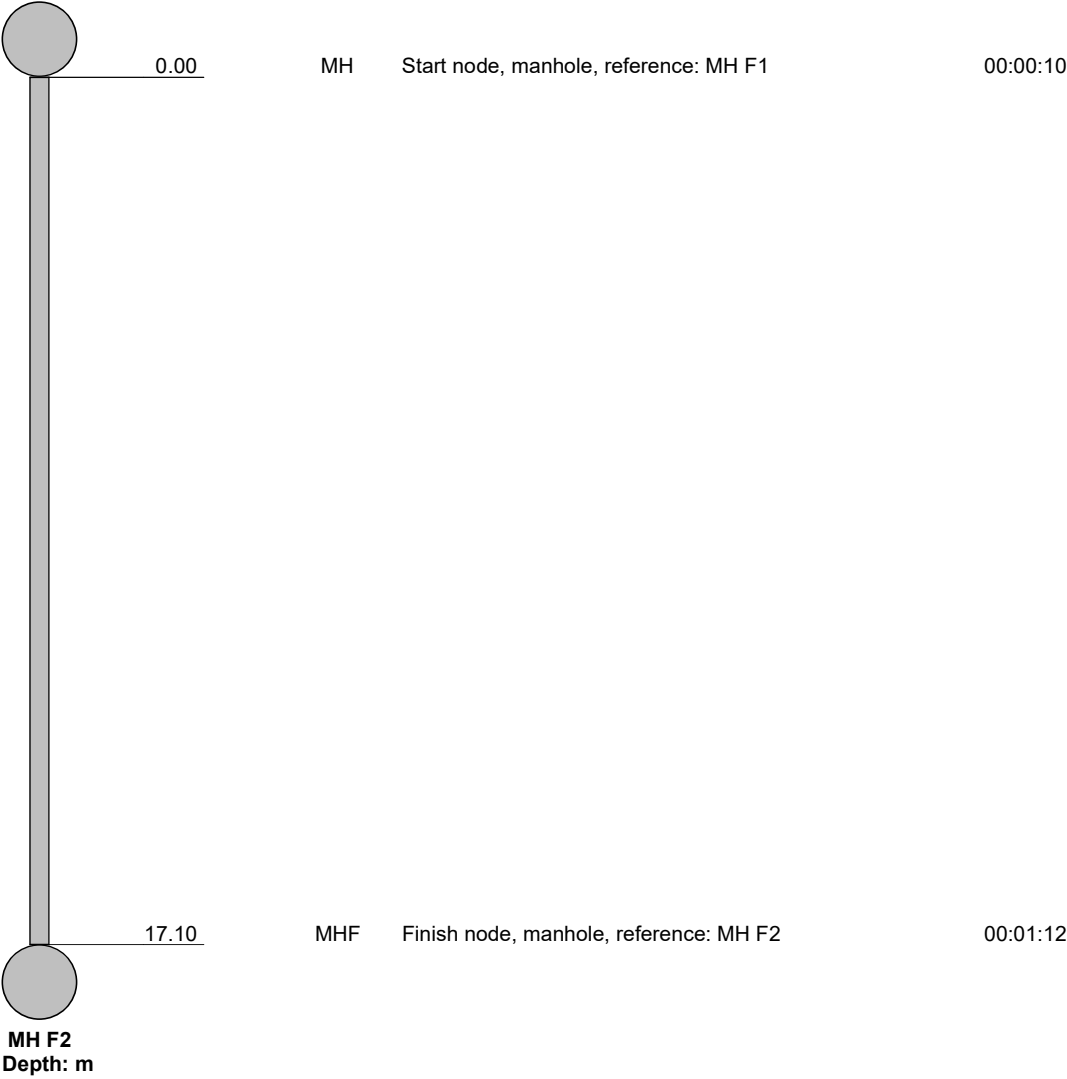
Scale:	1:149	Position [m]	Code	Observation	MPEG	Photo	Grade		
<p>Depth: m MH F1</p>

0.00	MH	Start node, manhole, reference: MH F1	00:00:10				
		17.10	MHF	Finish node, manhole, reference: MH F2	00:01:12				
<p>MH F2 Depth: m</p>									
<b>STR No. Def</b>	<b>STR Peak</b>	<b>STR Mean</b>	<b>STR Total</b>	<b>STR Grade</b>	<b>SER No. Def</b>	<b>SER Peak</b>	<b>SER Mean</b>	<b>SER Total</b>	<b>SER Grade</b>
0	0.0	0.0	0.0	1.0	0	0.0	0.0	0.0	1.0
