**Second Floor Repair & Refurbishment Works**  
As Proposed

Client Moresby Hall Hotel Limited

Project Repair & Refurbishment Programme  
Moresby Hall  
Moresby  
Whitehaven  
CA28 6PJ

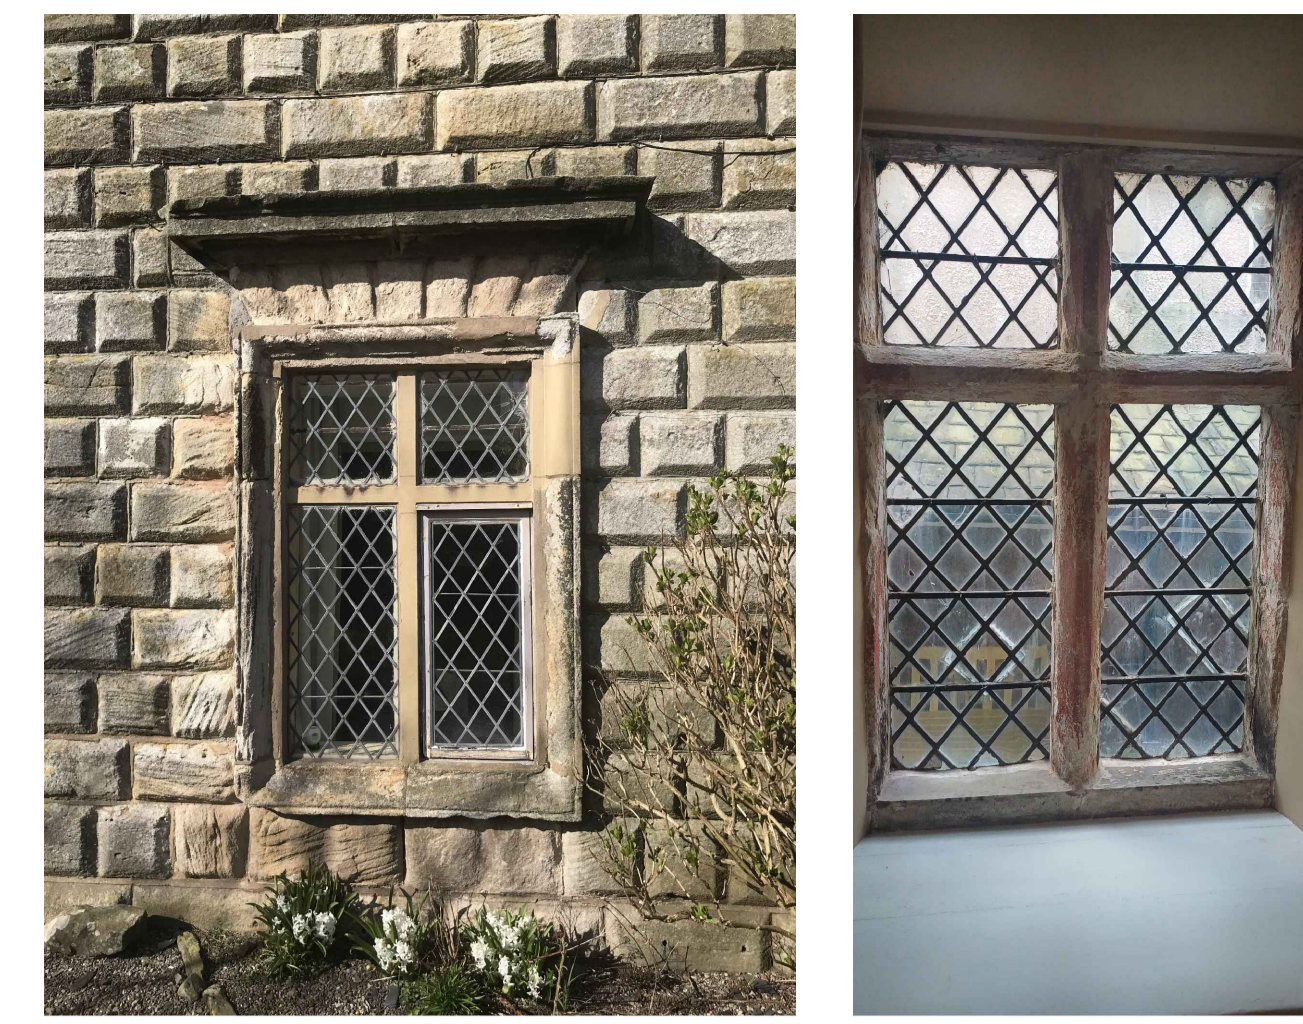
Photographs of typical external & internal window arrangements to front elevation.

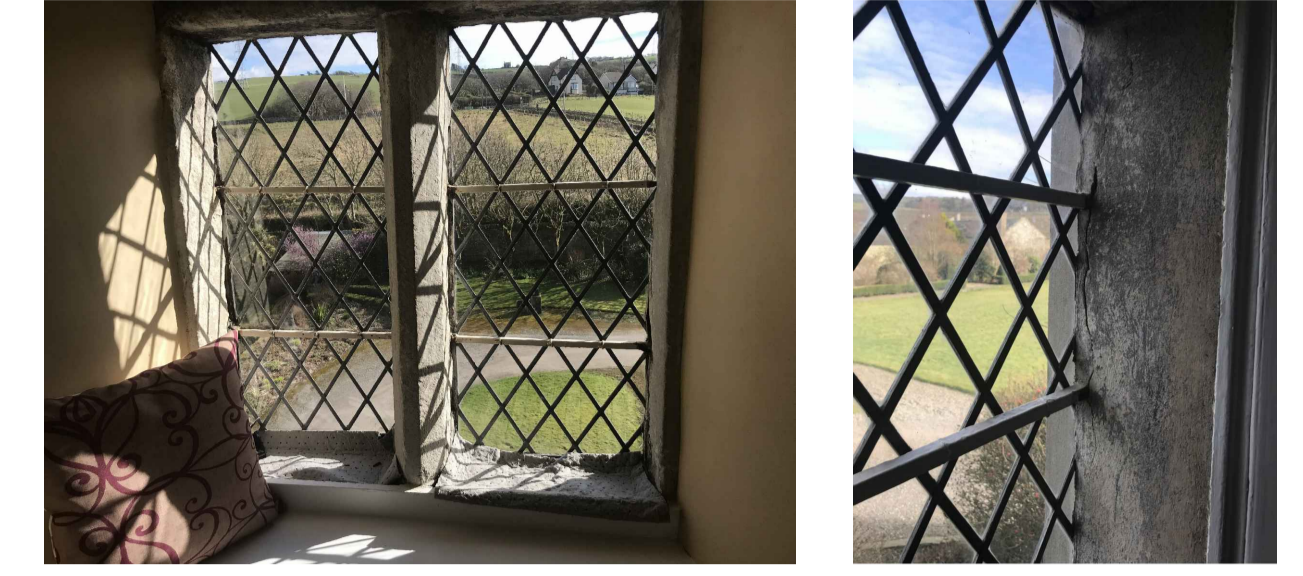
Photographs of typical ironwork to existing windows.

**Ironwork Repairs**

Review existing saddle bars to identify damage including: corrosion, fractures, etc. Seek to identify the cause of any failure / issues and address any ongoing issues, for example ineffective rainwater goods, localised roof repairs required. Remove any loose material, oil with suitable palmation oil / other preparatory treatment, restorable as required. Note: The proposals are limited to refurbishing and stabilising existing saddle bars, any bars found to have failed should be identified for replacement, however, this is not anticipated at this stage.

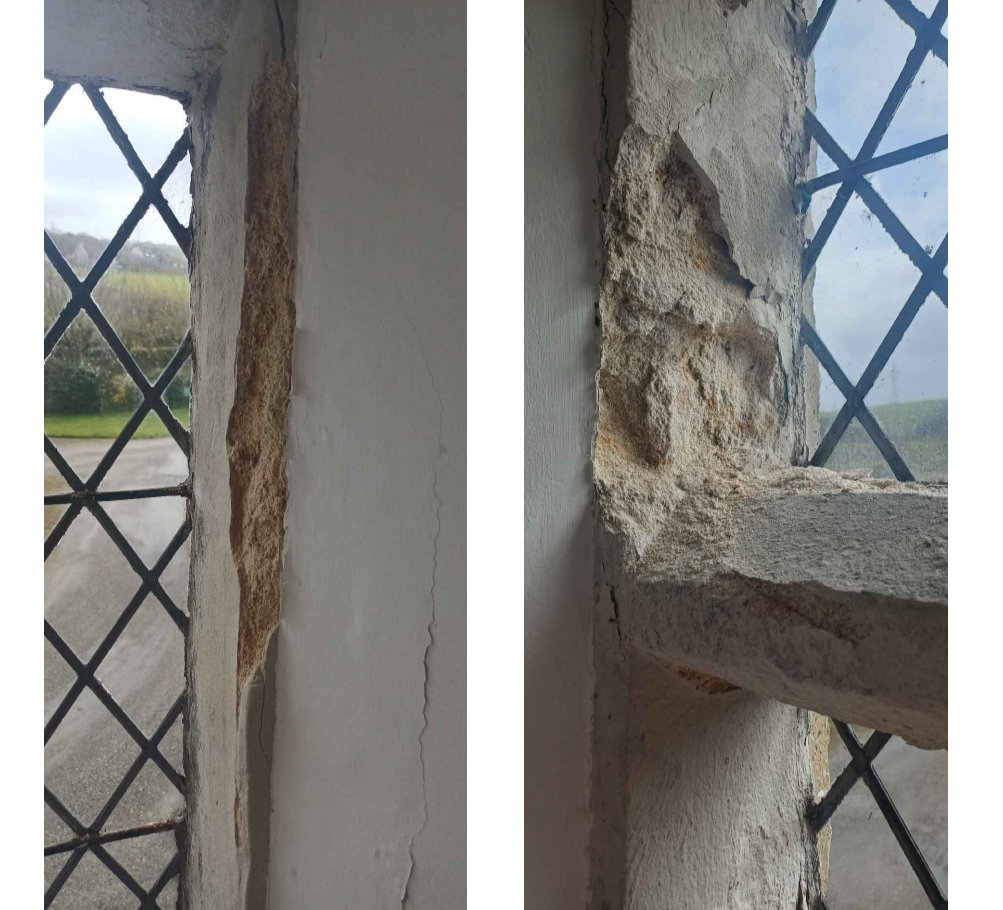
Photographs of typical internal stonework deterioration to existing windows.

**Stonework Repairs**

Review existing stone to identify damage including: delamination, fractures, etc. Seek to identify the cause of stonework failure and address any ongoing issues, for example ineffective rainwater goods, localised roof repairs required. Remove any loose material taking care to retain samples of stone and mortars for analysis, as required. Record existing condition of each stone to individual window openings and identify stones requiring: no works, mortar repair (to be limited), ident repair, replacement. Repairs to be in sandstone to match existing, all pointing and repointing works to be in suitable lime mortar, to match existing mix as far as possible.
