**Applicant response to The Georgian Group consultee response dated 16/10/2025 from Dr. Thomas Whitfield**

#### **Applicant response to Ross Anthony email dated 16/10/2025 from Historic Buildings and Places.**

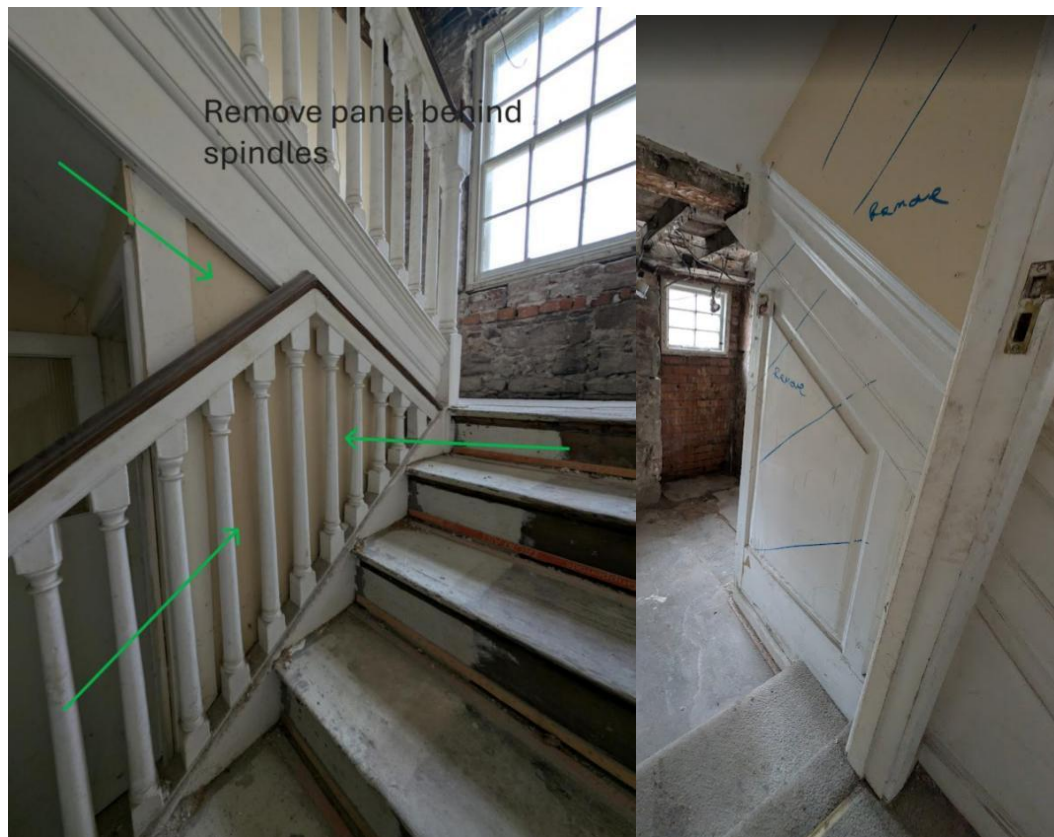
Only the tan coloured triangular plywood section is proposed to be removed as this was believed to have been added to provide privacy to those in the bathroom which had been created in the 1965 conversion. The white wooden panels below will remain (Ignore crayon stating 'remove'). For clarification, this tan coloured panel is only visible at ground floor level at the rear of the main corridor that leads to the top of the cellar, not from the cellar steps itself.

- Looking at photo from ground floor stairs, it looks to me as though the wall above panelling has been added when the door across the lower rear hall was added, suggesting 1965.

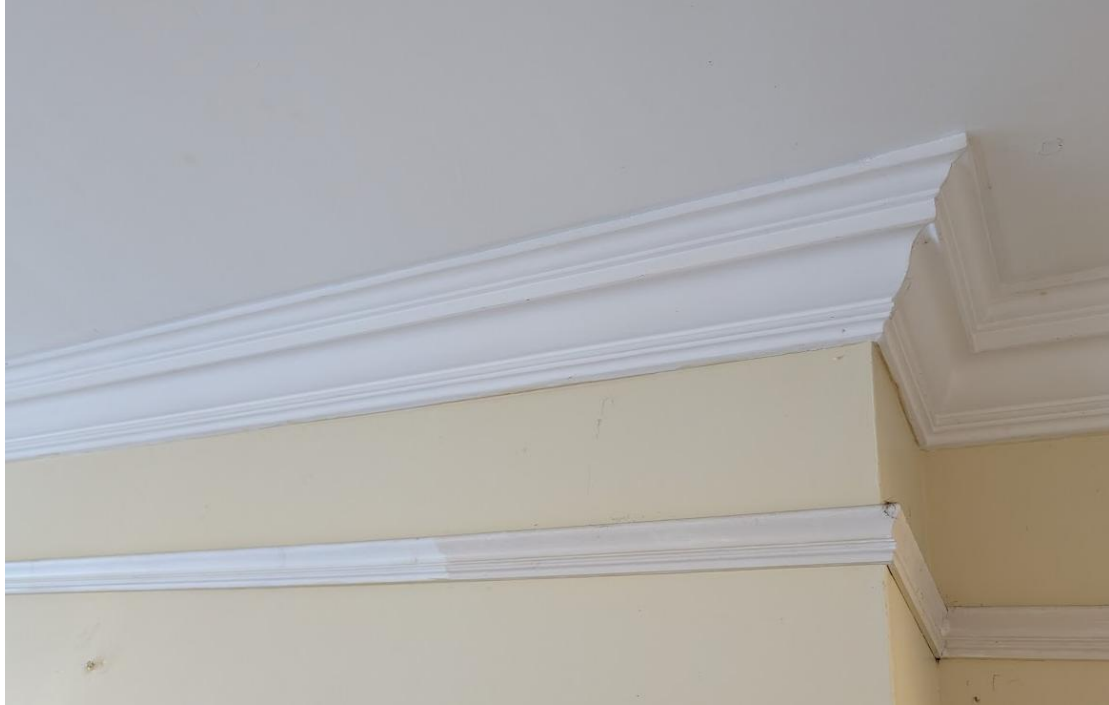
Cornicing and picture rail as present in front ground floor room 2024. Note the lack of paint layers allowing fine contour definition. Applicant believes replaced circa late 1990's, early 2000's as it fits the enlarged stud work around the chimney breast formed in 1965. Pre-1965 would not be long enough to encapsulate the studded chimney breast.

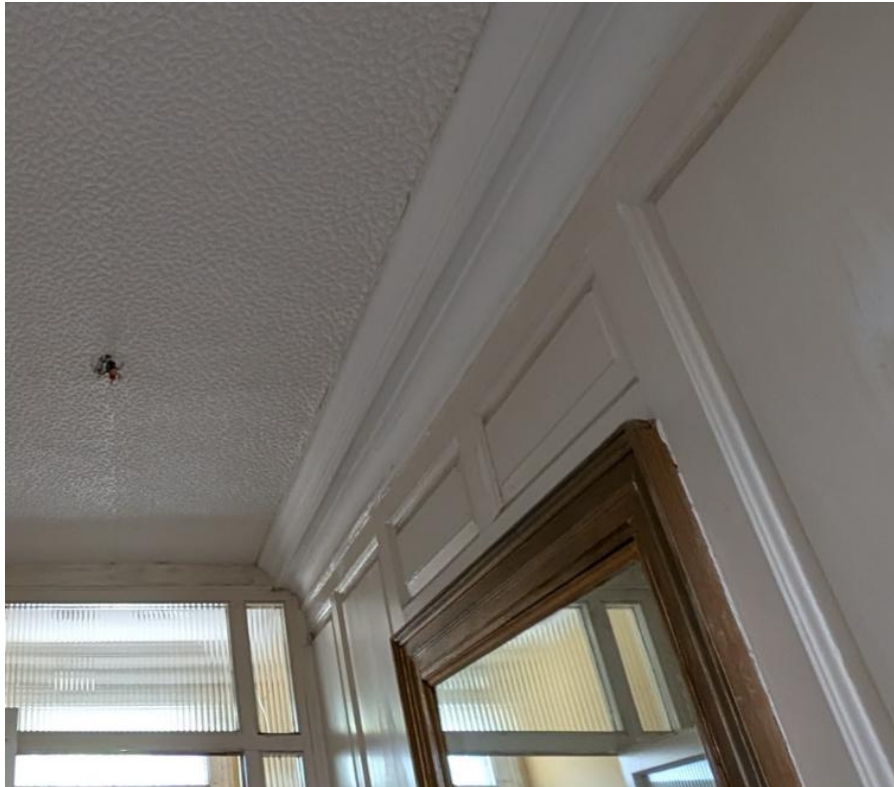
Believed to be original style cornicing in corridor and as such, applicant would prefer to follow replacement with this design. It is logical that this cornicing would remain original if the panel it sits on is also original and the corridor itself has not changed width. Cornicing is absent from all rooms except the corridor, kitchen and rear 1<sup>st</sup> floor bedroom. All are non-matching.

All skirting is substantially matching and modern. Drawings can be supplied of any replacement.

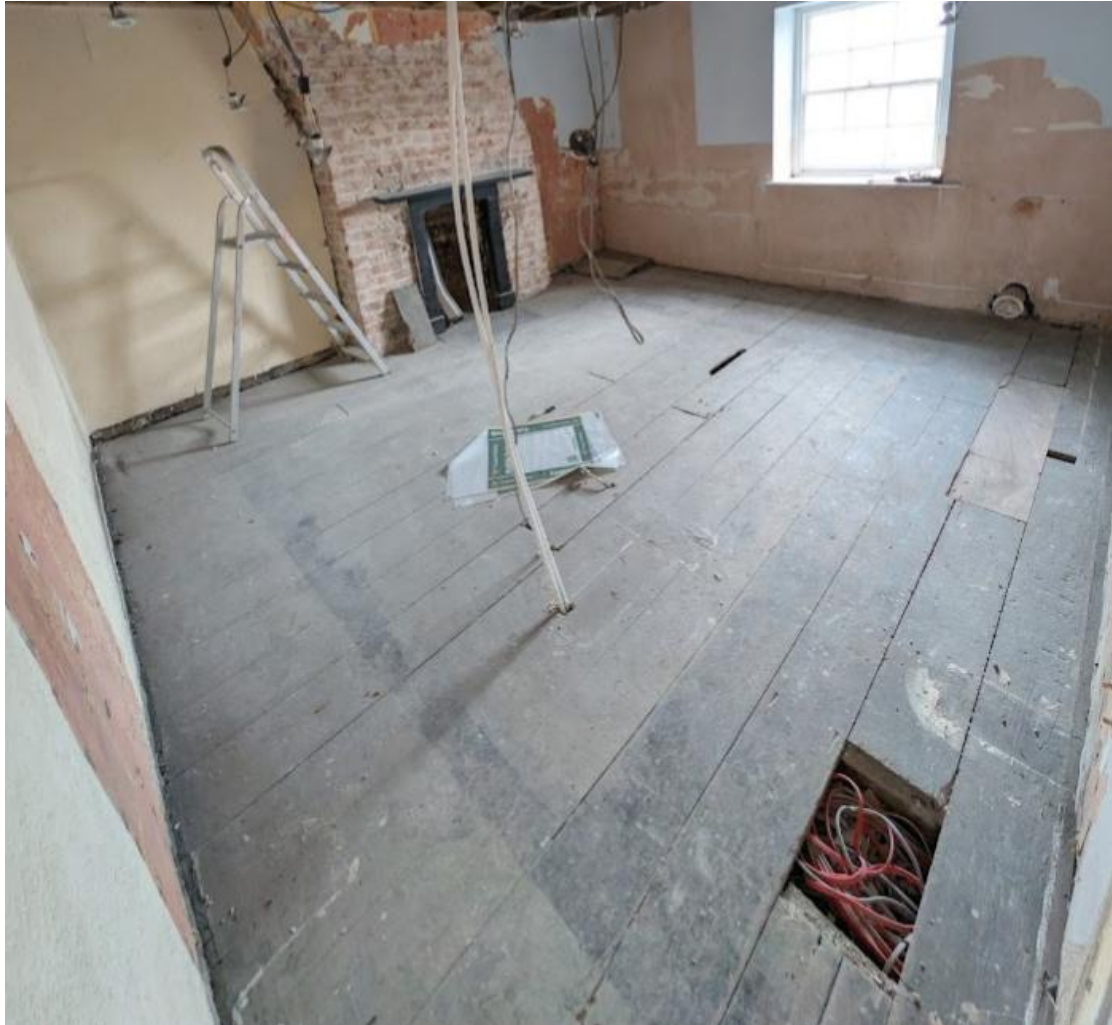
**Bathroom floor. Current condition. 14 full length boards, longest is 4200mm. All between 19 and 21mm wide. 3 boards are much shorter.**

It would not be desirable from a heritage and aesthetic perspective to simply cut 15 small pieces of original board to 400mm long and insert into the space the MDF currently occupies. A correct looking repair would necessitate using the longest lengths of wood possible to bridge the beginning of the MDF section, all the way to the wall. This distance is 2560mm.

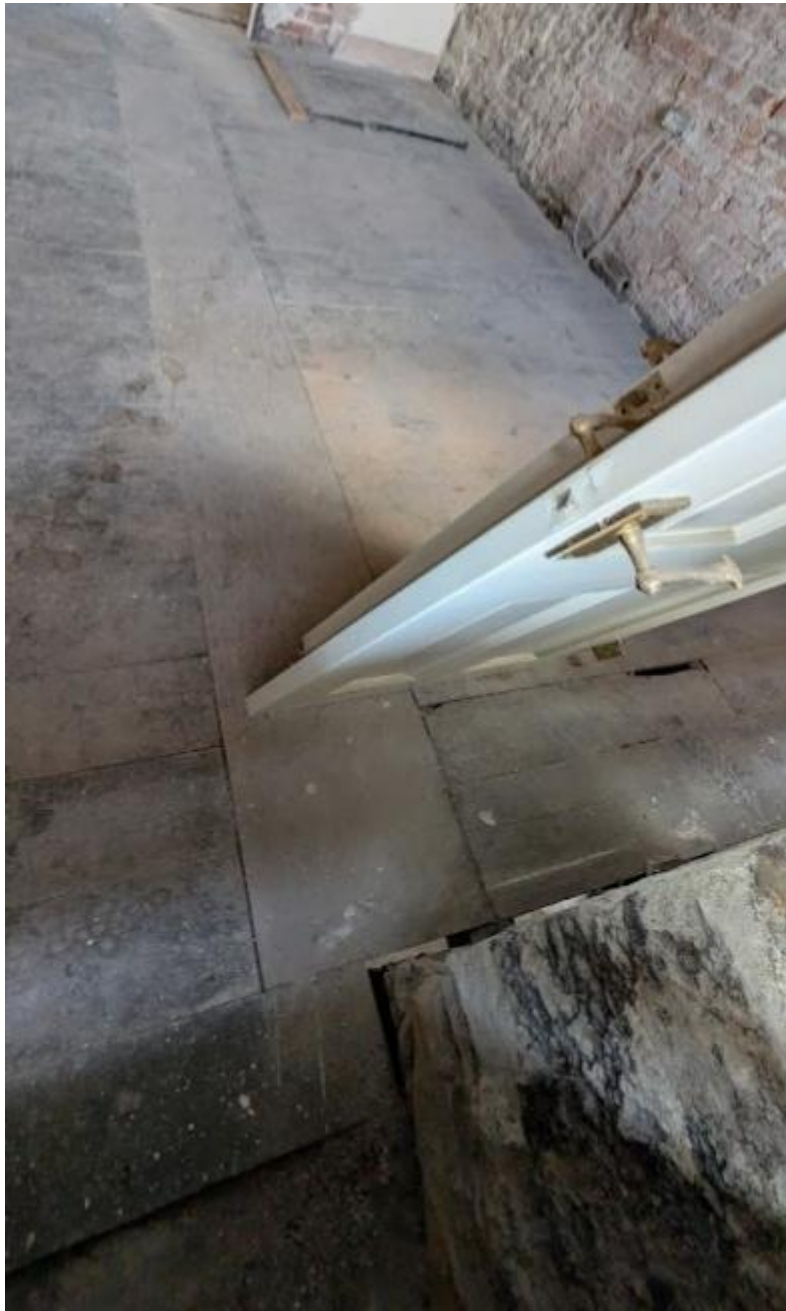
**MDF In-fill in 2<sup>nd</sup> floor front room. MDF is 3620x1750. Boards running from the right side of the MDF to the wall will be retained for the repairs in the longest lengths possible.**

The more affected area is on the 2<sup>nd</sup> floor front room where one full board has been partially replaced by a non-matching board (3620x1750) and one area of approximately 3500x400 has been removed across the width of the room and approximately 15 boards are detrimentally affected.
