Distington Community Garden

GROUNDWORK N E & CUMBRIA

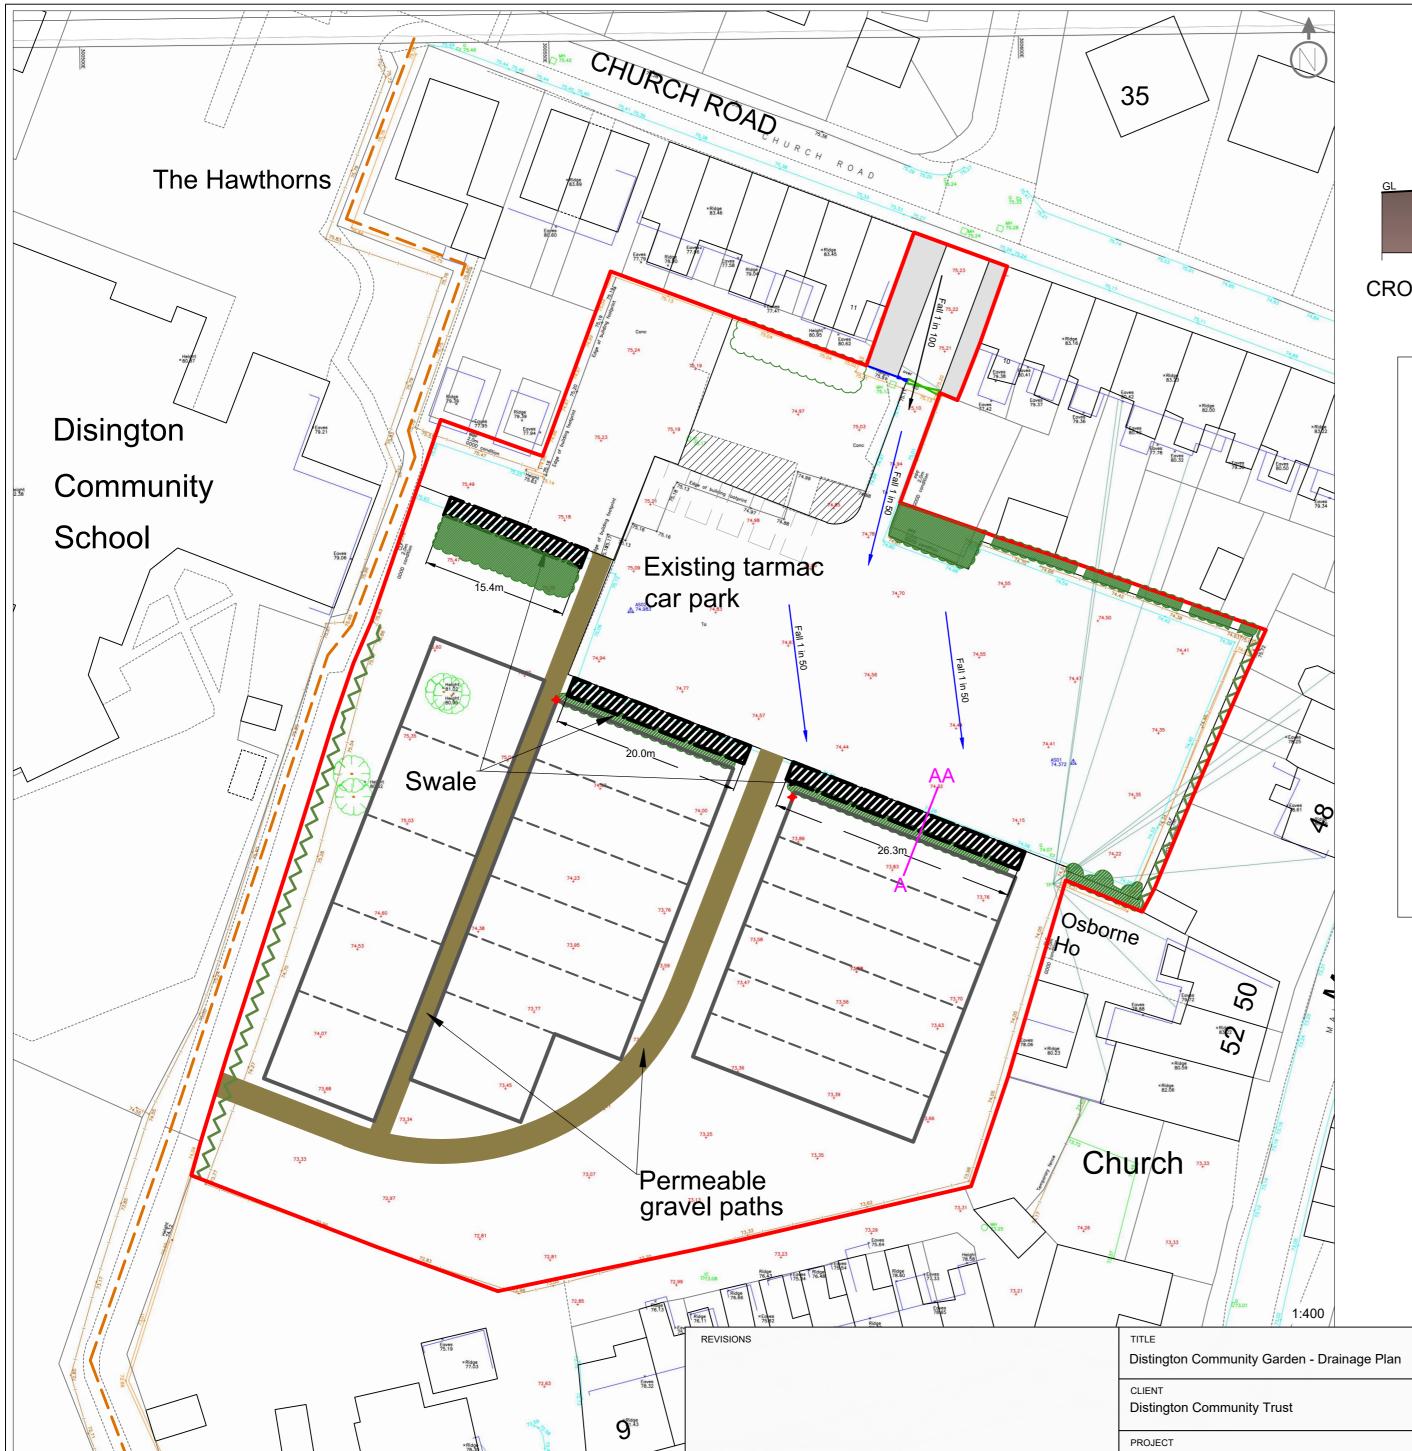
Ground levels on existing tarmac car park and hardstanding areas fall from north to south and surface water currently runs off into adjacent soft ground.

A retrofit sustainable drainage feature is proposed to enhance surface drainage: swales, 2m width x 200mm depth as shown in Section A - AA, to be constructed along southern edge of car park and hardstanding area
