Project: **PRO-CURE WEST CUMBERLAND HOSPITAL PHASE 2 DEVELOPMENT**

Dwg Title: **EXISTING DRAINAGE REHABILITATION SKETCH**

Project No:	Size:	Date:	Drawn By:	Designed By:	Checked By:
072419	A1	JUL 21	DM	PT	PT
Scale: 1:500					
Project Code:	Originator:	Zone:	Level:	Type:	Discipline: Category / Number: Rev:
WCHPH2-CUR - VV - XX - DR - C -	04008	- P03

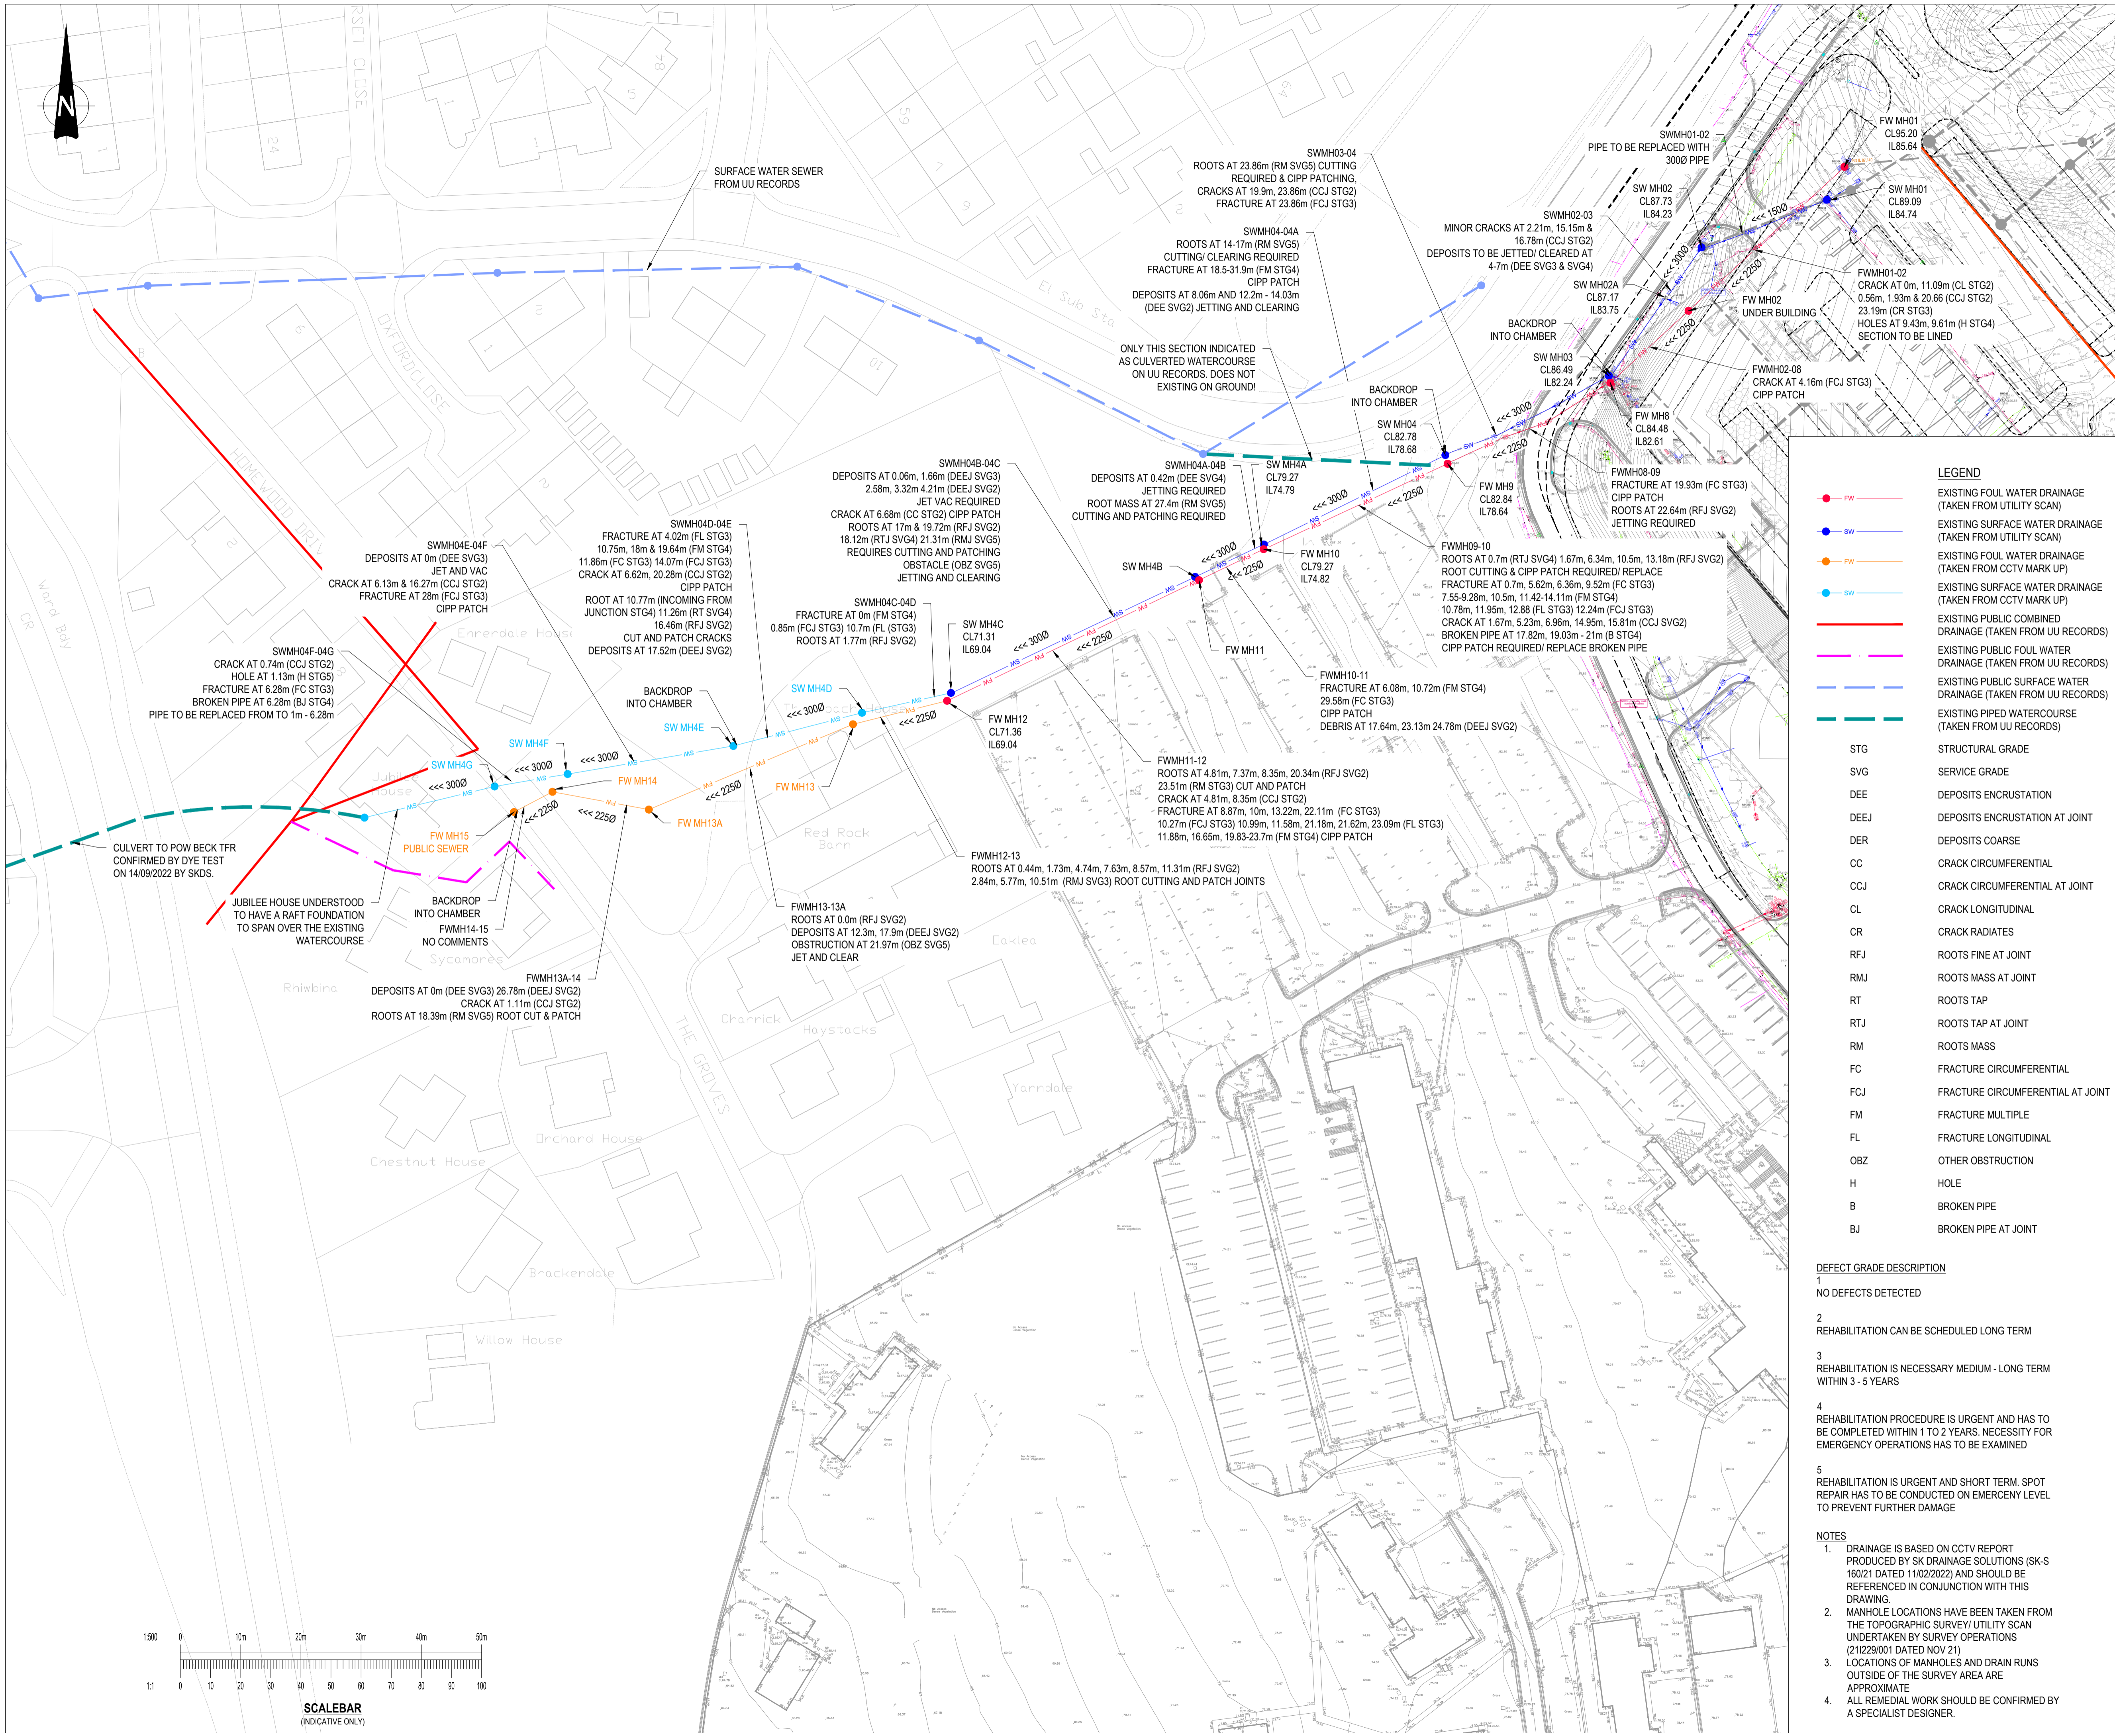
- DRAINAGE IS BASED ON CCTV REPORT PRODUCED BY SK DRAINAGE SOLUTIONS (SK-S 160/21) DATED 11/02/2022 AND SHOULD BE REFERENCED IN CONJUNCTION WITH THIS DRAWING.
- MANHOLE LOCATIONS HAVE BEEN TAKEN FROM THE TOPOGRAPHIC SURVEY/ UTILITY SCAN UNDERTAKEN BY SURVEY OPERATIONS (21229/001 DATED NOV 21)
- LOCATIONS OF MANHOLES AND DRAIN RUNS OUTSIDE OF THE SURVEY AREA ARE APPROXIMATE
- ALL REMEDIAL WORK SHOULD BE CONFIRMED BY A SPECIALIST DESIGNER.
