Ref: Erect roof over existing sheep pens.

Part field No 1654 & 1041

Flood Risk Assessment.

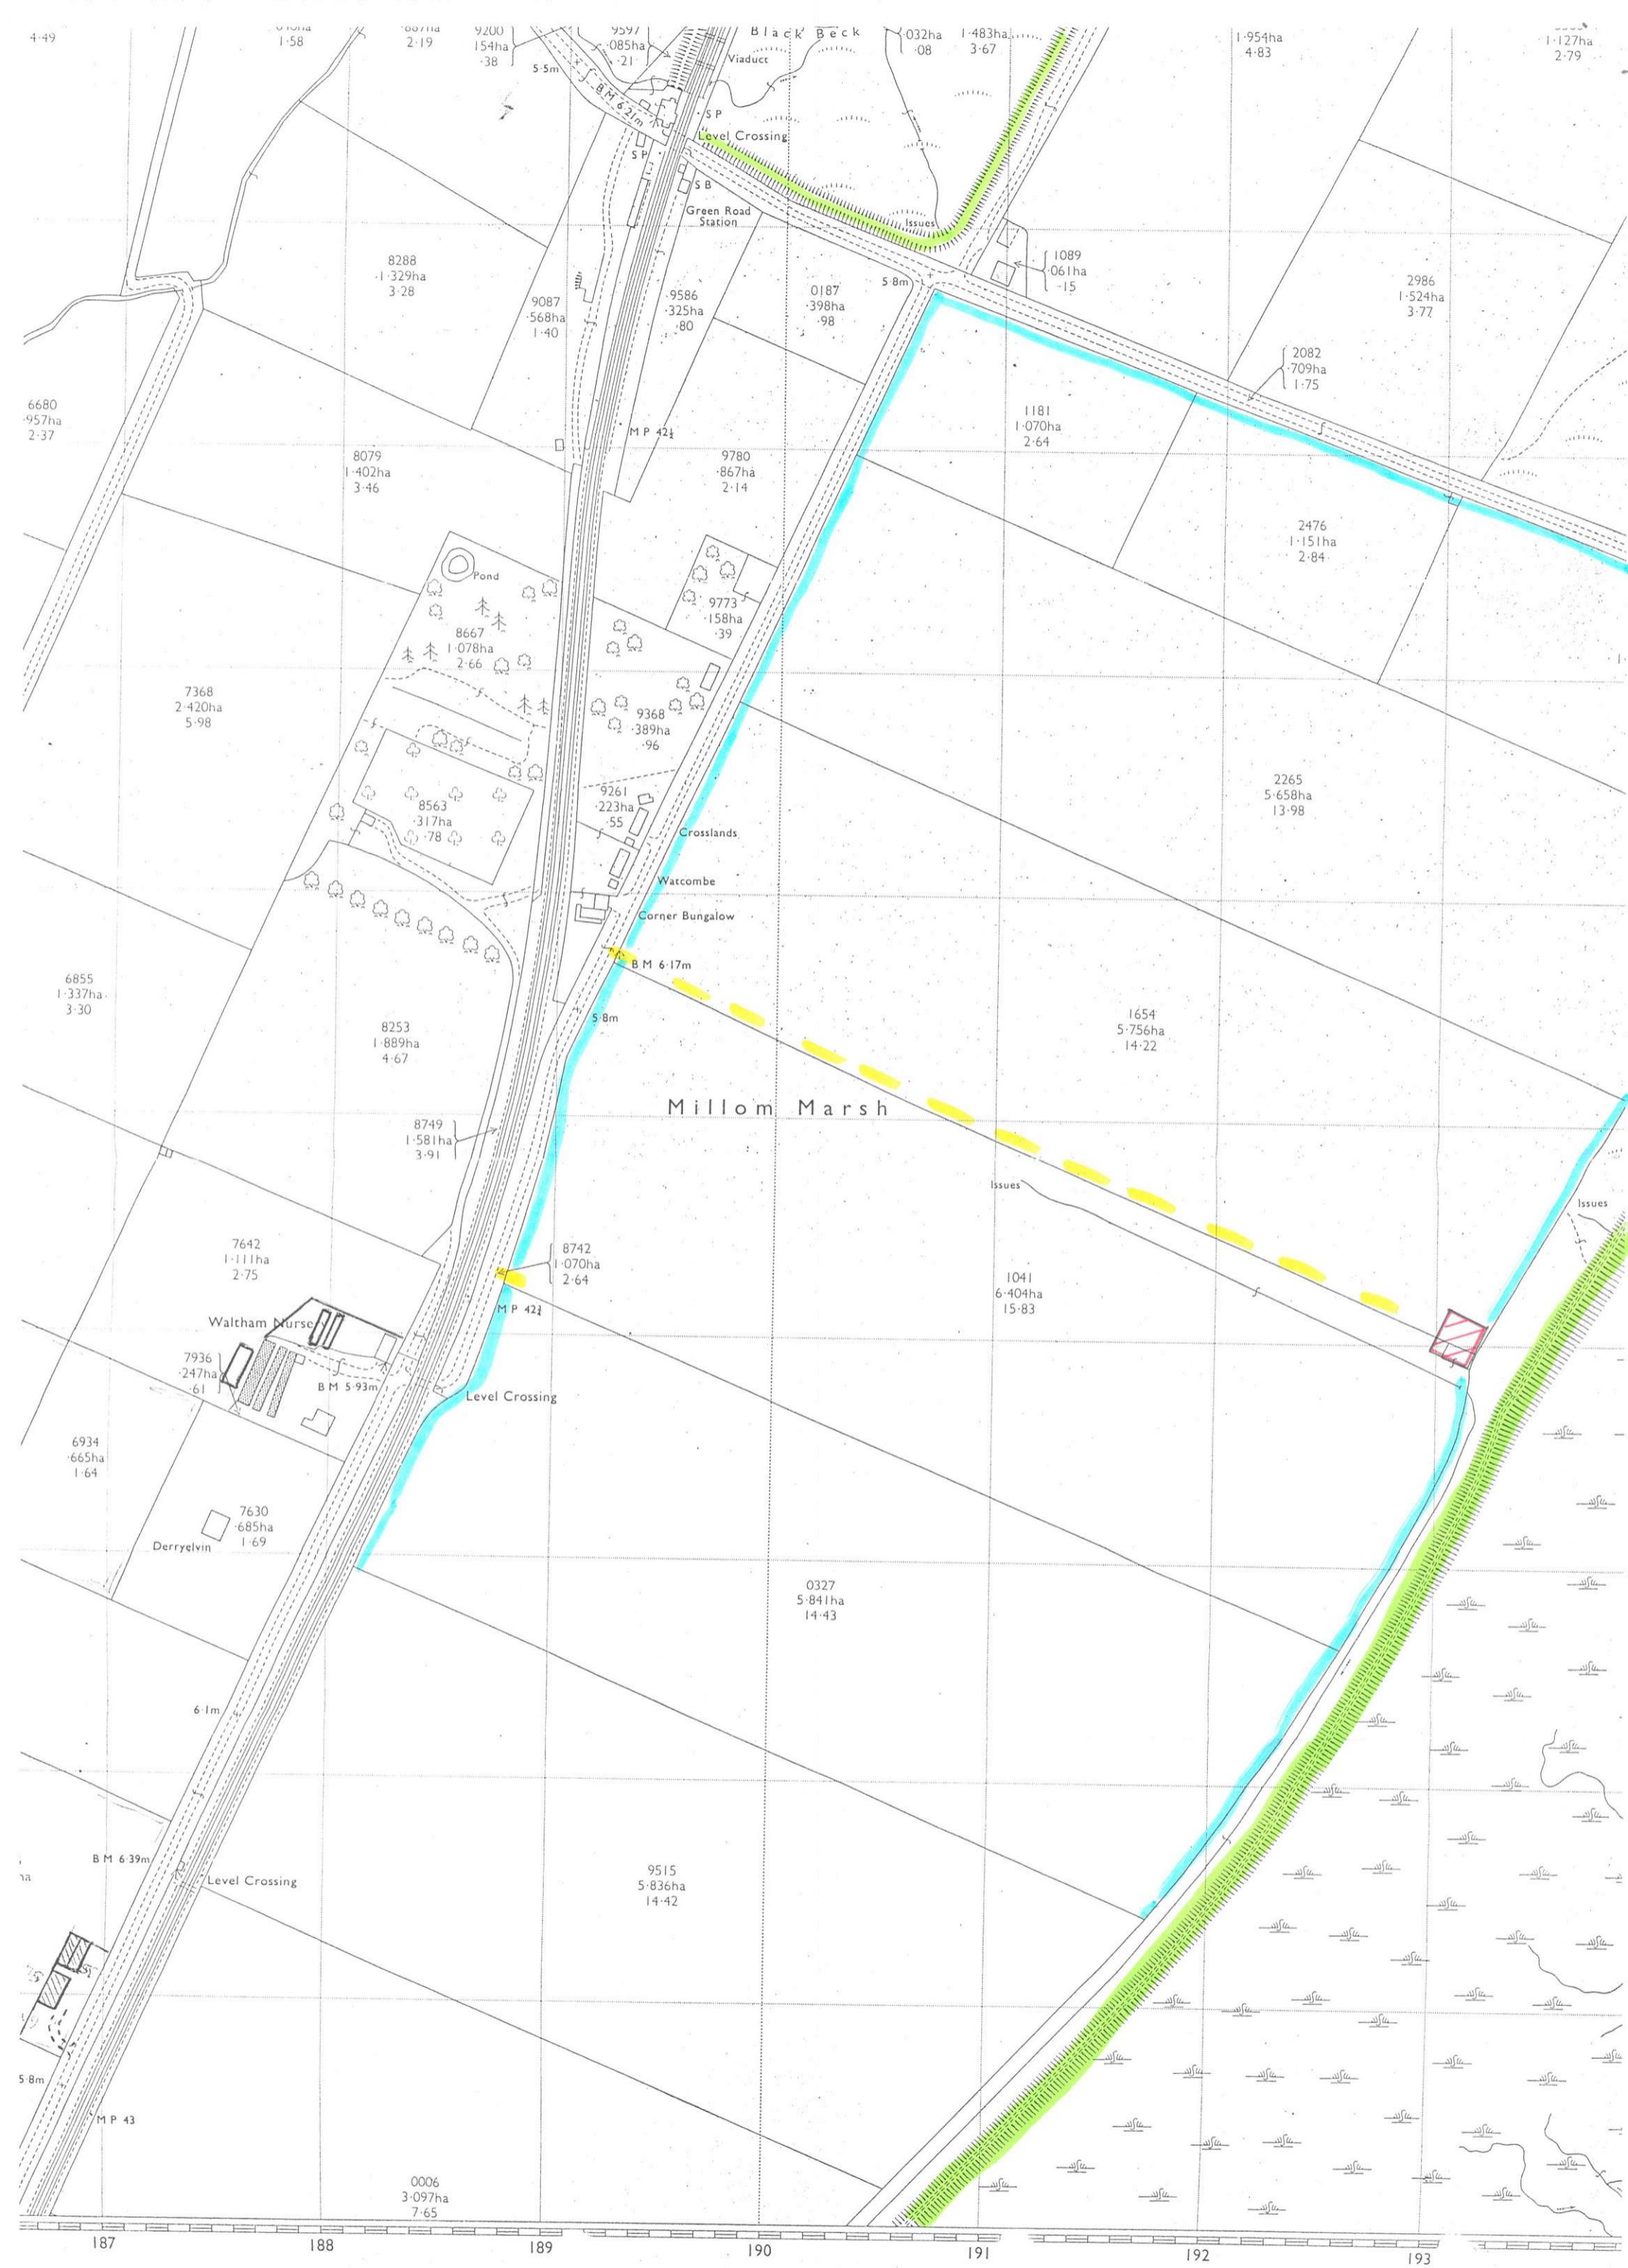
Enclosed: (showing main features mentioned later in the assessment)

- Copy of O.S. map, scale 1:2500 showing
 - A) Location of the proposed building, marked **RED**.
 - B) Field access gate, & basic path to proposed, identified **YELLOW**.

- C) Estuary Tidal protection embankment, identified **GREEN**
 - D) Farm boundary, identified **BLUE**
- The Location of the proposed building, along with all the fields in this area lie within flood Zone 3, but benefitting from flood defences

- All the land on the west side of the Duddon estuary is protected by an embankment (c) which was completed in 1963 & extends from Millom to Duddon bridge with only one large interruption being where the "Black Beck" enters the estuary at Green Road station (the banking returning both sides of the beck as far as the railway embankment). This embankment was constructed by Lowther estates & from levels taken for an earlier assessment, the height is approx 7.0 A.O.D.
