Raf! Erect roof over midden stone. Waterblean Farm The HU! Millon LA185HA

Flood Risk Assessment

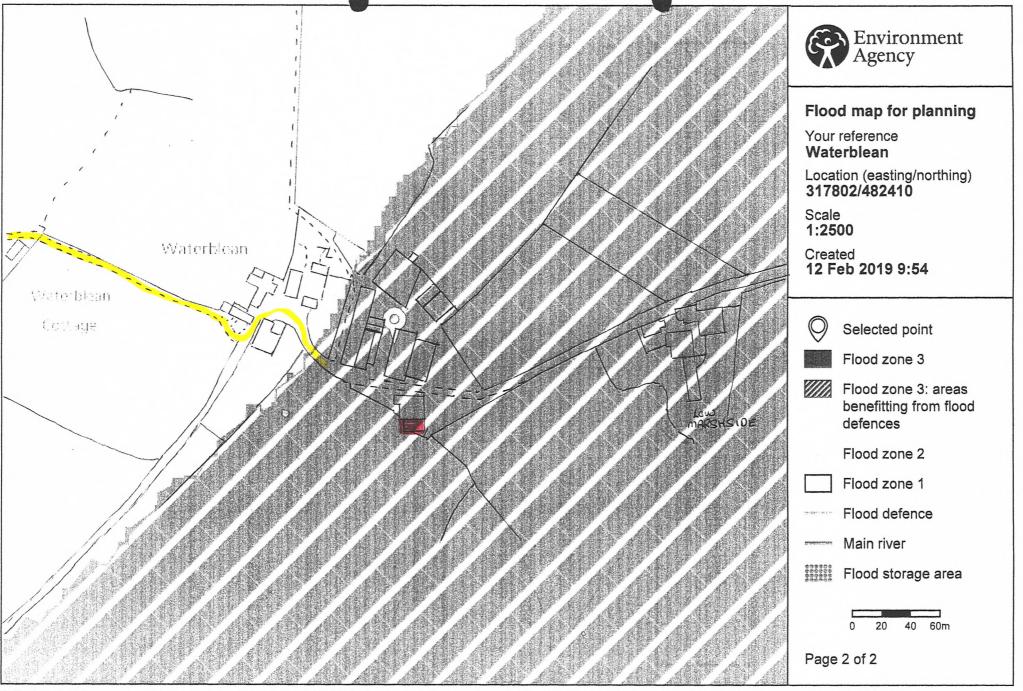
- D) Farm boundary, identified BLUE
- (2) Copy of Environment agency flood map, scale 1:2500, showing
 - E) Location of proposed building marked REO
 - F) Extent of flood Zone 3, benefitting from flood defences (ie & above) - identified HATCHED.

- a) Acoss track identified town.
- · The Location of the proposed building, along with all the modern existing. farm buildings lie in a glossed plain is Zone 3; as identified on E.A. map
