# Remediation Options Appraisal & Strategy

# Land at Thornlea Carleton Egremont

Reference: GEO2022-5275

**Project:** Land at Thornlea, Carleton, Egremont **Report:** Remediation Options Appraisal & Strategy **Report Status:** Draft for Design Team Review

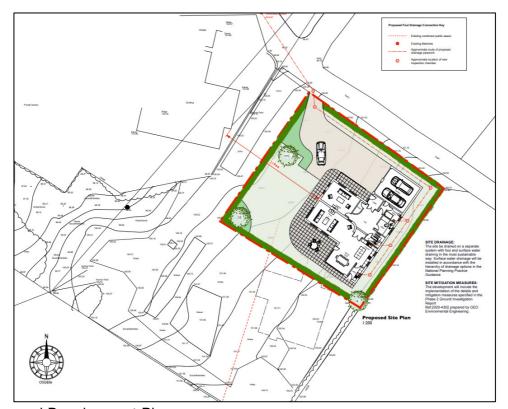
Figure 1.1 Proposed Development Plan

It is understood that the Client plans to develop the site for residential end use. Full development details are available from the Client.
