THE IRON LINE, MILLOM

MINING RISK MITIGATION STRATEGY

Curtins Ref: 080874-CUR-XX-XX-T-GE-00009

Client Name: Cumberland Council

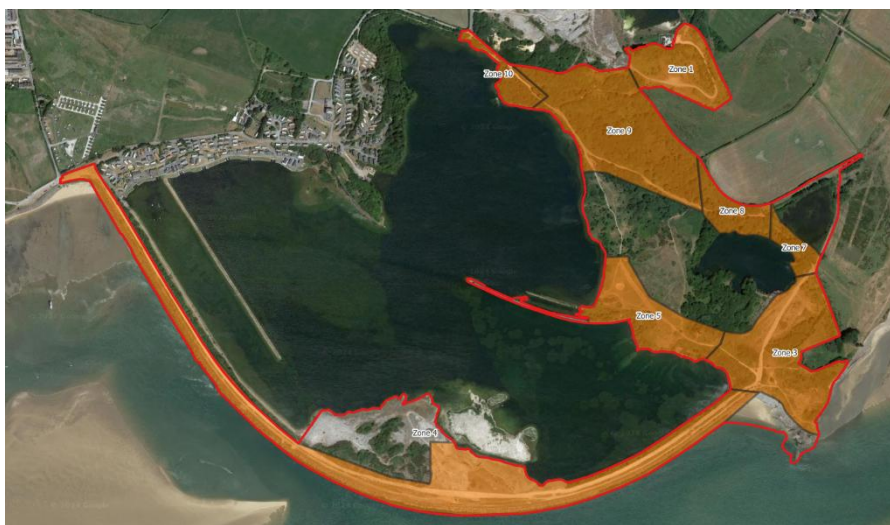
Figure 1 – Site Location Plan with Development Zones, site boundary is shown in red.

The main development is proposed in Development Zone 1, where a Visitors Centre building will be constructed. The remainder of the Development Zones will receive some development such as new roads, paths and hides. The locations of the Development Zones are illustrated in Figure 1.

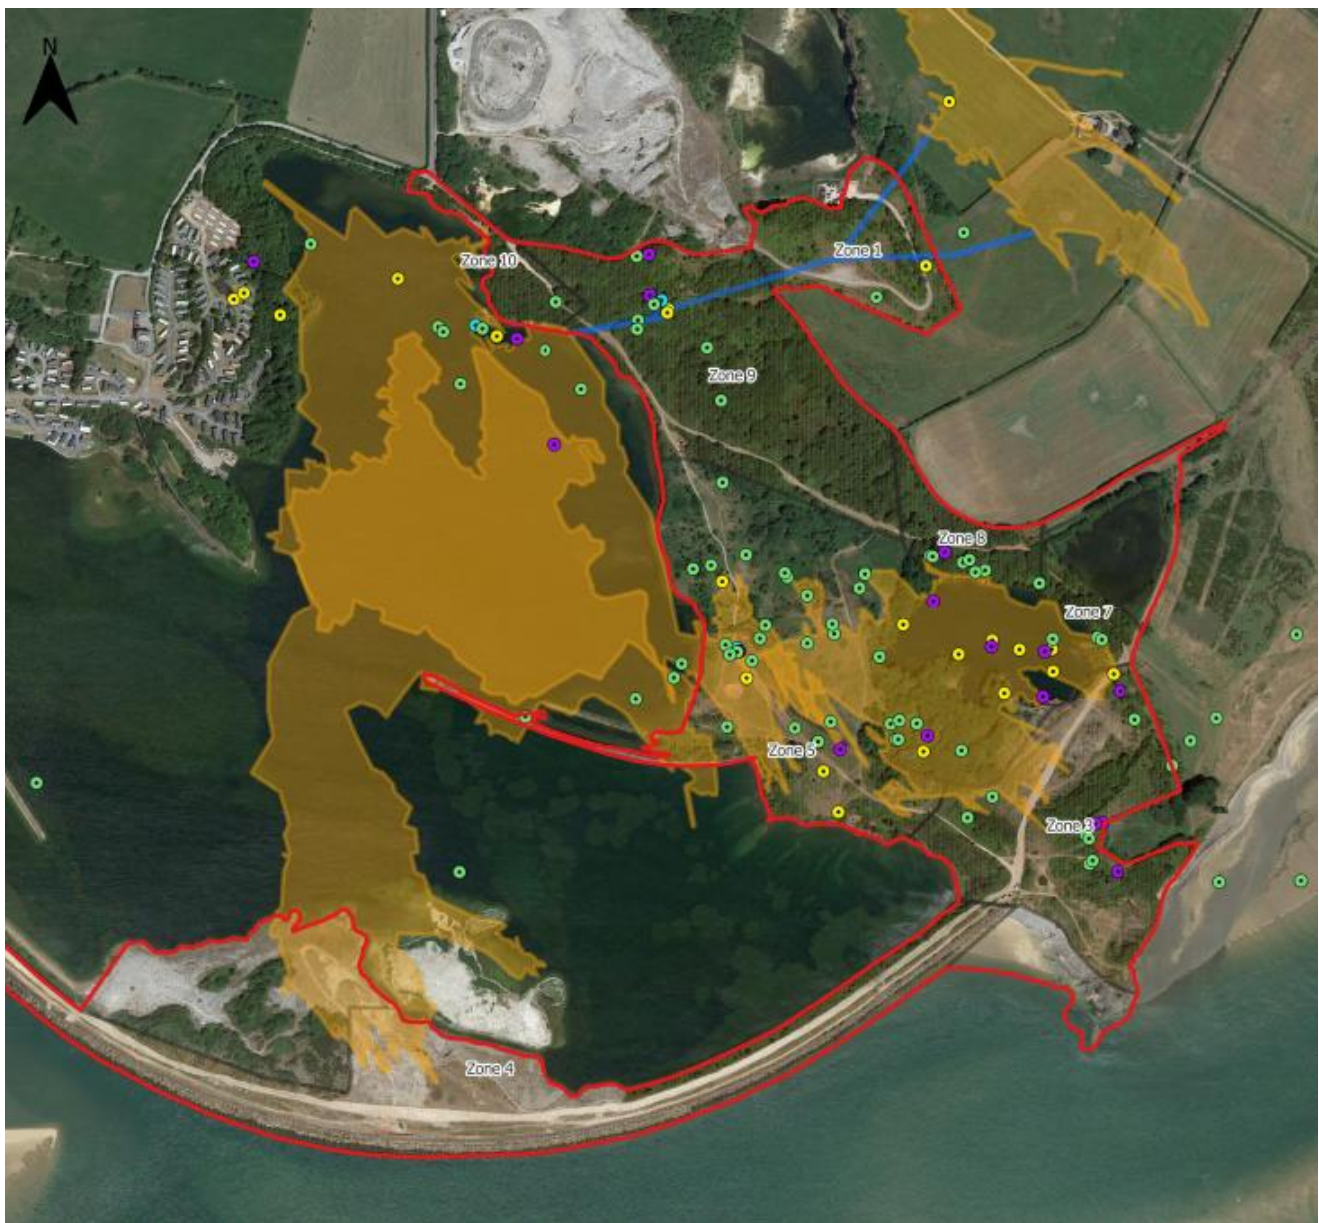
Figure 2 – Mining Features

Blue data from Curtins Phase 1 Envirocheck Mapping
Green data from Curtins Phase 1 Envirocheck data
data from Northern Mine Research Society interactive map
Yellow data from Historical Archive Mapping
Orange Shading showing Ore Body Workings
Blue Line showing Underground Road
Approximate Site Boundary in **Red**.

A total of 122 No. shafts or ‘unspecified pits’ (a shaft or any extractive process such as a quarry/opencast mine or excavation) are noted to be located within the site boundary, based on various information sources including the Envirocheck, Historical Archive Mapping obtained from the Cumbria Archives and Millom Discovery Centre, and from the Northern Mine Research Society. A number of potential mine entries identified across the data sets above are likely to be duplications, however given the inaccuracies in mapping the exact co-ordinates are unknown. Figure 6 shows the approximate locations of these extracted potential mine entries. It’s acknowledged that it is not be possible to investigate every possible shaft due to cost and other constraints such as ecological constraints. Furthermore, the site’s proposed use is broadly a continued use with the exception of the visitors centre.

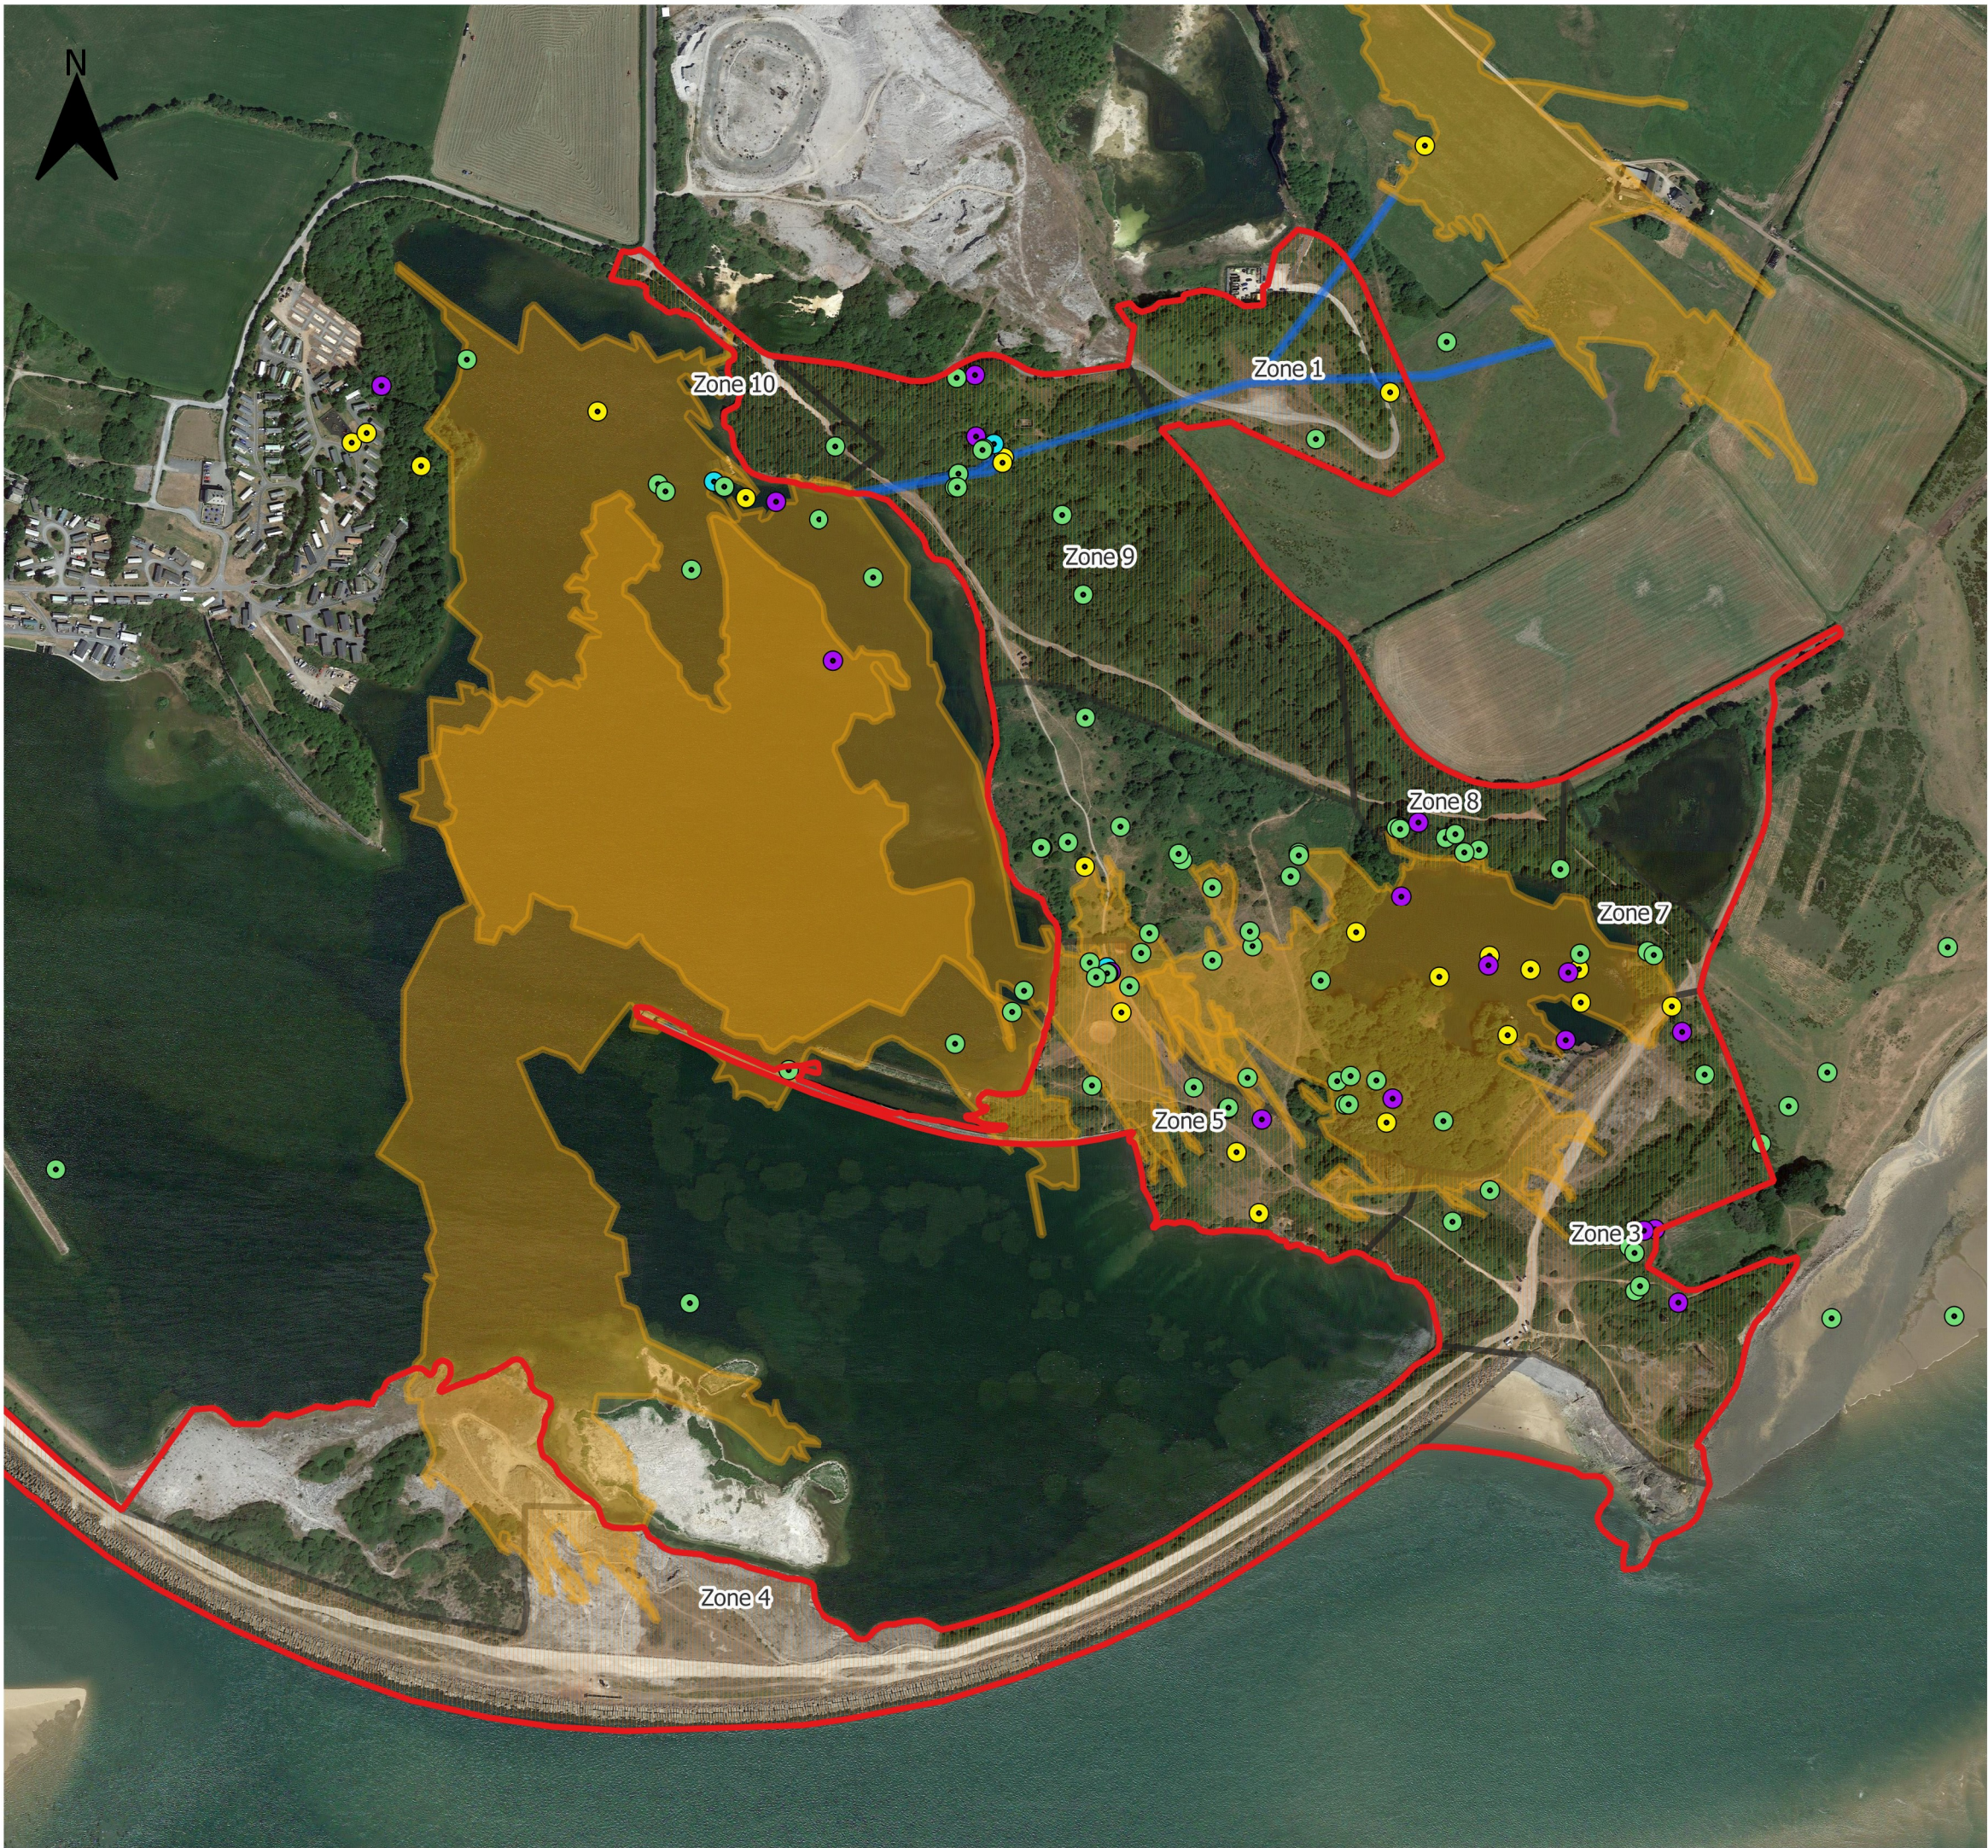
Status				
INFORMATION				
Project:				
Iron Line, Millom				
Drg Title:				
Summary of Historical Ion Mining and Associated Features				
Scale:	Size:	Issue Date:	Drawn:	Checked:
NTS	A3	17/05/2024	JL	NF
Drg No:				Rev:
080874-CUR-XX-XX-DR-GE-80013				P01
© This drawing is the copyright of Curtins Consulting Ltd

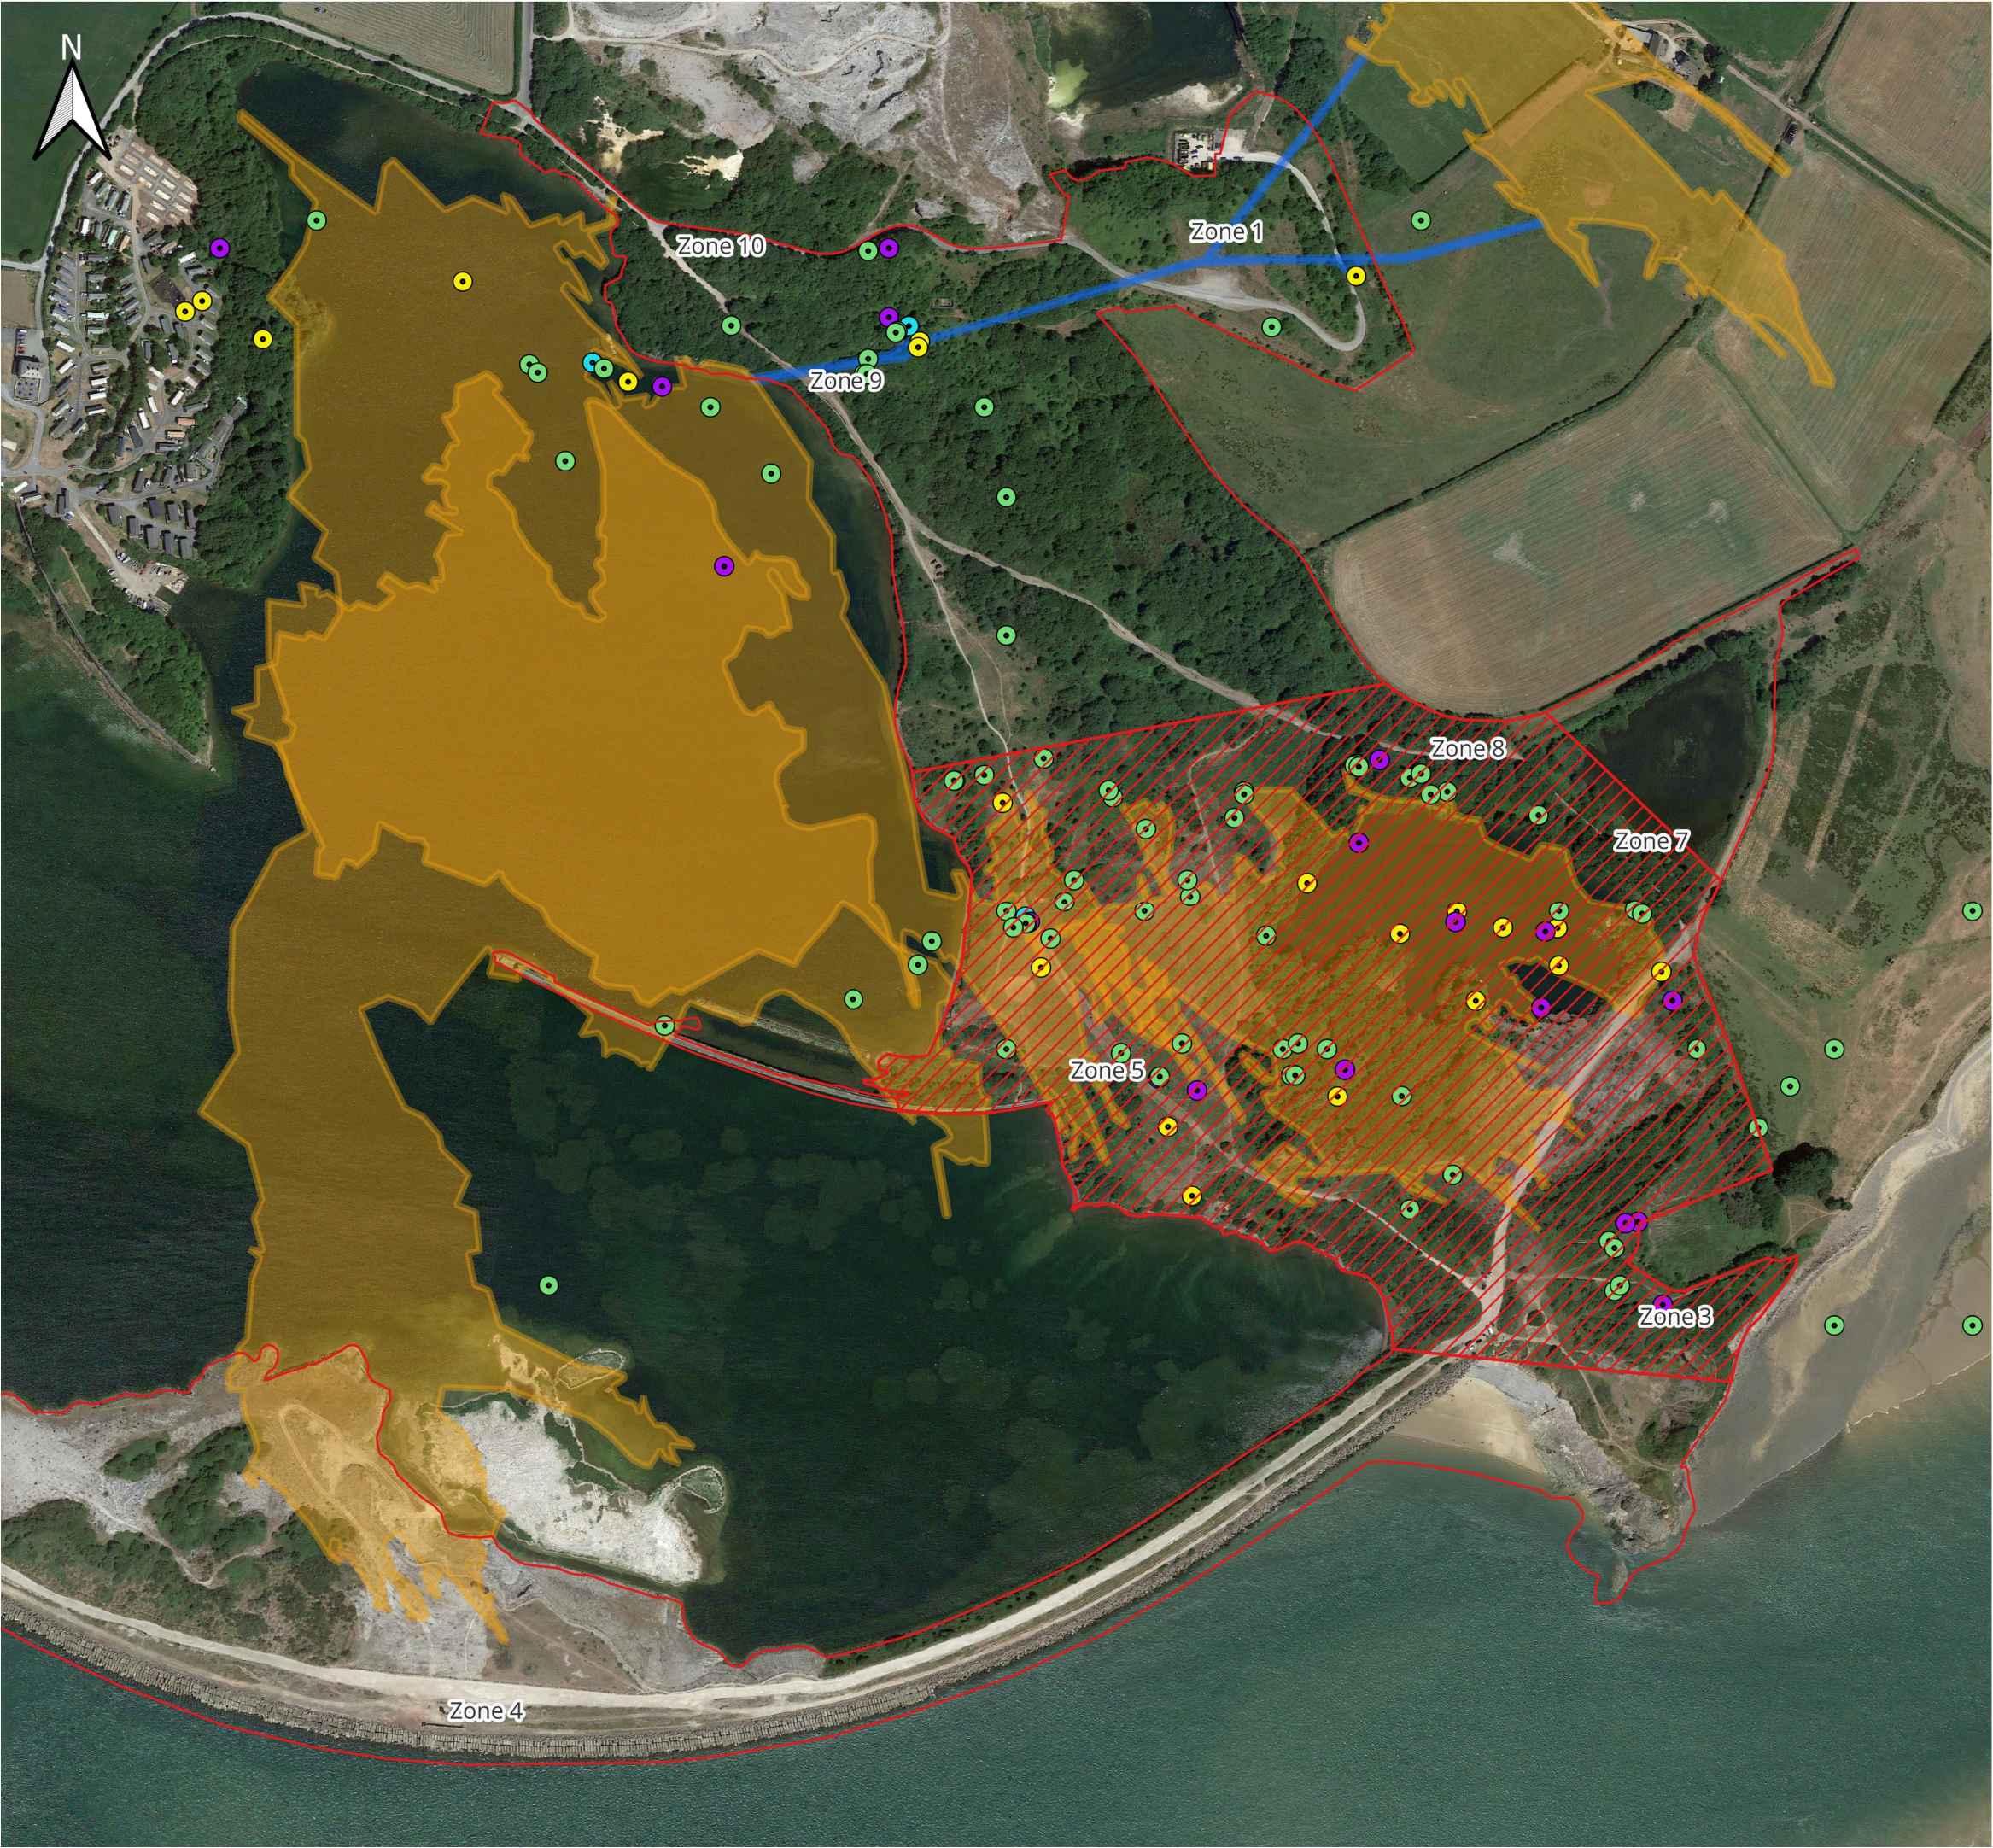
Area of Highest Risk_GeoGrid
