Main Gate Planning Application Contaminated Land Risk Assessment

Produced by Sellafield Ltd Contaminated Land Specialist, Land Quality and End States

This Contaminated Land Risk Assessment has been produced as part of a full planning application for improvements to the main gate area of the Sellafield site. The development includes:

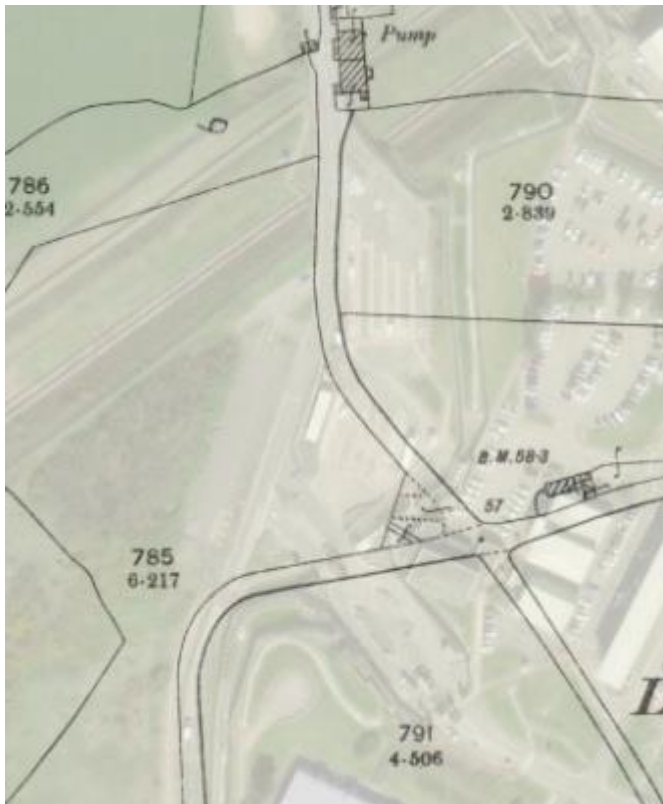
Year		Comments
c. 1900

<p>Before the construction of the Royal Ordnance Factory in the 1940s the site was farmland, and the Main Gate area was previously a crossroads surrounded by fields.</p>

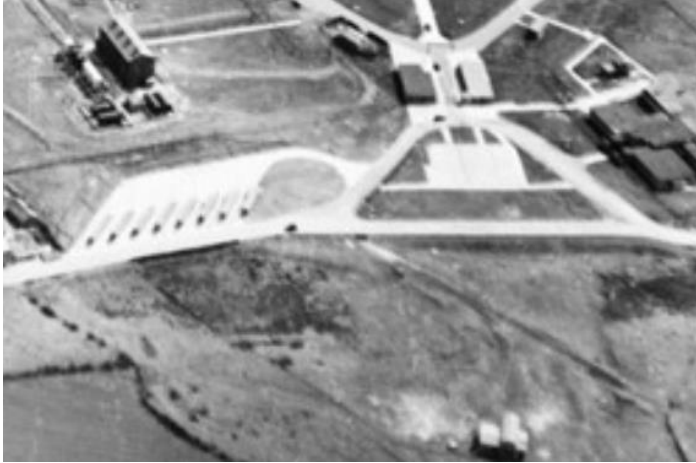
1946

<p>When the ROF was built the main gate was located at the crossroads shown on the previous map, and the main road south straightened. The area to the north of the Main Gate became the main bus lane area with a series of inspection / drop off bays and turning circle.</p>
1951

The above aerial images show that there has been incremental development of the Main Gate area over the lifetime of the Sellafeld site but the overall footprint and historic use of the area

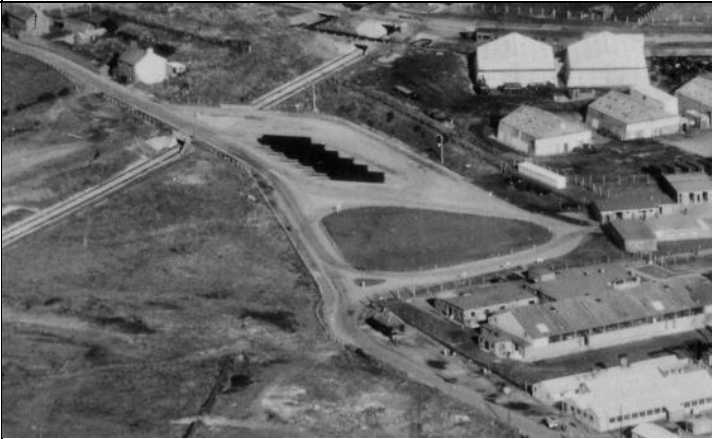
<p>In 1950 the sealines were created in a trench to the north of the bus lanes. The carpark on the large turning circle outside the Main Gate was removed and the whole area grassed over.</p>
1964

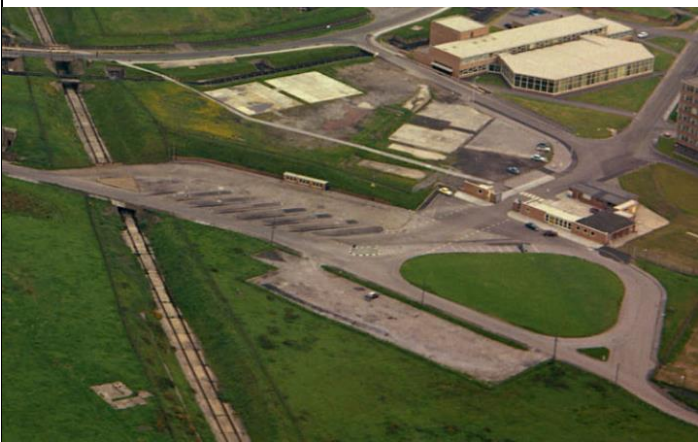
<p>In the 1960's the layout remained broadly the same, but the Main Gate was moved slightly to the north and a car park area created to the west. The shelters were removed from the inspection / drop off bays, but the raised kerbs remained in place.</p>

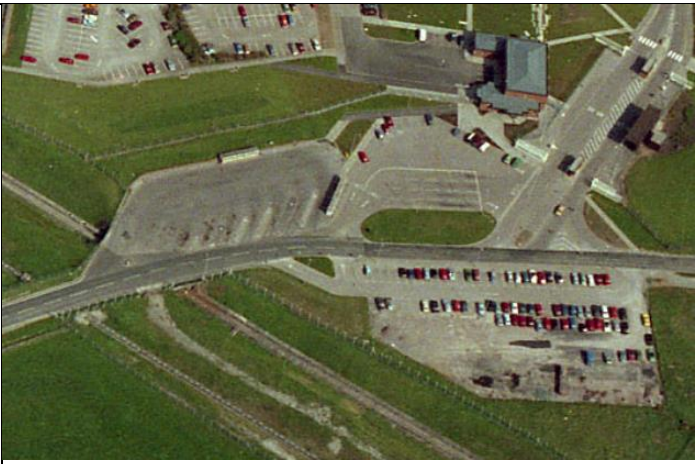
1986

<p>In the early 1980's the majority of the turning circle was removed and new vehicle inspection / queueing lanes were put in place. The main gate and site access was moved to the south into its current position.</p>
2018

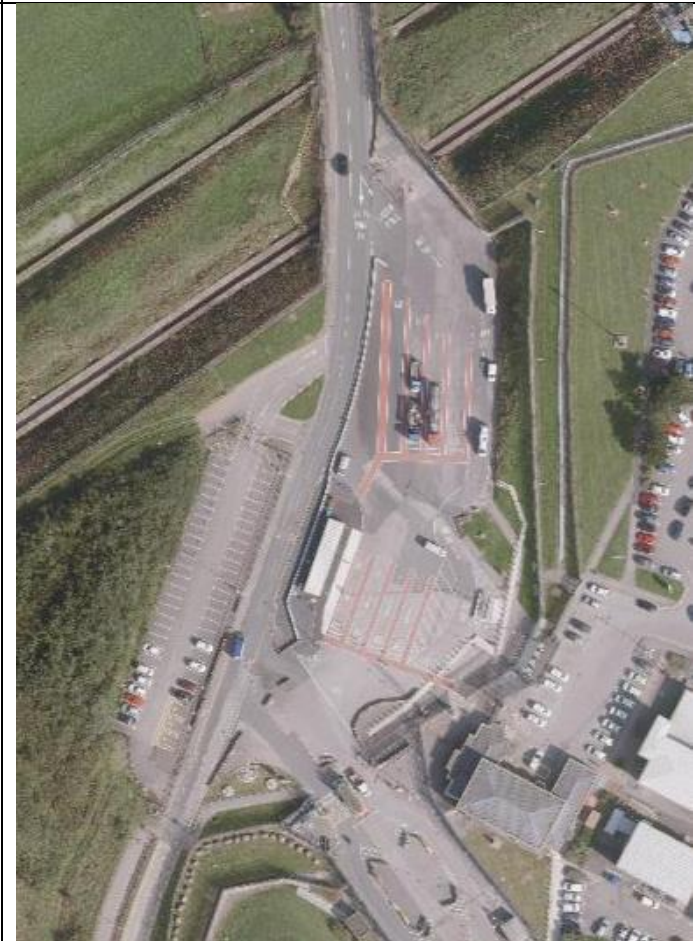
<p>In 2017 the former bus bays were removed and replaced by additional inspection / queueing lanes. This remains the current layout.</p>

has remained broadly the same. The area has only been used for bus lanes, inspection bays and parking areas with no evidence of additional industrial use.
