## Preliminary GEO Environmental Appraisal (*GEO\_App*)

**Ref: GEO 2016-2088**

**Location: Land at Whitehaven Commercial Park**

A Preliminary Geo-Environmental Appraisal (*GEO\_App*) has been undertaken for the proposed commercial/industrial redevelopment at a piece of land within Whitehaven Commercial Park, Whitehaven. This appraisal has been completed for Eskdale Environmental Services Ltd.

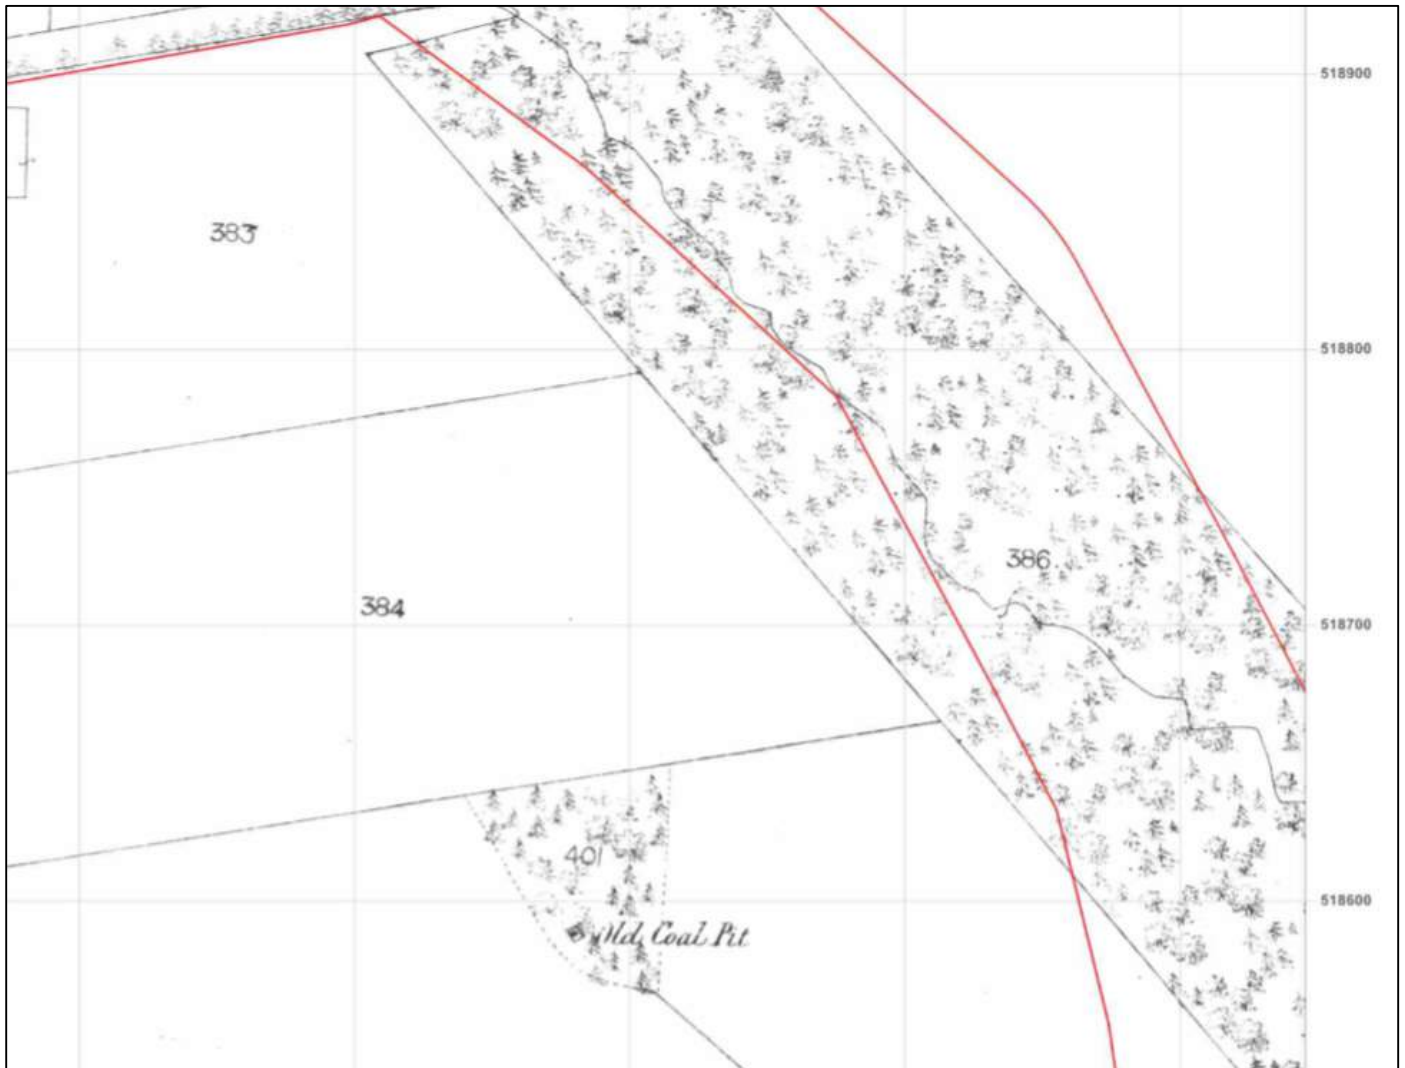
1862

**Historical Map Extracts**

Historically the site was recorded as fields/agricultural land for many years until the construction of the railway line (with cutting). During this time no obvious structures were present on site, although coal mine entries were noted around the site.
