Status: **ISSUED FOR INFORMATION** S2

Client: **GRAHAM**

Project: **PRO-CURE WEST CUMBERLAND HOSPITAL PHASE 2 DEVELOPMENT**

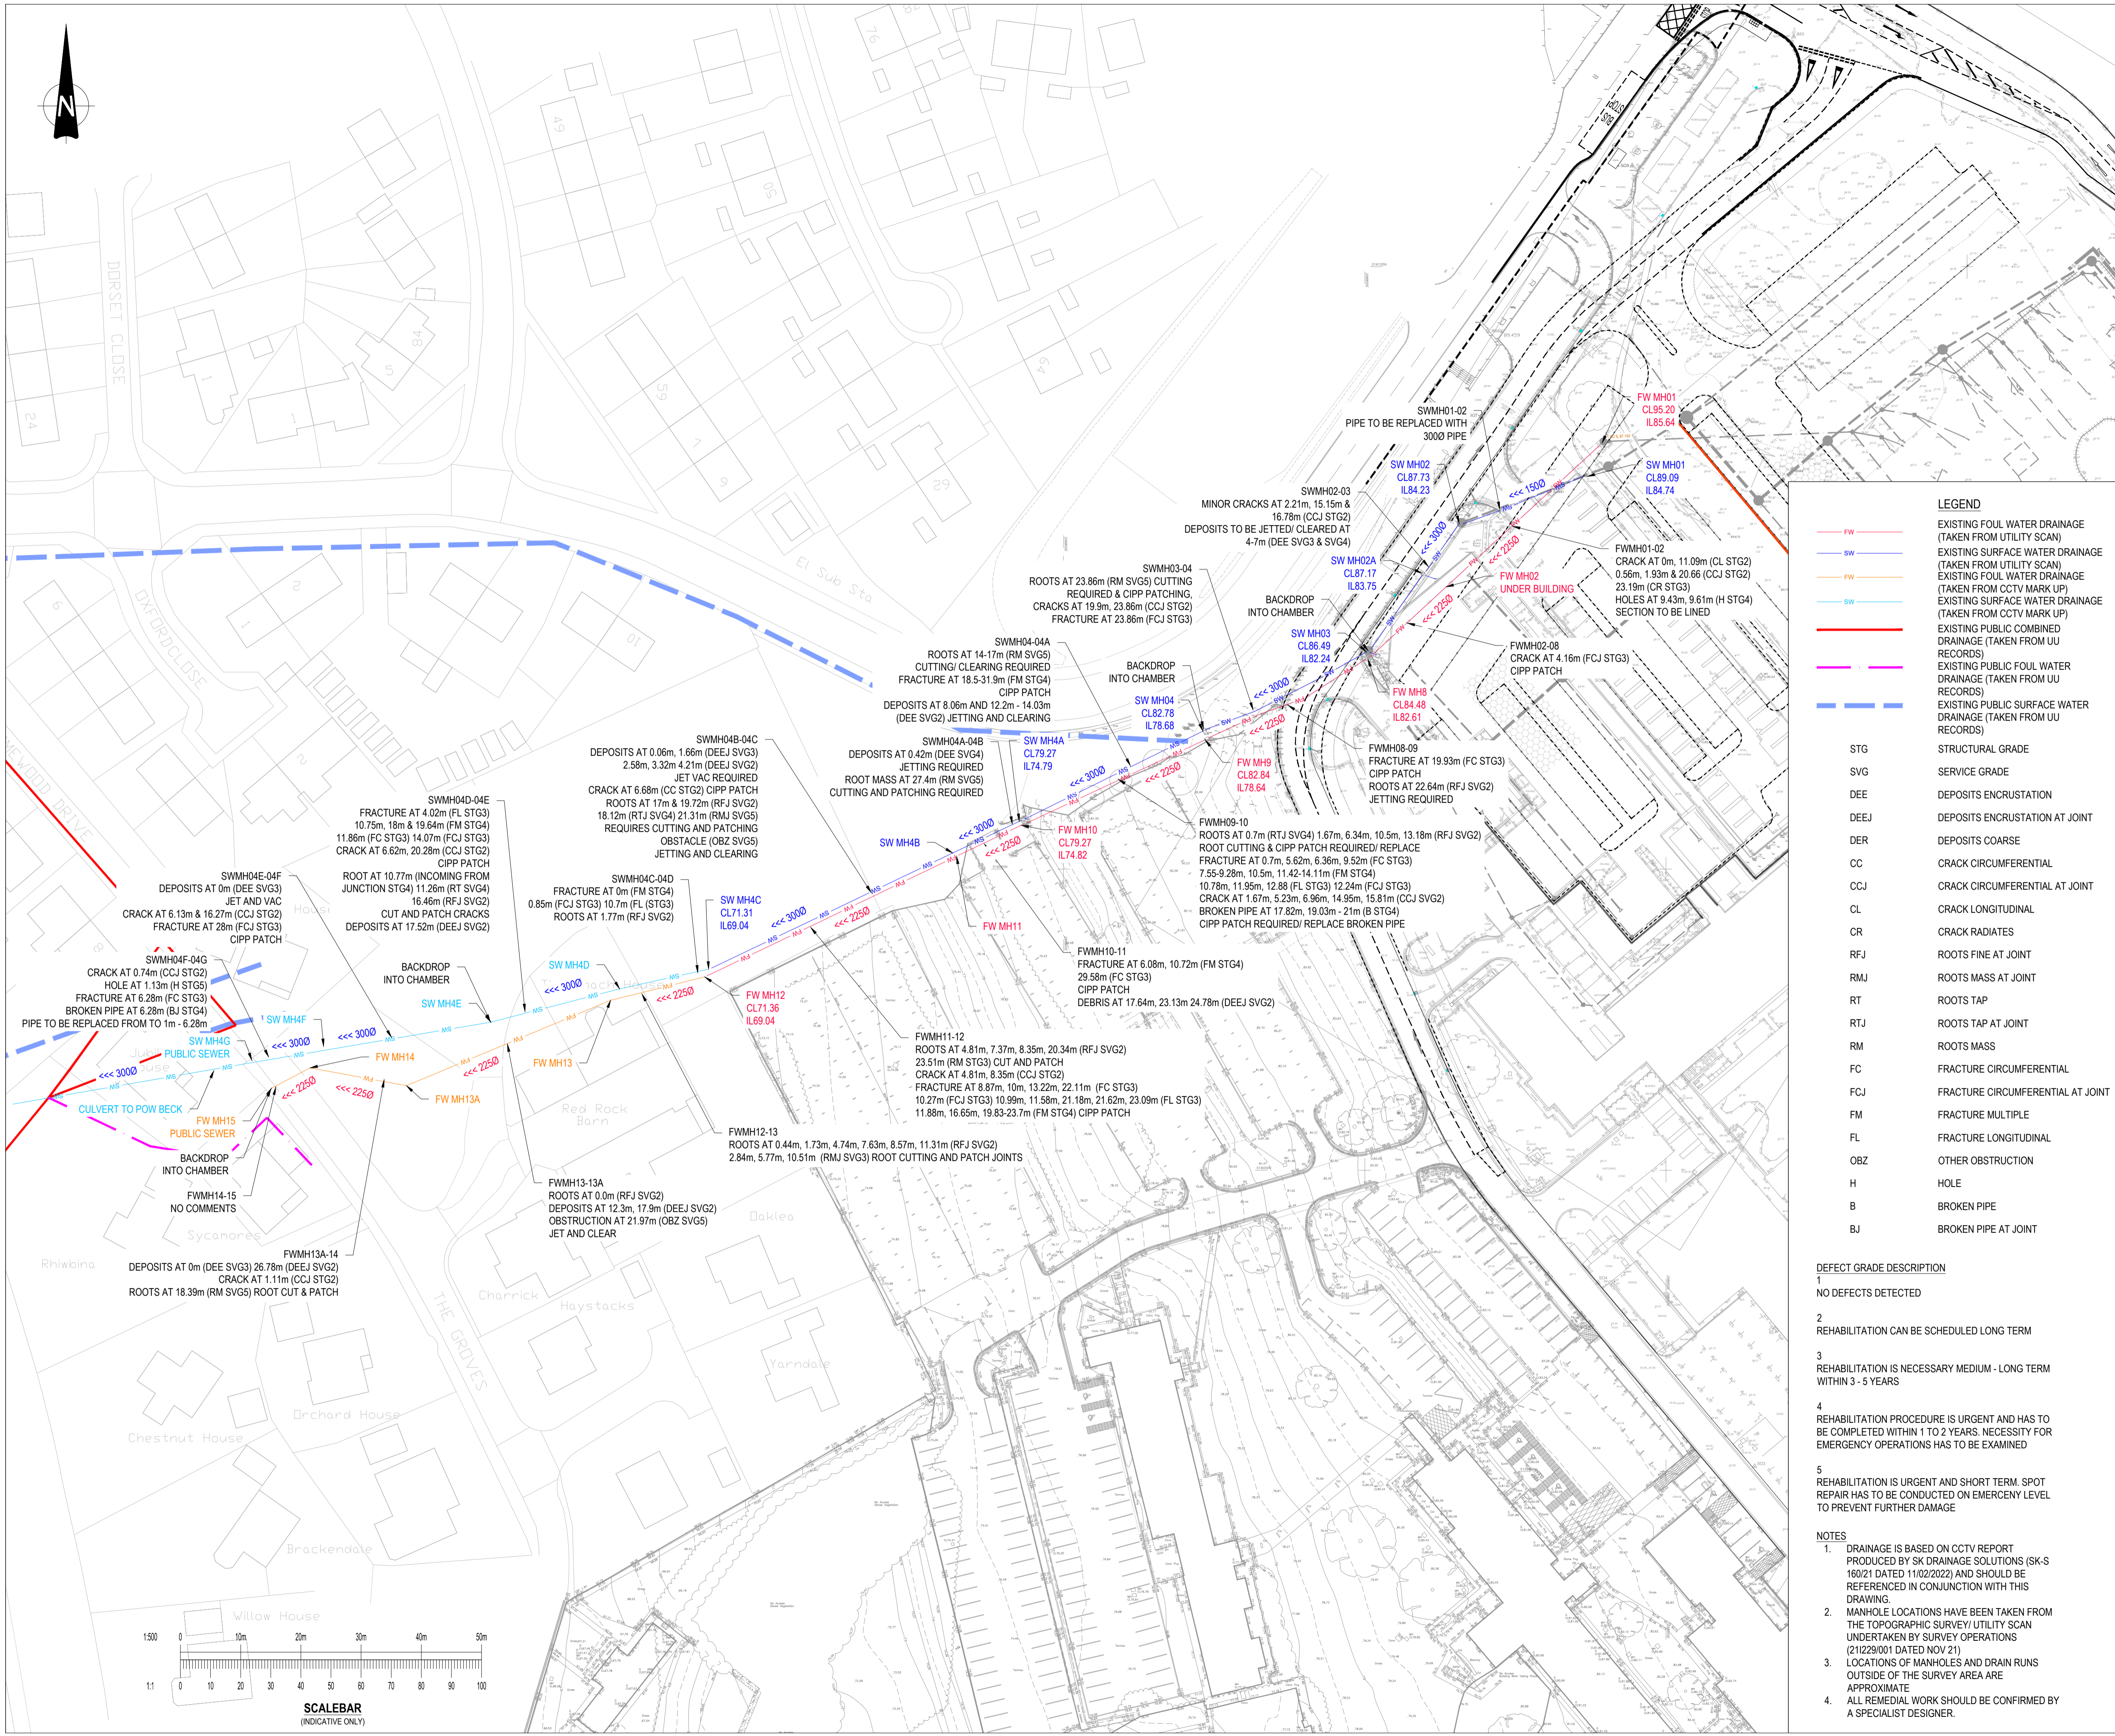
- DRAINAGE IS BASED ON CCTV REPORT PRODUCED BY SK DRAINAGE SOLUTIONS (SK-S 16/21) DATED 11/02/2022 AND SHOULD BE REFERENCED IN CONJUNCTION WITH THIS DRAWING.
- MANHOLE LOCATIONS HAVE BEEN TAKEN FROM THE TOPOGRAPHIC SURVEY/ UTILITY SCAN UNDERTAKEN BY SURVEY OPERATIONS (211229/001 DATED NOV 21)
- LOCATIONS OF MANHOLES AND DRAIN RUNS OUTSIDE OF THE SURVEY AREA ARE APPROXIMATE
- ALL REMEDIAL WORK SHOULD BE CONFIRMED BY A SPECIALIST DESIGNER.
