# Arboricultural Impact Assessment

# Haile Moor Mine, Egremont

# Prepared For: Electricity North West

# Document Reference: 10969.001

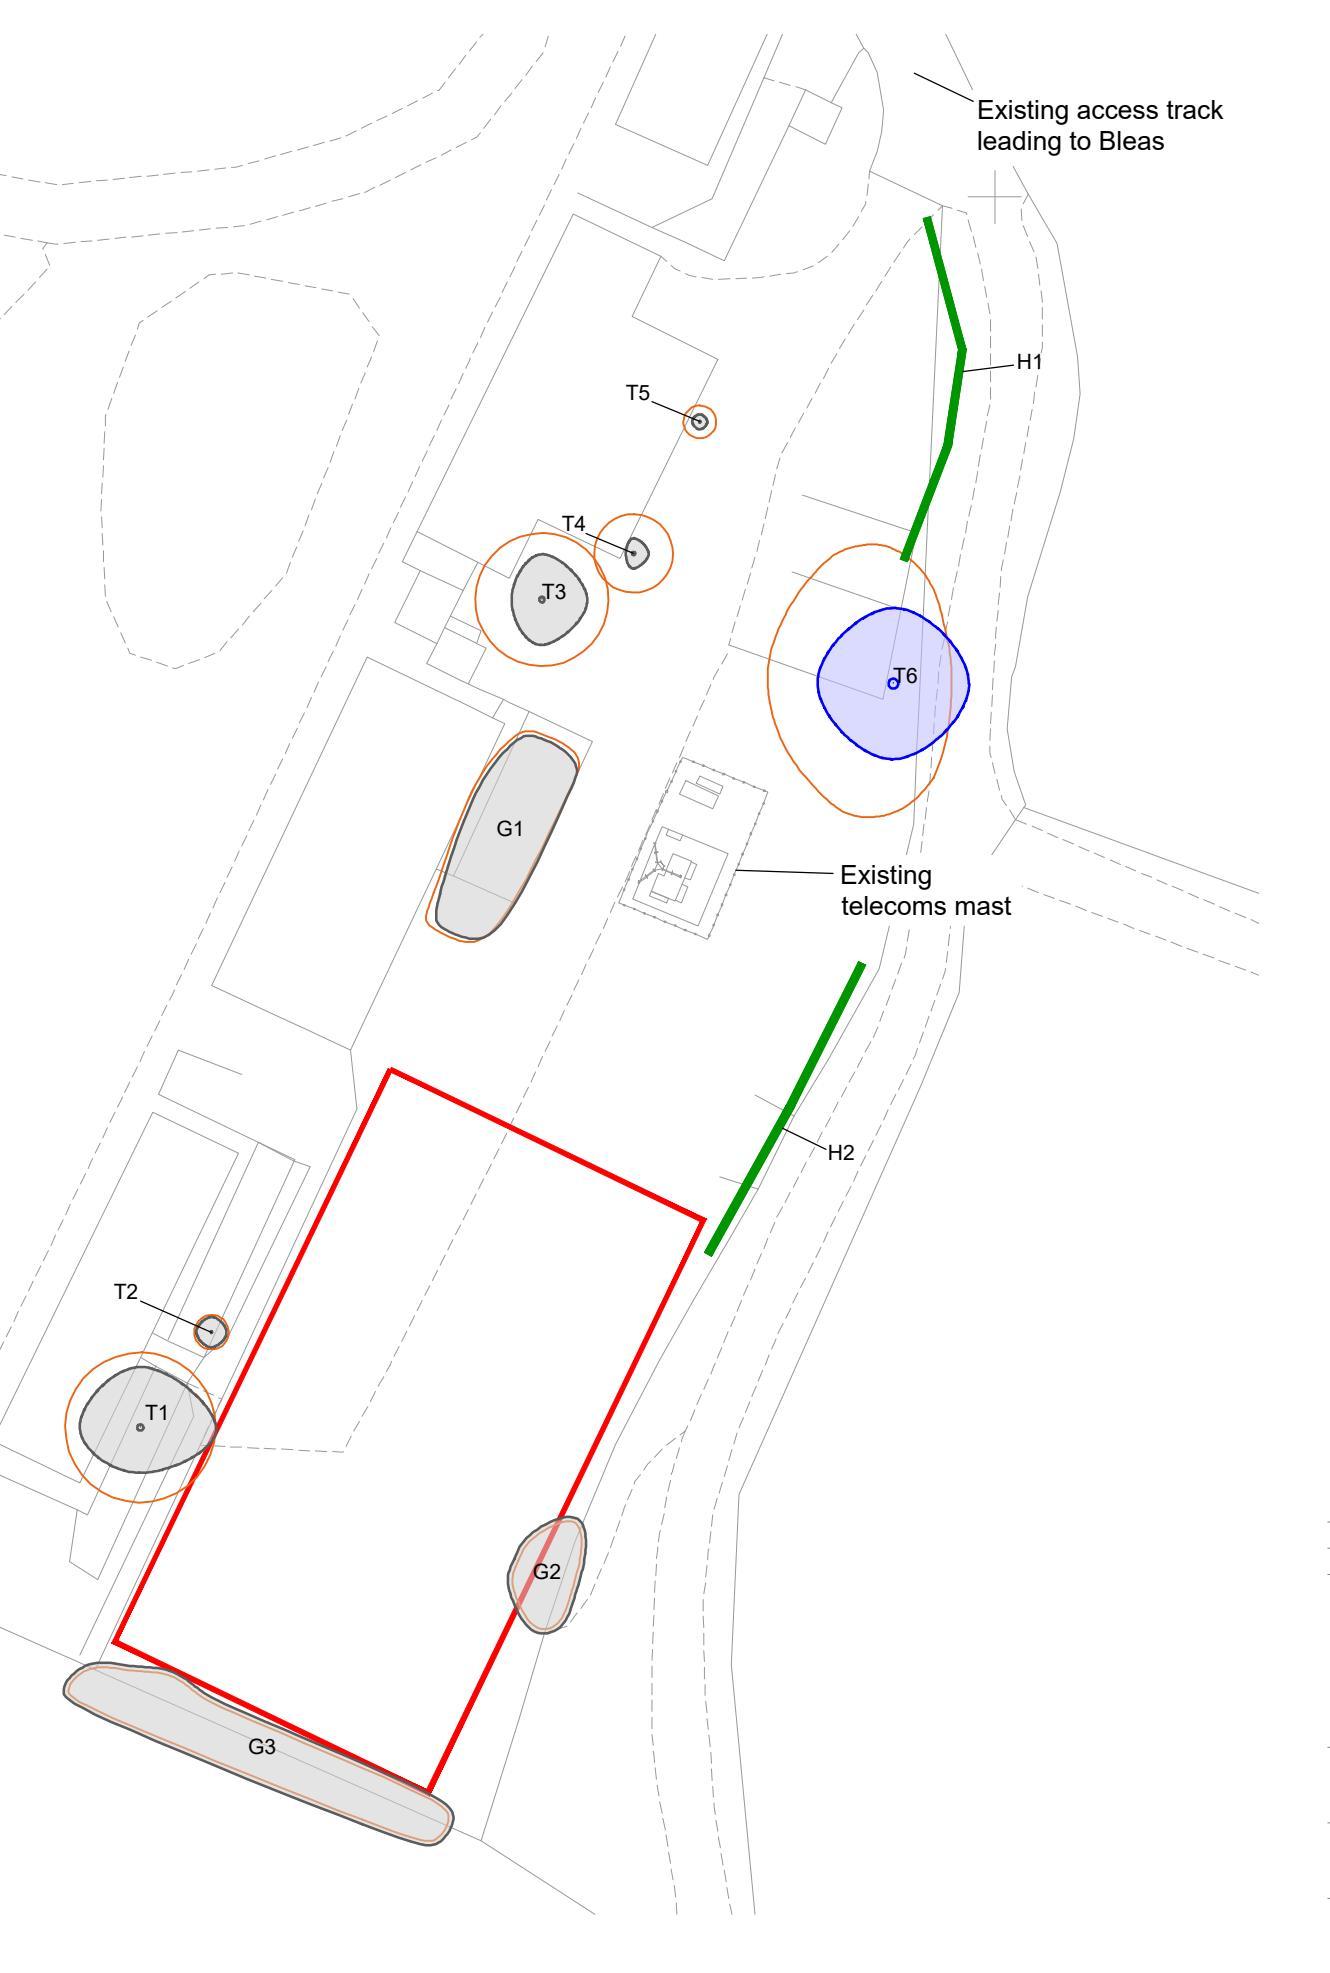
#### Drawing Num D10696.001

2.1. This drawing presents an overview of the existing trees within influencing distance of the proposed development. It also summarises the results of desktop searches for any designations, legal and regulatory restrictions or special status of relevance to arboriculture.

- 2.3. 6 individual trees, 3 groups of trees and 2 hedges were recorded within influencing distance of the application site. With the exception of the hedges, these are all self-set, with the majority being low-growing and scrubby in nature

- 2.4. The largest and most prominant individual tree is T3, an early mature sycamore growing on the eastern boundary of the site. The tree is free from structural defects and exhibits good form, despite a large pile of stone deposited within its rooting area.

- 2.5. Hedges H1 and H2 contribute to a wider network lining the access track off Bleas which at the time of the survey had been heavily flail pruned.
- 2.6. Trees have been categorised in accordance with BS 5837 to describe their arboricultural, landscape or cultural qualities: A (high quality), B (moderate quality) C (low quality) and U (unsuitable for retention). The categorisation of tree quality allows a weighting to be given to each tree within the context of proposed development but is not prescriptive. Hedgerows are not categorised.

- 2.8. Feature locations, their quality categories, canopy spreads and root protection areas are shown opposite. All arboricultural information recorded during the survey is presented at Appendix A.

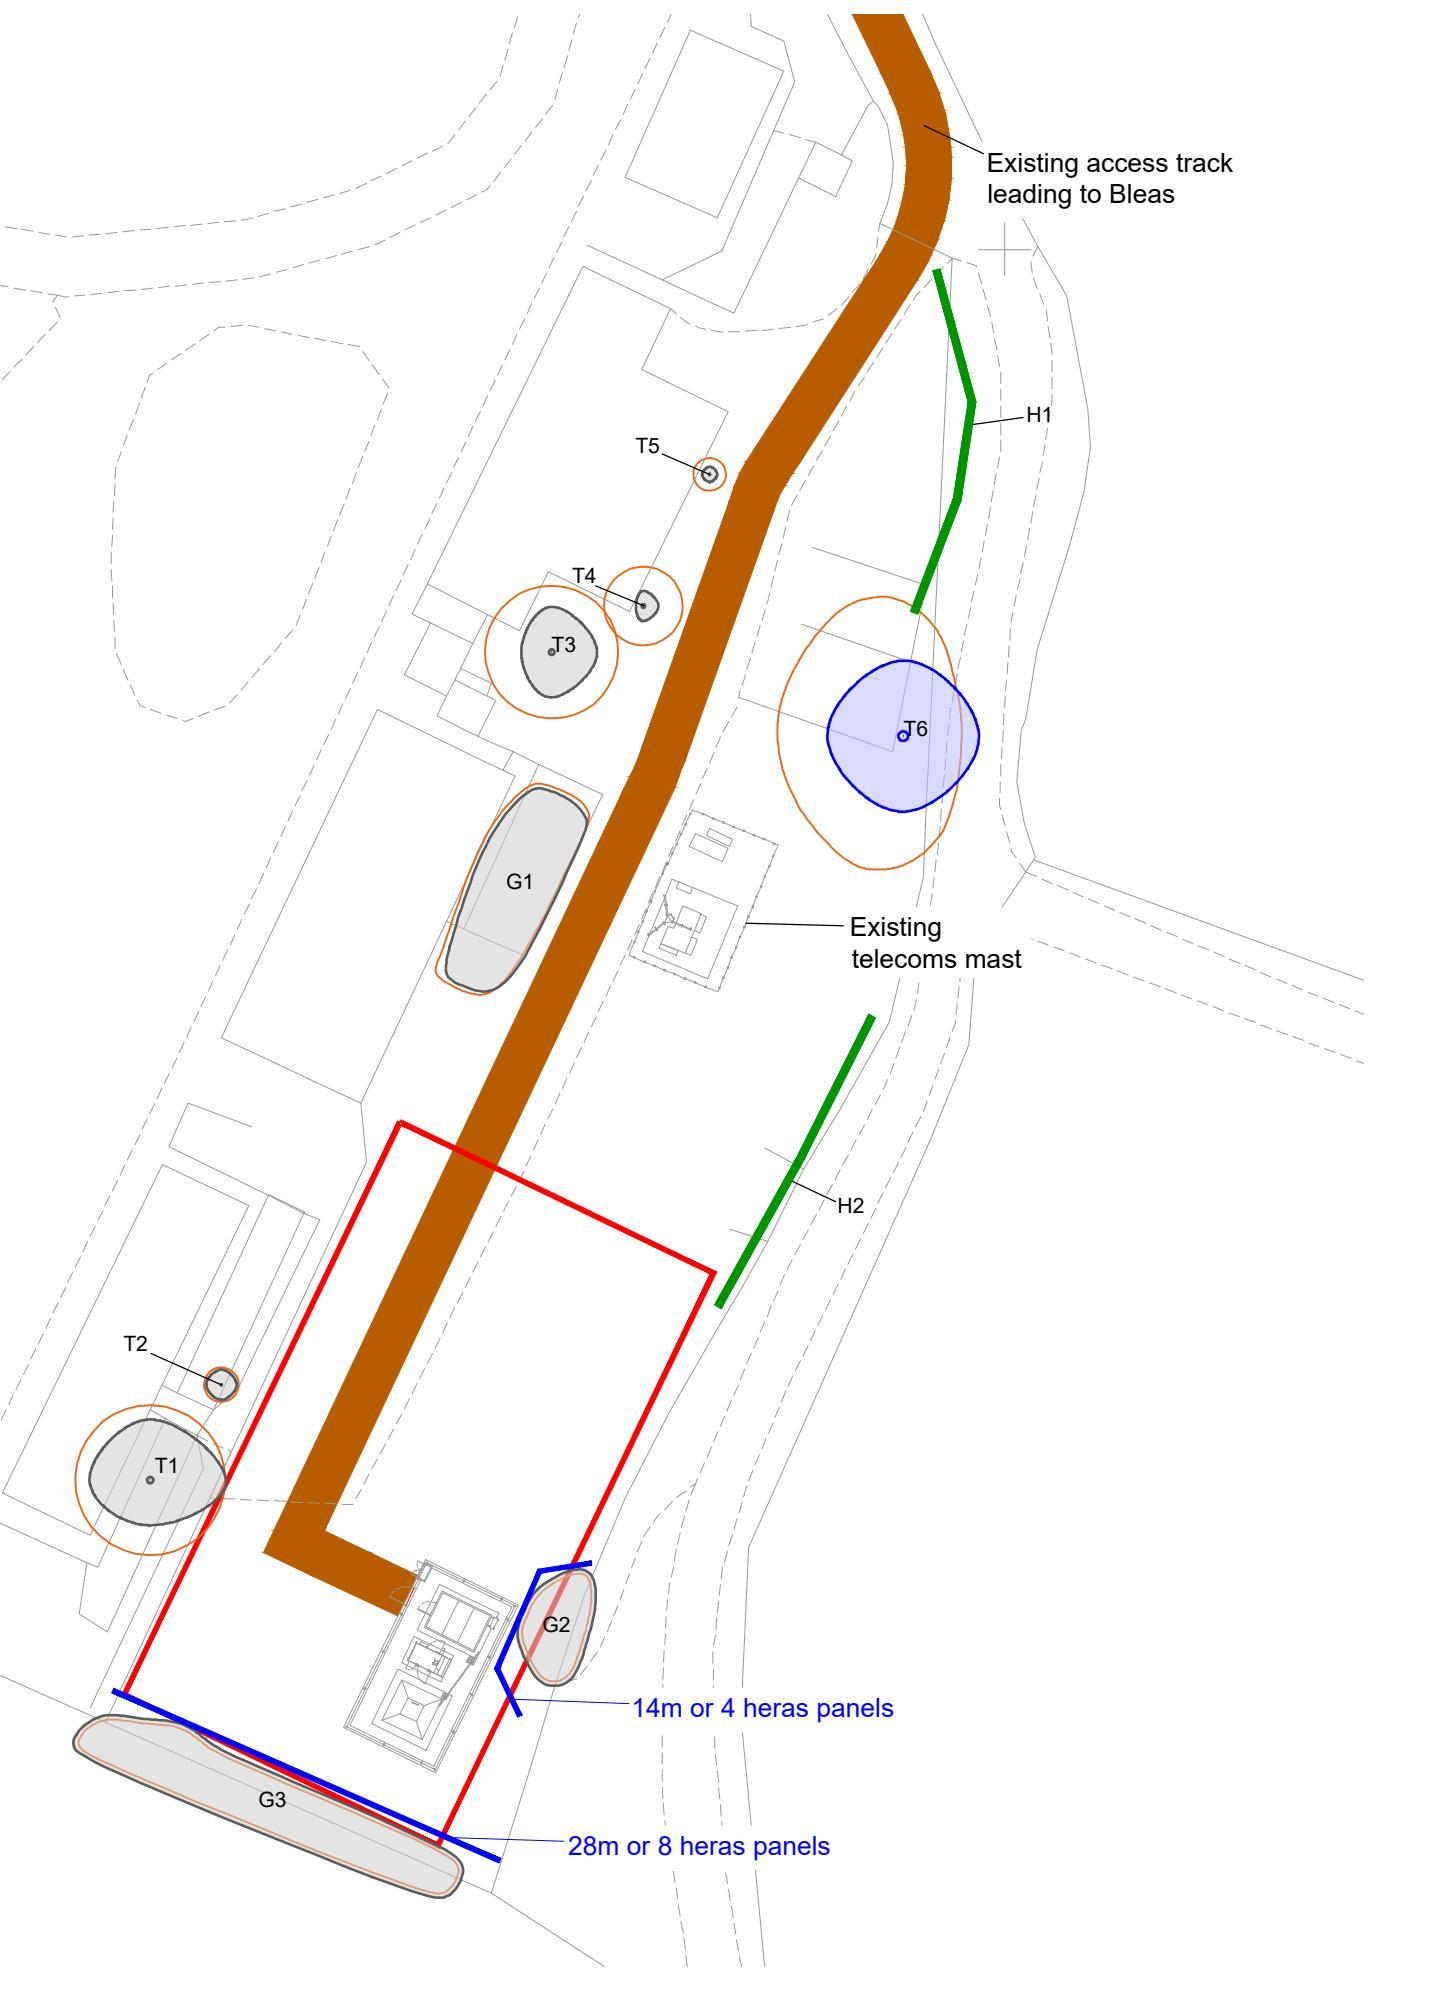
#### Drawing Number D10696.002

- 3.1. In simple terms, the effects on arboriculture comprises an account of which existing trees would not be retained within the proposed development; what significance they have; and whether adverse effects would or can be mitigated or offset.
- 3.2. This drawing presents the results of an assessment in accordance with BS 5837, including a definitive account of which trees would be removed or pruned.

3.3. The proposed development comprises the construction of a new telecoms mast comprising an 18m high lattice tower, generator, equipment cabinet and meter cabinet, enclosed by palisade fencing on a concrete ring beam. To facilitate the proposals, the ground will be locally re-graded to create a construction platform. The proposed layout is shown opposite and is based on drawing P2407\_002-GA-004-B provided by Electricity North west.

- 4.4. The alignment of temporary tree protection measures, shown opposite as a **thick blue line**, will be marked out and installed as shown opposite.

Temporary Tree Protection Fencing (c. 42m) (Must be installed prior to works commencement)

- 4.5. The specification for tree protection fencing will be as per Appendix C.
- 4.6. The site manager will inspect and verify the correct installation of tree protection and maintain a photographic record.

- 4.7. Tree protection fencing will not be removed or realigned; and storage, excavation, level change, and access is prohibited within areas of tree protection except as described by this document or an approved Arboricultural Method Statement.

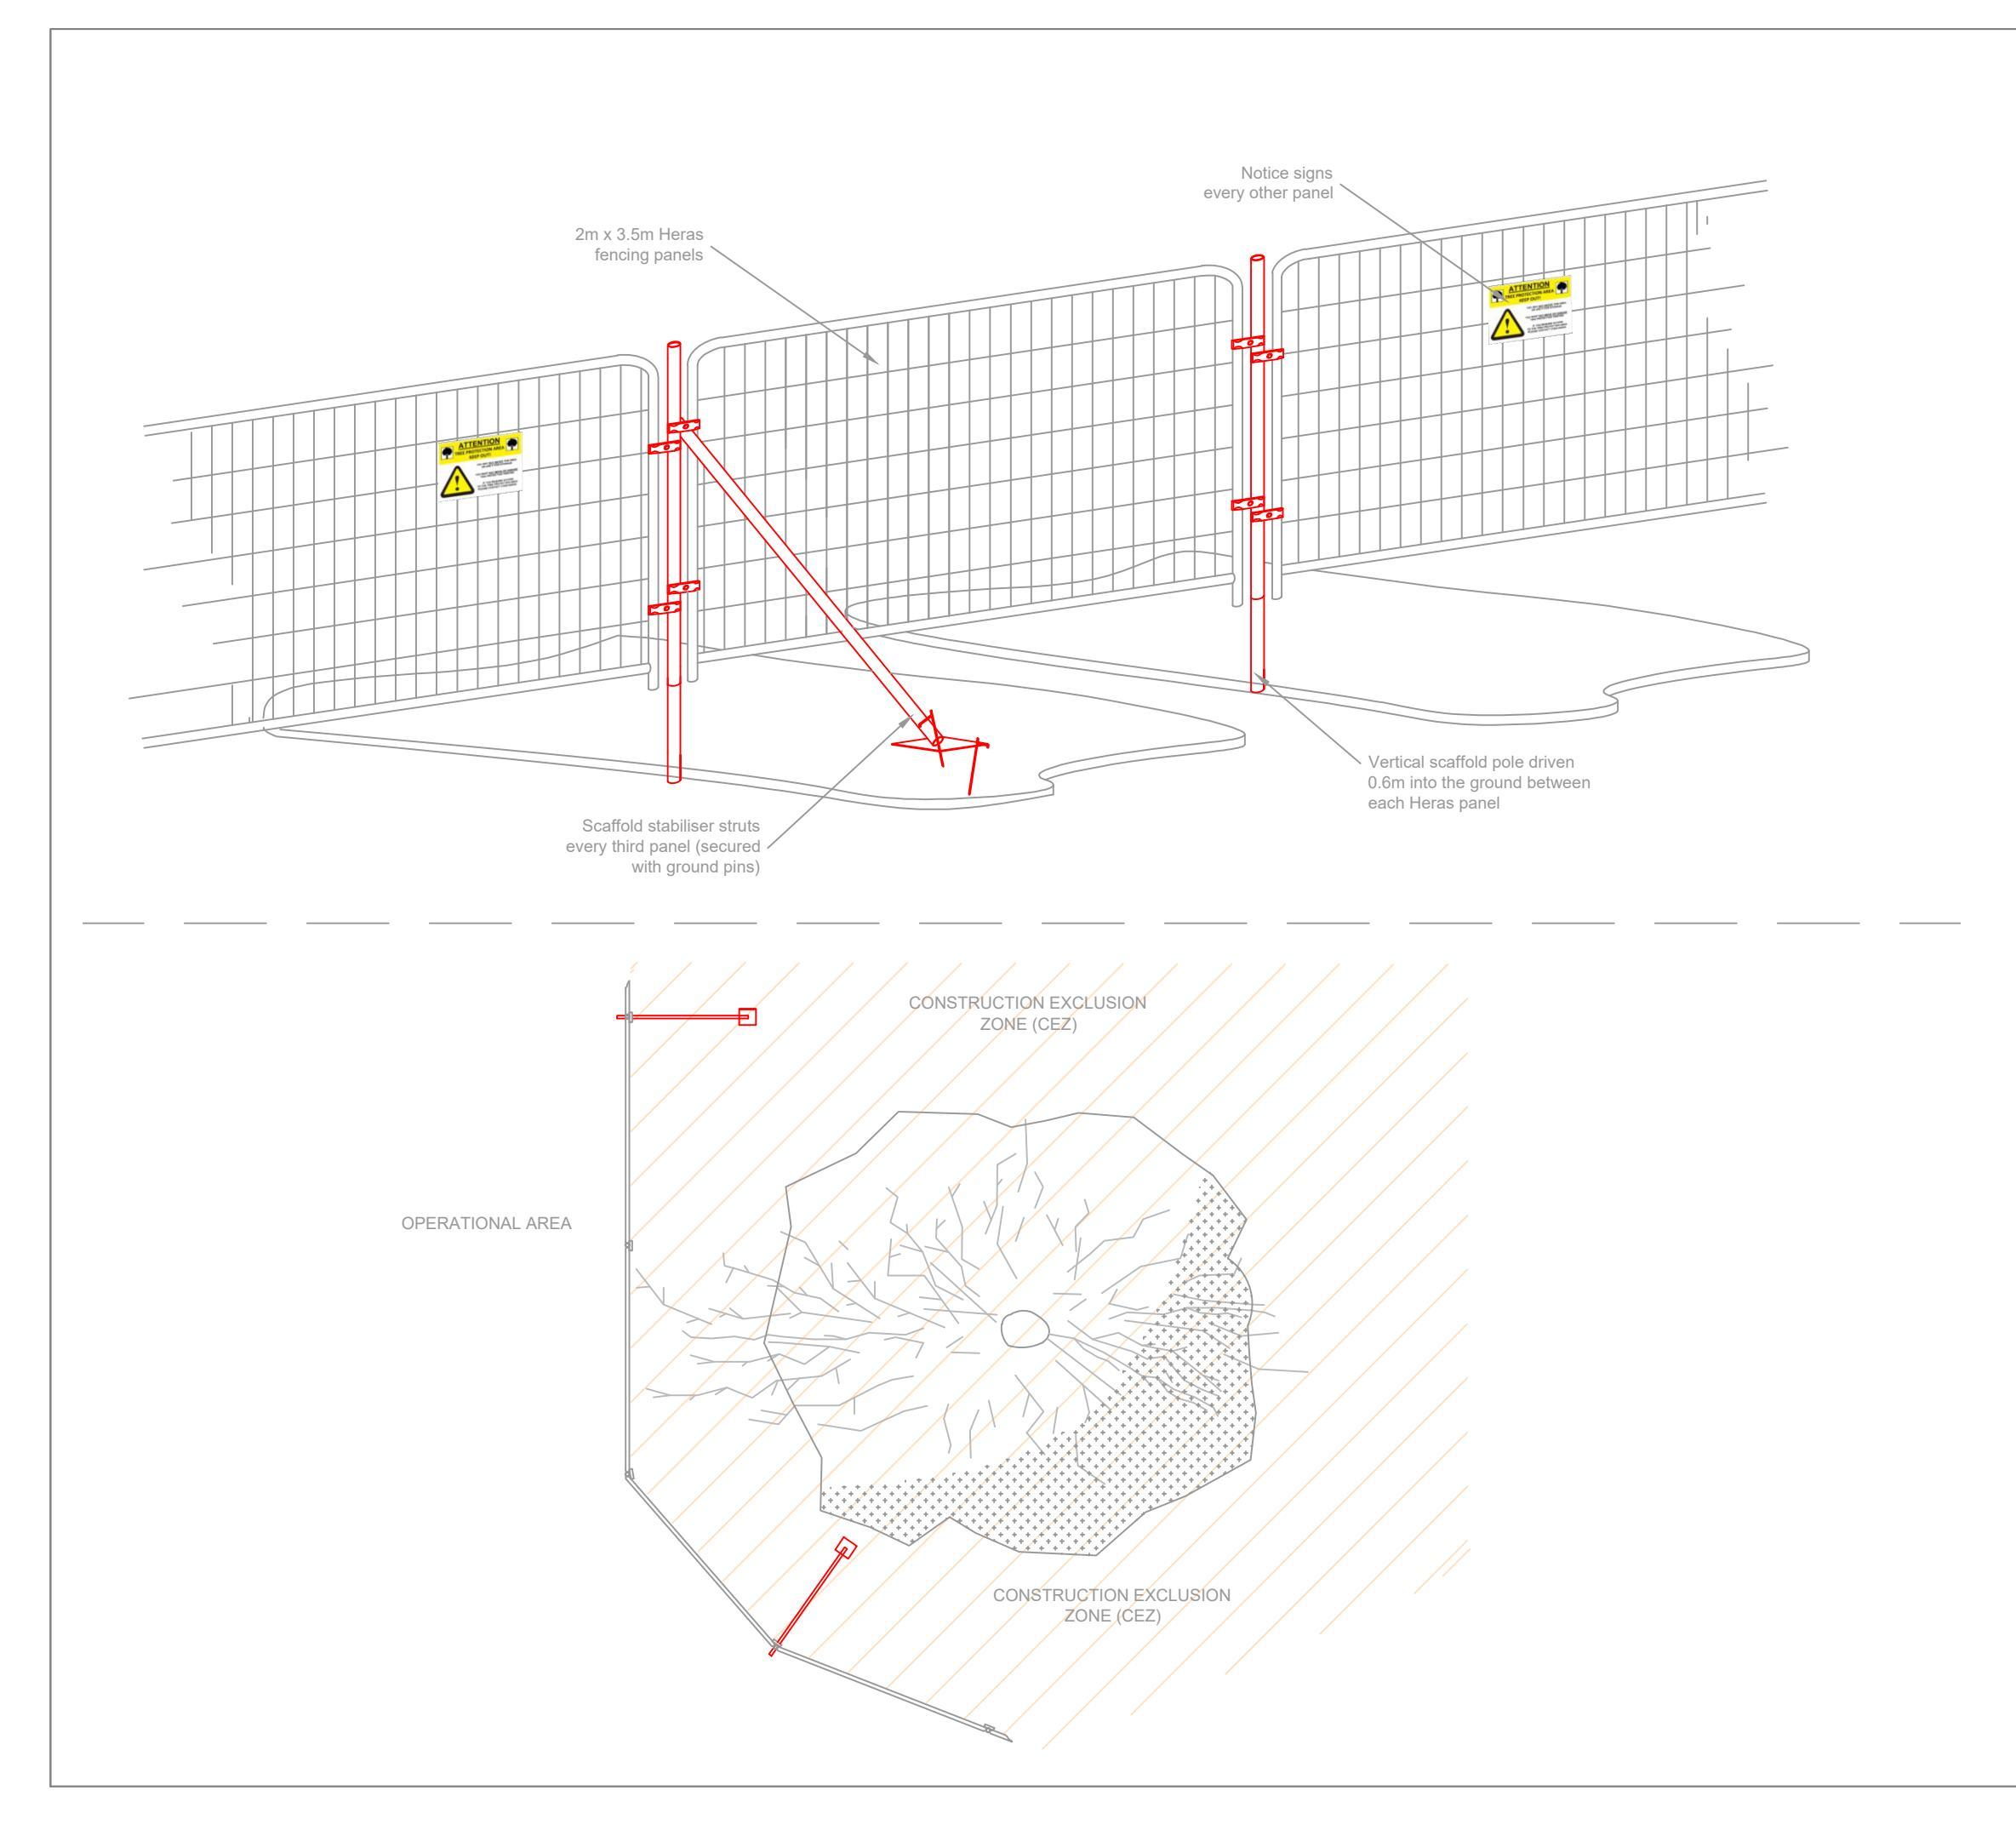
Per 3No. Heras panels (10.5m)	
Component	Quantity
2m x 3.5m Standard Heras panels	3
3m Galvanised steel scaffold pole	3
Heras fecurity fence clip	12
Heras stabilising support bar	1
Stabilising pin	2
Tree protection notice	2
