ADDENDUM 2

TREE SURVEY

EDGEHILL PARK PHASE 3 WHITEHAVEN

Job Title:	EDGEHILL PARK PHASE 3, WHITEHAVEN
Job Number:	587
Document Title:	ADDENDUM 2 TO TREE SURVEY
Prepared by:	A M Turner
Date:	October 2020
Checked:	J C C Robinson
Date:	October 2020
Approved by:	W J Turner, M.Arbor.A
Date:	October 2020

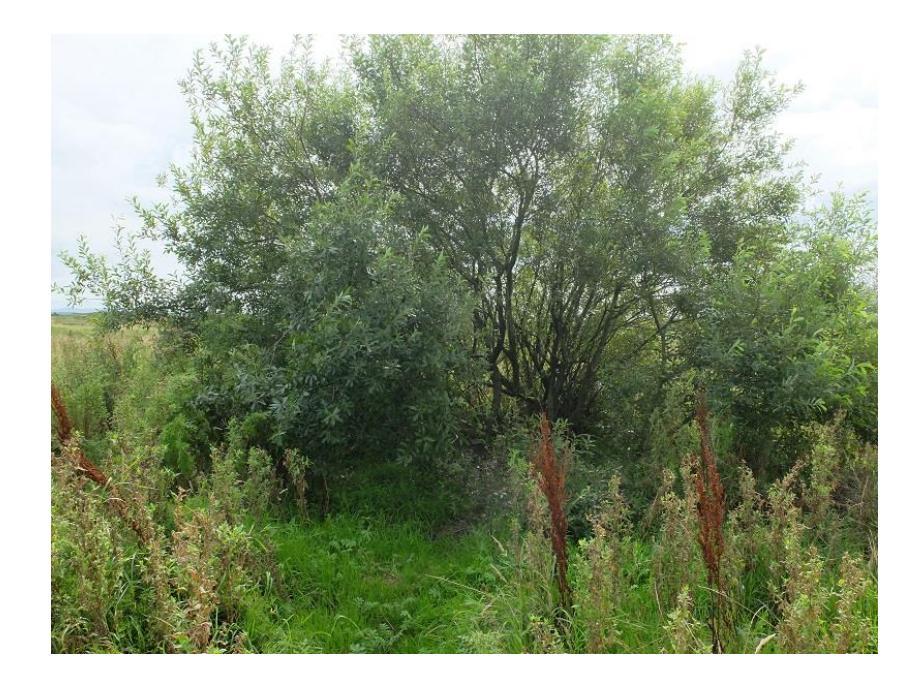
View looking south east towards mature former coppice willow T1, as shown in Plate 1.

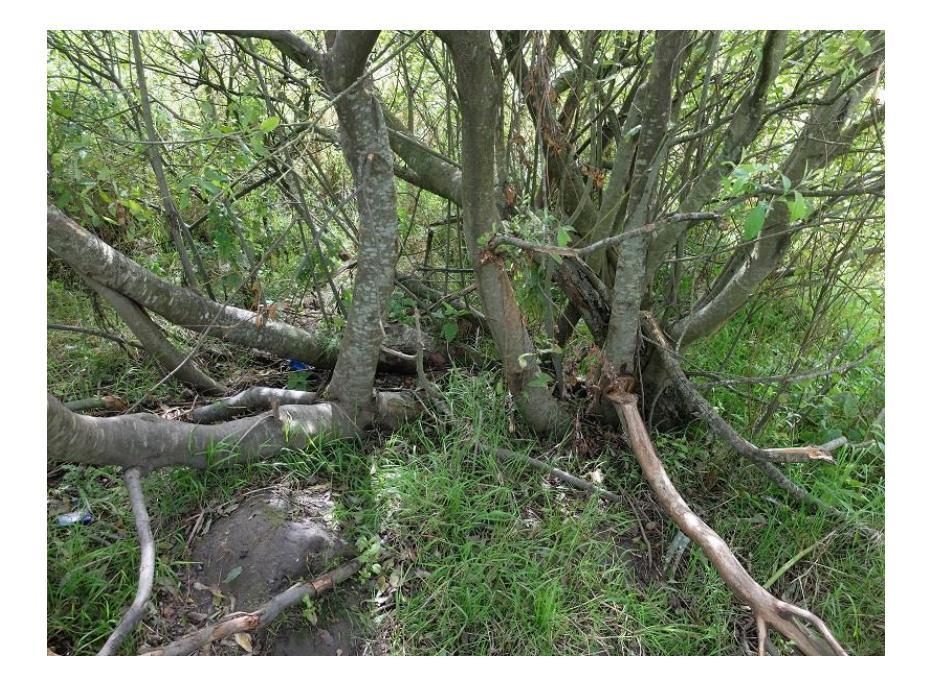
View looking at former coppice boles of T1, a multistem with 7 boles, as shown in Plate 2.

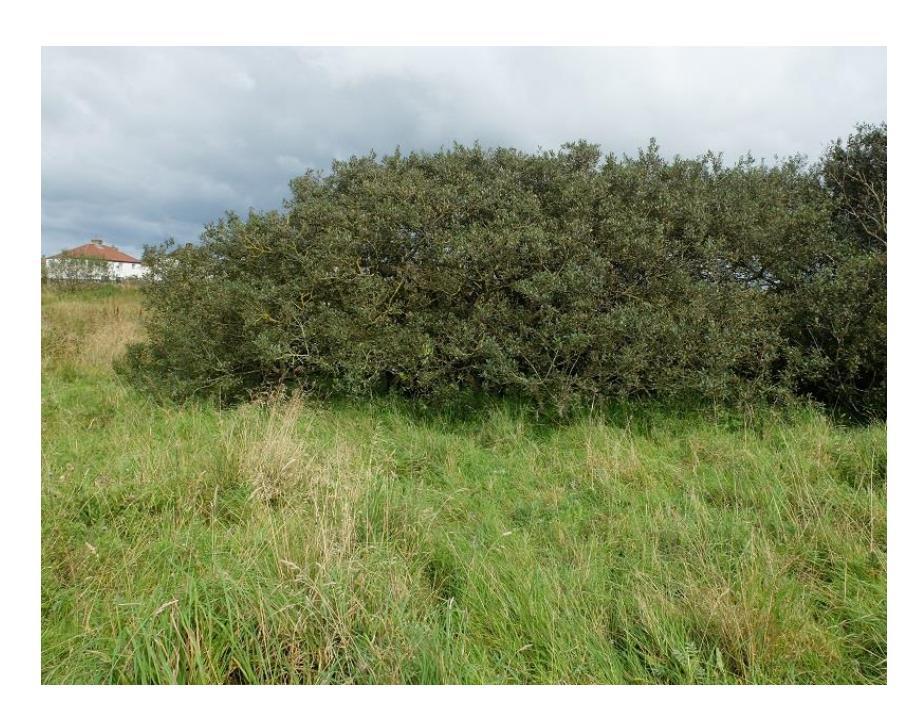
View looking north east towards T2, growing in close proximity to T3, as shown in Plate 3.

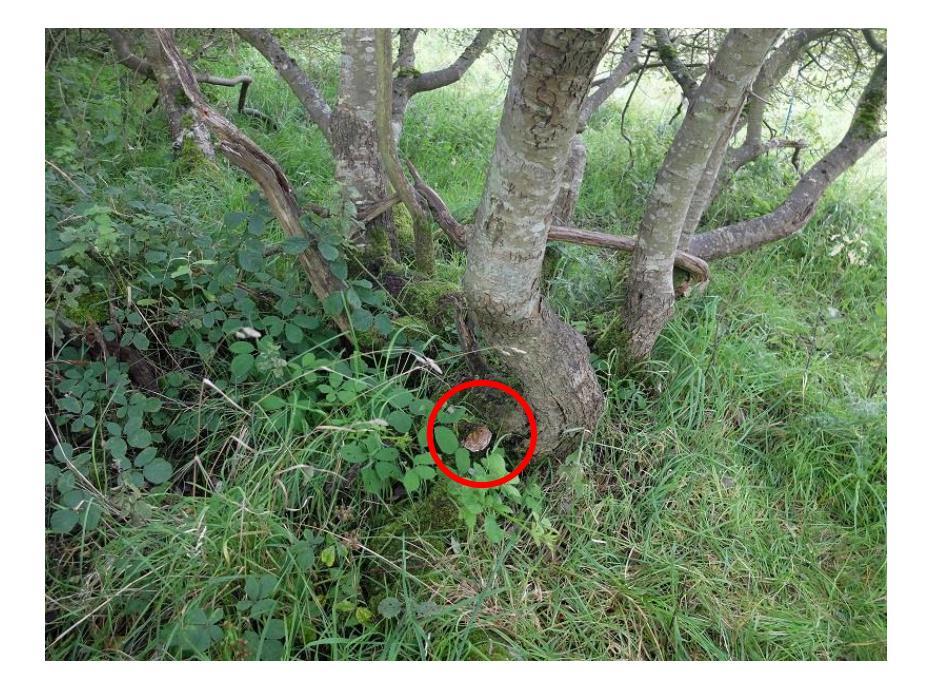
View within the north east section of the wide spreading former coppice boles of T2, a multistem with 12 boles. A small area of *Ganoderma sp.* present to north east bole highlighted in red, as shown in Plate 4.

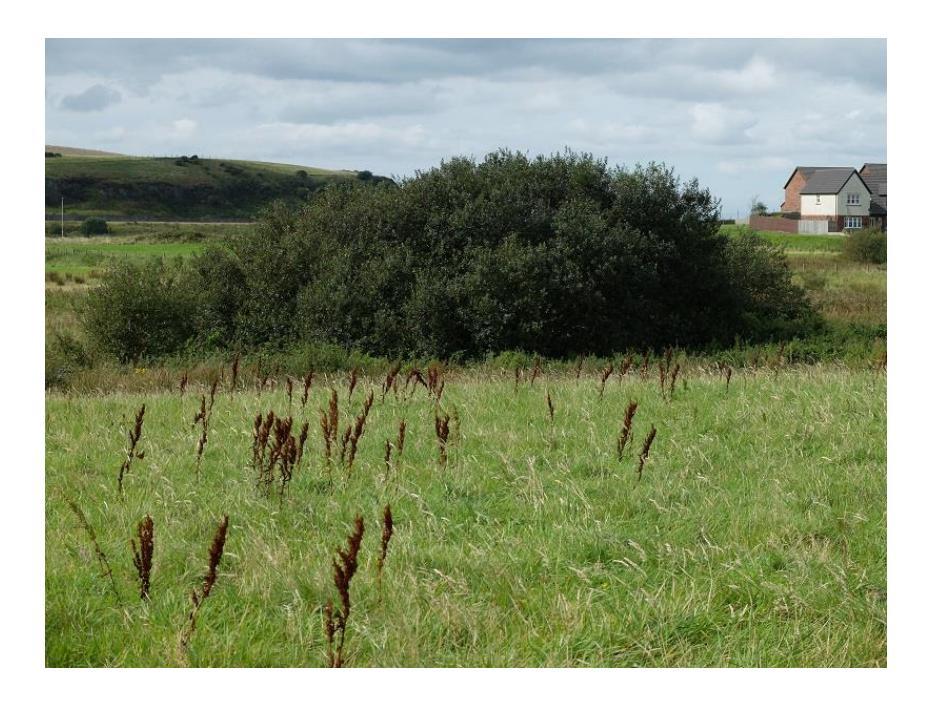
View looking north west towards a wide spreading former coppice willow, as shown in Plate 5.

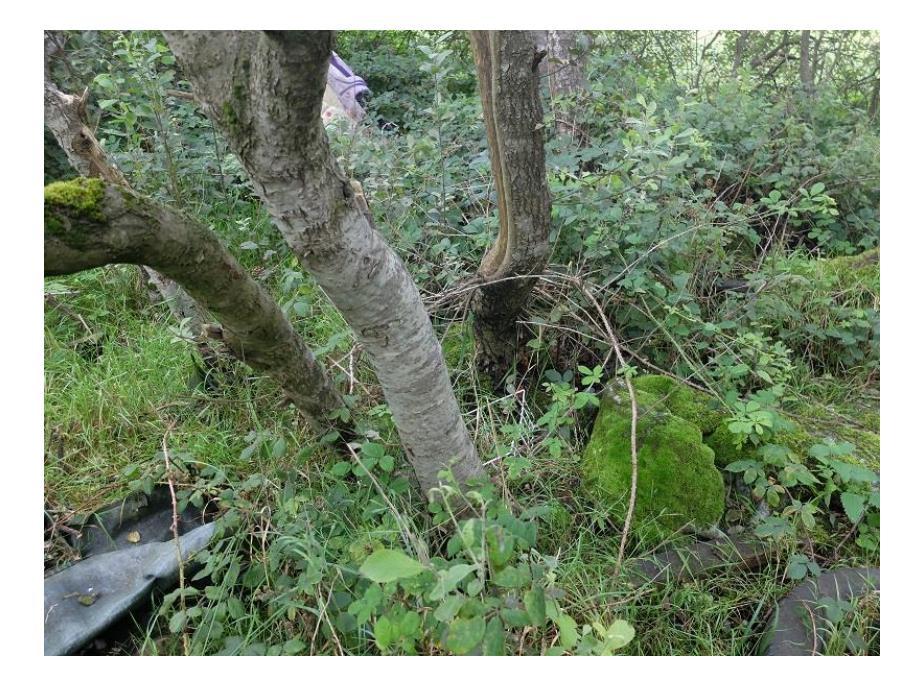
View within west part of wide spreading former coppice boles of T3, a multistem with 20 boles. Evidence of domestic fly tipping beneath wide spreading canopy, as shown in Plates 6.

T3 Grey Willow – Salix cinerea Multi-stem with 20 boles. Old coppice willow. Base and bole appear sound. Wide spreading base with 12 suckering stems and 8 large boles. Evidence of domestic fly tipping beneath wide spreading canopy. Mature in fair condition. NPBH.	7	450 145 X 8 320 100 X 12	7	7	10	8.5	c.100	10	25	L	B2	4.9 X 8 4.2 X 12	To be removed for development and replaced with suitable native species

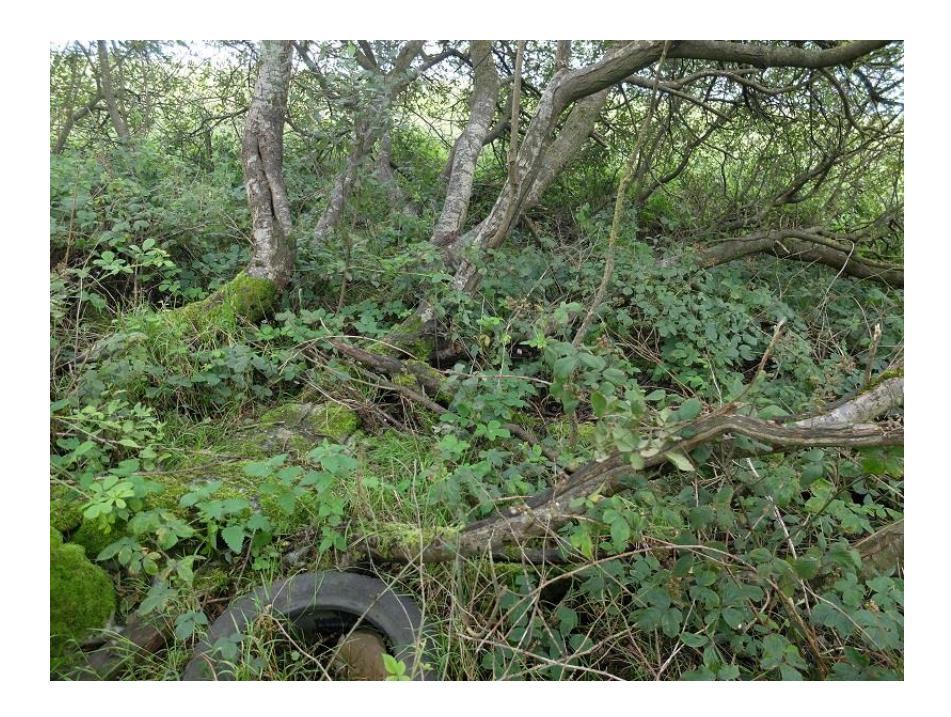
View within east part of wide spreading former coppice boles of T3 with further evidence of domestic fly tipping, as shown in Plate 7.

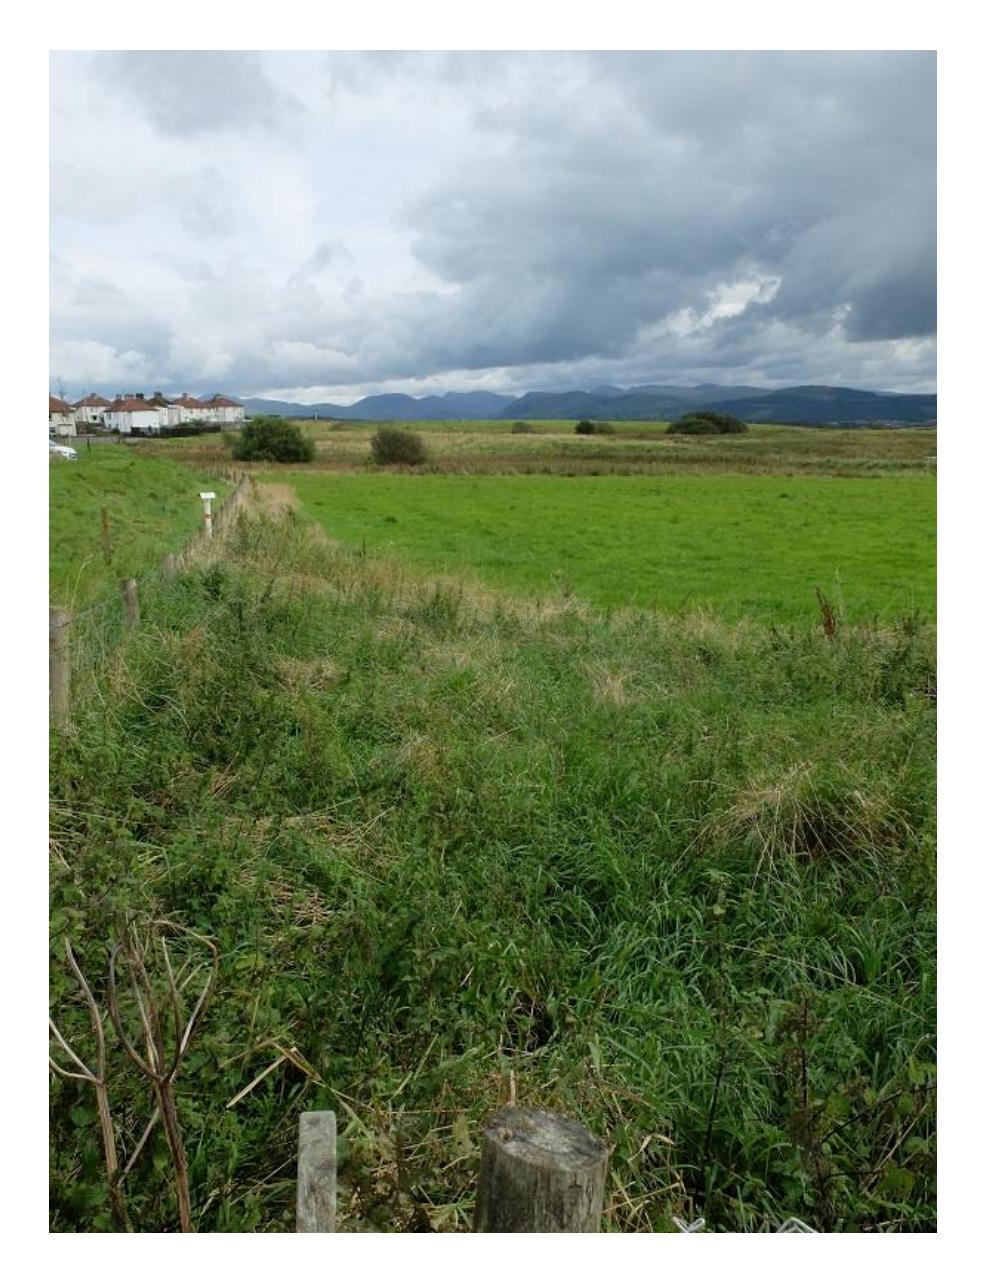
View looking east along the northern boundary of the site towards localised stands of regenerating willow scrub, as shown in Plate 8.

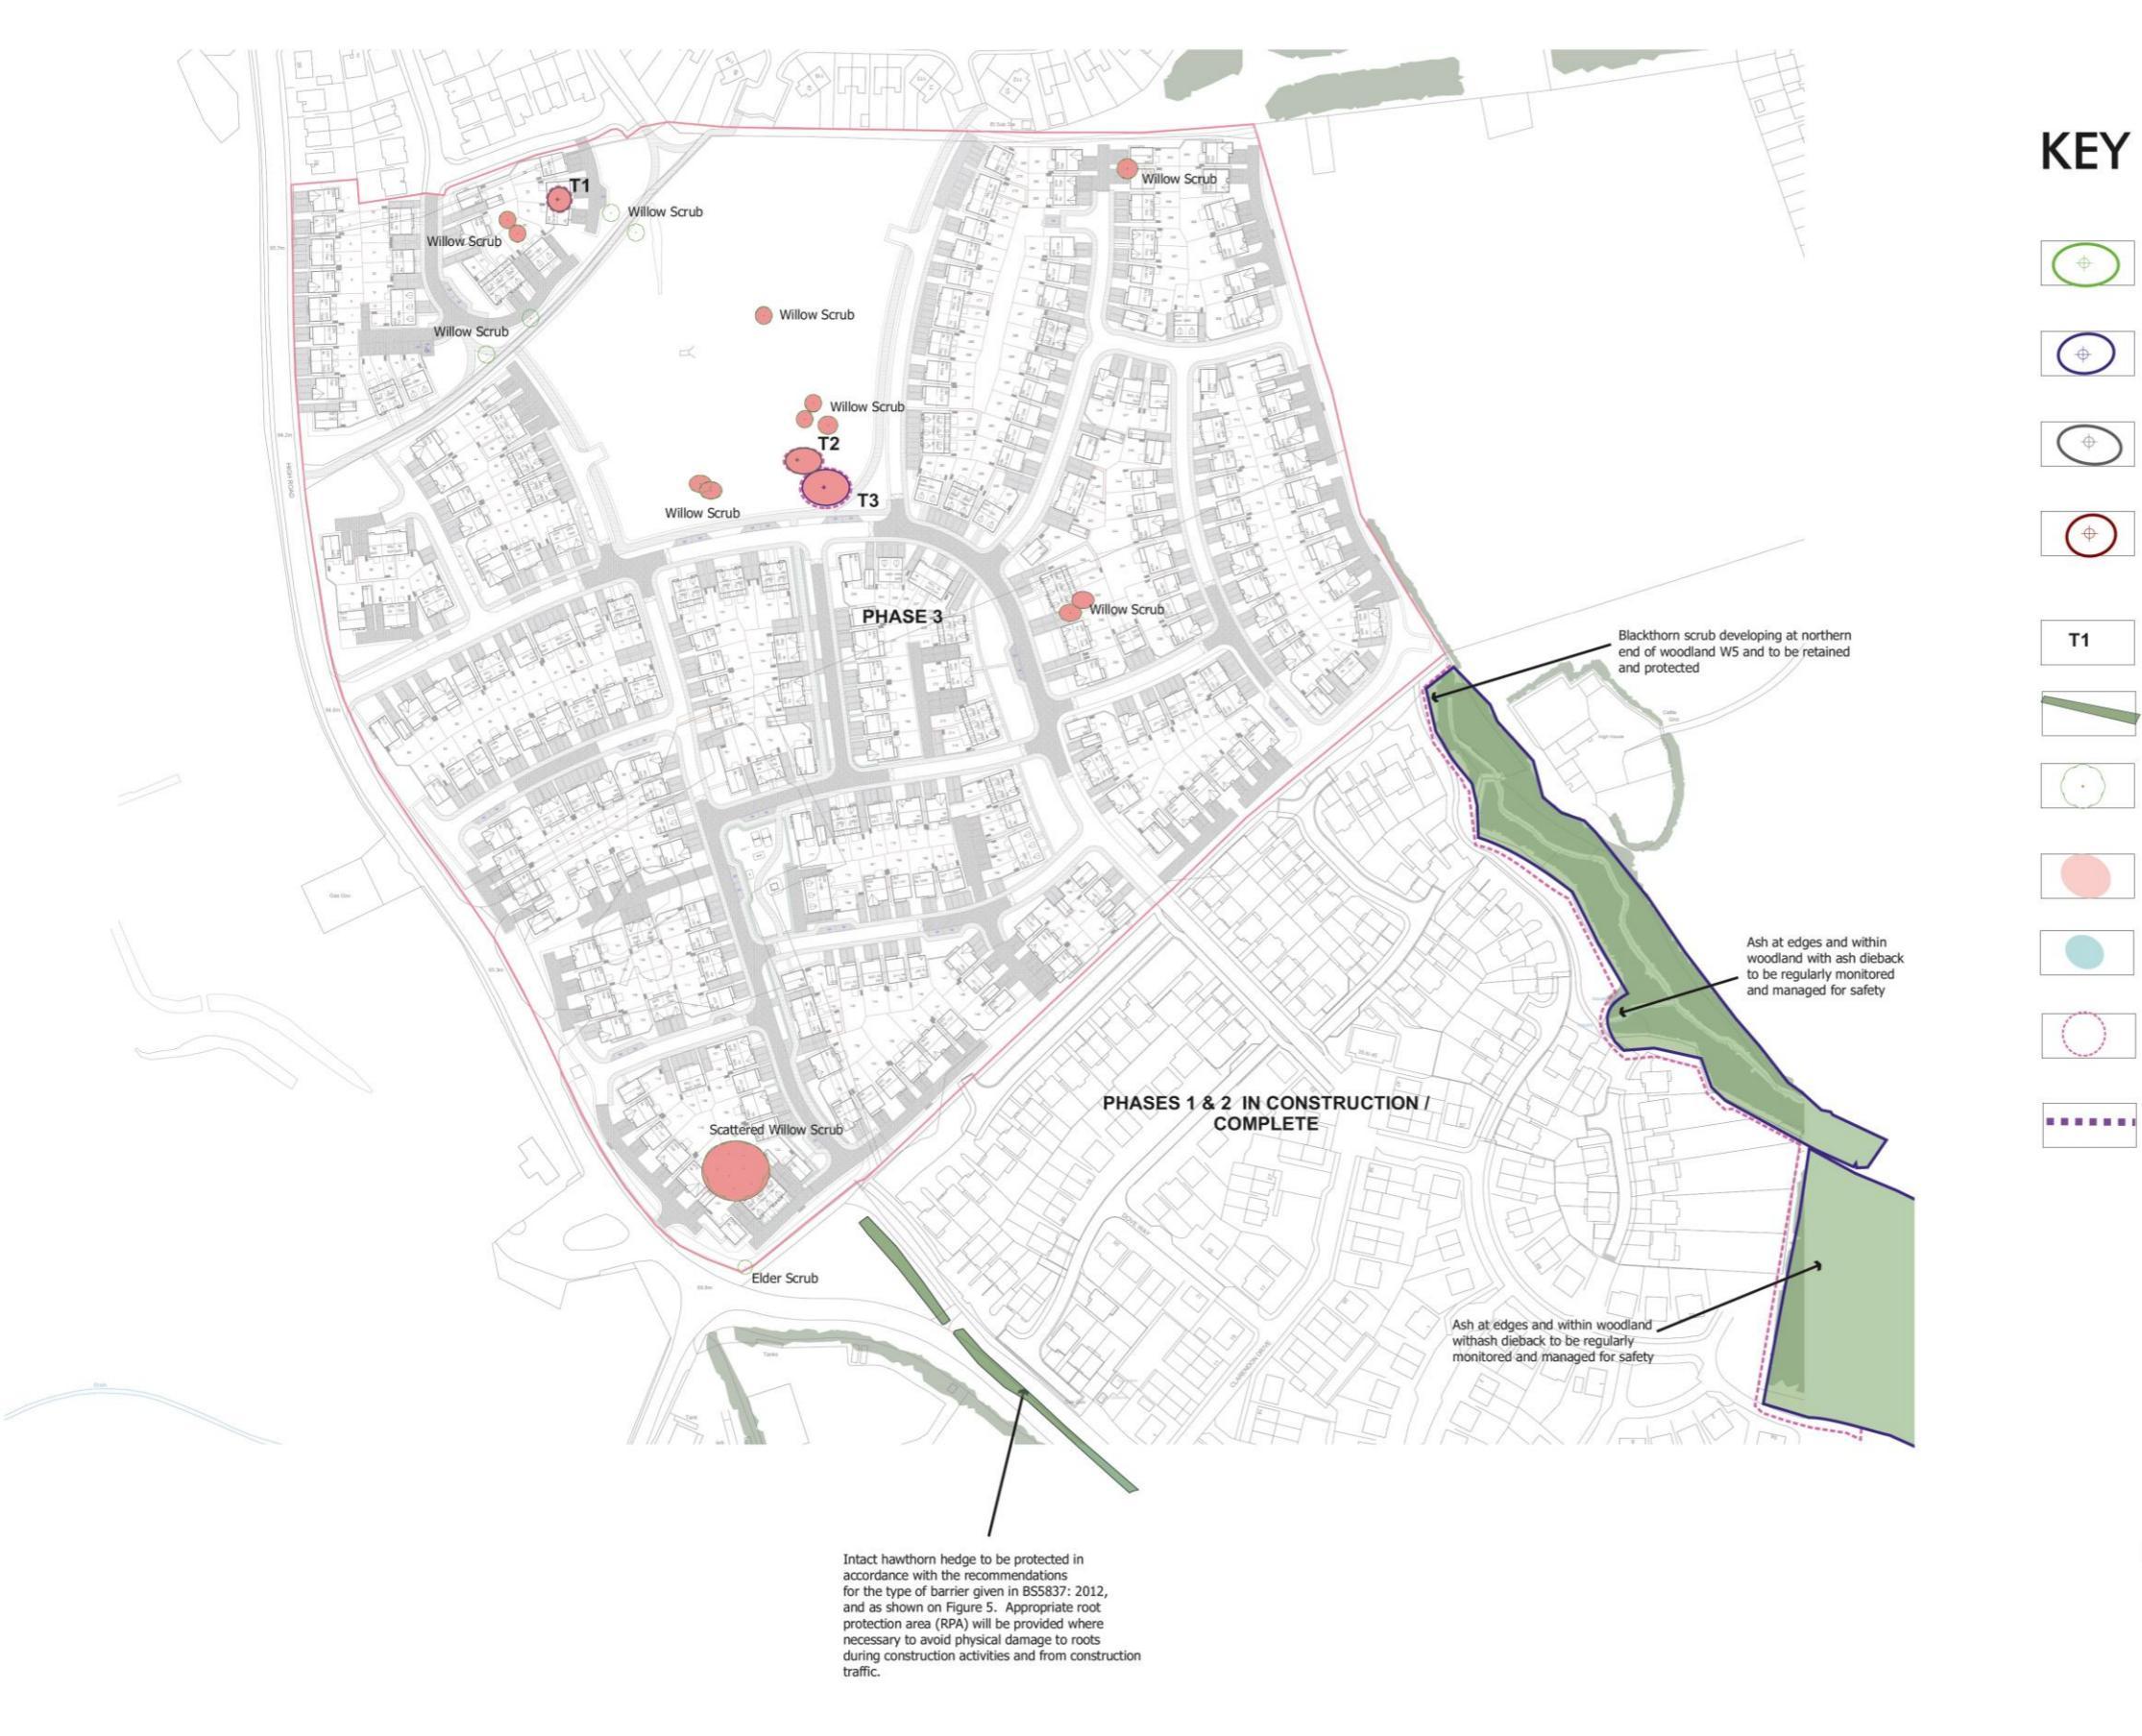
Figure 4: Arboricultural Impact Assessment and Tree Protection Plan

Tree in close proximity to proposed development and requiring appropriate and sensitive mitigation measures to avoid adverse damage to the health, future growth and safety of tree in accordance with BS 5837: 2012

Protection of existing trees and mature vegetation to be retained in proximity to development will be required during the construction works in accordance with best practice and to BS5837: 2012, 'Trees in Relation to Design, Demolition and Construction - Recommendations'. Appropriate protective barriers, any other relevant physical protection measures including ground protection and construction exclusion zones to protect the root protection areas, will be provided to avoid physical damage to trees and root plates during construction. These measures are shown on **Figure 4** and set out in **Appendix 3** - Method Statement for Contractor. Measures include:

- Protection against potential damage on site by barrier fencing and/or ground protection before any materials or machinery are brought onto the site, and before any development or stripping of soil commences in accordance with the recommendations for the type of barrier given in BS5837: 2012, 'Trees in Relation to Design, Demolition and Construction Recommendations' and as shown on **Figure 5**. Appropriate root protection areas (RPA) will be provided where necessary to avoid physical damage to roots during construction activities and from construction traffic.
- Areas of retained structural planting such as scrub, or designated for new structural planting, should be similarly protected.

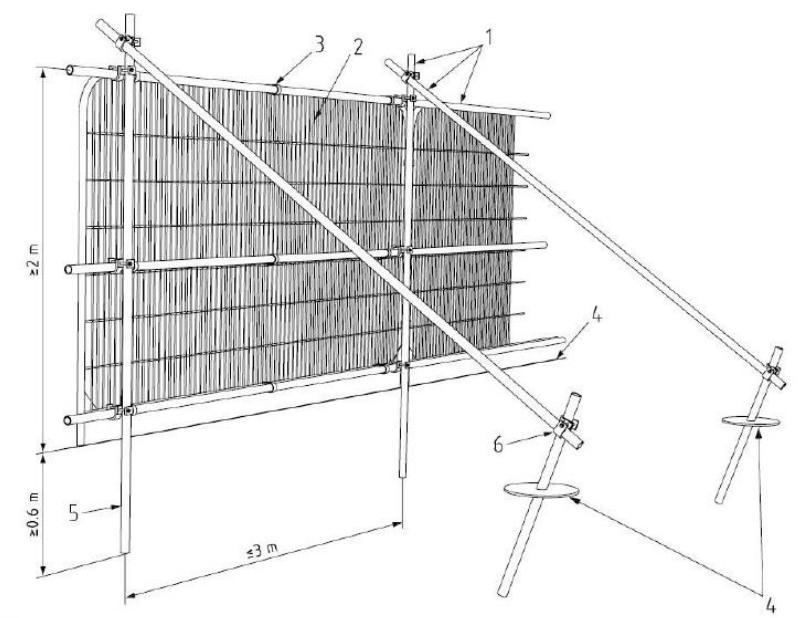
Default specification for protective barrier

- 1 Standard scaffold poles
- 2 Heavy gauge 2 m tall galvanized tube and welded mesh infill panels
- 3 Panels secured to uprights and cross-members with wire ties
- 4 Ground level
- 5 Uprights driven into the ground until secure (minimum depth 0.6 m)
- 6 Standard scaffold clamps

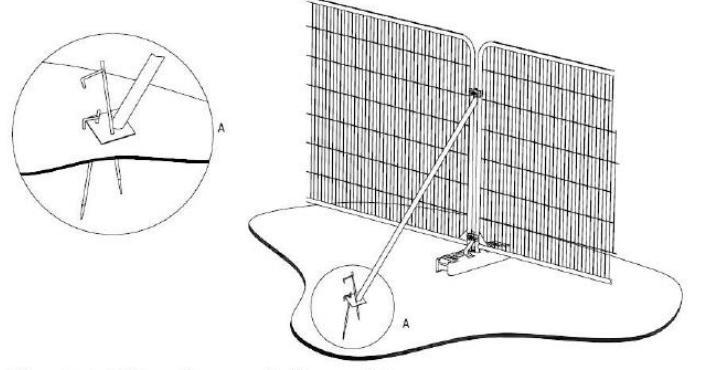
a) Stabilizer strut with base plate secured with ground pins

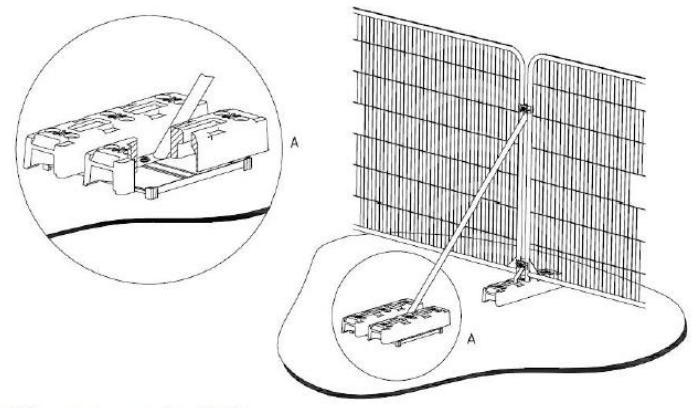
b) Stabilizer strut mounted on block tray
