## Bat Survey at Distington Hall Crematorium, Workington, Cumbria, CA14 4QY

## 2019

Job No	ArP18SCO021/BAT1	Doc No.		1	
Title	Bat Survey at Distingt	on Hall Crematoriu	um, Workington,	Cumbria, C	A14 4QY: 2019
Location	Distington, Cumbria				
Document Ref	ArP18SCO021/BAT1.001				
Revision	Prepared by	Checked by	Issued to	Date	Signed
DRAFT FOR CLIENT COMMENT / APPROVAL ONLY.	Sam Griffin	Victoria Griffin	Louise Cleminson	12/07/19	UNSIGNED UNSIGNED
FINAL	Sam Griffin	Victoria Griffin	Louise Cleminson	12/07/19	John Griffin . Ap OO

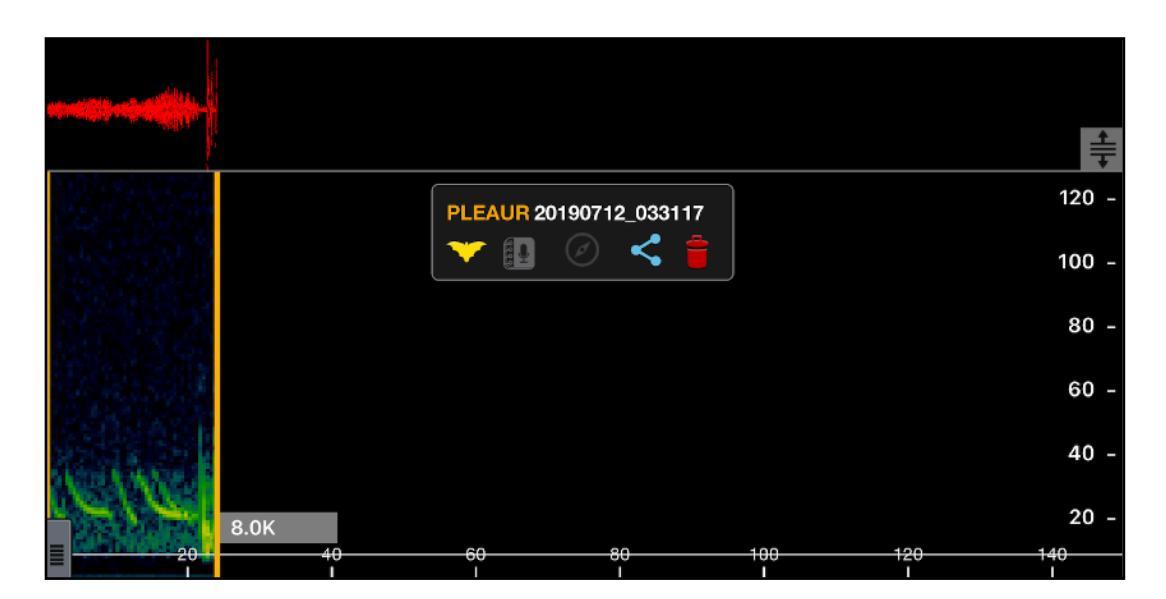
**Figure 6:** Showing short spectrogram of a brown long-eared bat recorded at 03:31 on 12 July 2019 at Distington Crematorium.

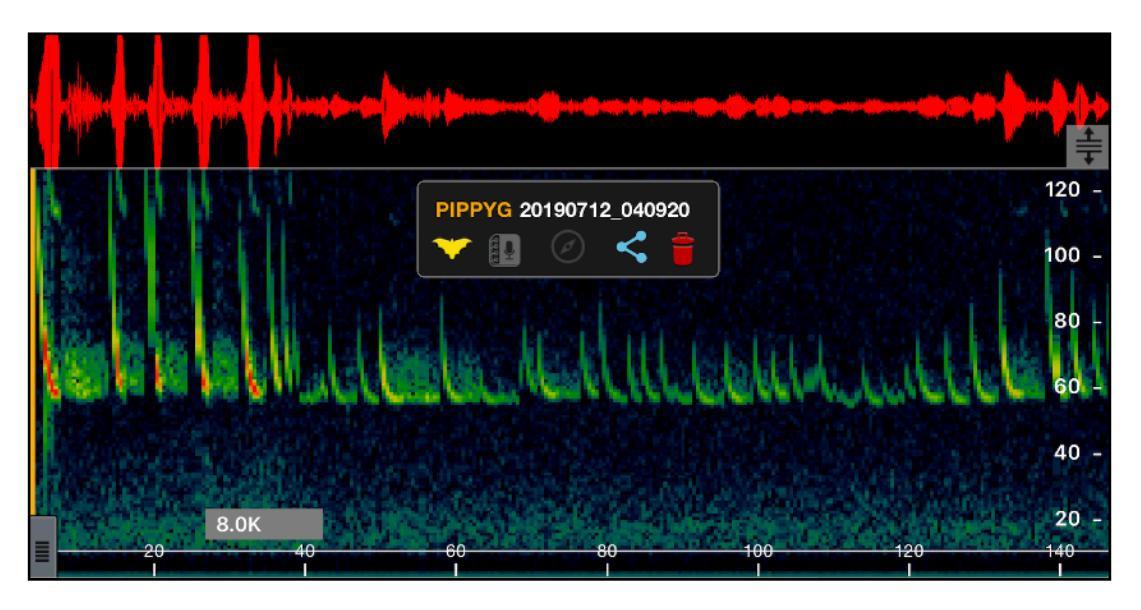
**Figure 7:** Showing spectrogram of a soprano pipistrelle bat recorded at 04:09 on 12 July 2019 at Distington Crematorium whilst flying to and from Roost 4.

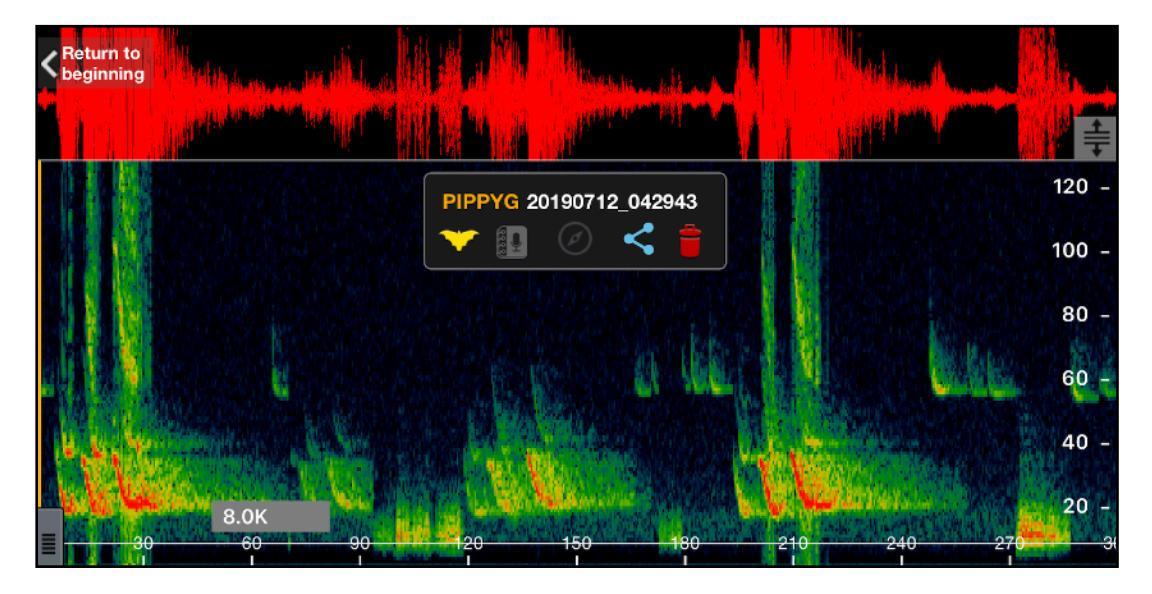
**Figure 8:** Showing spectrogram of a soprano pipistrelle bat recorded at 04:29 on 12 July 2019 at Distington Crematorium whilst flying to and from Roost 4. NB - Loud social calls.

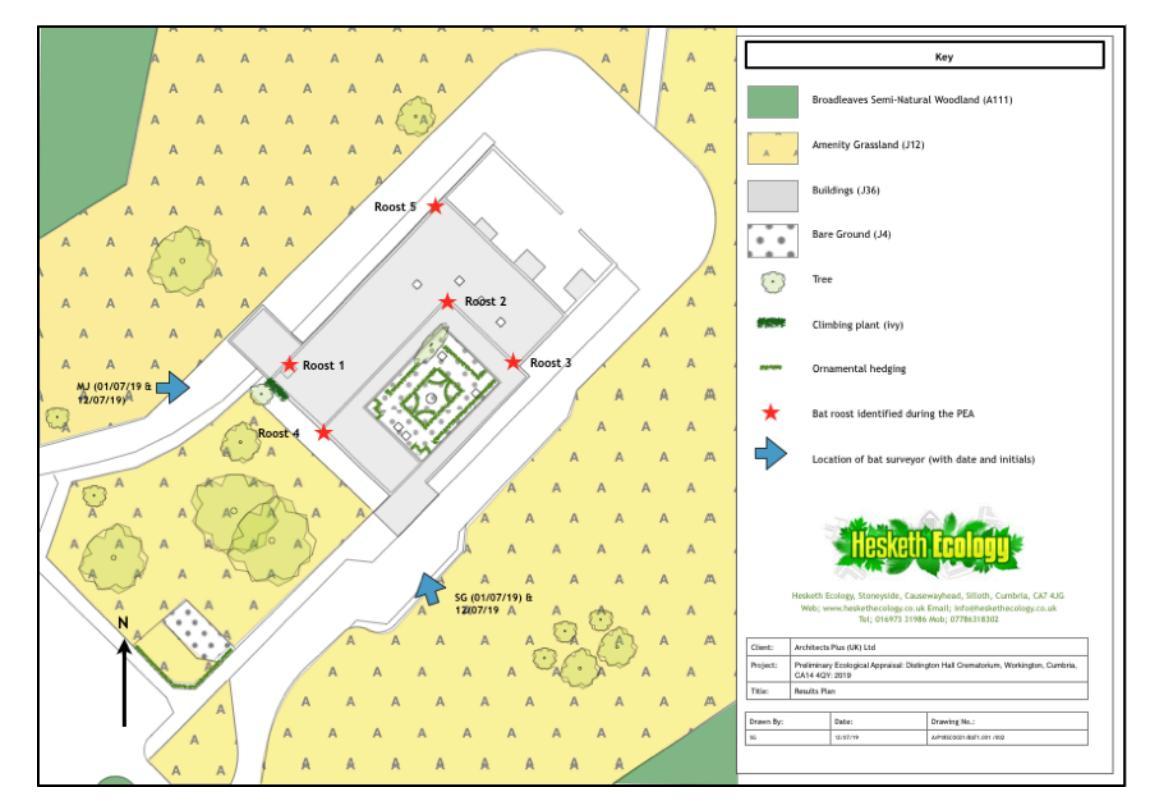
Figure 9: Survey Results Plan.

During the site inspection three distinct accumulations of bat droppings were identified around the building. Two of these accumulations were identified on the flat roof of the ground floor areas, beneath gaps behind the retrofitted fascia above. One accumulation of droppings was found beneath the canopy adjoining the northern side of the building directly adjacent the main entrance. These accumulations of droppings all contained both old and fresh droppings and all droppings identified were small and typical of Pipistrelle sp. bats. Being early in the active season, it is quite possible that further potential roost locations were not identified during this site inspection as a result of historic evidence having been lost over winter.

During the dusk emergence survey (01/07/19) the first bat was recorded at 21:46hrs (15 mins after sunset), this was a soprano pipistrelle bat (Pipistrellus pygmaeus) which was observed approaching the crematorium building from the west. A small number of soprano pipistrelle bats were then observed foraging around trees within the amenity grassland to the south of the building and around trees to the north and south. At c.22:15hrs a single soprano pipistrelle bat was seen to repeatedly fly to and from gaps behind the retrofitted metal fascia on the southern elevation. This behaviour continued for a period of 10-15 minutes but the bat was not seen to enter any crevice and no bats were seen to emerge from this area. Bat activity was generally rather limited in the area immediately surrounding the building. Higher levels of activity were observed in and around the woodland which surrounds the site and bats were observed flying over the building. A small number of common pipistrelle calls were recorded throughout the survey. No bats were definitely seen to emerge from the building during the dusk survey. Bats emerging from a roost at dusk can be harder to identify than bats returning to a roost at dawn and considering the scope of the activity survey and the location of the surveyors (i.e. observing areas affected by the proposed external extensions only) it is possible that bats emerged from other areas of the building, however it can be confidently asserted that no bats emerged from 'Roost 1' (See Figure 5) during this dusk survey.

During the dawn survey no bats were seen to enter Roost 1 or Roost 2. A single soprano pipistrelle bat was seen to enter Roost 5 and 3 soprano pipistrelle bats were seen to enter Roost 4.

From the results of the daytime site inspection and two activity surveys it would appear that the Crematorium building contains numerous roost locations, all likely to be used by pipistrelle sp. bats. Bat were confirmed as roosting in 2 locations at the time of the surveys - but field evidence suggests that a variety of other locations are also used. As the feature used by roosting bats - the retrofitted metal fascia - is broadly identical throughout the building it is tempting to consider this as a single roost, however due to the spatially separated location of the identified roost sites they are treated as individual roosts for the purpose of this survey report.

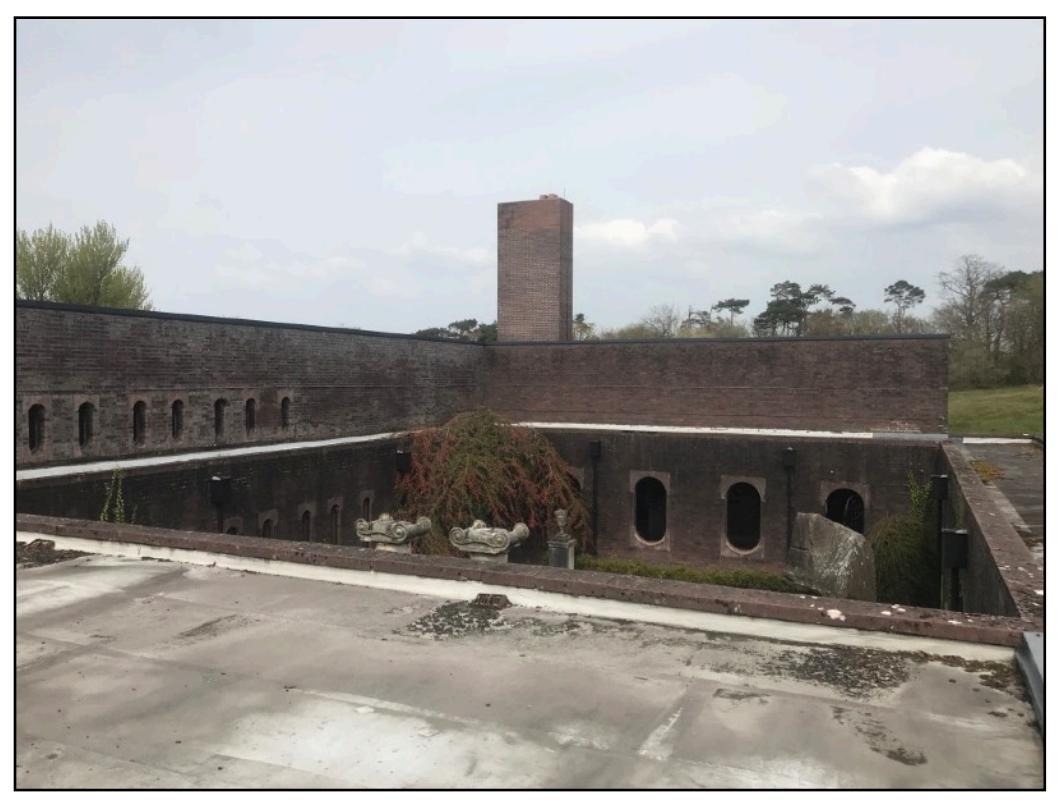
The structure of the original building offers very little opportunity for bats to roost. Being flat roofed, no internal roof voids exist and no slate / tile roof cladding exists on site. However the retrofitted metal fascia / capping does now offer some rather unusual bat roost potential. As the fascia / capping is metal, it is likely that the crevice behind has an extreme thermal range - getting very hot in the sun, but cooling down significantly at night. Ordinarily this may make this roost potential sub-optimal for bats, but as this fascia / capping extends around the entire building, it is likely that there will always be opportunity for any bats roosting beneath this feature to move to more suitable conditions during extremes of temperature. It is however unlikely to be sufficiently insulated for bats to use during the winter months.

Figure 13: Showing the flat roof of the ground floor areas and internal courtyard.

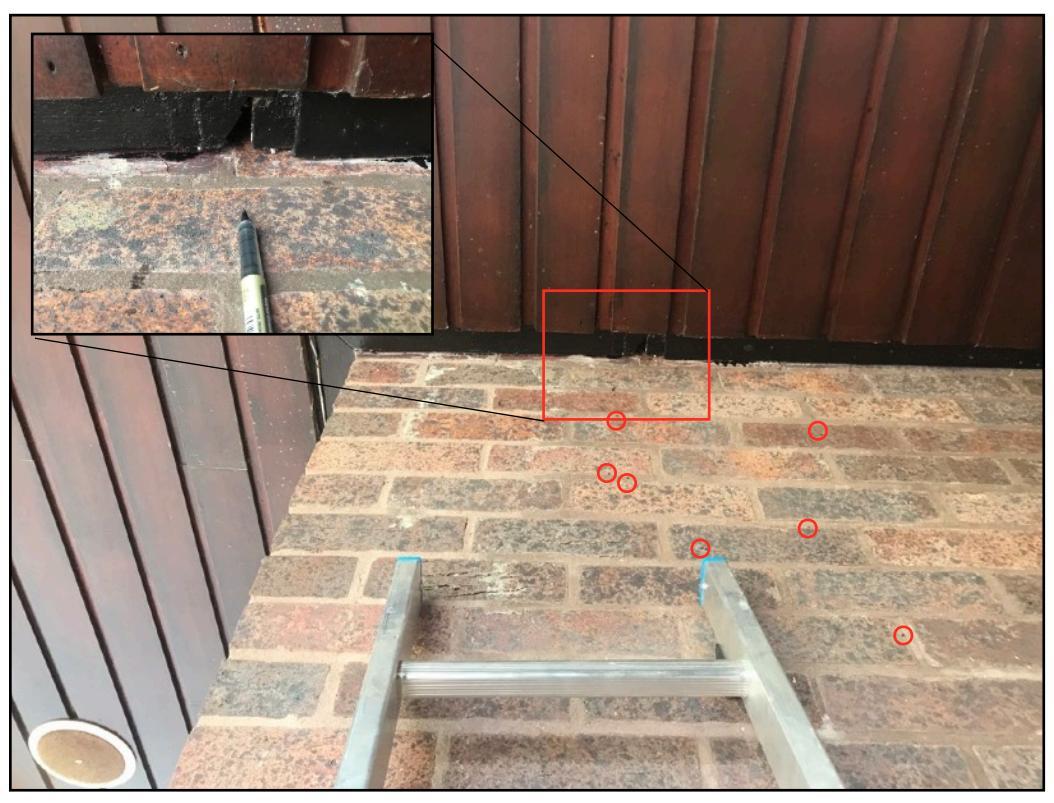
**Figure 14:** Showing bat roost (Roost 1) identified beneath the canopy at the entrance to the crematorium with droppings adhering to the wall identified in red. See Figure 7.

In order to avoid disturbing bats occupying Roosts 1 & 4, it is recommended that timing constraints are employed to ensure that no bats are present when potentially disturbing works take place. The metal fascia feature used by bats at Distington Hall Crematorium is highly unlikely to offer sufficient insulation to be used as a hibernation roost. Bats are therefore likely to vacate these roosts by November of any given year. Work to construct the external canopies on the south west elevation should be completed between November 1st and March 15th, thus occurring when bats are unlikely to be present and therefore avoiding disturbing bats during the works.

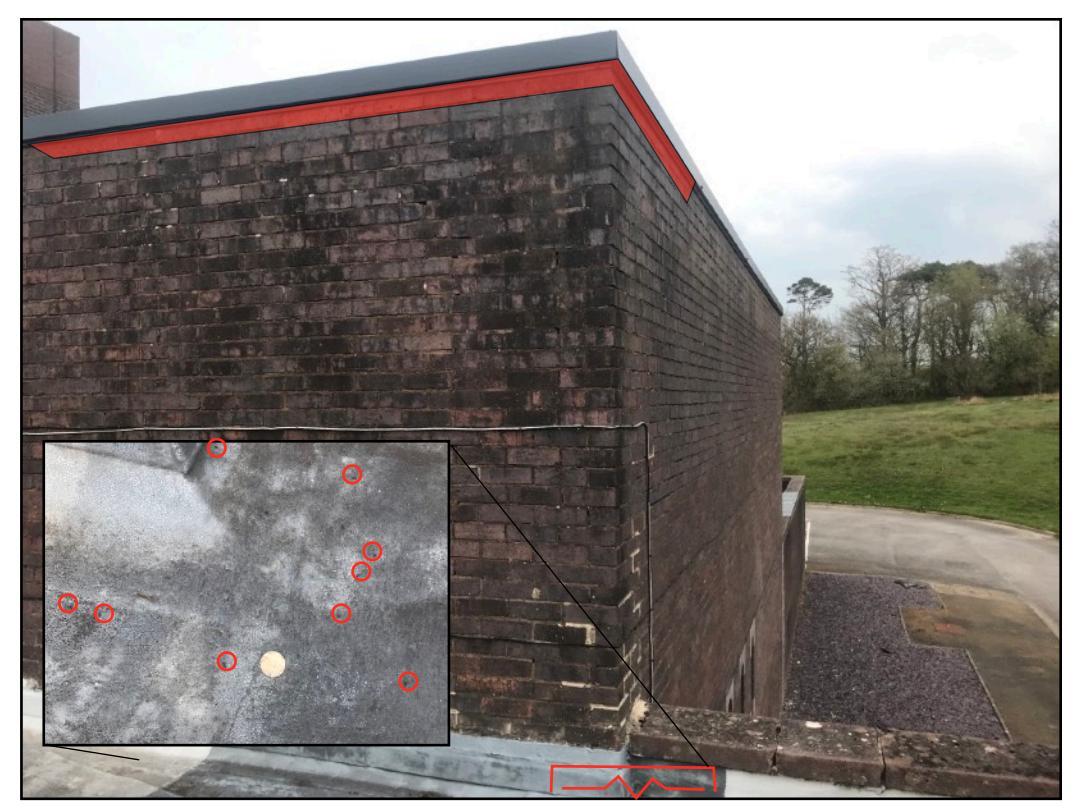
**Figure 15:** Showing bat roost (Roost 2) identified above the flat roof on the south eastern elevation with droppings below identified in red on the inset and presumed roost location and extent identified in red on main photograph. See Figure 7.

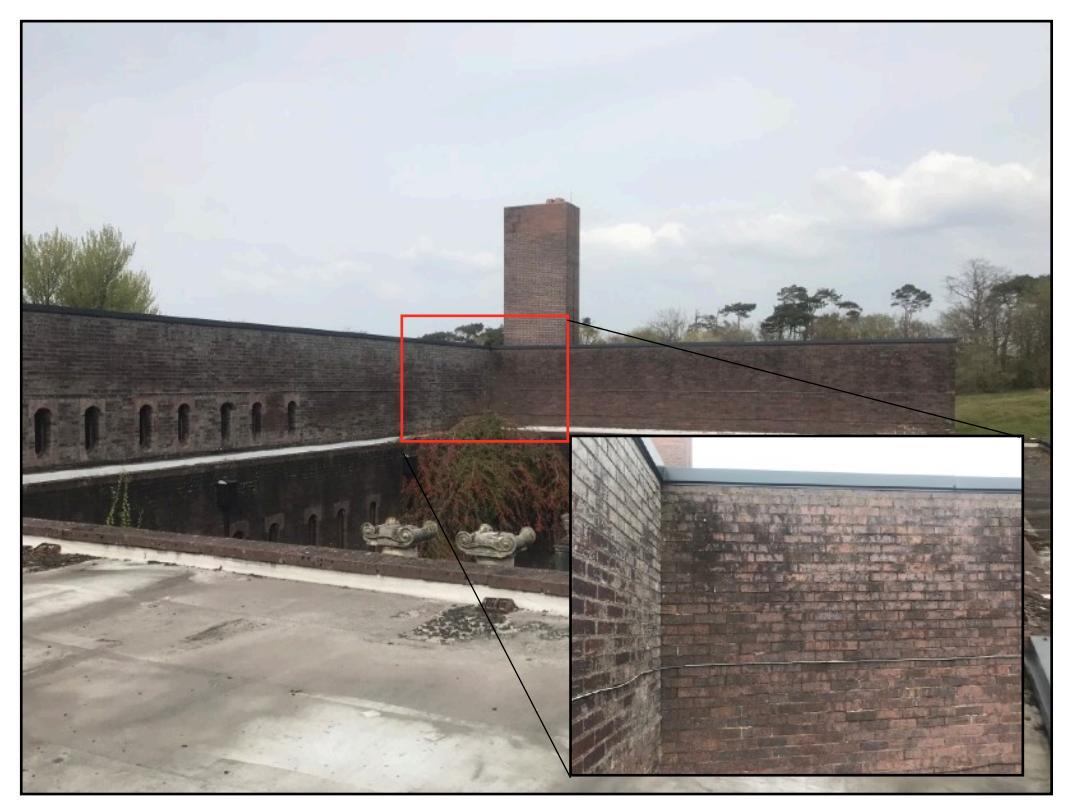
**Figure 16:** Showing bat roost (Roost 3) identified above the flat roof on the south eastern elevation with roost location identified in red in the inset. See Figure 7.

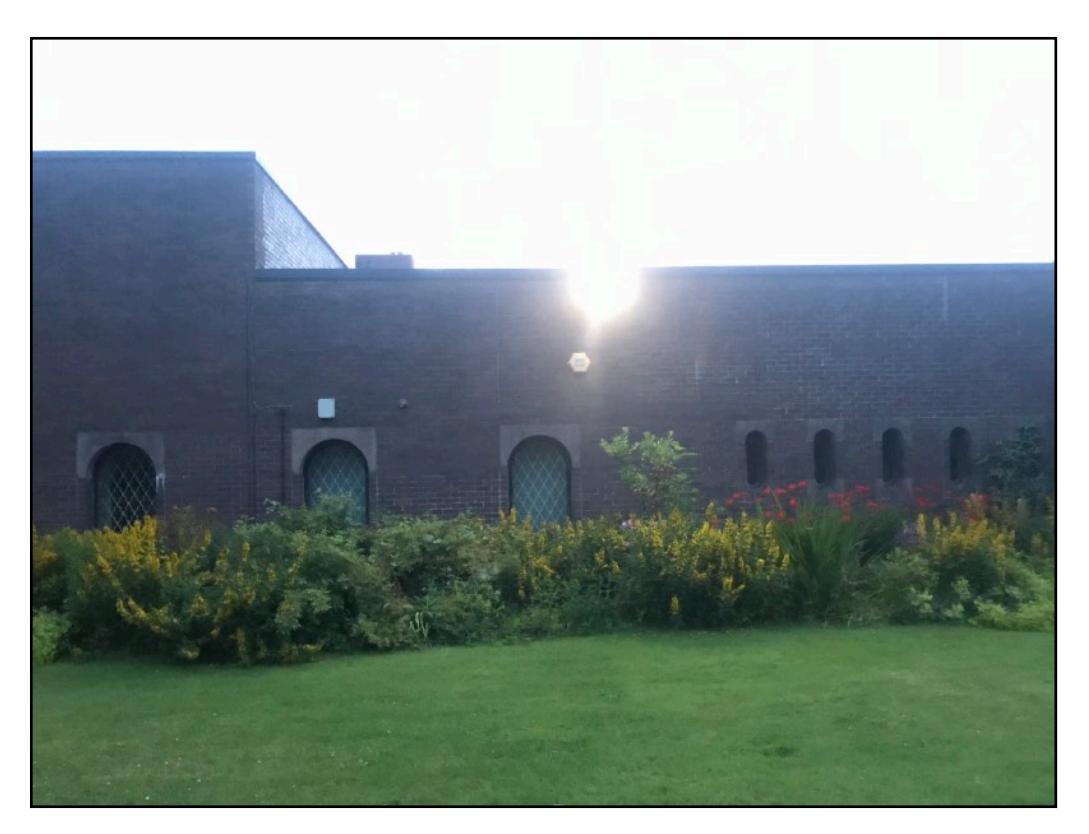
From 03:50hrs onwards soprano pipistrelle bats were seen repeatedly flying to and from gaps behind the metal fascia on the southern elevation. This behaviour was sustained for some time and gaps along the entire length of this elevation - on both the single storey and two storey height sections - were investigated. At 04:15hrs a single soprano pipistrelle was seen to enter a gap at the extreme western end of the single storey section, adjacent where the single storey section adjoins the two storey height section (See Roost 4 on Figure 9). This bat was then followed by a second soprano pipistrelle at 04:20hrs. At 04:22hrs a single soprano pipistrelle was seen to enter a gap on the northern elevation (See Roost 5 on Figure 9) of the building well away from the proposed works on the western elevation. At 04:25hrs 2 soprano pipistrelle bats re-emerged from Roost 4 and were seen flying between Roost 2 and Roost 4 above the single storey section. At 04:35hrs 3 soprano pipistrelles entered Roost 4 and did not re-emerge.

**Figure 17:** Showing bat roost (Roost 4) identified during the dawn survey on 12/07/19. See Figure 9.
