Cleator Moor Innovation Quarter – Unit 1A

INTERIM BAT ROOST ASSESSMENT REPORT

784-B034942 Rev 1

Copeland Borough Council

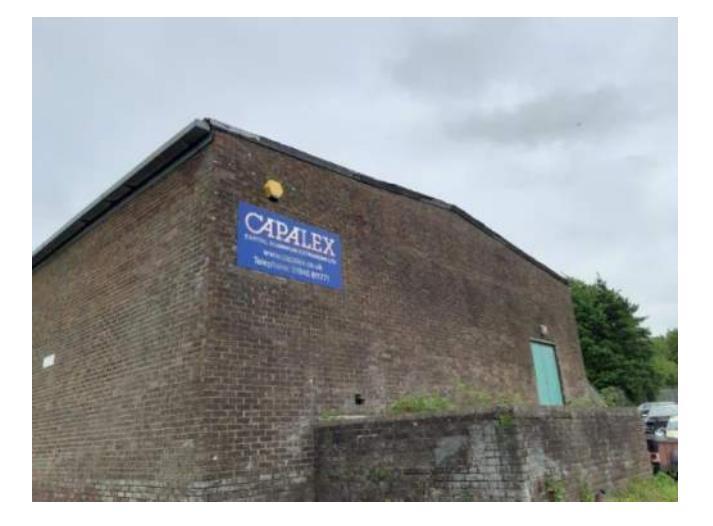
Photograph 1 – Western corner of Unit 1A on Leconfield Street

Unit 1A comprised a tall brick-built building with a slight double pitched roof finished with bitumen (see Photograph 1).

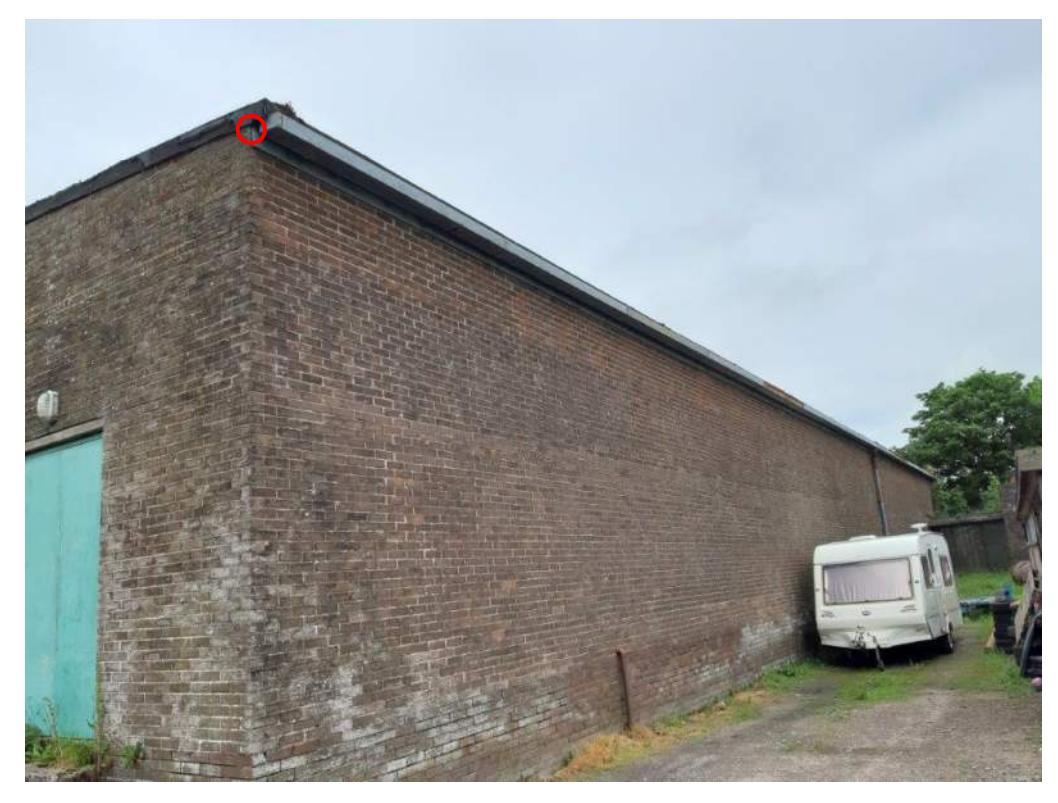
Photograph 2 - Roost 1, Unit 1A

During the dusk emergence survey, a single common pipistrelle bat was observed emerging from the gap between the brick wall top and the wooden facia / bitumen roof overlap on the southern corner of Unit 1A at 21:42, (22 minutes after sunset. (See Figure 2, Roost R1 and Photograph 2 below)).

• Roost R1 is located at the southern roof corner to B6, with a single egress point gap between the brick wall top and the bitumen roof overlap. A single common pipistrelle was observed using this roost on two occasions (during the dusk emergence survey on 29th July 2021 and during the dawn re-entry survey on 10th September 2021) (see Photograph 2 and Figure 2).

The development proposals, in particular the recladding of the roof will directly impact on Roost R1 through destruction of the roost (permanent loss).

As the proposed works will result in the destruction of the common pipistrelle day roost (R1) within Unit 1A, an EPSML must be obtained from NE to permit the refurbishments works to Unit 1A and compensate for the roosting feature lost.

The roost will be subject to a pre-check with endoscope prior to any works commencing on site. Following the inspection, the identified bat roost will be subject to destructive search under the close supervision of the EPSML Named Ecologist or an Accredited Agent. The bitumen roof overlap to Unit 1A will be removed by hand in anticipation that bats may be present.

It is also recommended that cladding and re-roofing activities conducted on the south-eastern elevation of Unit 1A are conducted under the supervision of a licensed bat ecologist under the EPSML. As compensation, one bat box such as Schwegler 1FF (or equivalent) will be installed in a similar position to the existing roost (i.e. south west corner of Unit 1A). This must then be retained intact and in situ for a minimum of five years.

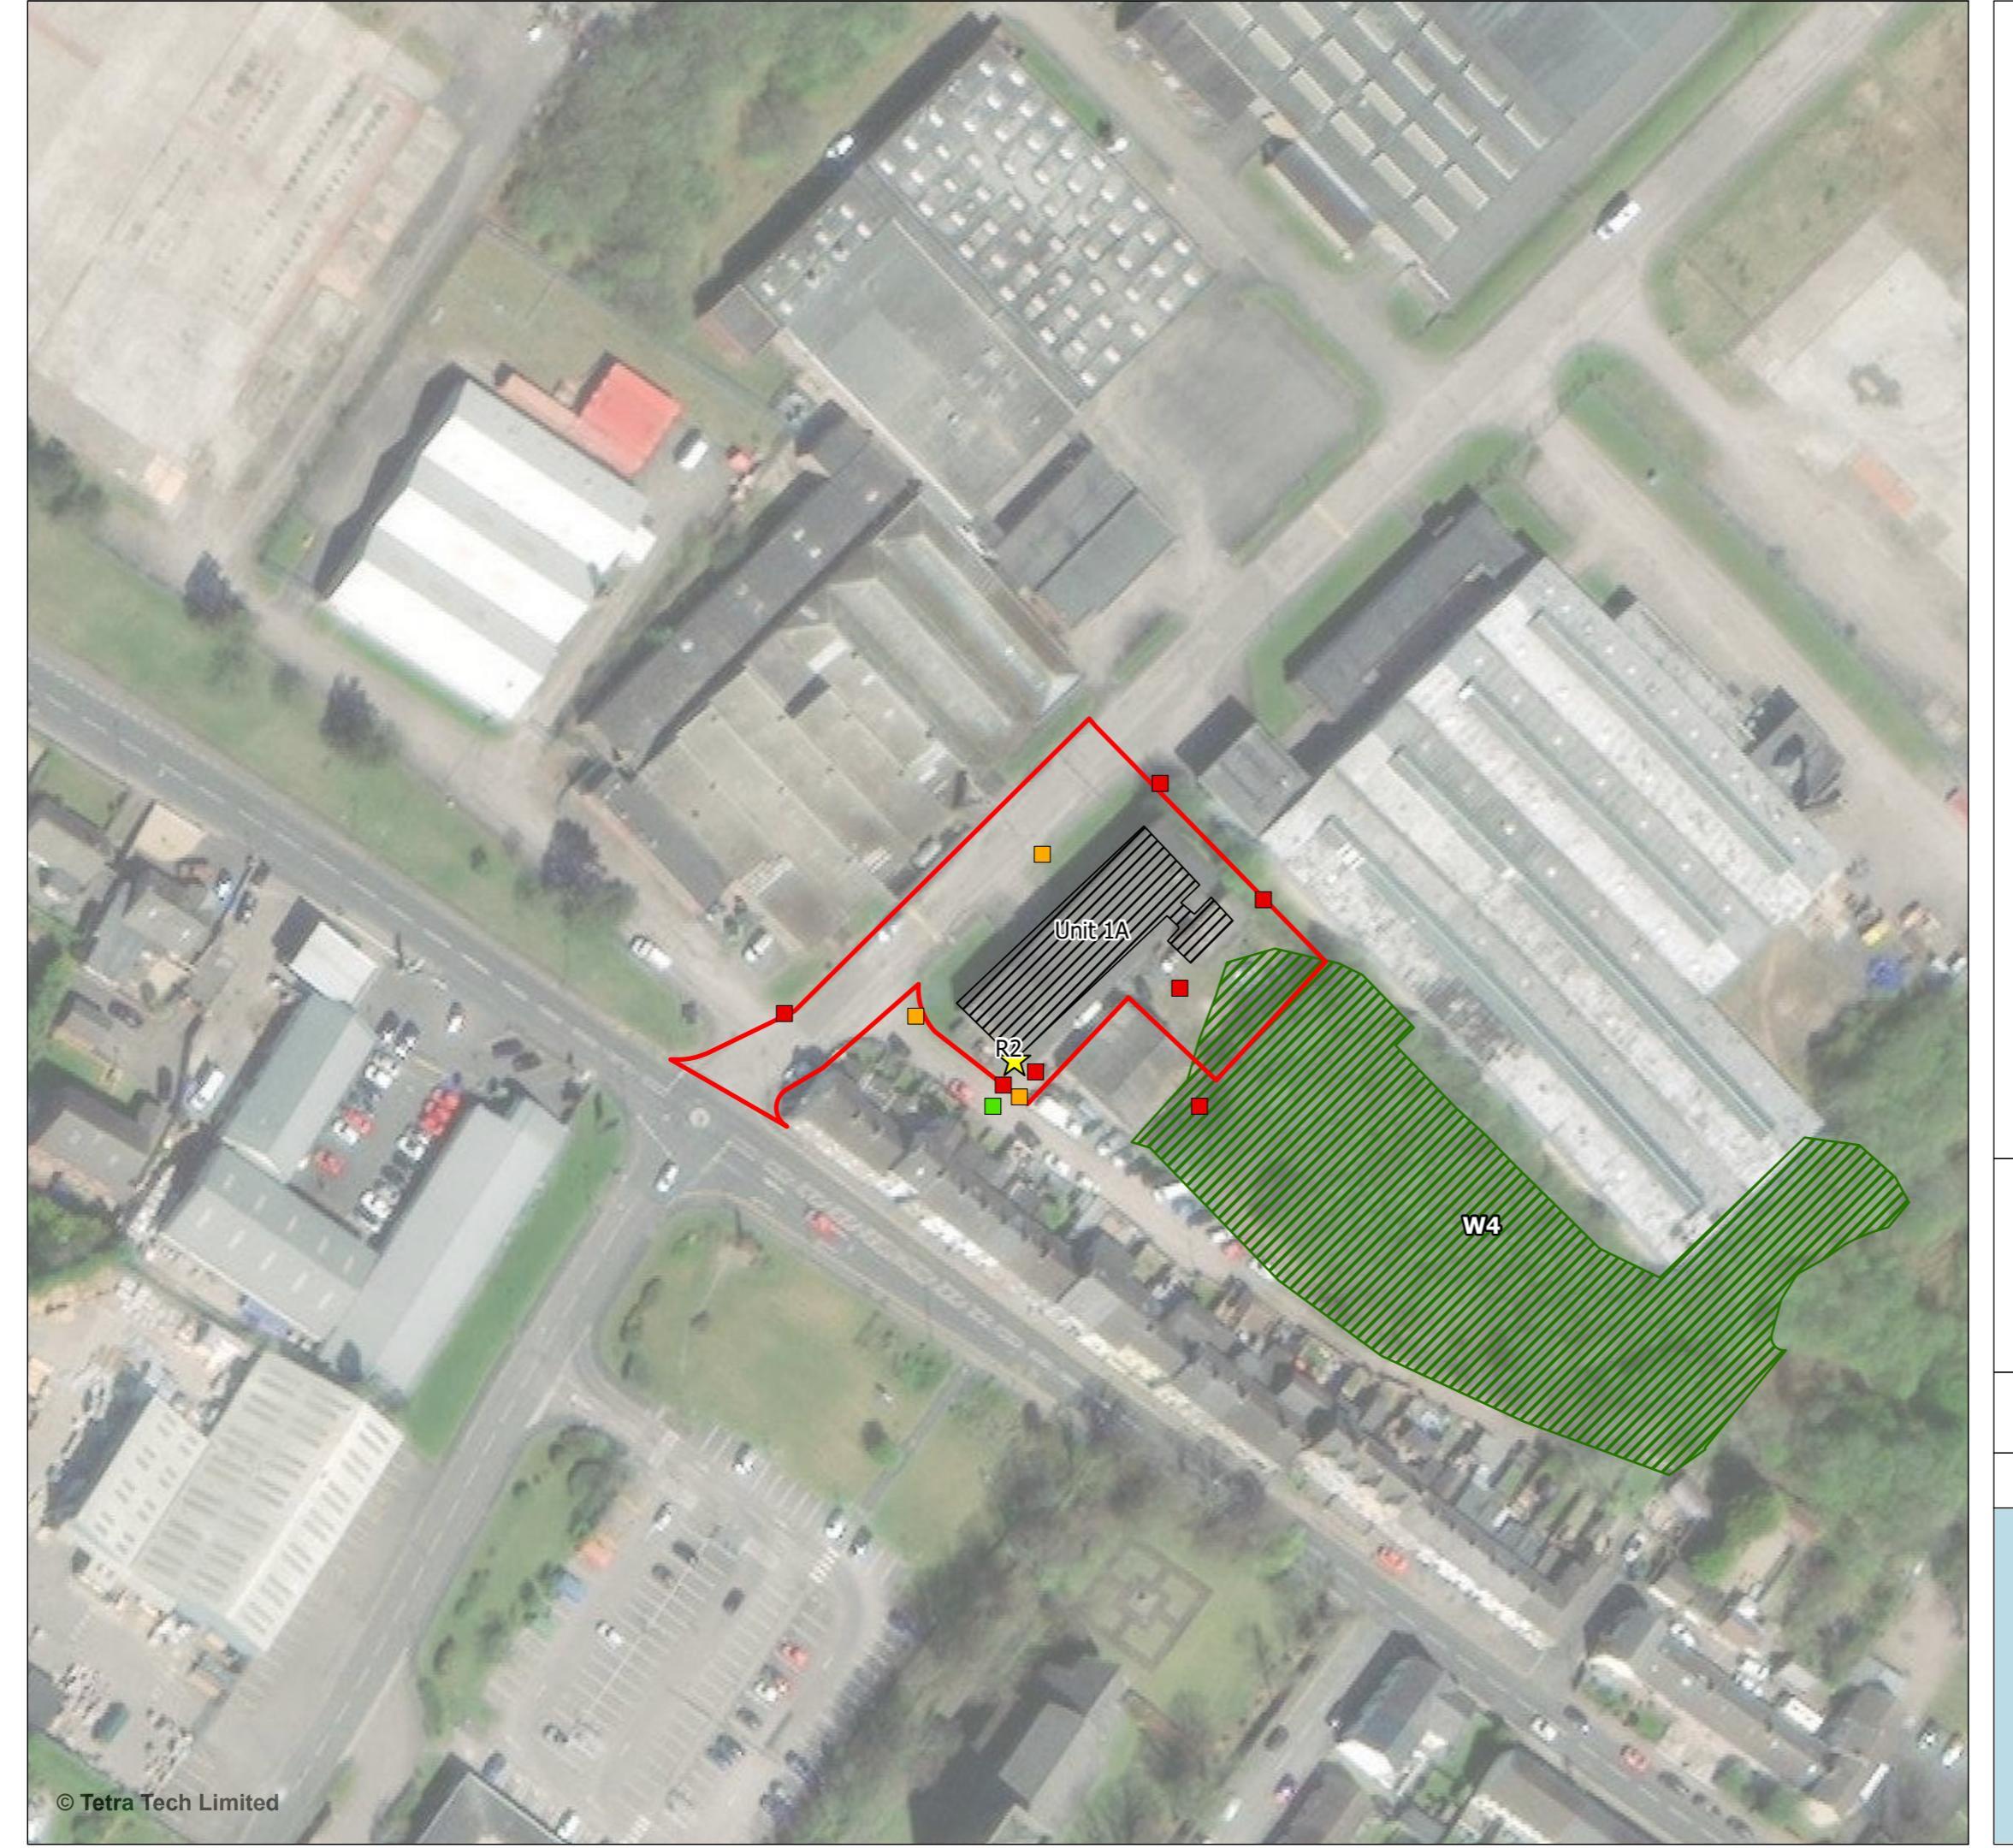
Figure 2 – Bat roost and ground level bat tree assessment summary map

During the dawn re-entry survey a single common pipistrelle re-entered a gap along the southern corner of the roof of building Unit 1A at 06:09 (12 minutes before sunrise). This was the same roost location as identified during the dusk emergence survey on 29th July (Figure 2, Roost R1).

During the dusk emergence survey no bats were recorded emerging from Unit 1A. No emergence was observed from the roost identified on 29th July and 1st September (Figure 2, Roost R1).

Bat roost and ground level bat tree assessment summary map CMIQ Proposed Hub - Unit 1A
